PROPERTY INSPECTION REPORT

1234 Sunny Lane, Anytown, CA 91001

DATE OF INSPECTION: 3/15/2020

VILLA HOME INSPECTIONS

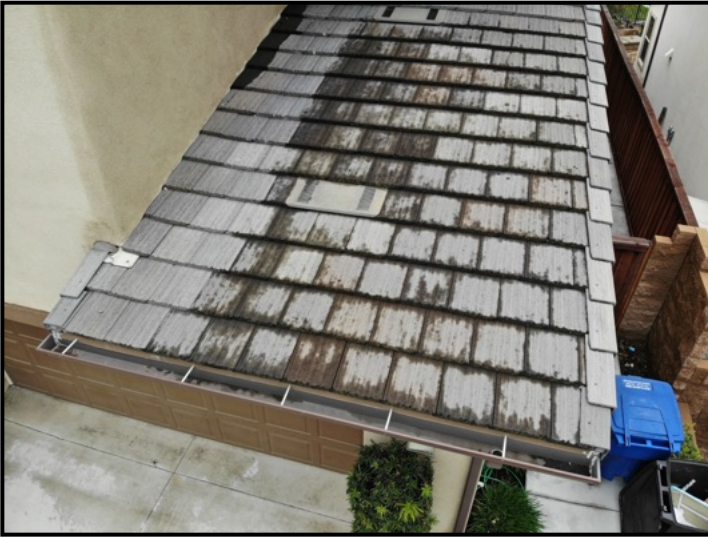
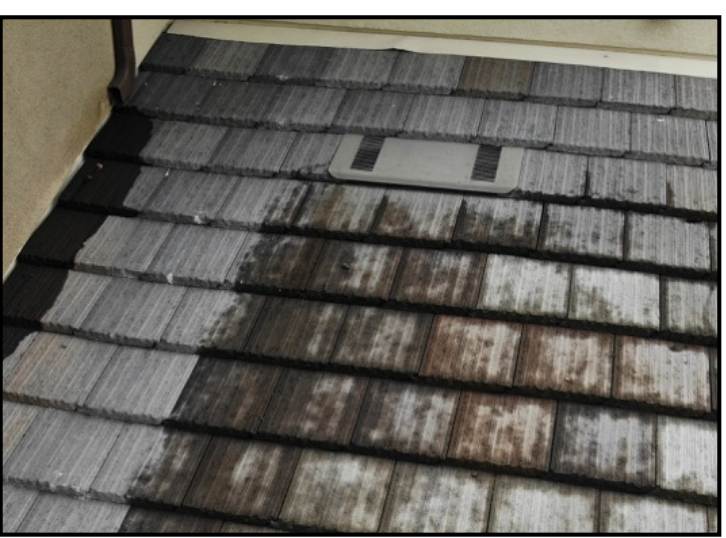
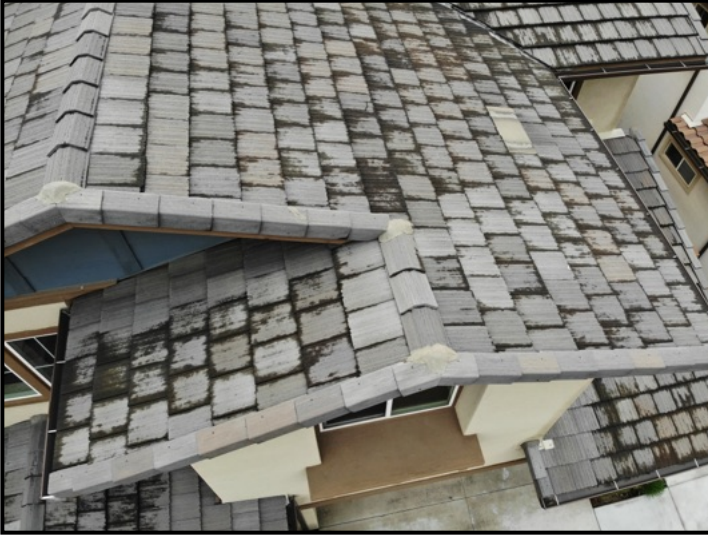
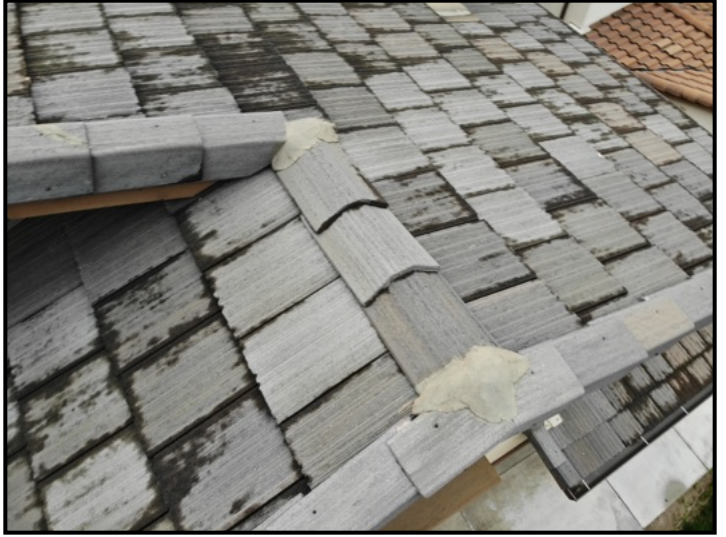
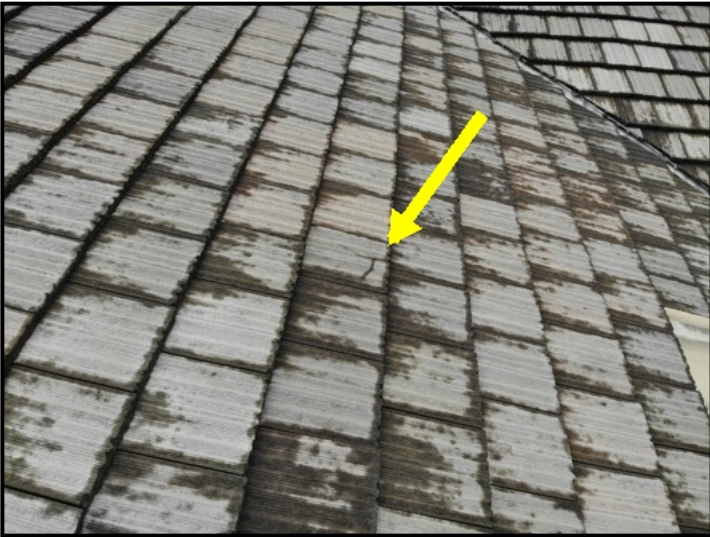
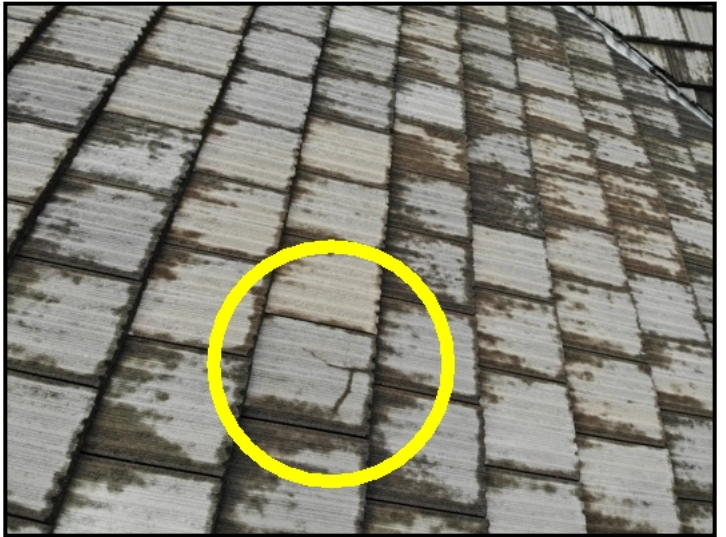
4. Covering Condition

- Roofing material appears to be within it's useful life.
- **Cracked or broken tiles observed.**
- **TYPICAL MAINTENANCE IS RECOMMENDED.** This usually consists of repair or replacement of damaged or missing shingles or tiles. This maintenance should help insure the weather tightness of the building and should be performed on a regular basis.
- See photos.

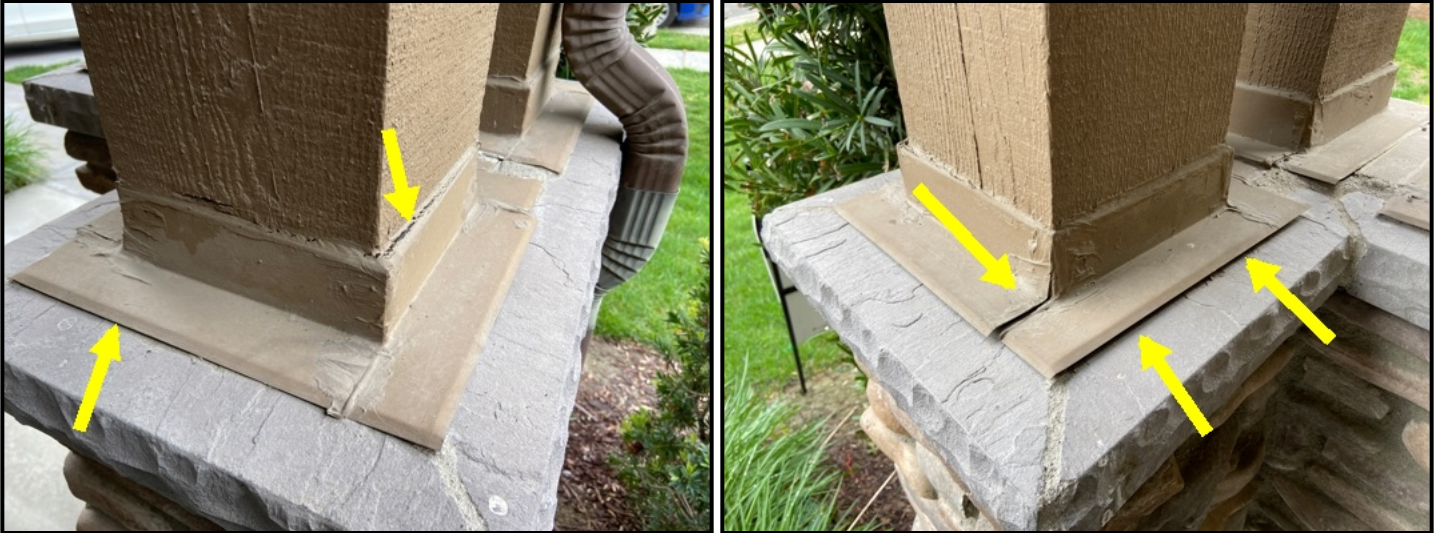
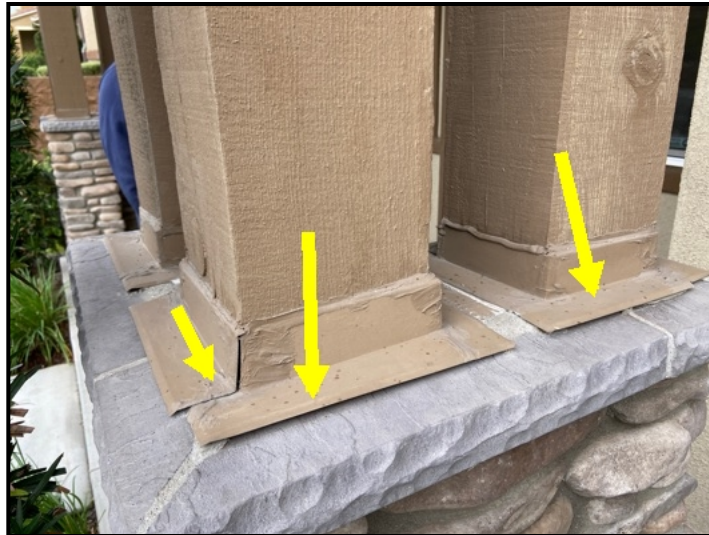
- Flashings at the porch wood columns are not sealed properly. See photos.

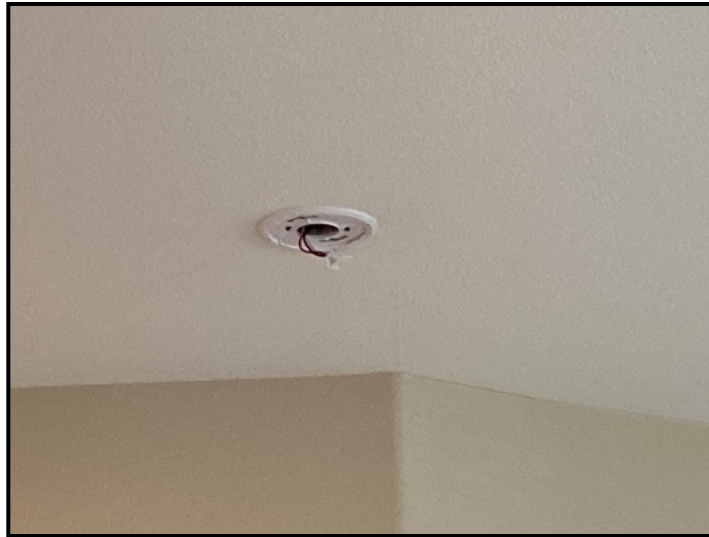
- **Hardwired type smoke detector has been removed from the wall or ceiling. A working smoke detector is required to be installed in every bedroom and adjacent hallway prior to the close of escrow.**
