# **RV Inspection Report**

2020 Gulf Stream Conquest 6238

WE RV SERVICES, LLC David Patty 256-605-0706 david@wervservices.com

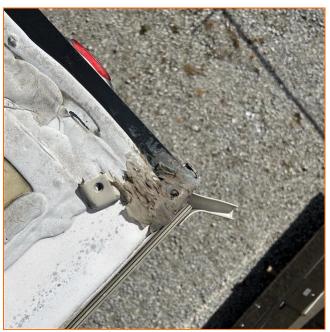
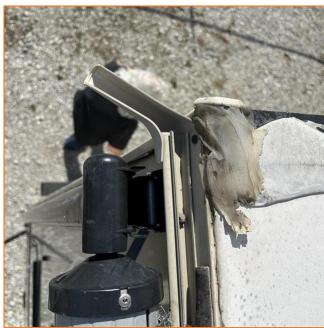
## Rear Cap, Joints and Seals

Both rear cap corners have been repaired, but the wrong kind of sealant was used. Recommend evaluation by a qualified service technician.

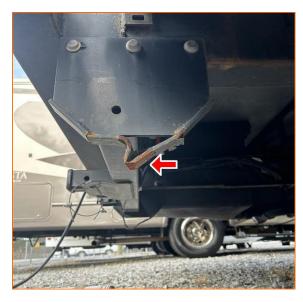
#### **Chassis and Frame Condition**

This part of the rear frame is bent. This causes no problem - it's just an indication that the rear has dragged previously.

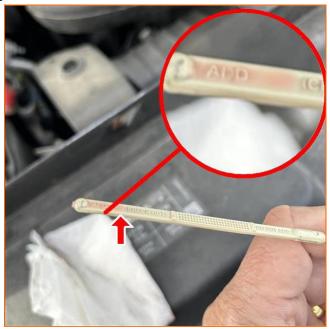
# **Engine Transmission Fluid level**

The transmission fluid is at the "ADD" level. Recommend filling to appropriate level.

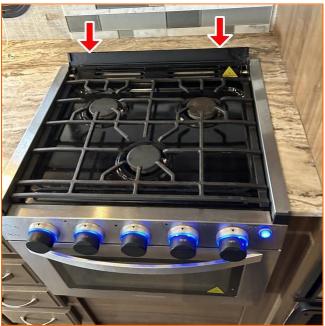
# **Cooktop - Burner Grate/Cover Condition**

The cooktop cover is missing. Recommend replacement.

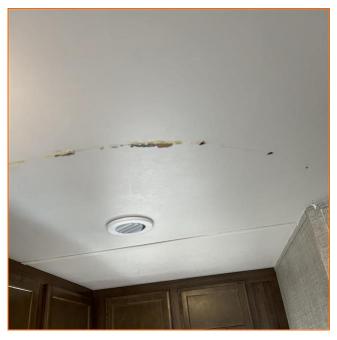
# Ceiling

There are some blemishes on the ceiling in the bedroom area. It appears that something was removed - possibly a curtain track.

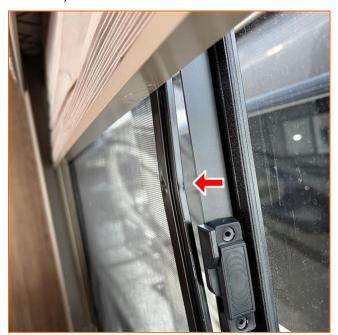
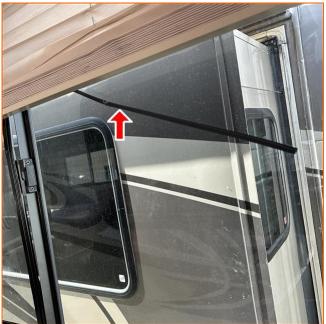
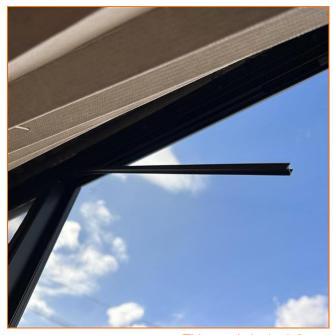
# Windows, Screens

This one is in the loft area

The screen at the dinette area is bent. Recommend straightening or replacement. Also, a piece of the interior window trim is detached and hanging down. Recommend repair.

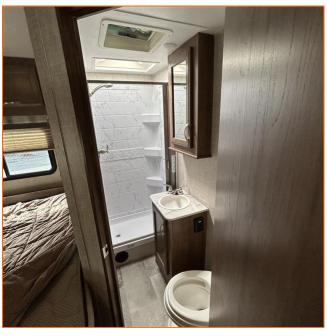
# Shower / Tub - Operation and Condition

The shower head handle is cracked and spraying water. Recommend replacement.

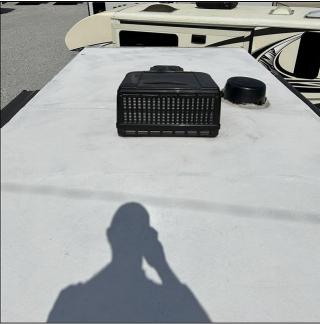
# 2.0 General Roof Condition Comments: Acceptable

Inspector observed a repair has been done on a small portion of the roof. It appears the repair is acceptable to prevent any water intrusion.

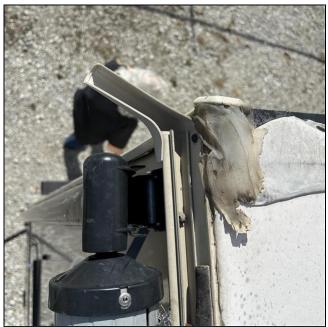
2.3 Rear Cap, Joints and Seals

Comments: Fair

Both rear cap corners have been repaired, but the wrong kind of sealant was used. Recommend evaluation by a qualified service technician.

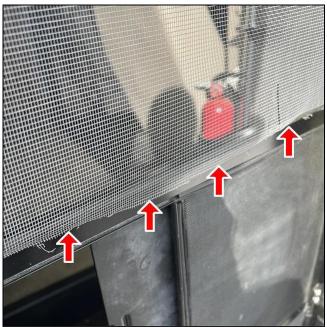
## 7.1.A Screen Operation and Condition

Comments: Fair

A one foot section of the screen is detached. Recommend reattaching the screen.

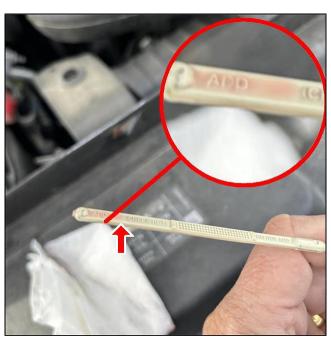
9.3 Engine Transmission Fluid level

Comments: Poor

The transmission fluid is at the "ADD" level. Recommend filling to appropriate level.

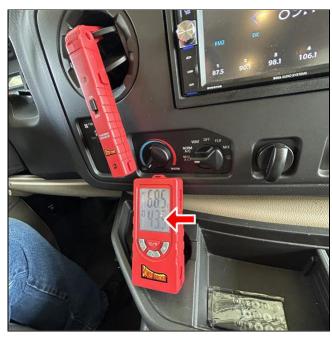
10.7 Dash Air Conditioner operation Comments: Acceptable

Dash air temp 43.3

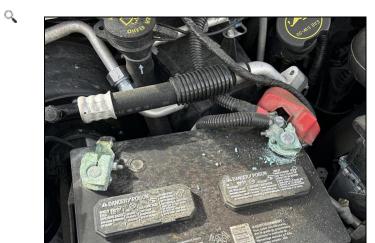
12.28 12-Volt DC Chassis Battery - Condition

Comments: Fair

The chassis battery terminals are corroded. Recommend cleaning.

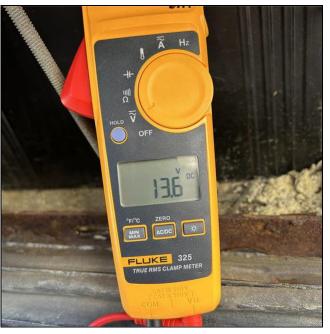
# 12.30 12-Volt DC House (Coach) Batteries - Condition

Battery voltage was 13.6 while plugged into shore power, and was 12.5 when unplugged from shore power. There should a voltage drop when unplugged from shore power and the converter kicks in. However, a drop of this amount indicates the battery may be weakening. Recommend evaluation of the battery.

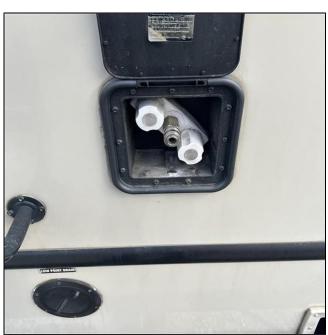
13.2 Outside Shower - Condition and Operation

Comments: Poor

The outside shower hose is missing.

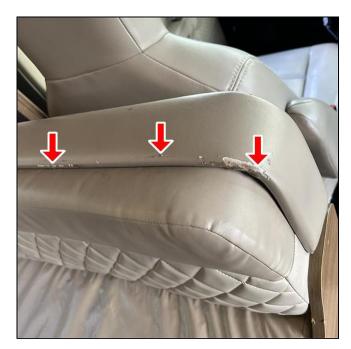
15.2 Dinette - Booth Seats / Chairs Comments: Fair

There are some blemishes on the dinette booth seat.

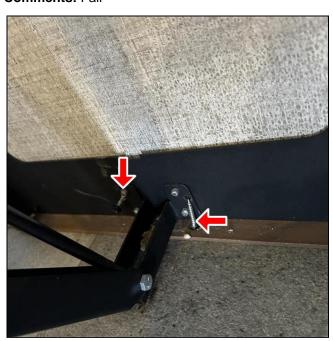
# 15.3 Dinette - Table / Bed Comments: Fair

There are two screws are loose at the base of the table leg. Recommend tightening screws.

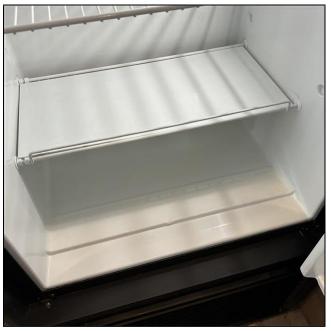
The drawer and door bins are missing from the refrigerator.

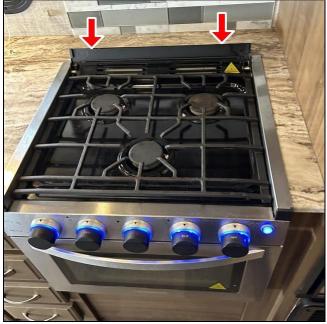
15.13 Cooktop - Burner Grate/Cover Condition

The cooktop cover is missing. Recommend replacement.

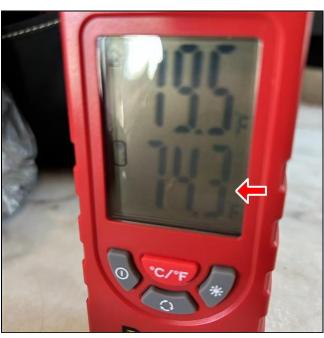
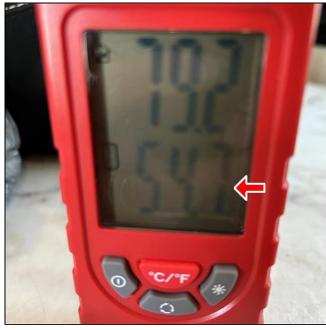
#### 17.0.A Air Conditioner Operation and Condition

Comments: Acceptable

Intake air temp 74.3

Output air temp 54.7

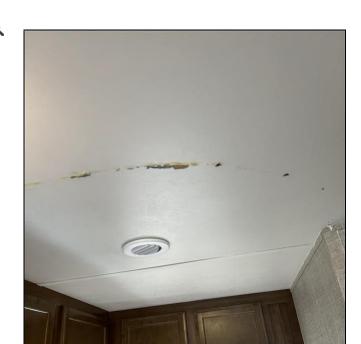
18.2 Ceiling

Comments: Fair

There are some blemishes on the ceiling in the bedroom area. It appears that something was removed - possibly a curtain track.

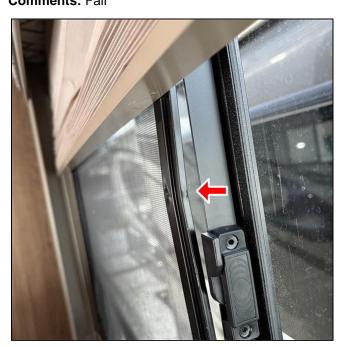
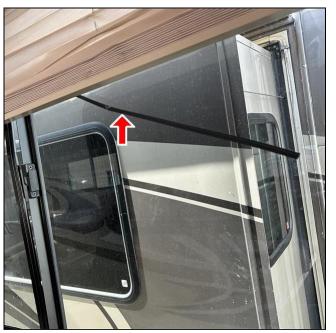
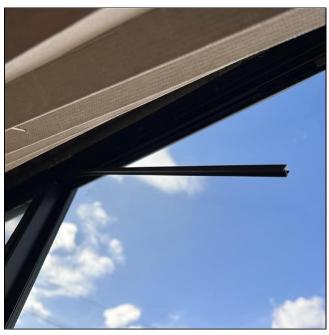
# 18.10 Windows, Screens Comments: Fair

This one is in the loft area

The screen at the dinette area is bent. Recommend straightening or replacement. Also, a piece of the

interior window trim is detached and hanging down. Recommend repair.

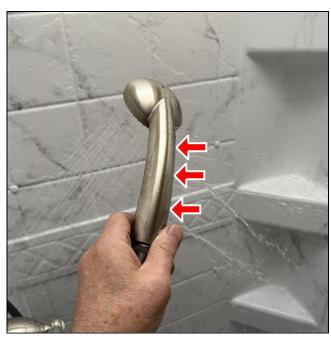
19.6 Shower / Tub - Operation and Condition

Comments: Fair

The shower head handle is cracked and spraying water. Recommend replacement.
