Inspection Report

Mr. Fuller RV Services

(7) 2009 Tiffin Phaeton 42QBH Floorplan

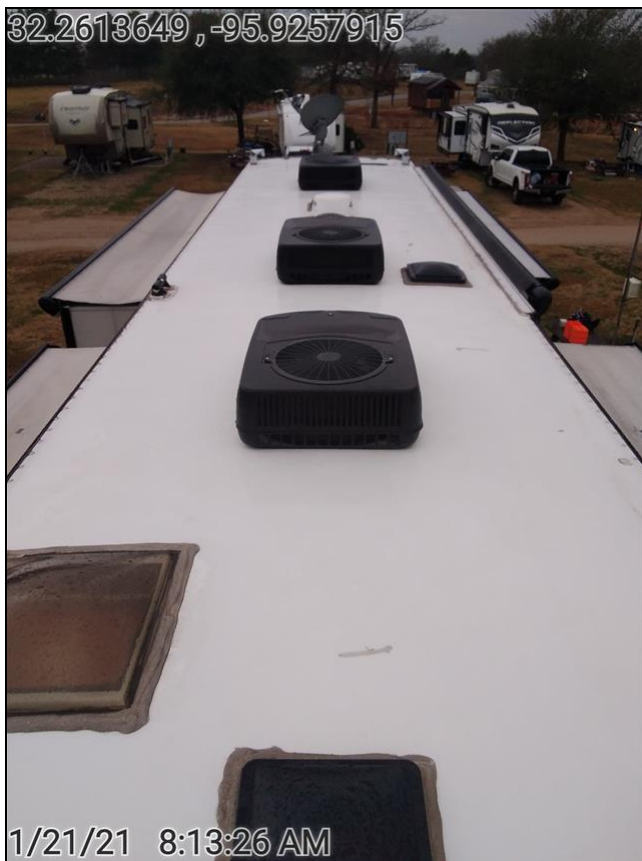
Roof facing front

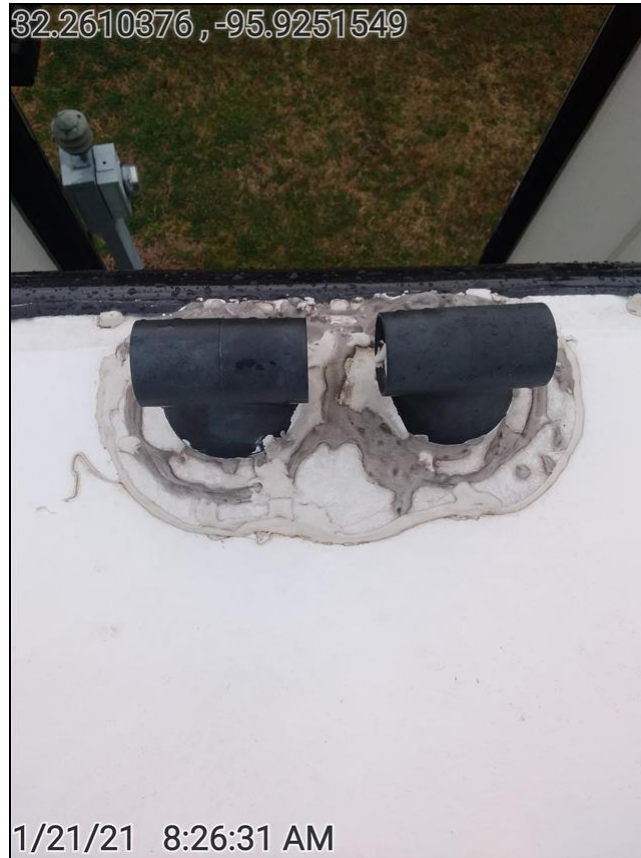
The plumbing vent covers are acceptable.

Plumbing vent cover.

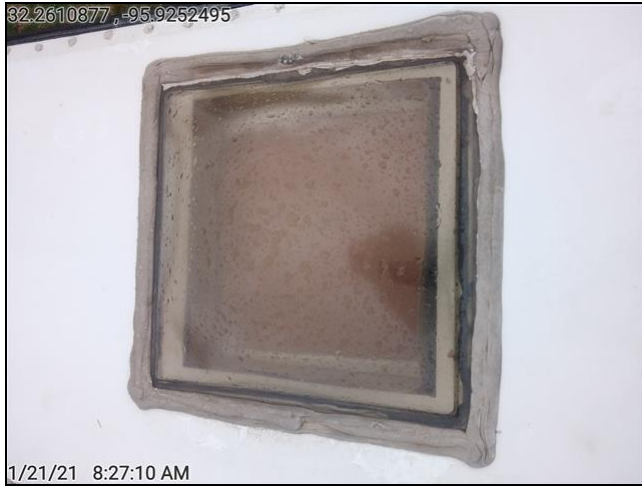
Main bath skylight

The main bath skylight is acceptable.

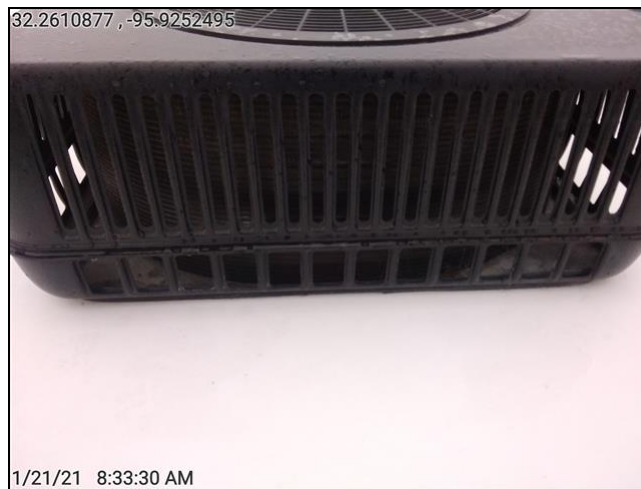
Rear AC coils.

The inspector observed that the AC coils are maintained in acceptable condition.

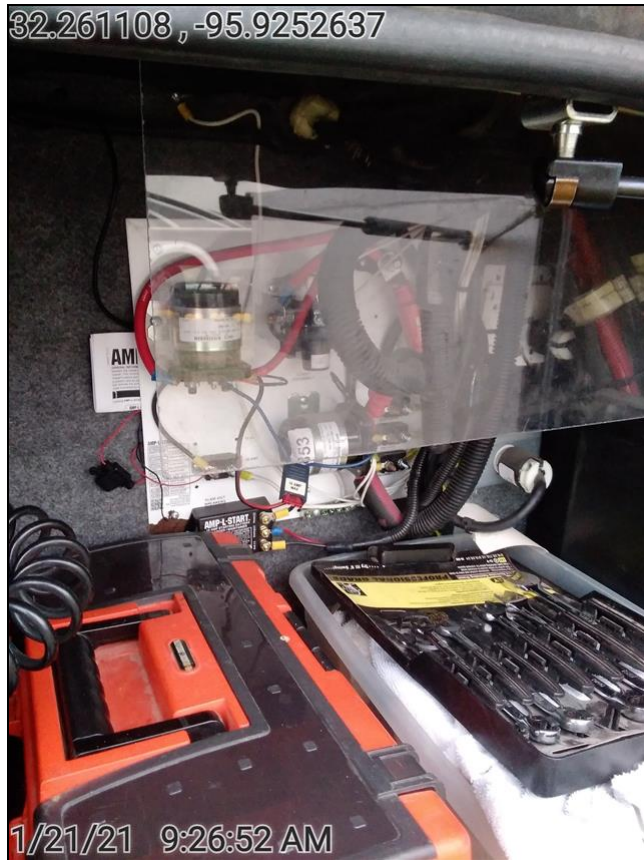
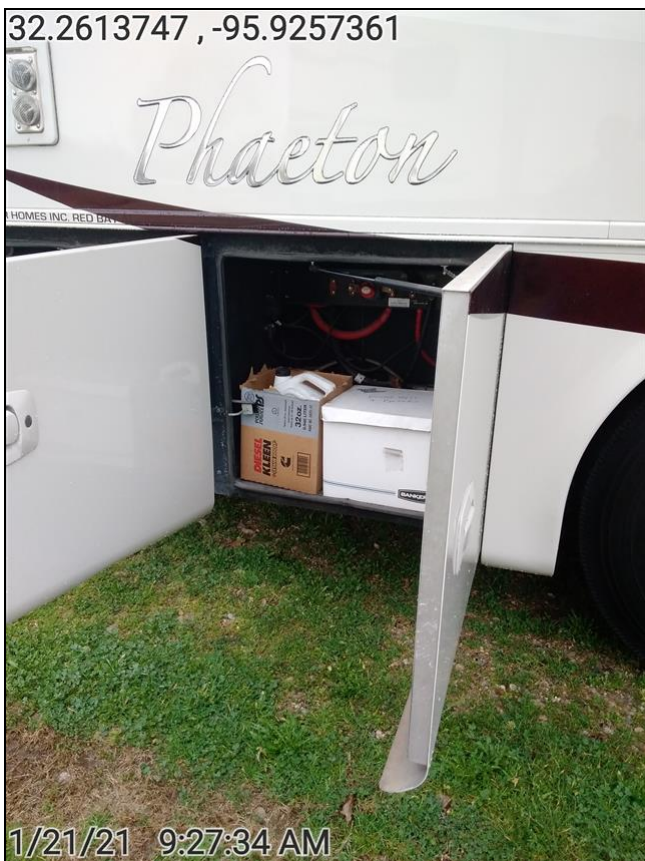
The curbside access cargo and access doors are in acceptable condition.

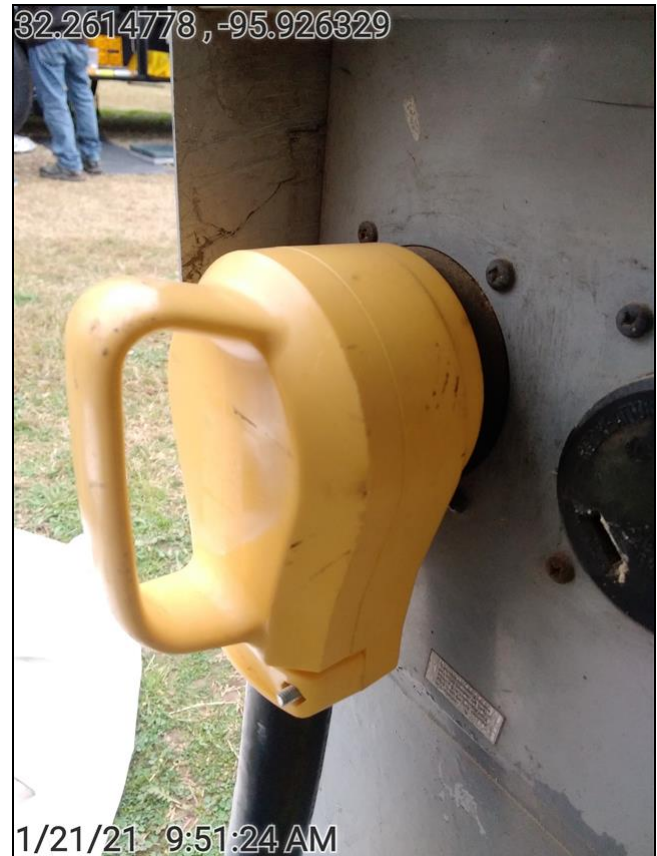
Shore power cord

The inspector noted that the shore power cord is in acceptable condition.

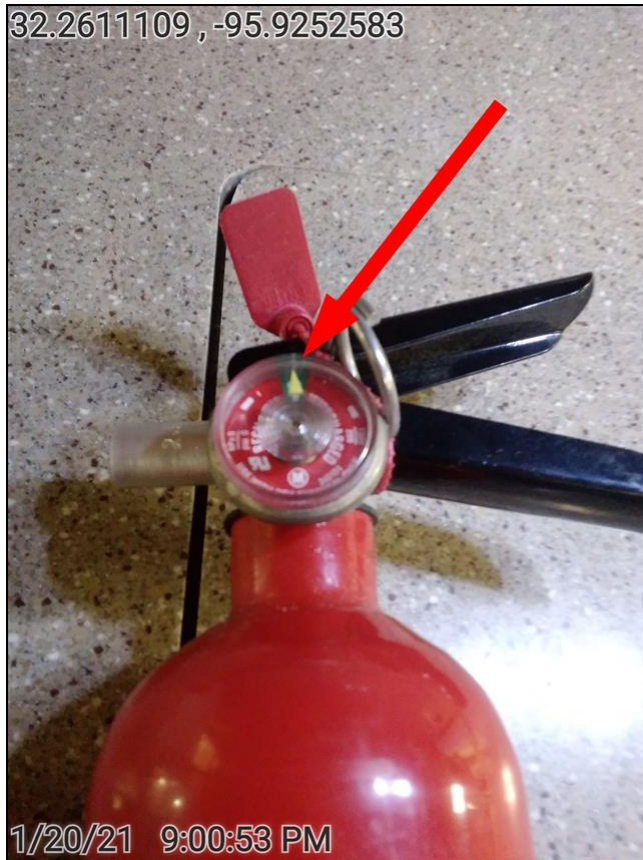
Fire extinguisher by entrance door.

The fire extinguisher located next to the entrance door charge indicator is in the green range.
