Building Condition Report

Norton Wagon Shops

38 NANTICOKE ROAD, MAINE NY

APRIL 24, 2019

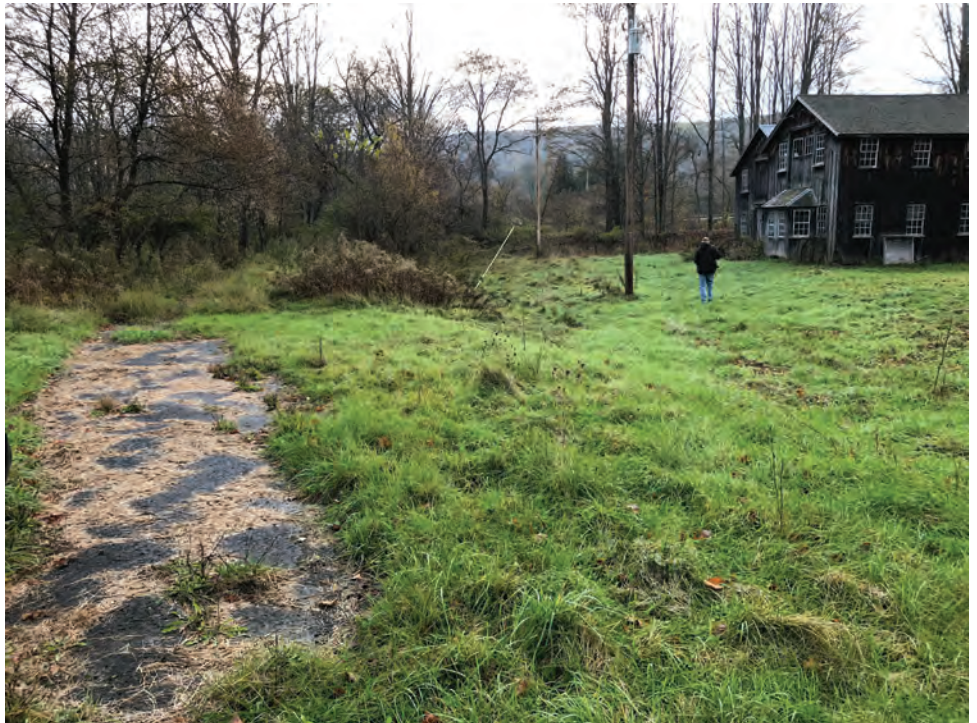
Site access is via an unimproved field. No signage, fencing or security lighting is present (refer to Fig. 6). Partial macadam paving is visible in the raised area of the abandoned road bed (see Fig 6).

Figure 6 - Abandoned Road Bed With Partial Macadam Paving Visible

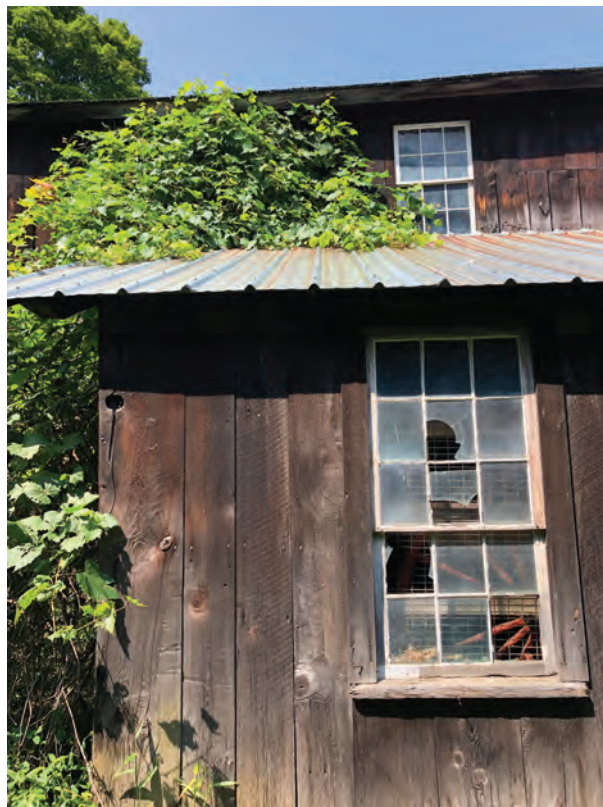
Figure 8

Regular high-water events and past and current maturing trees/bushes closely adjacent to the building may have disrupted the building stone and masonry piers supports. Climbing vines and multi-branch low bushes collect moisture and hold it against the building exterior (refer to Fig 8, 9 and 44). Unable to routinely dry out, this will cause the wood to deteriorate. Any plant growth in contact with the building's surfaces also allow insects and vermin to travel easily into the buildings.

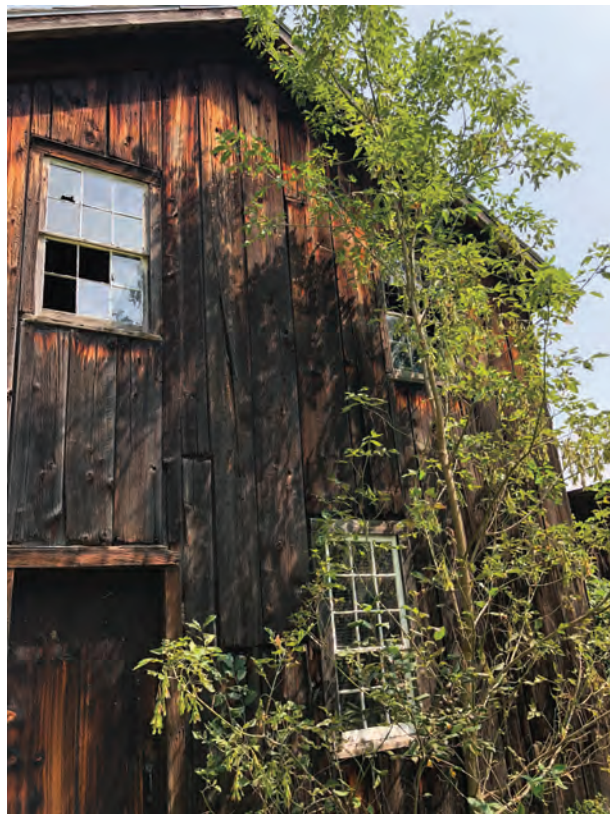
The Shop building elevation has two upper and one lower window opening. A one-story lean-to is attached to the east side of the Shop. The endwall of the lean-to is set back from the gabled end of the Shop. The lean-to has one window opening. The window sashes are intact. Many panes of glass are missing, and the paint has deteriorated on the upper windows. The window head flashing and sills show signs of severe weathering and are no longer protecting the window openings. This is typical for their age, southern exposure and for wooden elements that project horizontally. The lower windows head flashing is completely missing, and the siding above has rotten away (refer to Fig 14).

Figure 14 - South Windows

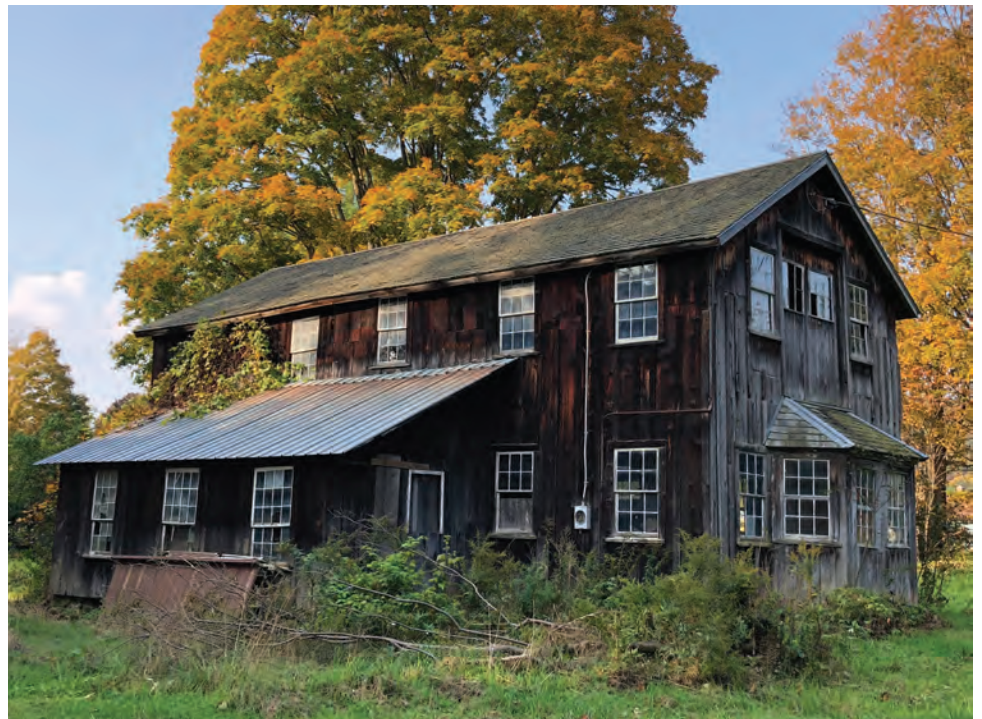
This side of the building has a 1 story attached lean-to with a shed roof. The Shop and lean-to are sided with vertical wood boards. Some joints between the boards are covered with batten strips. The older portion of the building (northern bays) has siding boards that are pieced/extended at the top. This may have occurred when the original building was lengthened and heightened (refer to Fig 16).

Figure 16 - East Elevation

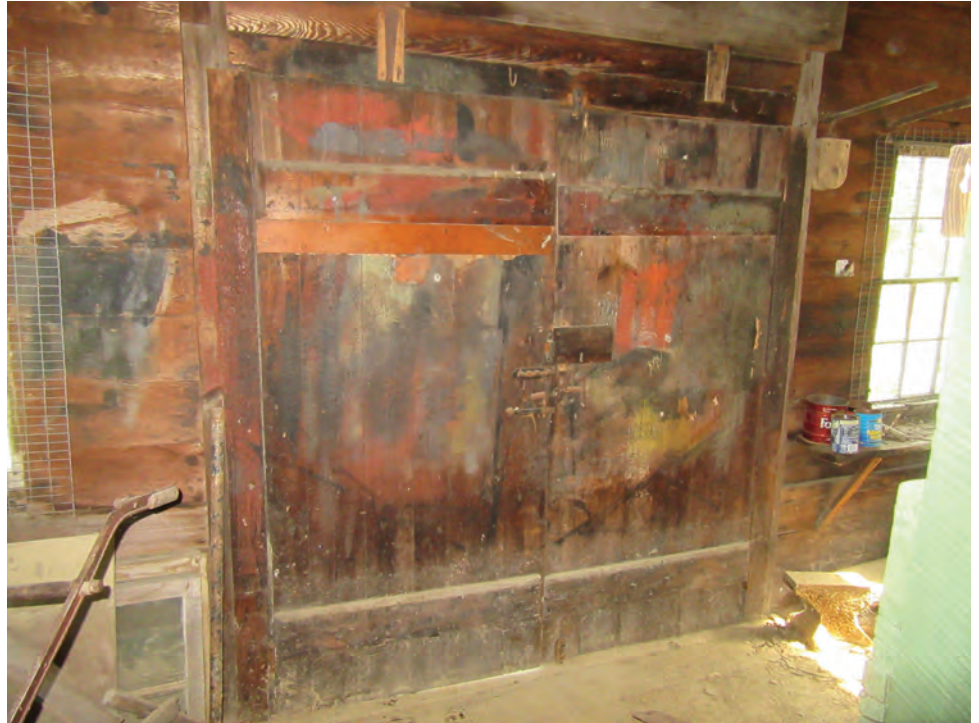
At grade level the Shop building has a pair of solid doors that swing inward. These doors are immediately inside the bayed entrance and in the same vertical plane as the gable end wall of the building. They have thumb latch and barrel bolt hardware (refer to Fig 19). The upper level of the Shop building also has a center pair of double doors that swing inward. They have windows cut into them that appear to be a retrofit and the windows themselves are single window sashes (refer to Fig 17). The lean-to has a pair of solid wood doors. One leaf has been retrofitted with what may have been a window sash that no longer exists (refer to Fig 20).

Figure 19 - Grade Level Shop Doors - Interior

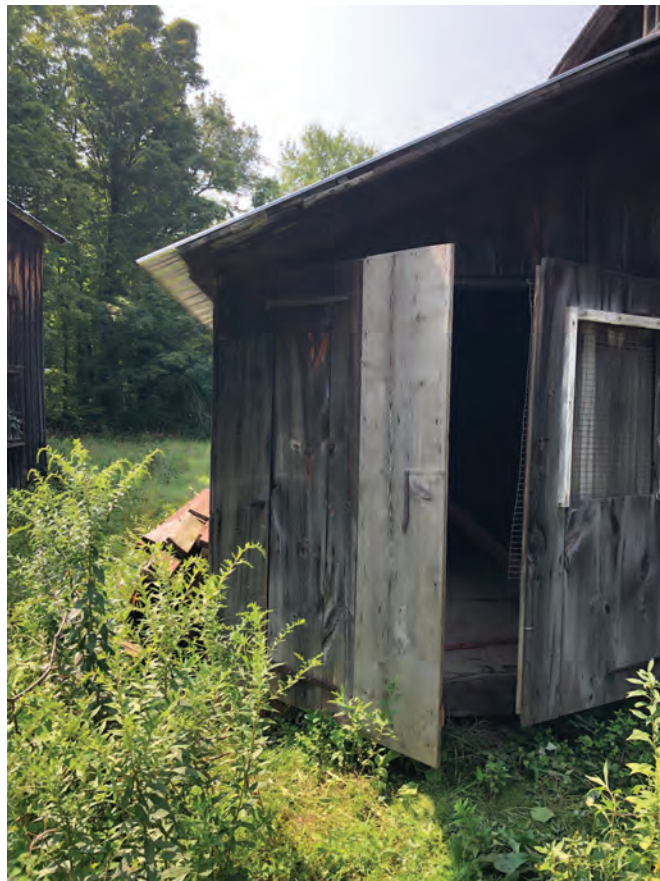
Figure 20 - North Elevation Lean-To

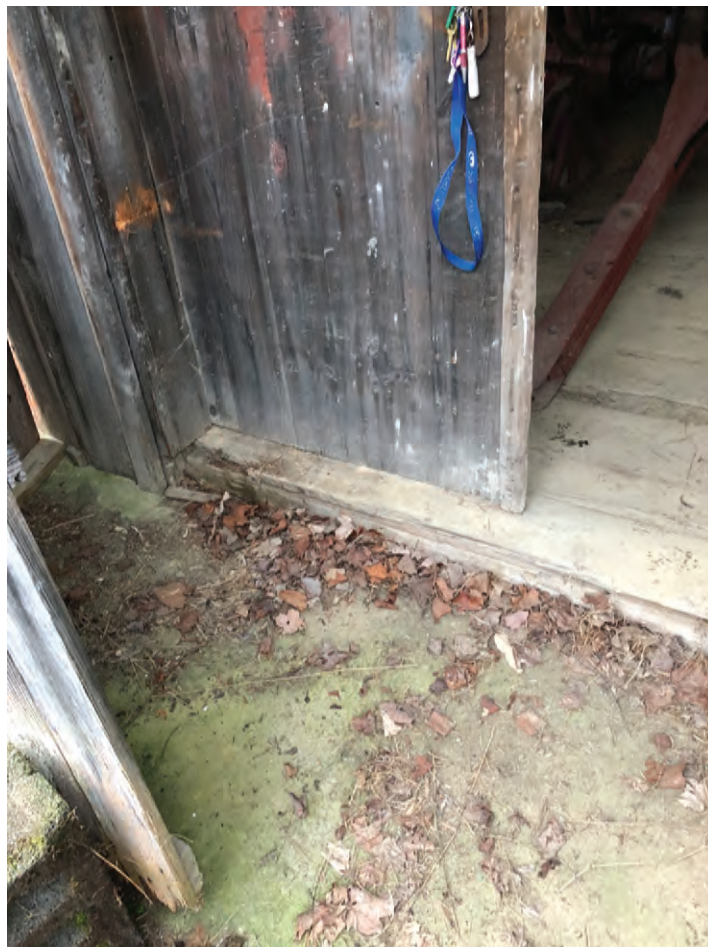
To enter the Shop you do so from the north side through the bayed entrance, which does not appear on the building until the 1930's. The bayed entrance is on a concrete floor pad. There is a step up into the original Shop structure (see Fig 22). Shop doors are located in the north interior wall (see Fig 19).

Figure 22 - Bayed doors entrance with step up

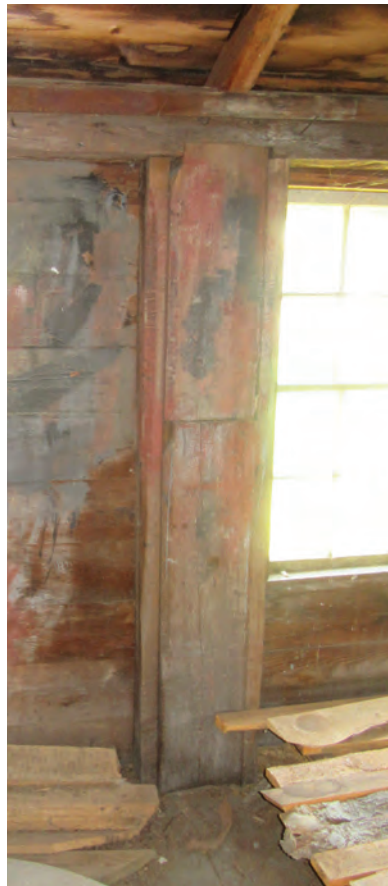
Figure 42 - Second Level Post With Visible Splice – Original Structure

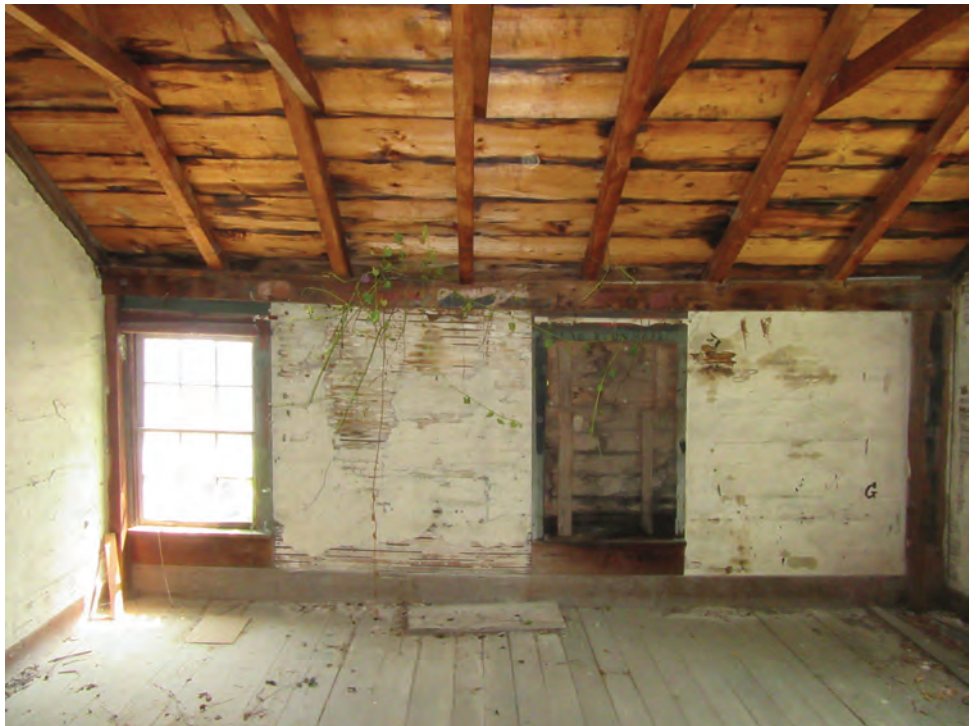
Figure 44 - Interior Second Level View East – Addition

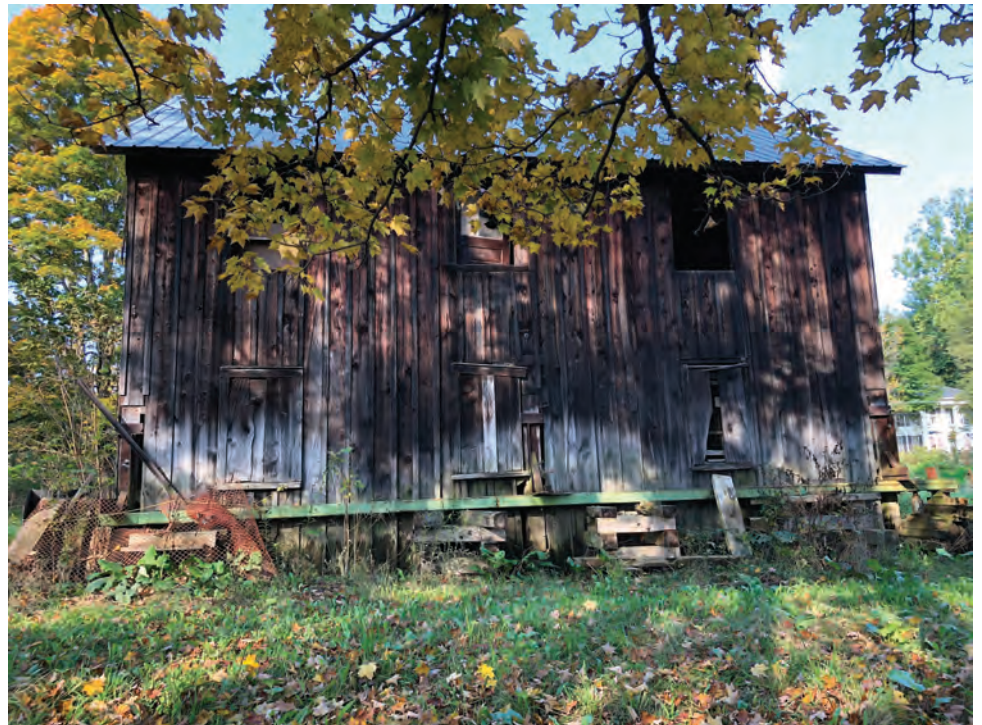
Figure 54 - East Elevation

This side of the building has evidence of temporary building stabilization measures including wood cribbing, tensile cabling and steel shoring. This building is sided with vertical wood boards with batten strips. Some battens are missing. The boards are mostly of one continuous piece. (see Fig 54). Deterioration of foundation piers, wood sill beams and wood posts are extensive. This side of the building faces Nanticoke Creek. Along this side of the building, some building foundation structure is visible. A more recent cinder block pier is noticeable at the northeast corner of the building (see Fig 55).

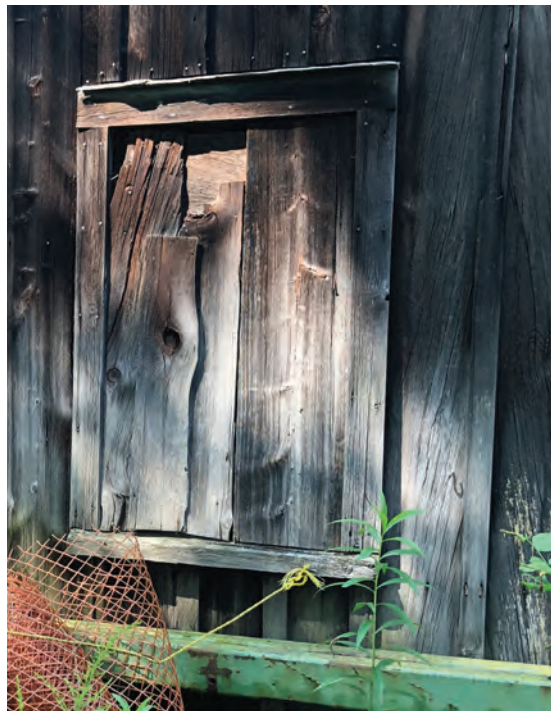
Figure 56 - Typical Boarded Finished Window

This elevation has three upper and three lower window openings. They closely align vertically and horizontally on each level. Three of the windows on the lower level are boarded up. The three upper windows are open. No existing windows are visible in any opening. One upper and the three lower windows have window trim, sill and heads with flashing or evidence thereof (see Fig 56). All window opening components are severely deteriorated. Two upper openings are unfinished, similar to those on the south side of the building.

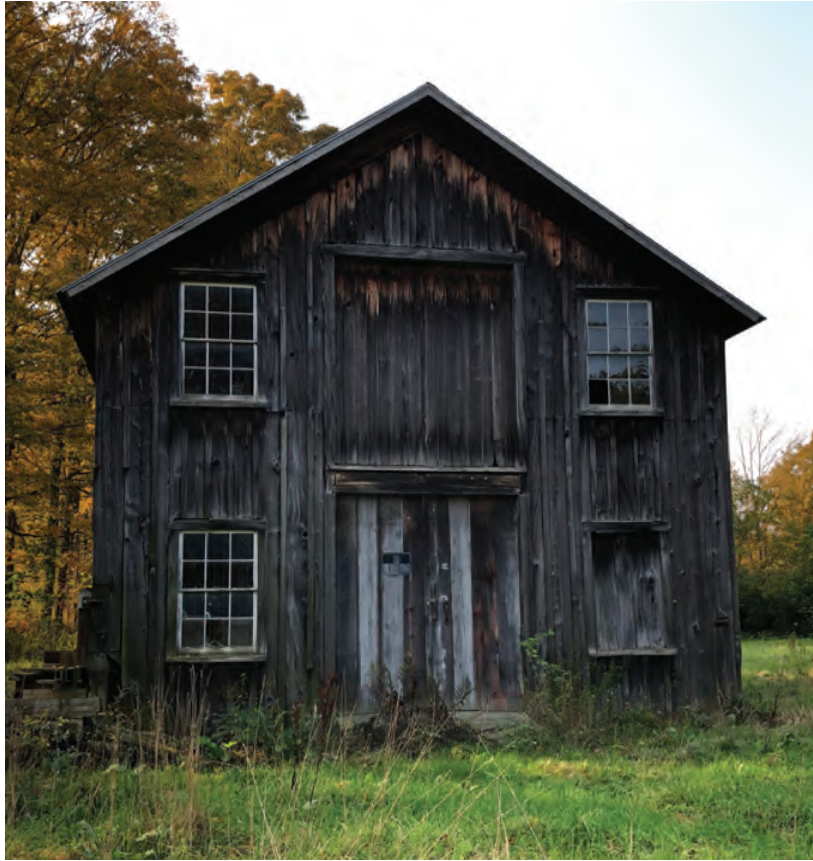
Figure 57 - description

This side of the building is a two-story gable end that is sided with vertical wood boards. All the windows and doors are symmetrically oriented (see Fig 57). The joints between the boards are mostly covered with battens. The boards are regularly spliced at the second-floor window sill line (see Fig 58).

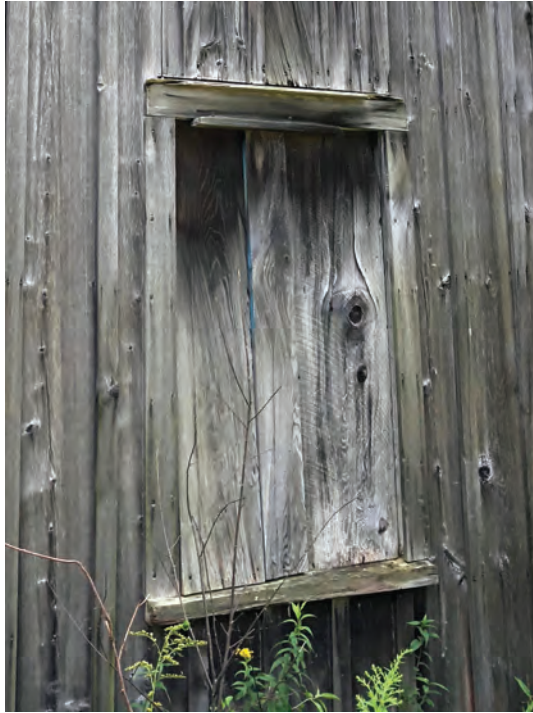
Figure 59 - description

This Barn building elevation is symmetrical. It has two upper and two lower windows. All sashes are intact except for one lower window opening which is boarded up. At the time of this report, one pane of glass is missing in on upper window sash. Window head flashing and sills on the lower windows show signs of severe weathering and are no longer protecting the window openings (refer to Fig 59).

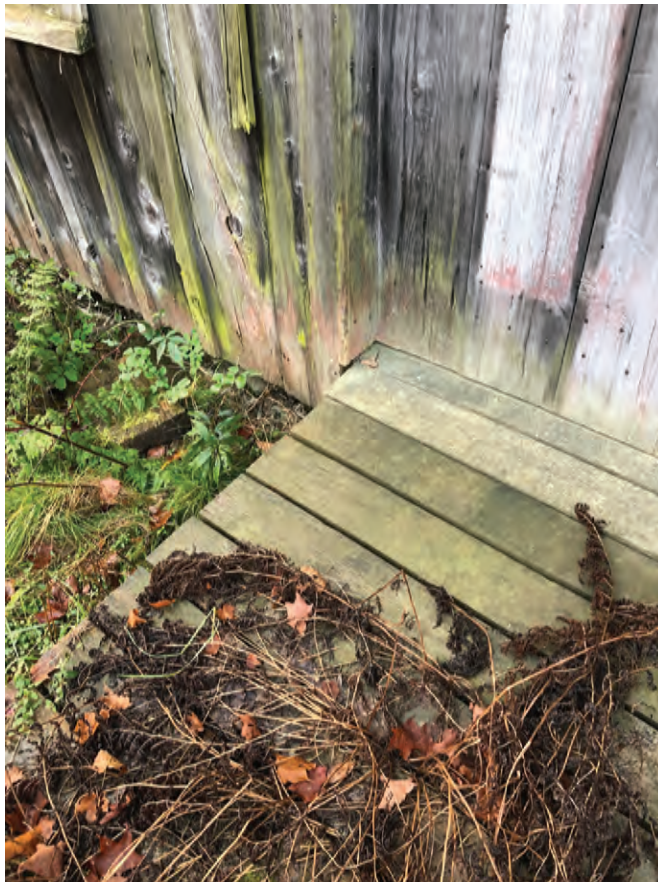
Figure 60 - Wooden Walk to Entrance

At grade level the Barn building has a pair of solid doors that swing inward. There is a sloped wooden walk from grade into the Barn (see Fig 60). On the second level there is a similar pair of doors directly in line with those below.

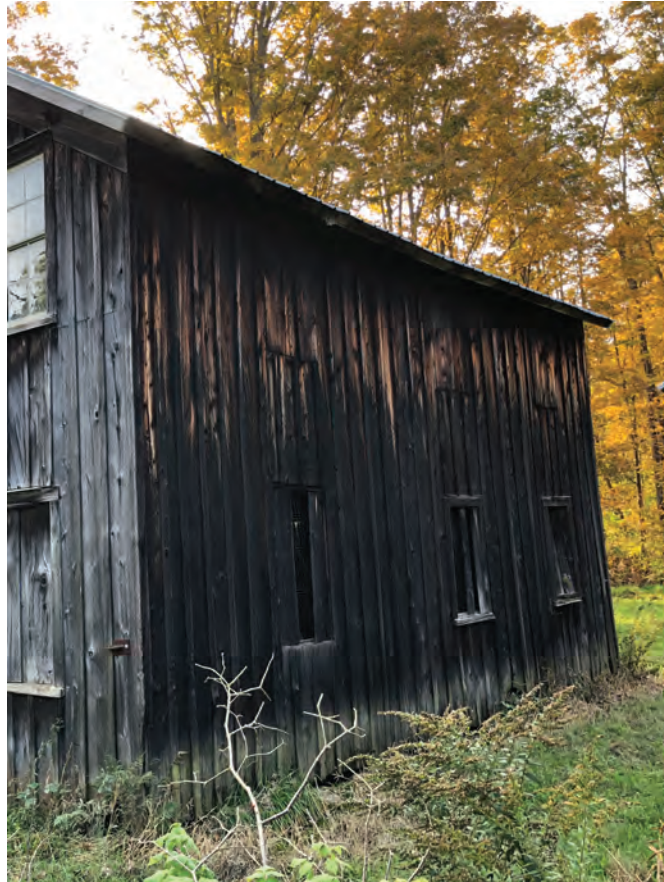
Figure 61 - West Elevation

This side of the building faces the Shop building. The wall is clad with continuous span vertical wood boards covered with batten strips. All the window openings are symmetrically oriented (see Fig 61).

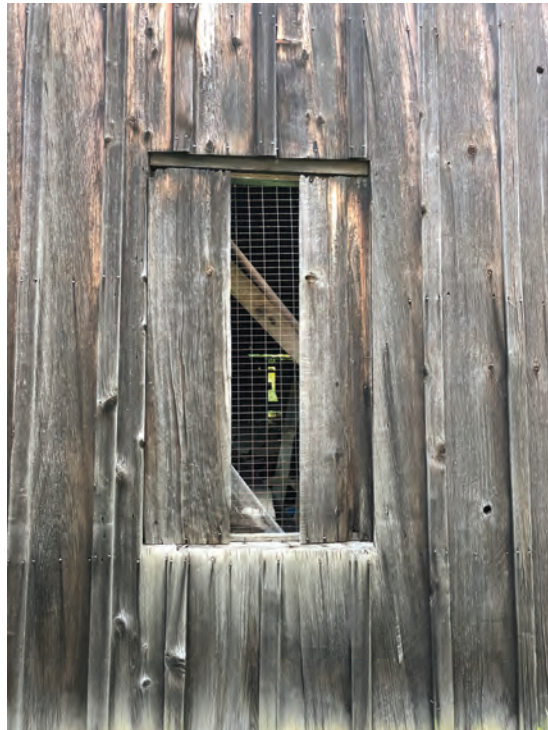
Figure 62 - Typical Boarded Unfinished Window Opening

This elevation has three upper and three lower window openings. They closely align vertically and horizontally on each level. All the openings on each level are boarded up. No existing windows are visible in any opening. Two lower windows have window trim, sill and heads with flashing or evidence thereof (see Fig 61). All window opening components are severely deteriorated. Four openings are unfinished, similar to those on the east and south side of the building (see Fig 62).

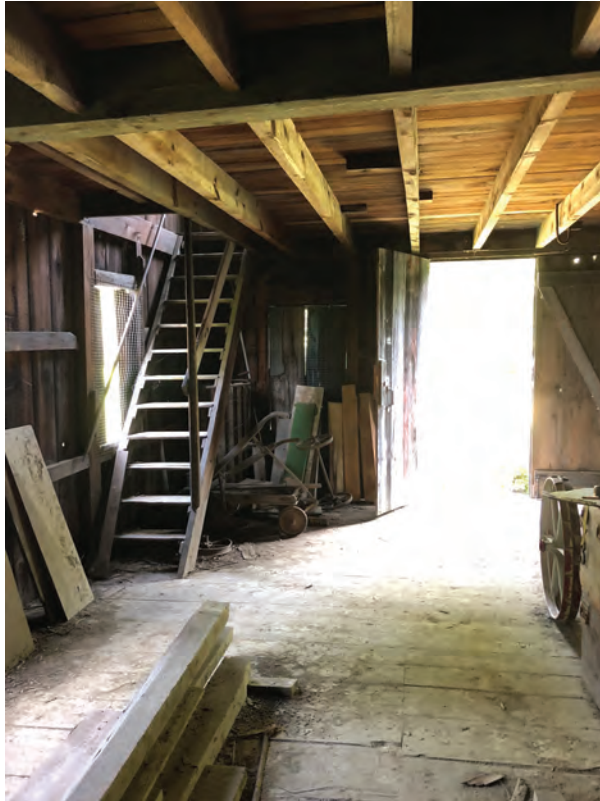
Figure 67 - Interior Grade Level View – North Entrance Doors and Stair to Second Level

A steep and narrow set of stairs lead to the upper level of the Barn at the northwest corner (see Fig 67 and Fig 75). At the top of the stairs is the second level of the Barn (see Fig 76 to Fig 79). The wooden building wall and roof structure is exposed throughout. Most of the wood roof framing components have been reinforced with additional wood members. The newer wood members do not have the darker color of the older wood (see Fig 80).

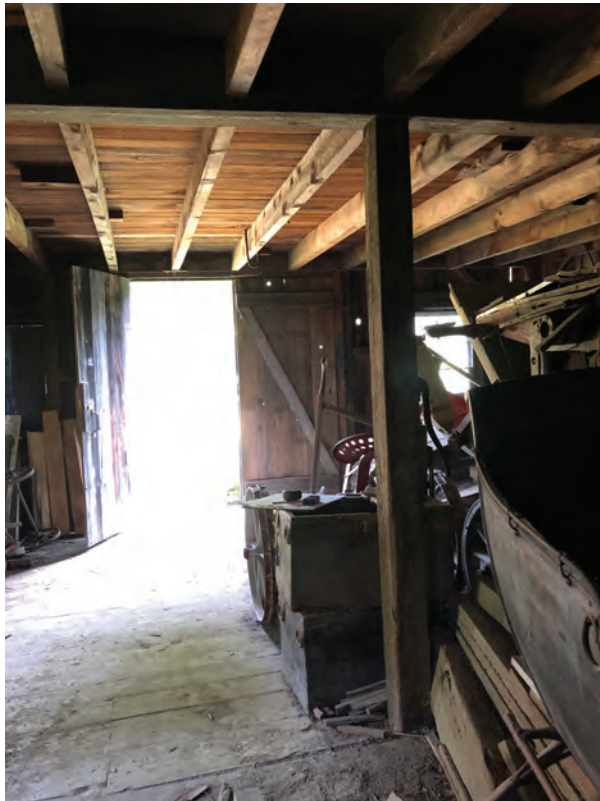
Figure 68 - description

One enters the Barn at the north side across a wooden walkway and through a pair of doors. On the grade level of the Barn, the main structural components of the wooden timber framing are exposed on the interior. Including posts, beams, knee timbers, joists, subfloor. The interior is cluttered with various artifacts, remnants, materials, and salvaged items. The subfloor is covered with a fine layer of silt and debris, evidence of past flooding (see Fig 63 to Fig 68). There is one intermediate wood post beneath the center of the beam that runs east to west and support the floor of the second level (see Fig 68).

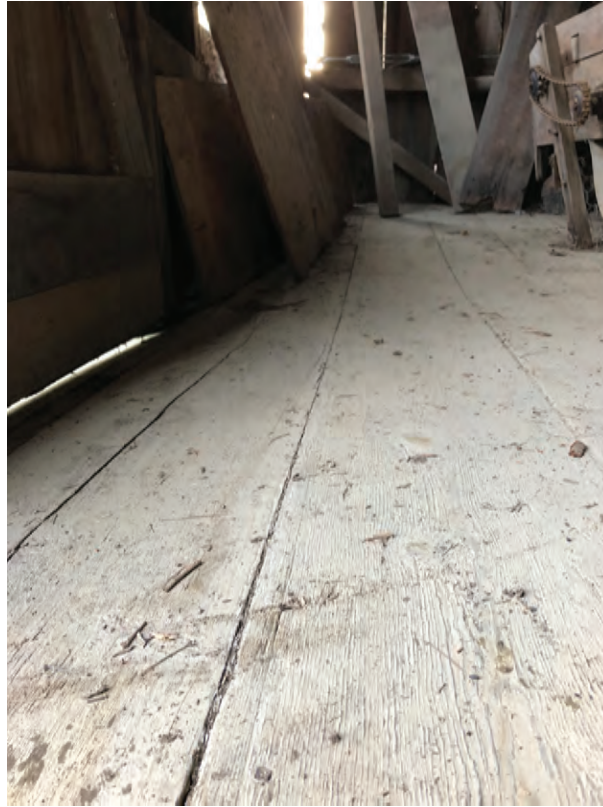
More evidence of temporary building stabilization measures including tensile cabling can be seen along the south wall (see Fig 65 and 66). These stabilization measures appear to have slowed the building collapse but not stopped or reversed it. There is evidence of settling or continued wood beam rot in the building's interior foundation system. The foundation system was not visible during the site survey but there is a noticeable drop in floor level; high point northeast corner low point north wall center (see Fig 69). Deterioration of subfloor and wood posts is extensive along the eastern wall (see Fig 70 to Fig 72). A portion of the subfloor also show signs of sagging which may be further deterioration of floor support/wood beneath (see Fig 73). This area is a low spot in the entire floor and may be subject to ponding when the building is flooded.

Figure 69 - Floor Level Drop – View From North Center Towards Northeast Corner

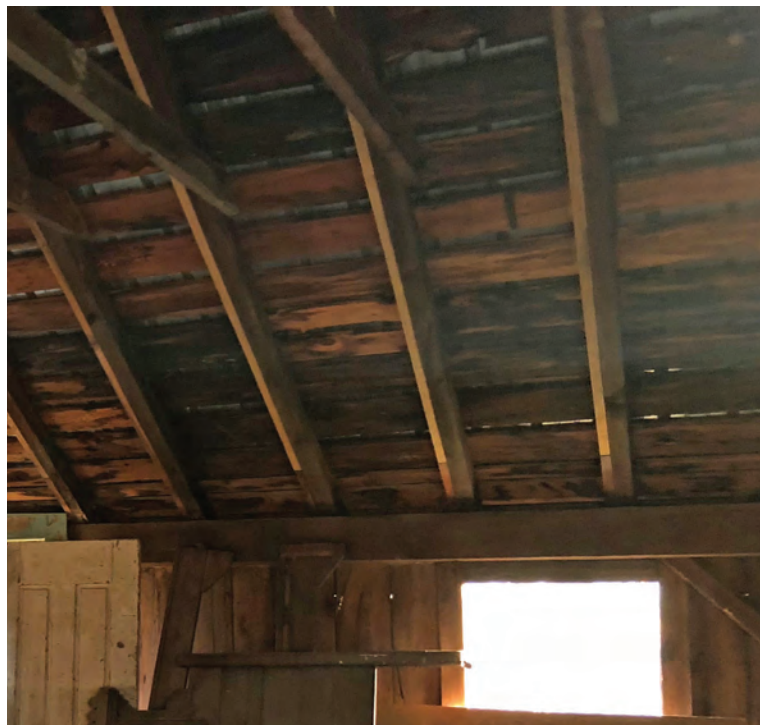
Figure 80 - Reinforcing at Wood Roof Framing

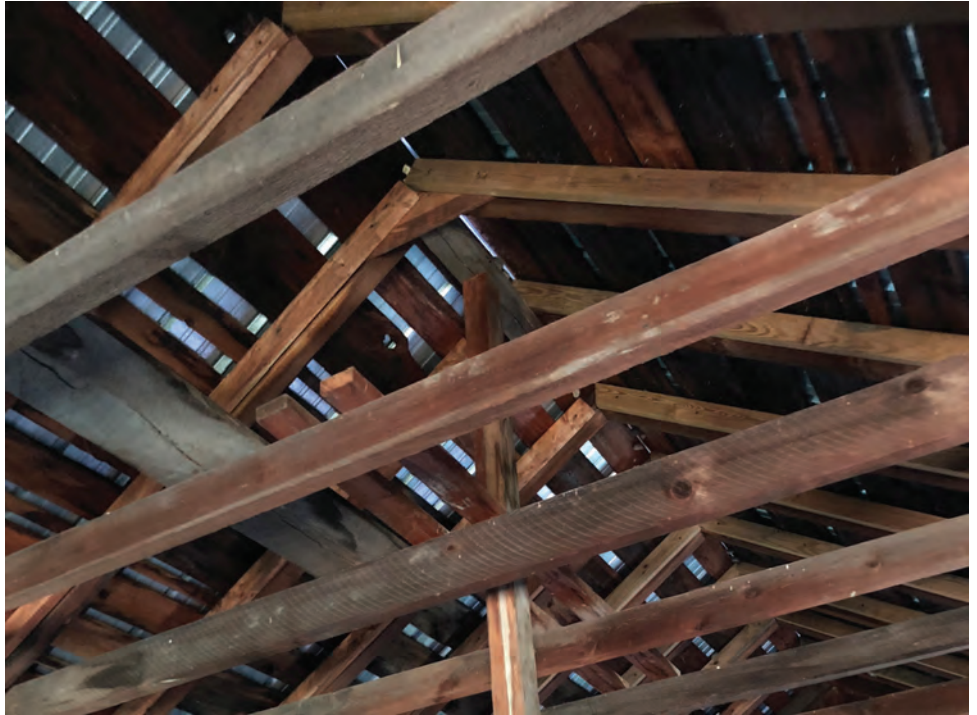
Like the Shop, the interior of the second floor of the Barn is sparingly filled with materials, artifacts and rubble. Unlike the Shop, the Barn does not have visible splices in the structural posts and may have been originally built as a two-story structure. There is one intermediate wood post beneath the center of the roof and it may align with a post in the grade level below. The roof framing does not have a continuous ridge board or beam. The necessity of this post is unknown (see Fig 81).

Figure 81 - Roof Framing and Intermediate Post
