# Sample Home Inspection Report

Prepared for: John and Jill Doe

1234 Sample Street  
Sample Town, TN 37001

Inspected by:  
William Carmichael TN License #2190  
BeSure1st Home Inspections, Inc.

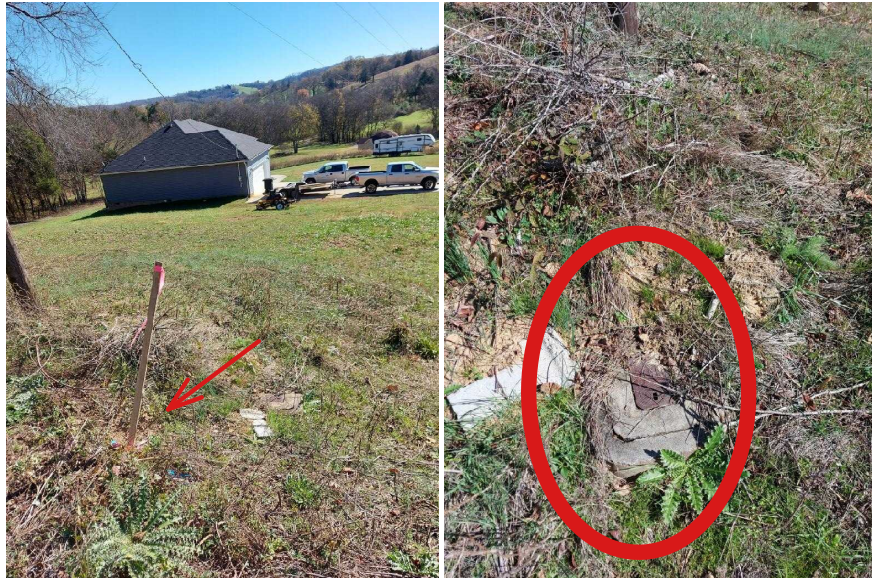
Main Water Shutoff: In ground meter box -- Main water shut-off and meter is

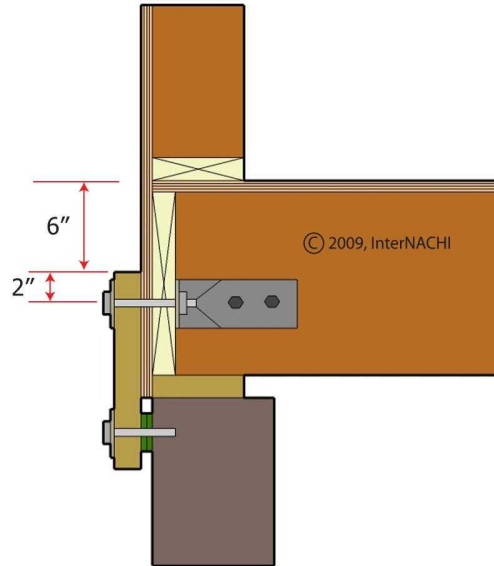
### Deck Ledger to House Connection

Deck: -- Treated wood -- The deck attachment to the home was improperly done. No ledger was used to connect deck floor joists to the home structure. Instead, joists were fastened directly to the home exterior wall with nails only. Nails are not considered adequate for long term stability. Elevated decks should be bolted securely with washers so that the bolts do not pull through. This connection may be structurally insufficient and may result in detachment and collapse of the deck. There were no visible concrete footings for the post. The posts may be set on footings and properly attached below grade but this was not observable. No flashing was observed on the deck band against the house wall. The Inspector recommends further evaluation and correction by a qualified contractor. While it may seem secure for the moment if the deck were loaded with numerous people it has the potential for collapse, especially as the wood ages.

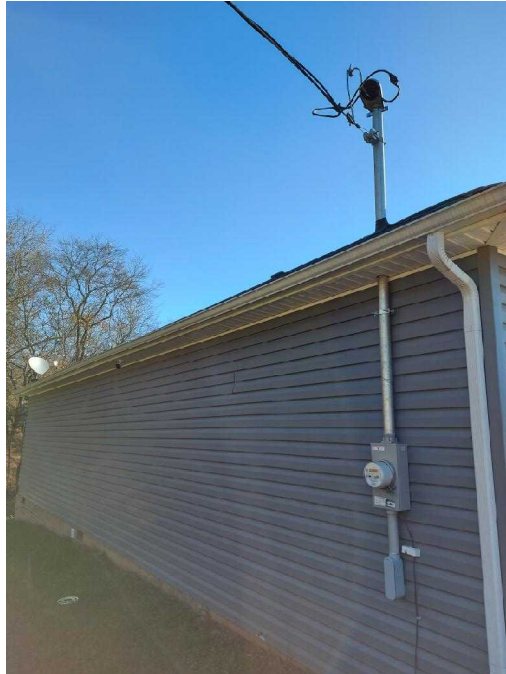
Electrical Mast: Mast- no tie back at roof

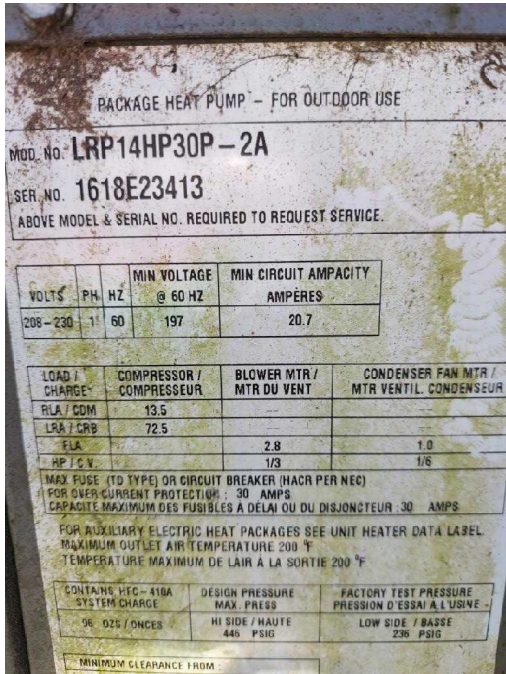
Model Number LRP14HP30P-2A

Serial Number 1618E23413

Area Served: Whole building Approximate Age: 2 years old. Manufactured in April 2018 per serial number.

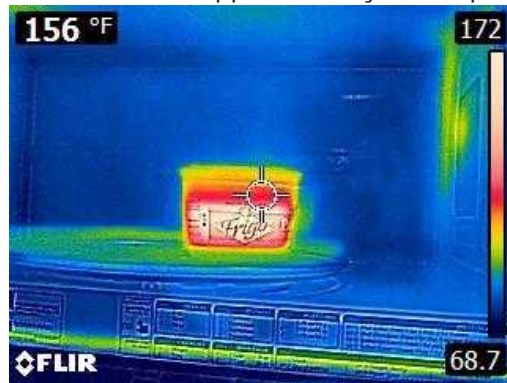
Microwave: -- Approximately one cup of water heated to 156F in one minute.
