JOHNSON WILBUR ADAMS, INC.

May 3, 2024

**Re: Palatine Stables – Palatine, IL
Structural Condition Assessment
JWA Project No. 2024201**

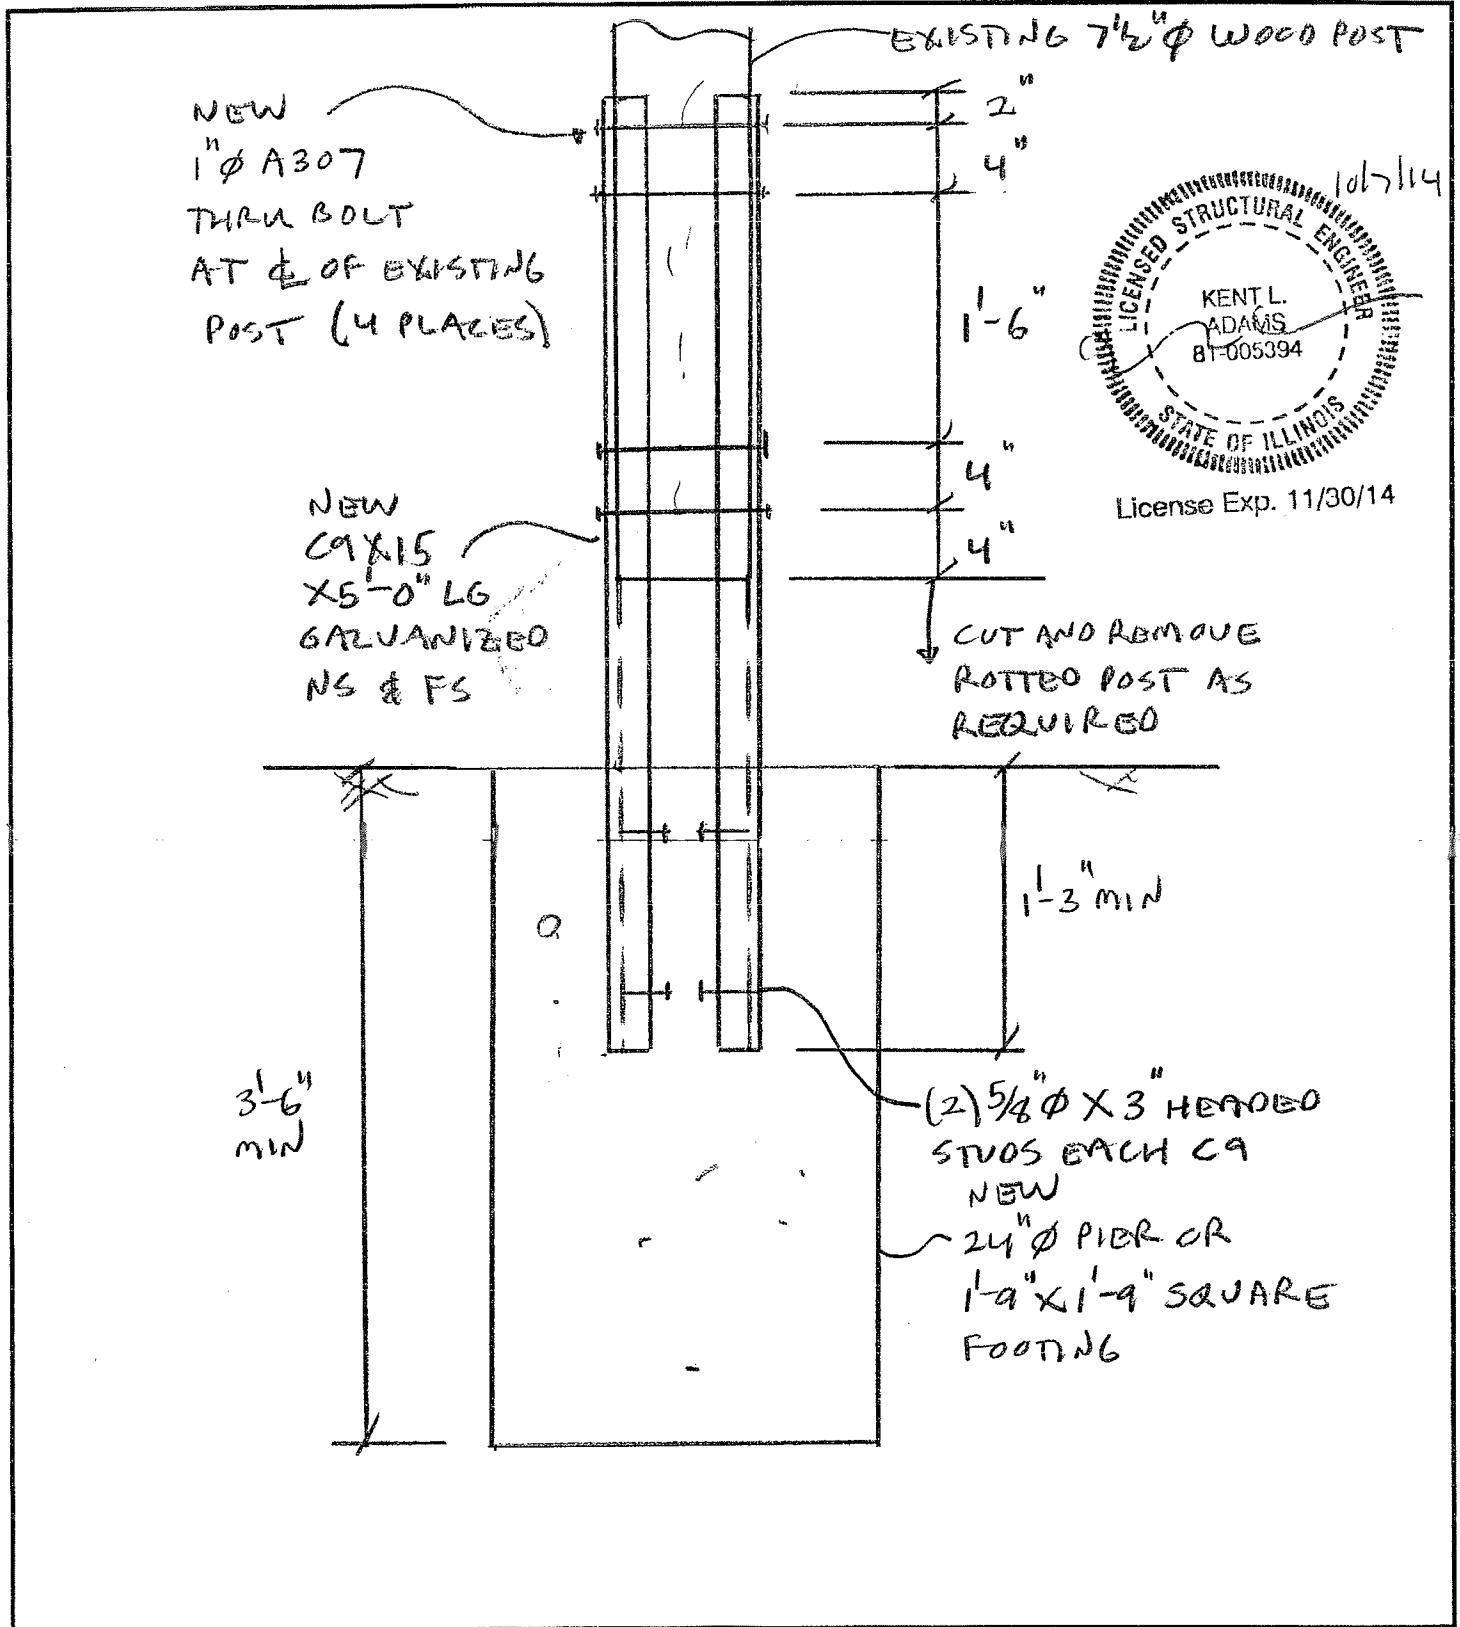
JOB PALATINE STABLES NO. 2014367
SHEET NO. SK1 OF 1
CALCULATED BY LLA DATE 10/6/14
CHECKED BY _____ DATE _____
DESCRIPTION _____

2. At both the east and west barn buildings rot was observed at the bases of numerous columns as a result of the long-term exposure to moisture below grade. Of the columns exposed at the time of the site visit 4 columns at the east barn building and 9 columns on the east side of the west barn building were observed to be rotted to the point that repairs are required. The exposed columns observed on the west side of the west barn building had either been previously repaired in 2014 or were in fair structural condition due to a sheet metal cover added to the exterior base of the wall. *It is my opinion that the current condition of the column bases at both barn buildings does not present an immediate life safety issue for continued use. However, the columns do contribute to the overall stability of the structure for both gravity and lateral loads. As a result, it is my opinion that the rotted column bases should be repaired as soon as possible to prevent any further damage to the barn structures over time. Since all of the column bases were not exposed at the time of my site visit it is my recommendation that all column bases be reviewed at the time of the repairs to determine the full quantity of repairs required. For reference refer to the attached Sketch SK1 of 1 dated 10/06/2014 for the repair detail used in 2014. In addition, refer to the attached sketches SK-1 and 2 of 2 dated 05/03/2024 for approximate locations of the columns observed to be rotted.*

CRACKED TRUSS
BOTTOM CHORD

INDICATES APPROXIMATE
LOCATION OF ROTTEN
COLUMN TO BE REPAIRED

TRUSS WITH
CUT BOTTOM
CHORD TO BE
REPAIRED

INDICATES APPROXIMATE
LOCATION OF
ROTTED COLUMN
TO BE REPAIRED
