DOUGLAS J. BURGASSER, P.E.  
THOMAS D. WURDER, P.E.

**Inspection:**

Date: [REDACTED]  
Property [REDACTED]  
Address: Spencerport, NY 14559  
Inspector: **Michael P. Yun, P.E.**

This is a two-story house with mostly vinyl sided exterior walls and an asphalt shingle roof surfacing.

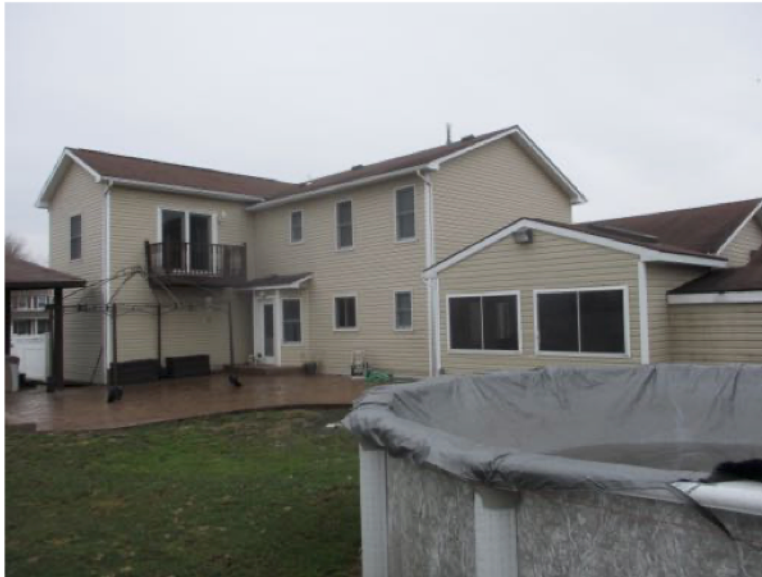
*Rear view of the house*

The exterior walls and siding are in generally serviceable condition. Some of the siding and trim at the rear lower portions of the house are damaged and sloppy. There is also small area of warped siding and trim. We suspect that this is due to placing a hot grill too close to the house. Siding and trim repairs are recommended. Minor weathering or slight damage on exterior wood trim was found in spots. There are also several areas where cracked and chipped trim paint exists. Rotted trim should be removed and replaced. Regular trim paint maintenance will be necessary for this house.
