SHIVER ME TIMBERS, INC.
MARINE SURVEYORS AND CONSULTANTS

1996 Fishing Machine 67

Report of Marine Survey

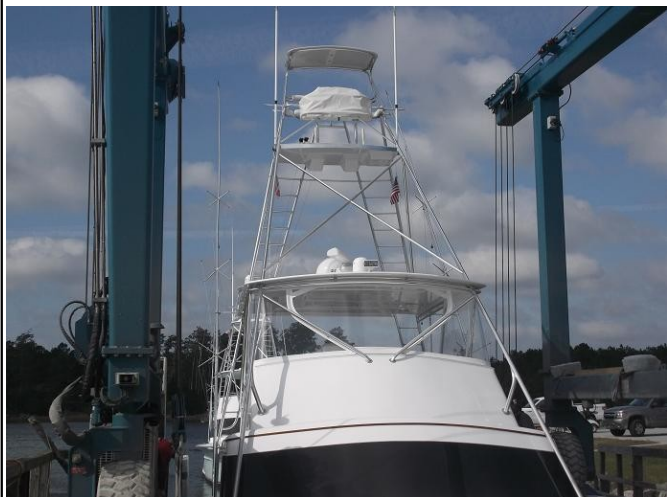
Tower

TUNA TOWER: Custom designed and installed tower including an upper station. Constructed with welded pipe joints. Good condition.
