Office of Transport Safety Investigations

TECHNICAL INSPECTION FINDINGS

WHEEL DETACHED FROM BUSABOUT BUS MO5184

14 JANUARY 2014

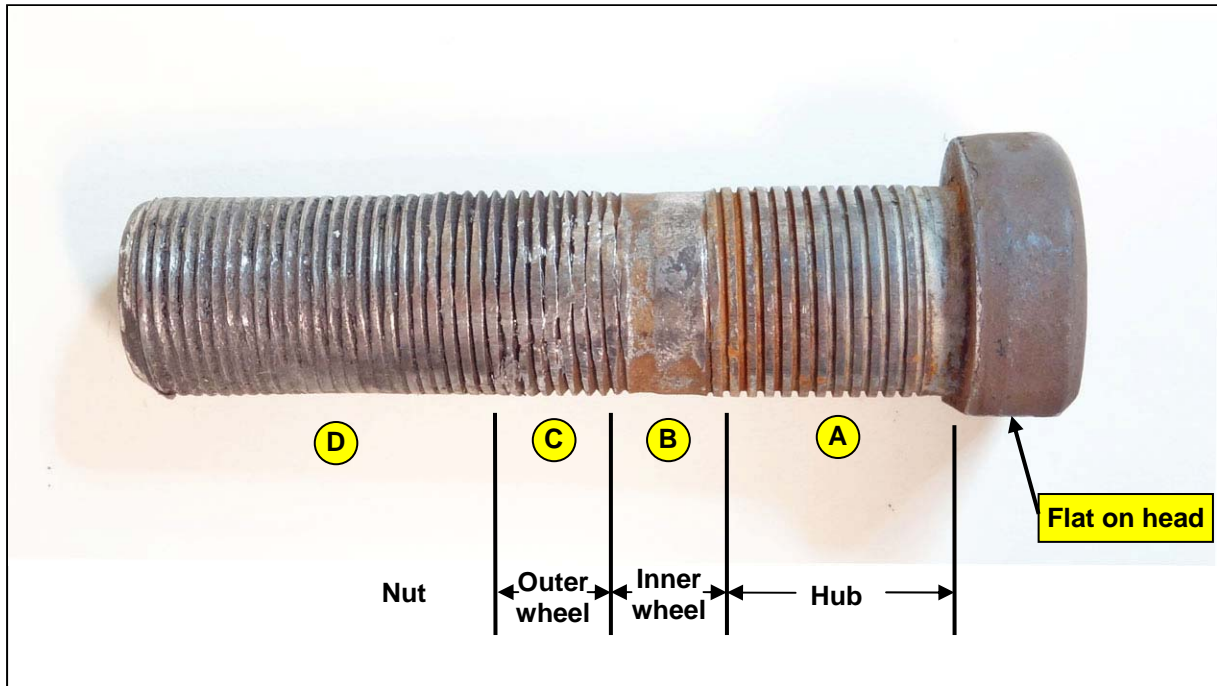
Photograph 9: Diagram of unbroken stud

Photograph 9 illustrates the relationship between the stud, the drive flange of the hub, the wheels and the nut.

A flat on one side of the head engaged a shoulder on the hub to prevent rotation in the drive flange.

The section labelled “A” had a square thread with a diameter measuring 22.05 mm machined on it, to provide an interference fit when pressed into the drive flange. The profile of the machined thread is shown in *Photograph 10*.

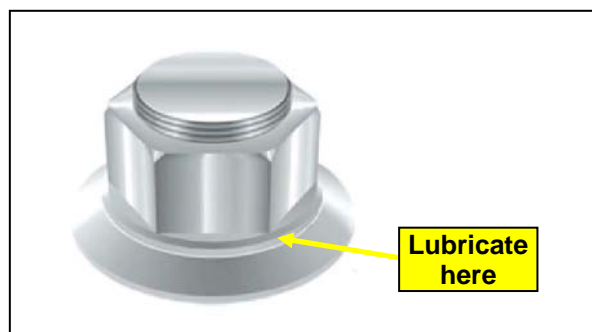
Figure 3: Wheel nut lubrication

The wheel fitting instructions provided by the manufacturer, Mercedes-Benz, specify lightly oiling the wheel nut between the hexagon head and the thrust washer at the location shown in *Figure 3*, and tightening the wheel nuts in several stages in a crosswise pattern to a final torque of 600 Nm. The instructions also specify re-tightening after the vehicle has travelled 50 to 150 km.
