### PROPERTY INSPECTION REPORT

Address: 0000 Sample Report Way, Dallas, TX, 75000

**Concerning:** 0000 Sample Report Way, Dallas, TX 75000  
(Address or Other Identification of Inspected Property)

**By:** Greg House, Lic #TREC #9986, SPCS #559963 10/23/2018  
(Name and License Number of Inspector) (Date)

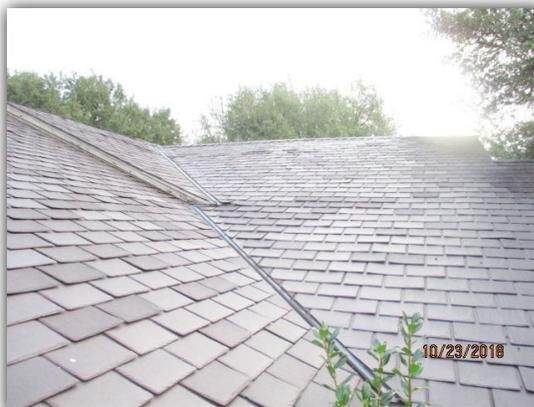
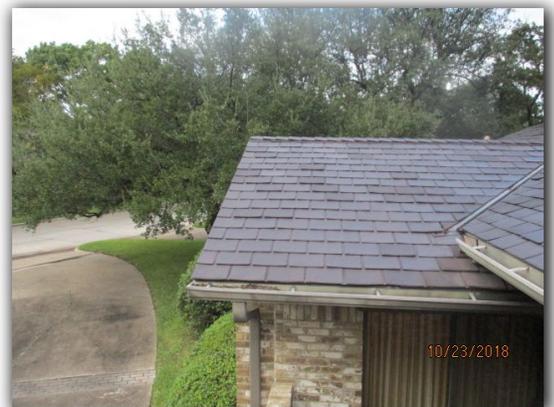
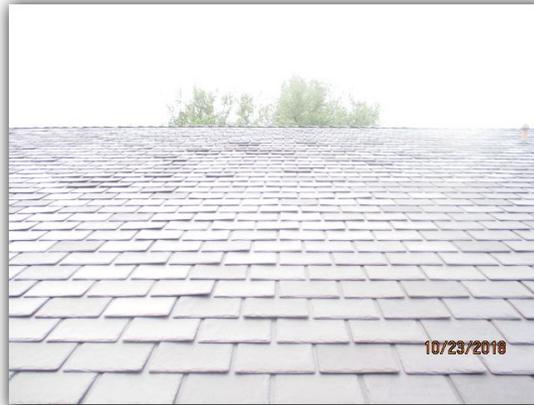
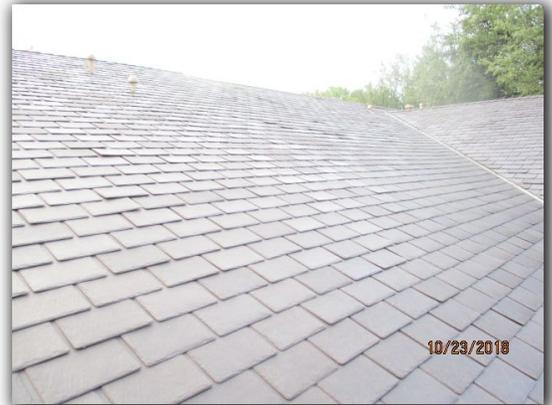
- Recommend consulting with a qualified roofing contractor to fully evaluate and determine the type and extent of repairs that may be required.
- The front covered drive roof edge has direct contact with tree. Tree is pushing roof tiles.

- The front roof ridge line edge appears to have damaged tiles.
- The faux (plastic) roof tile material has unusual curling and lifting at multiple locations around property. This may be due to roof heat load, and absence of upper attic ventilation (see Attic section of report).

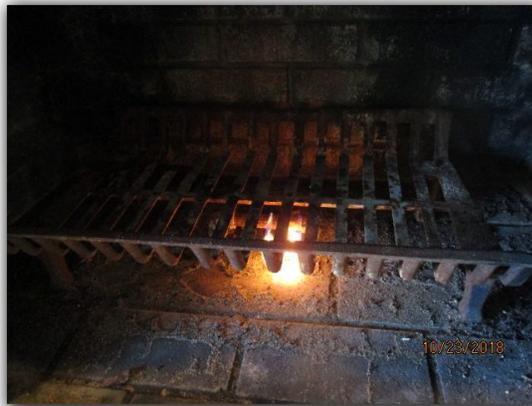
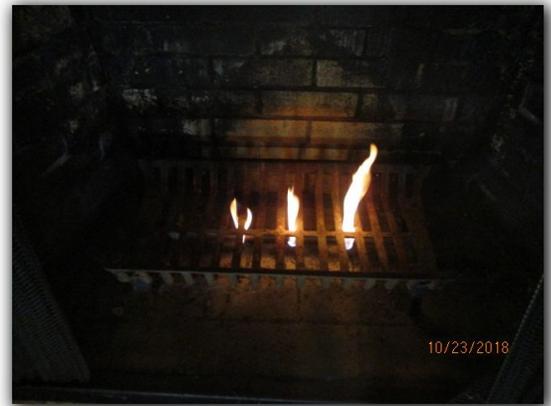
The chimney does not have a chimney crown as would now commonly be installed. The chimney crown is a metal "topper" that prevents rain and moisture from entering chimney, and also acts to "knock down" any sparks that may escape.

- The fireplace has amount of soot present. Fireplace may be in need of routine cleaning.
- The back side of the firebox opening/brick lintel is not properly sealed with high temp caulking. Opening is present along brick edge, which may allow for entry of sparks.
- Observed cracks in the masonry firebox walls. **It is recommended that these be repaired by qualified fireplace/chimney professional prior to use.**
- The game room fireplace still has paper tag on damper. Recommend removal prior to use.

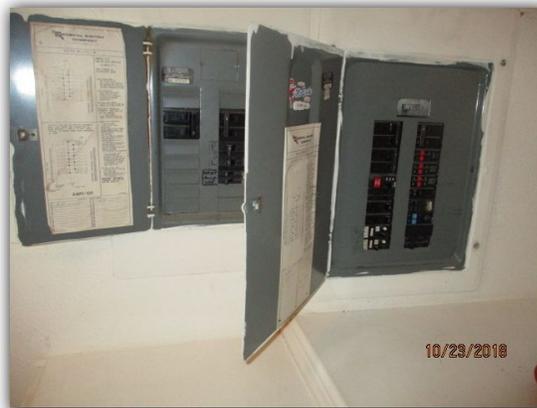
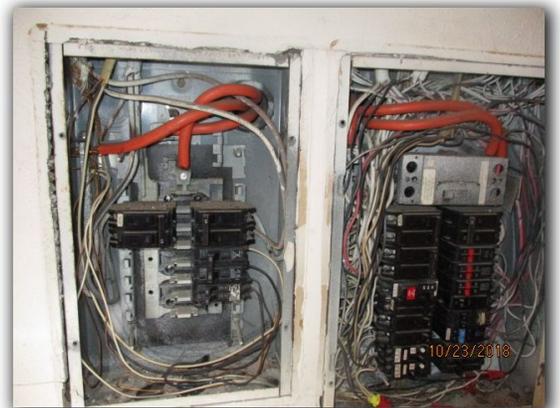
- Recommend having the electrical panel checked by a qualified, licensed electrician.
- The main panel has GFCI breaker(s) that are not tripping with test button.
- The exterior ground rod connection is broken/not attached.
- Infrared inspection of main panel showed breaker with unusual amounts of heat at breaker(s)

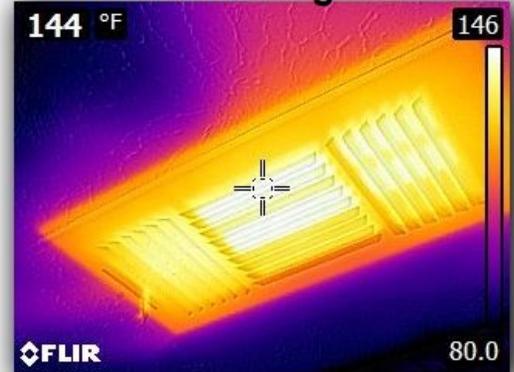
### Master zone heating.

- The flexible gas supplying the furnace is not stubbed with black pipe into cabinet. It is possible for the vibration of the cabinet to slice or damage flexible gas lines. Also, current standards call for free/clear access to both ends of flex line connections.

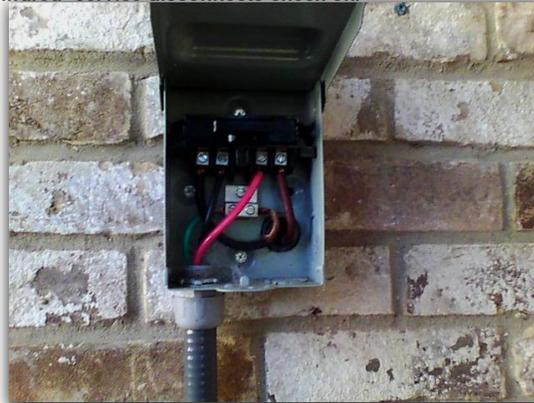
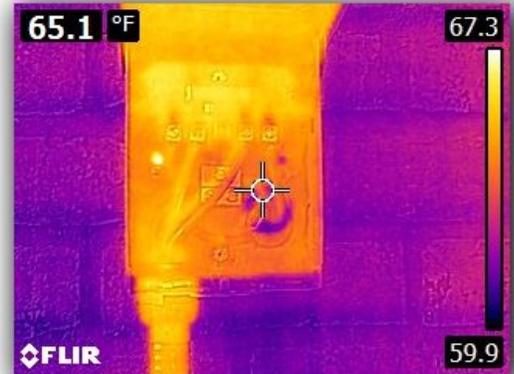
Infrared- service disconnects check ok.

- Recommend that the HVAC system be fully inspected and evaluated by a licensed HVAC Technician.
- The master bedroom zone evaporator coil housing appears to be much older unit, and has evidence of organism or fungal type growth.

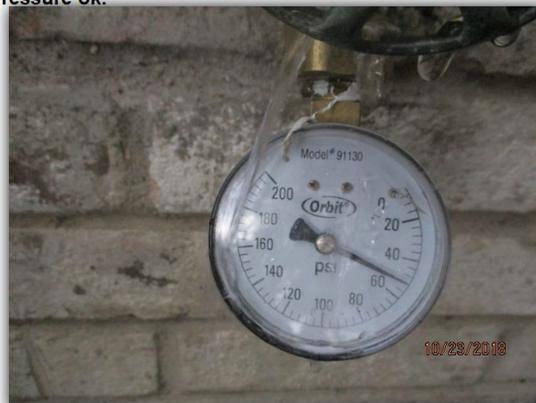
Pressure ok.

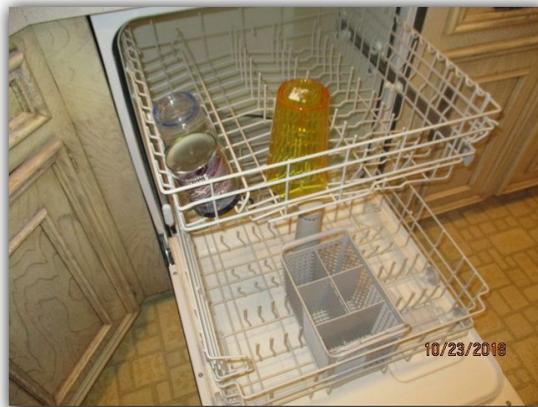
Dishwasher appeared to operate correctly, went through full "normal" cycle, heating element operated, and tub was drained.

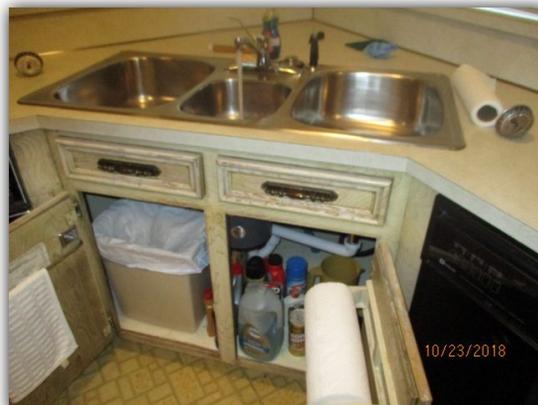
The disposal operated without excessive noise or vibration, and no leaks or damages were observed.

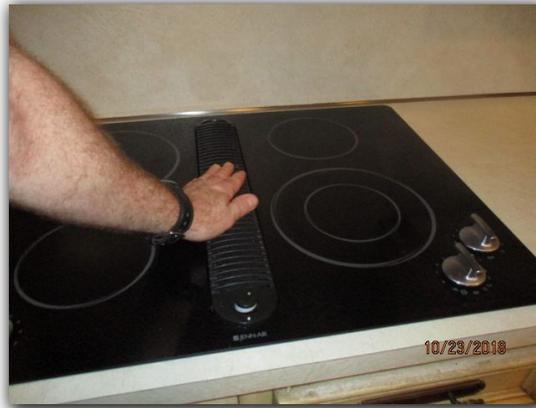
Range hood responded to all controls (speeds, settings, lights if present) and filters are in place.

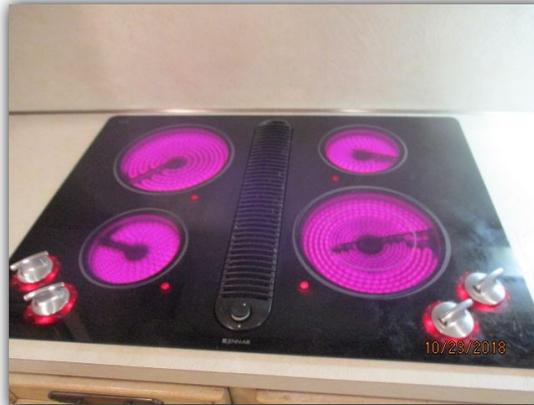
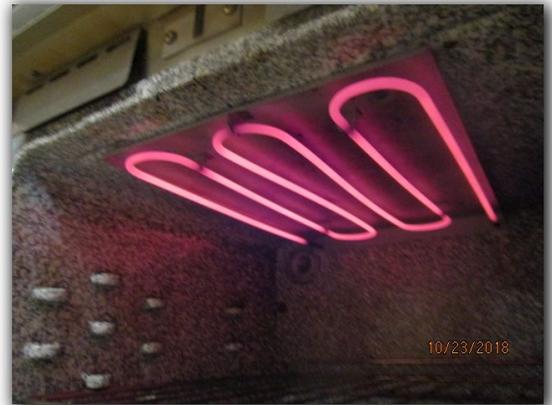
- The oven door hinges are damaged/worn. Door "sags" when fully open.

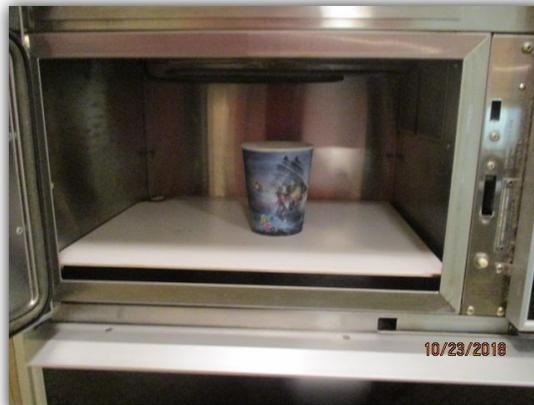
The microwave unit(s) responded to control, and passed the water test. Note - performance of microwave(s) will vary depending upon various conditions such as age, wattage, etc.

- Observed interior microwave oven surface damage/deterioration.

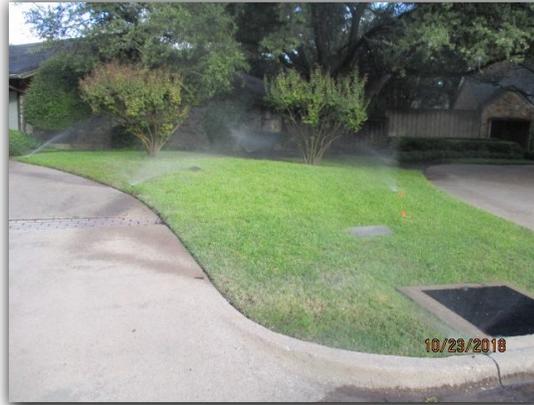
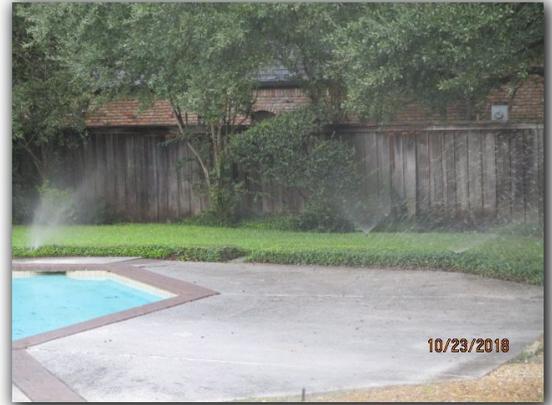
- Unable to locate sprinkler system back flow preventer/shut off valve controls. This unit may be hidden under soil or landscaping. Visual inspection of this unit could not be performed.
- Did not observe any type of rain sensor / freeze sensor at time of inspection. Sensor disables scheduled watering programs when it has been raining, or is in freezing temperatures.
