SEWER SCOPE CAMERA INSPECTION

1234 Main Street
Carrollton, TX 75007

Buyer Name
04/05/2023 9:00AM

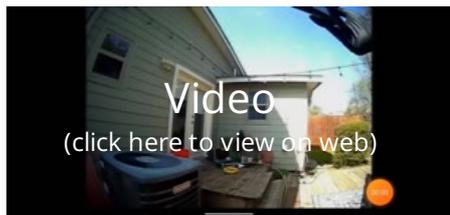
Functioning as Intended

The main drain and sewer laterals appear to be functioning as intended at the time of the inspection. Refer to "Deficient Items" listed in report for any drain

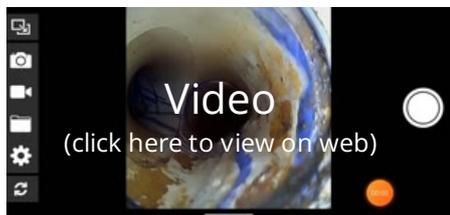
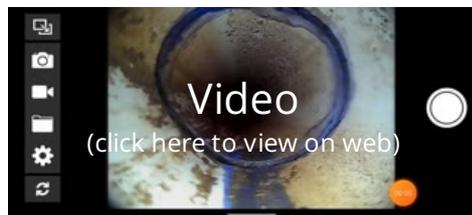
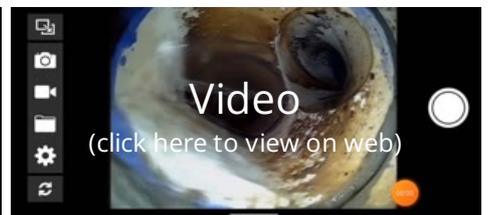
Cast Iron Drainpipes

Portions of main drain lines are cast iron. Cast iron waste lines are known to deteriorate and leak overtime. It is beyond the scope of this inspection to determine if there are leaks in the waste lines in non-visible areas. Most cast iron pipes today are over 40 years old and may be nearing the end of their life expectancy. Budgeting for future replacement is recommended. For a more detailed analysis of the cast iron waste lines, a licensed plumber should be consulted.
