## TopHome Inspection LLC

## Home Inspection Report

**3520 Primrose Ave**

Inspected on Thu, Sep 23 2021 at 2:00 PM

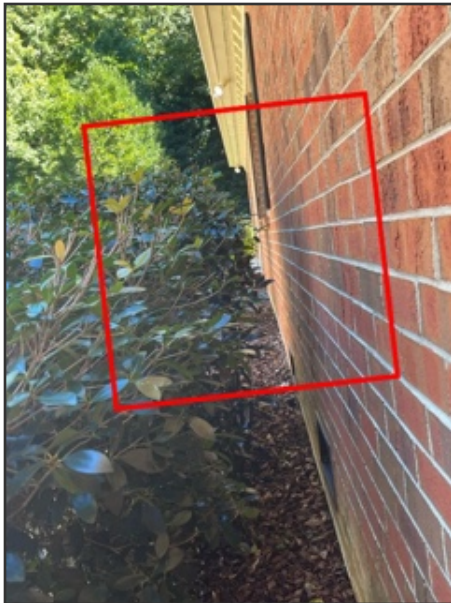
Figure 1-1

Vegetation is growing very close to the property. This should be trimmed at least 12 inches away from the siding. This will cause damage to the structure. Recommend trimming by a landscaping/Tree company.

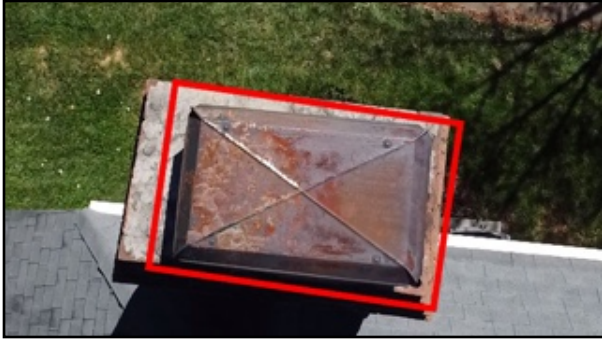
Figure 2-1

Very rusted chimney chase cover was found. Rusty streaks are a indication the chase cover is beginning to break down, increasing the risk for water penetration. This can lead to significant damage to the system. Recommend further evaluation by a qualified chimney sweep.

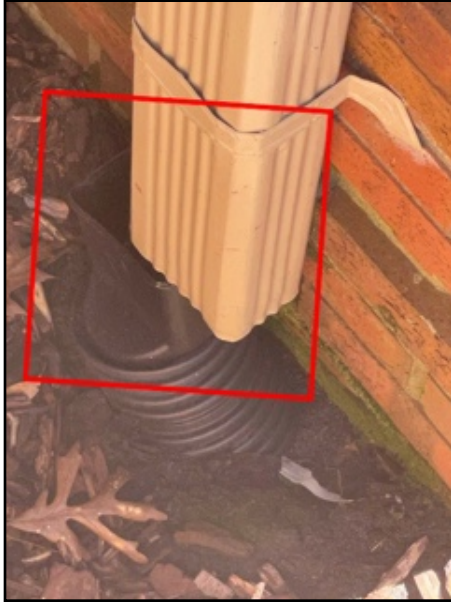
Figure 3-1

I noticed a downspout that was disconnected. This will allow moisture intrusion and further damages to the foundation. Recommend further evaluation by a handyman.

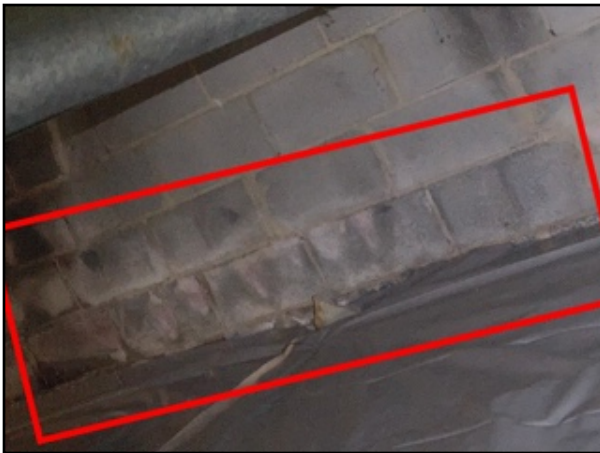
Figure 4-1

Efflorescence is a crystalline deposit of salts that can form when water is present in or on brick, concrete, stone, stucco or other building surfaces. It has a white or greyish tint and consists of salt deposits left behind when water evaporates. In addition, efflorescence can appear as a powdery substance on floors and walls and requires special care to treat. Moisture stains and high moisture readings were noticed inside the crawlspace, this is indication of major moisture intrusion. Recommend further evaluation by a foundation specialist.

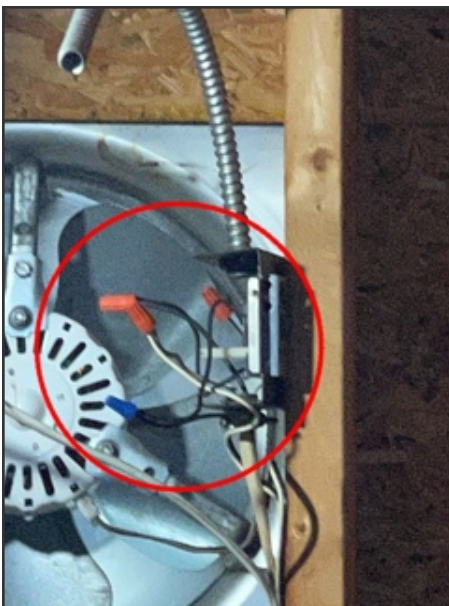
Figure 5-1

I noticed exposed electrical cables in the attic. They should be properly concealed in a junction box. This is a safety hazard. Recommend further evaluation by a general contractor.

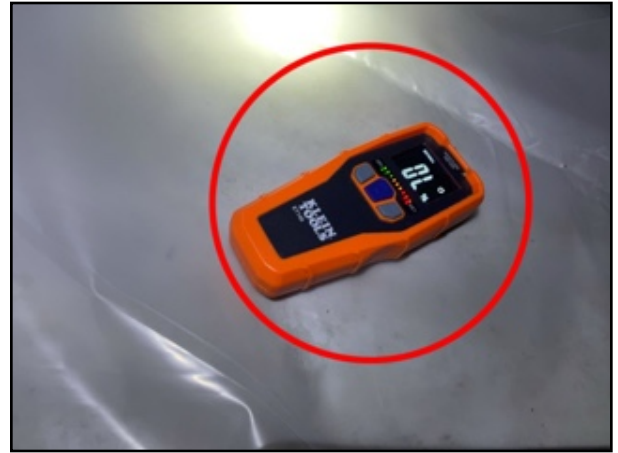
Figure 6-2

There were several area inside the crawlspace that were wet and moist this indicates major water intrusion. This will cause damaged and problems to the foundation and the property. Recommend further evaluation and repairs by a qualified crawlspace specialist.

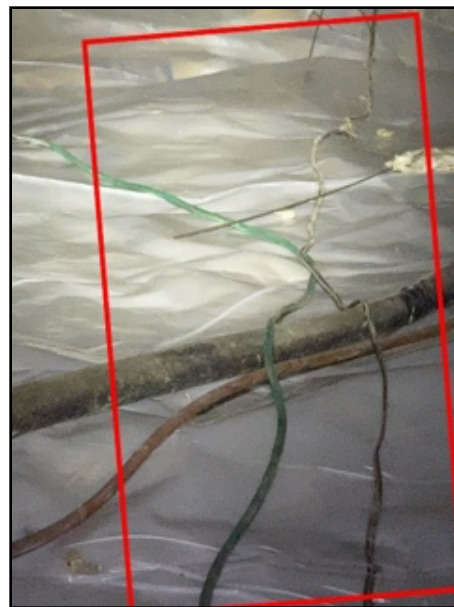
Figure 7-2

I noticed improperly concealed electrical cables inside the crawl space, they should be properly concealed in a junction box. This is a safety hazard and all wires should be secure to the floor joists. Recommend further evaluation and repairs by a foundation specialist.

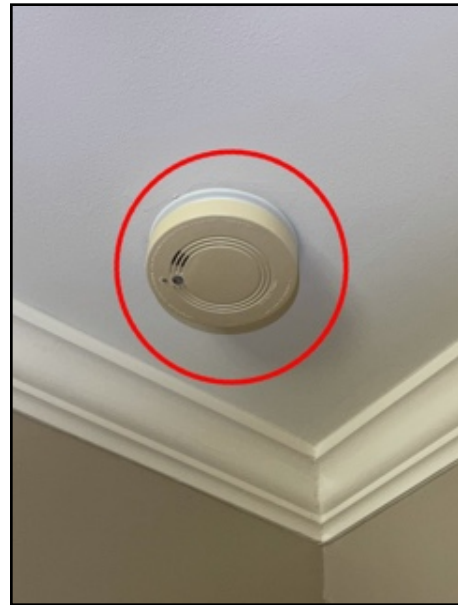
Figure 8-2

I noticed several smoked detectors in the house but according to the National Fire Protection Association (NFPA), smoke alarms should be installed on every level of your home. Fire detectors should also be installed inside of every bedroom and outside of each sleeping area as well as at least 10ft away from the kitchen. This is a major safety concern as failure to properly detect fires will allow further damage to occur and put lives in danger. Recommend installing more fire detectors by a general contractor.

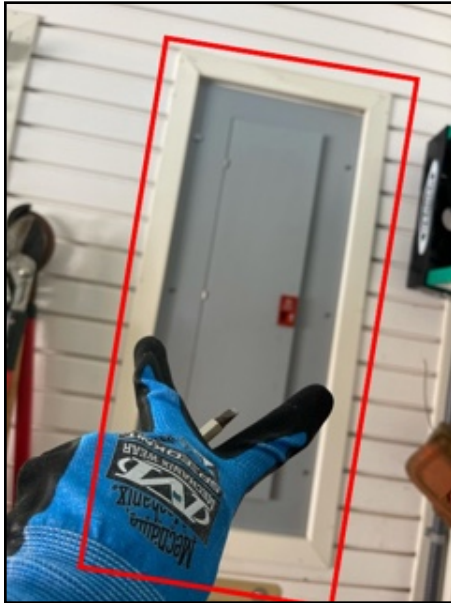
Figure 9-1

At the time of inspection I couldn't fully inspect the service panel. It had a molding that would not let me take out the door. Recommend further evaluation by liscense electrician.

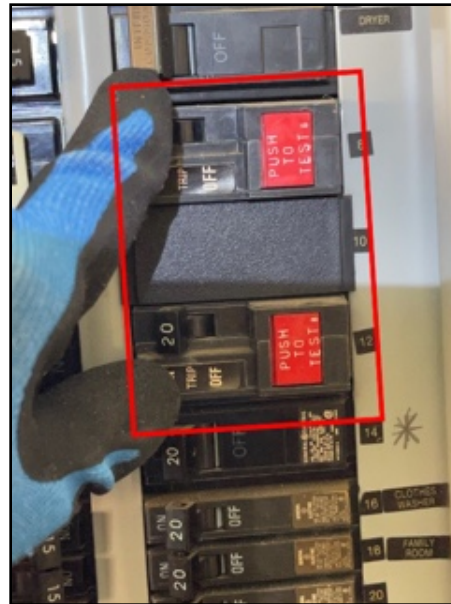
Figure 10-2

I noticed loose breakers in the panel. Loose and disconnected wires can become hot enough to start fires or can create serious shock hazards because the breaker doesn't always trip and shut off the power. Recommend further evaluation by a liscense electrician.

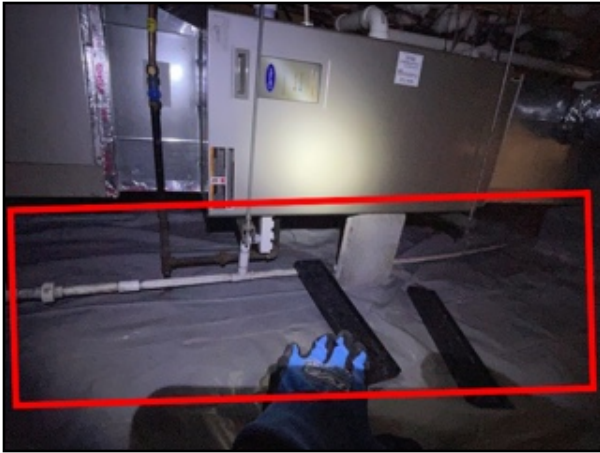
Figure 11-1

I noticed that the heat pump didn't have a water pan. This will allow moisture intrusion into the foundation and cause further damages. Recommend further evaluation by an HVAC specialist.

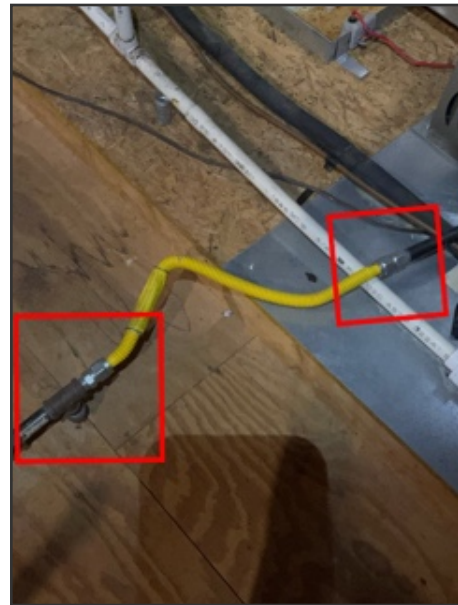
Figure 12-2

At the time of the inspection a shut off valve was not visible near the heat pump. This is a safety hazard. Recommend further evaluation by a heater contractor.

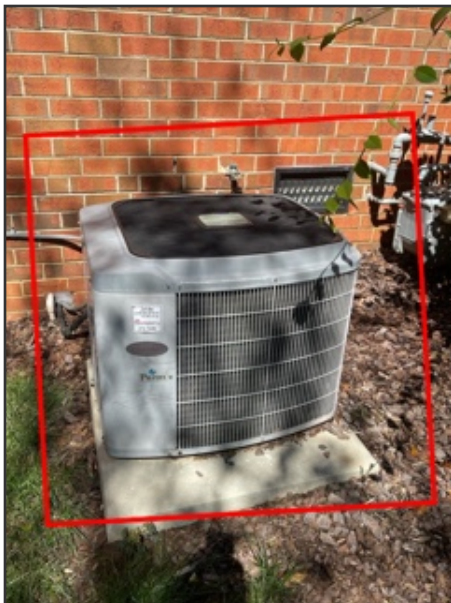
Figure 13-1

The HVAC system is past the expected life expectancy. Recommend further evaluation by a qualified HVAC specialist.

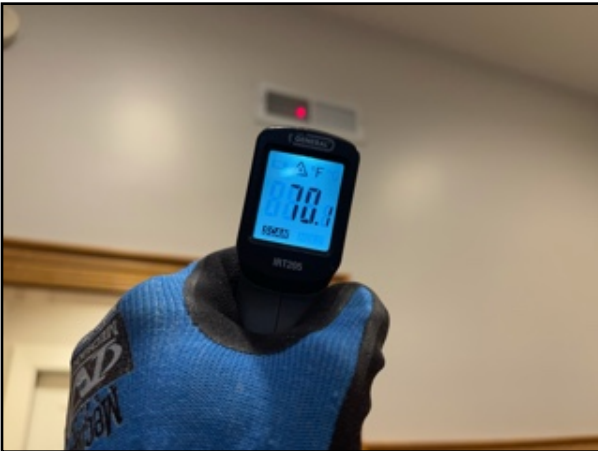
Figure 15-1

AC Return Air Temp: 68

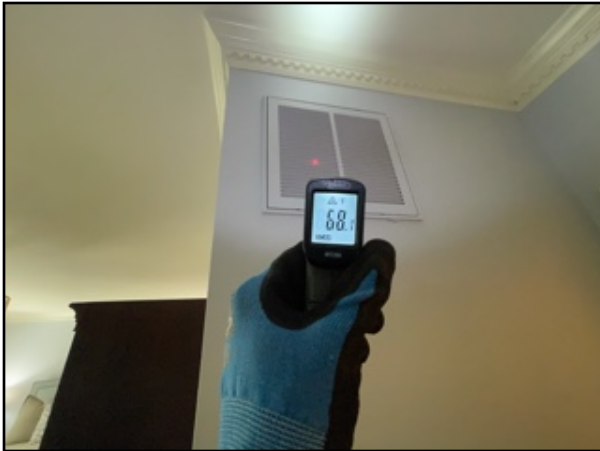
Figure 16-1

AC Return Air Temp #2: 67

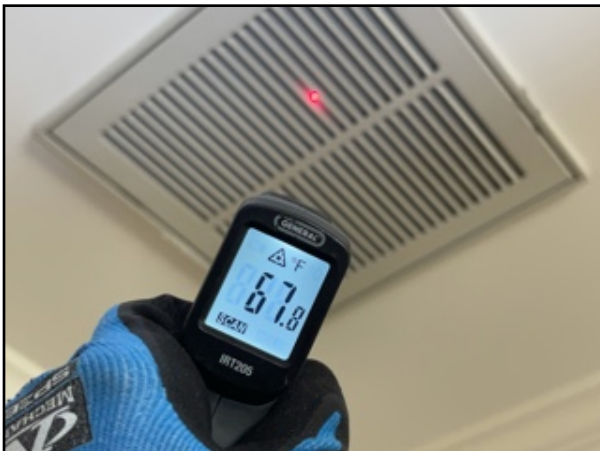
Figure 17-1

AC Temperature Drop: -7

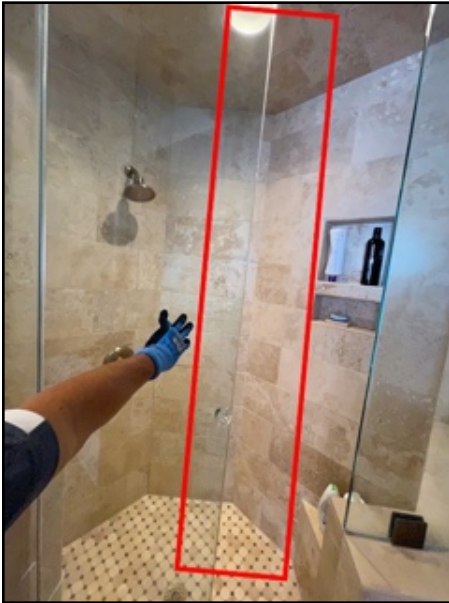
Figure 19-1

At the time of the inspection I noticed that the shower door had to be pulled instead of pushed to get out of the shower. This is a safety hazard. Recommend further evaluation by a general contractor.

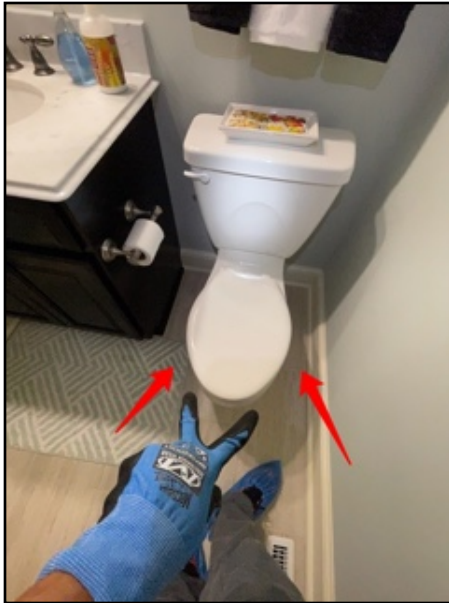
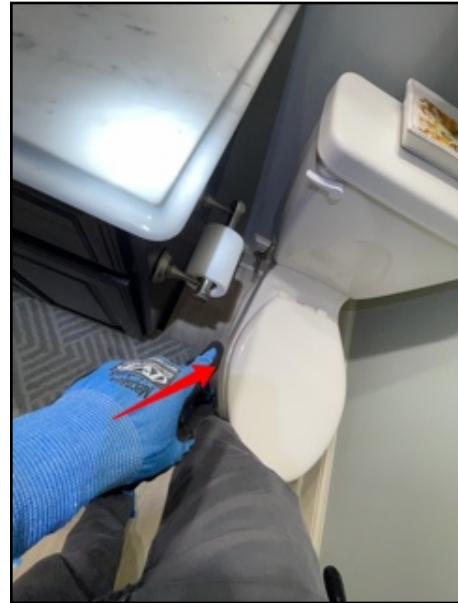
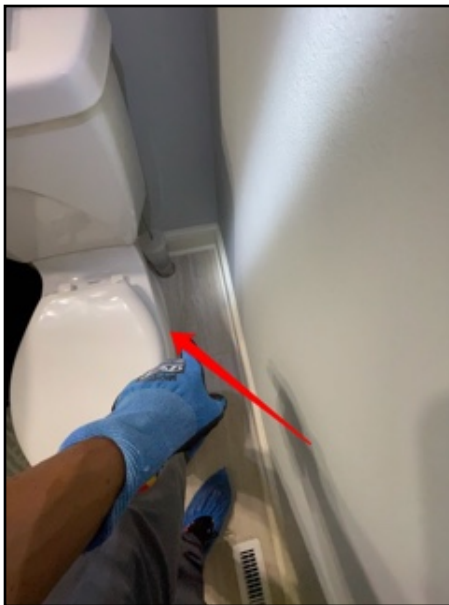
The toilet tank is not secured to minimize movement. This can cause leaks or deterioration by constant movement. Recommend further evaluation by a qualified plumber.

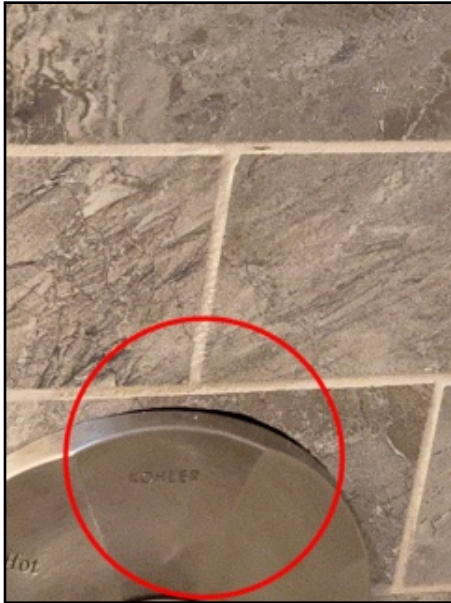
Figure 21-1

The escutcheon plates was not properly installed. These should be repair and caulked to keep water from infiltrating the walls. Recommend further evaluation and repairs by a qualified licensed plumber and a carpenter.

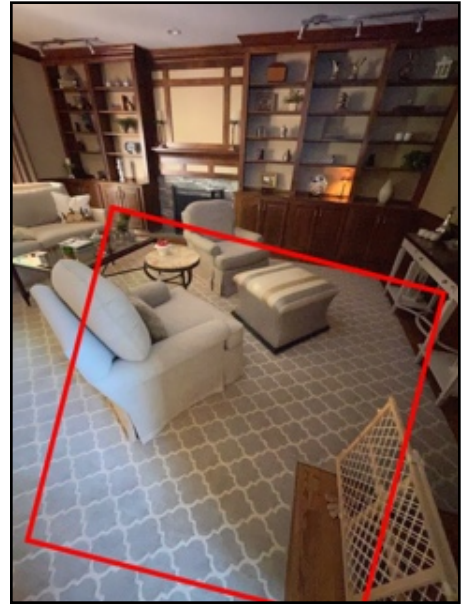
Figure 22-2

At the time of the inspection I could not fully inspected the flooring since a big carpet was covering most of it. Recommend further evaluation by a general contractor.

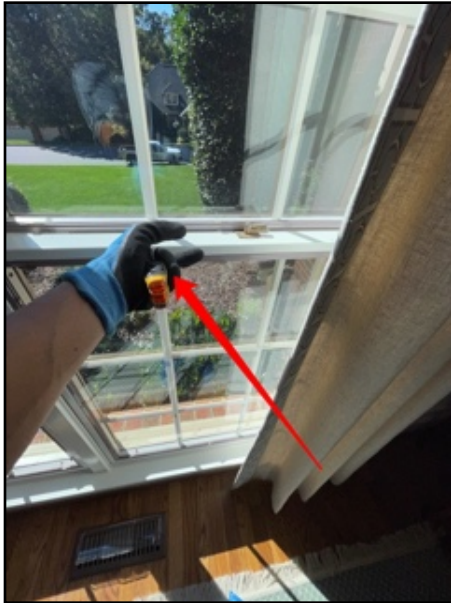
Figure 23-1

All windows were missing screens. This will allow unwanted insects inside the house. Also multiple windows didn't open. This is a safety hazard. Recommend further evaluation by a windows contractor.

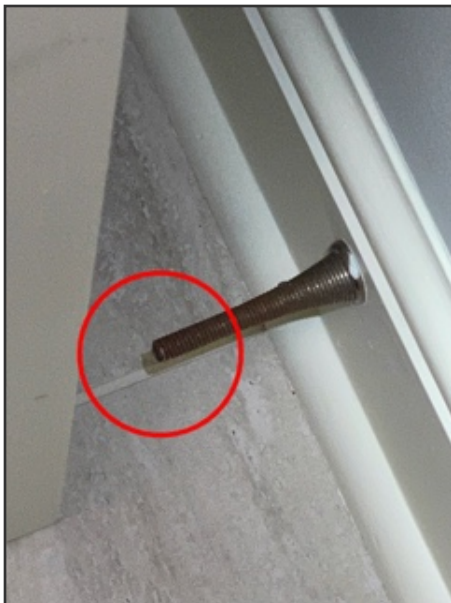
Figure 24-1

I noticed a door stopper that was missing the cap. This will damage the door. Recommend further evaluation by a handyman.

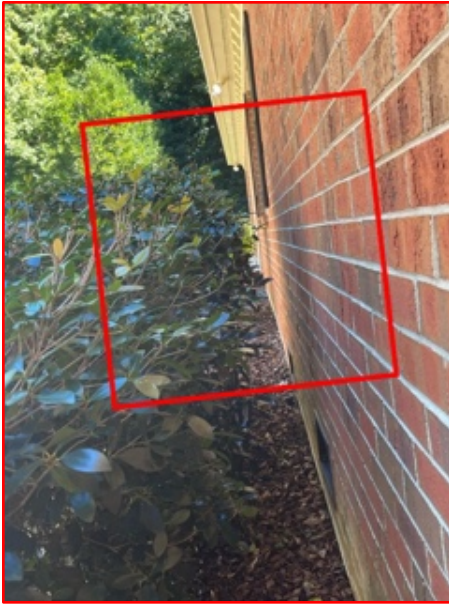
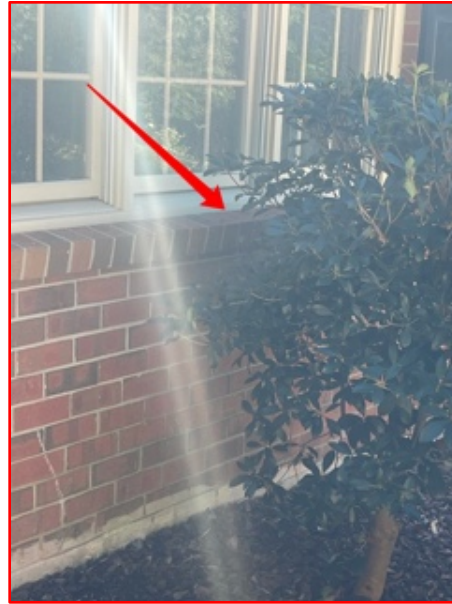
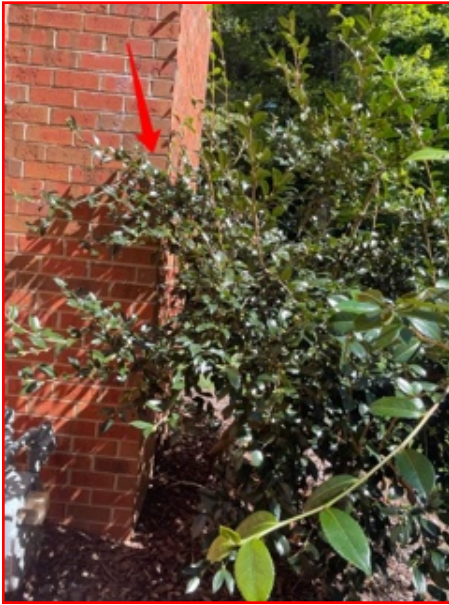
1) Vegetation is growing very close to the property. This should be trimmed at least 12 inches away from the siding. This will cause damage to the structure. Recommend trimming by a landscaping/Tree company.

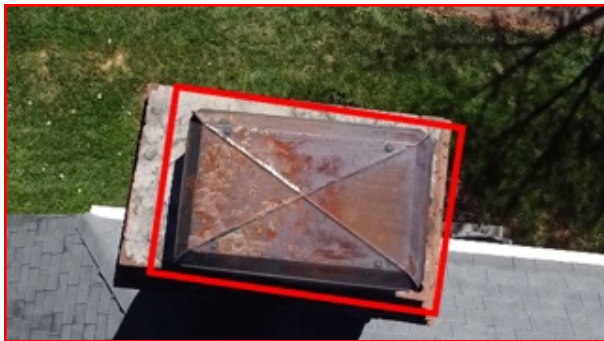
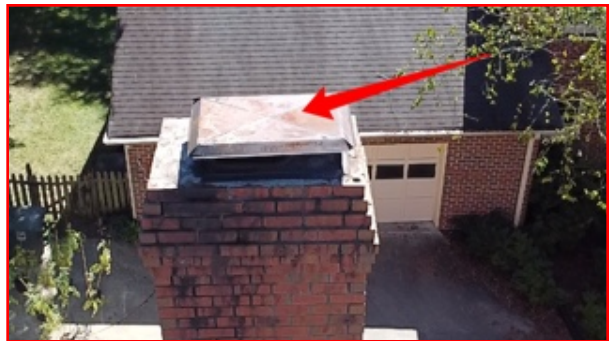
2) Very rusted chimney chase cover was found. Rusty streaks are a indication the chase cover is beginning to break down, increasing the risk for water penetration. This can lead to significant damage to the system. Recommend further evaluation by a qualified chimney sweep.

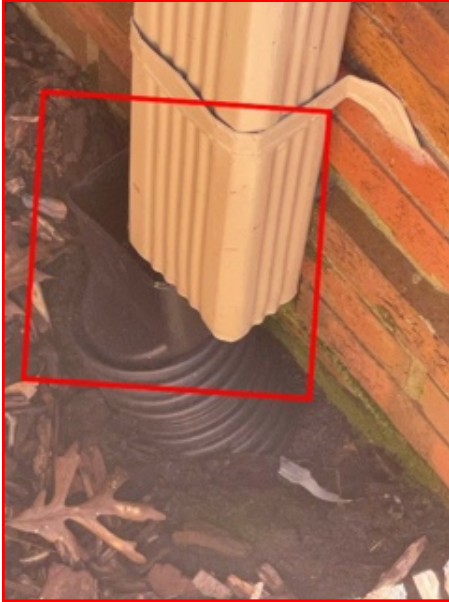
Figure 3-1

3) I noticed a downspout that was disconnected. This will allow moisture intrusion and further damages to the foundation. Recommend further evaluation by a handyman.

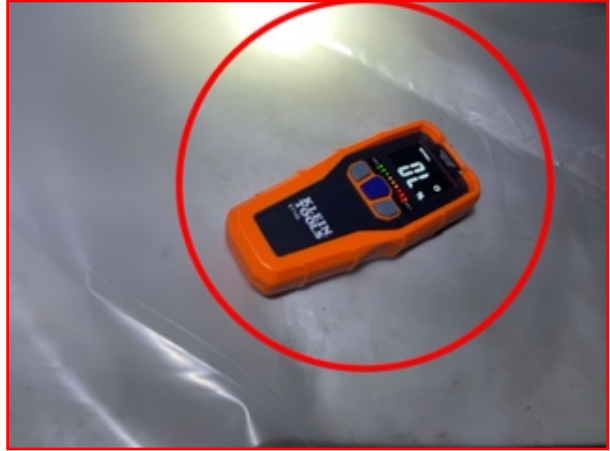
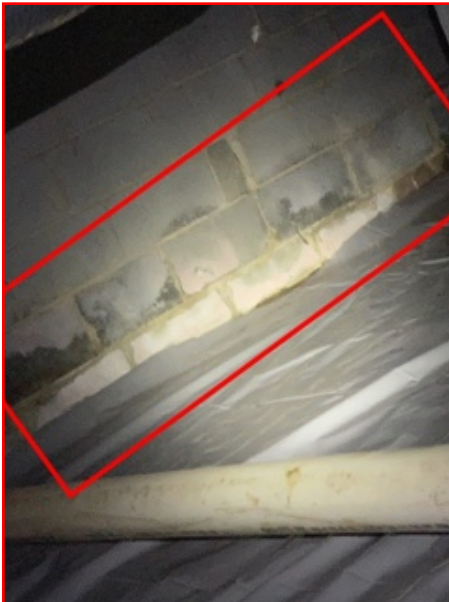
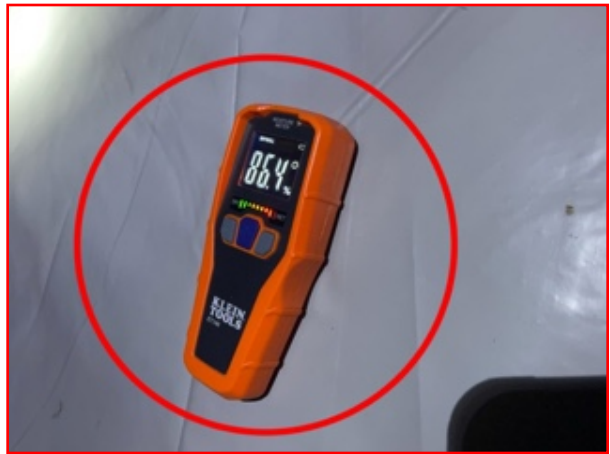
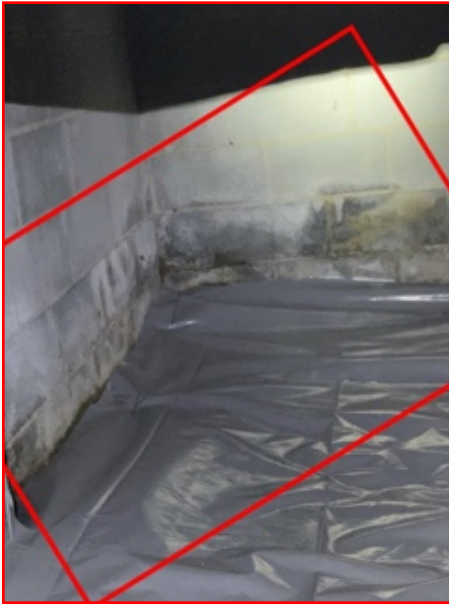
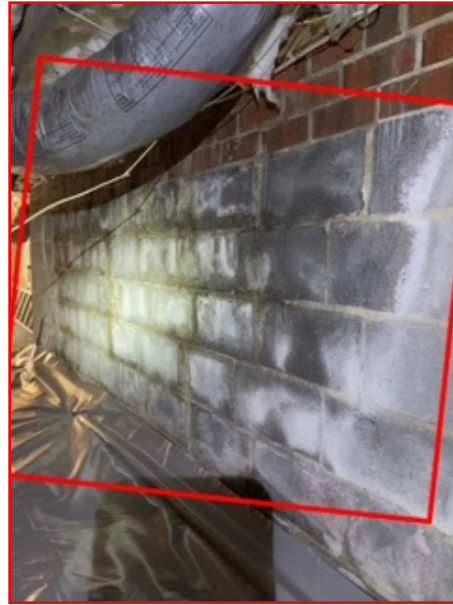
4) Efflorescence is a crystalline deposit of salts that can form when water is present in or on brick, concrete, stone, stucco or other building surfaces. It has a white or greyish tint and consists of salt deposits left behind when water evaporates. In addition, efflorescence can appear as a powdery substance on floors and walls and requires special care to treat. Moisture stains and high moisture readings were noticed inside the crawlspace, this is indication of major moisture intrusion. Recommend further evaluation by a foundation specialist.

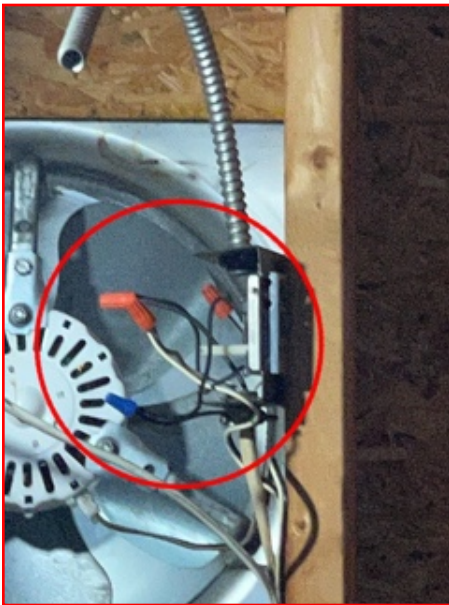
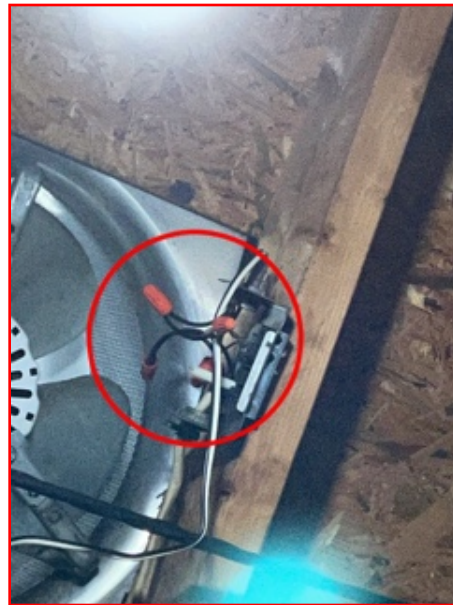
5) I noticed exposed electrical cables in the attic. They should be properly concealed in a junction box. This is a safety hazard. Recommend further evaluation by a general contractor.

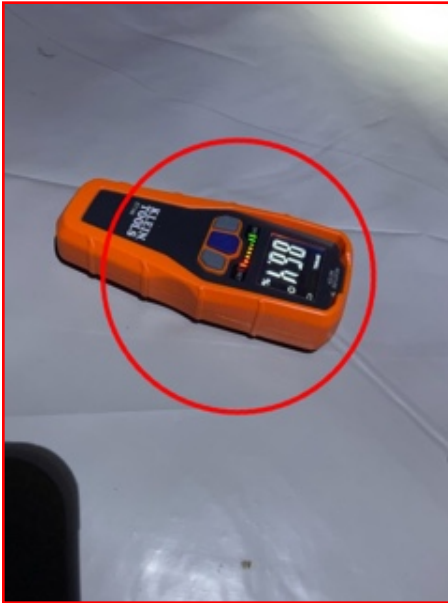
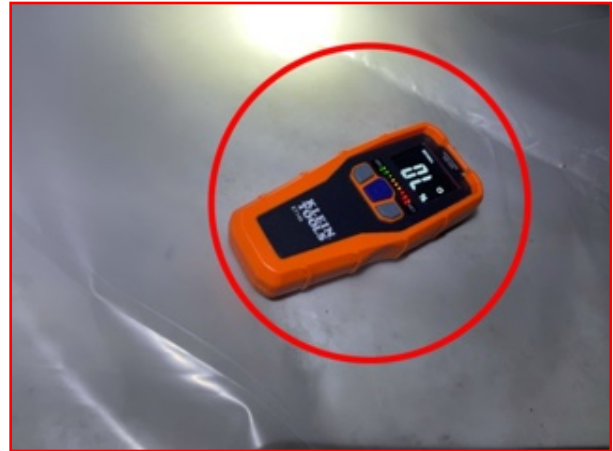
6) There were several area inside the crawlspace that were wet and moist this indicates major water intrusion. This will cause damaged and problems to the foundation and the property. Recommend further evaluation and repairs by a qualified crawlspace specialist.

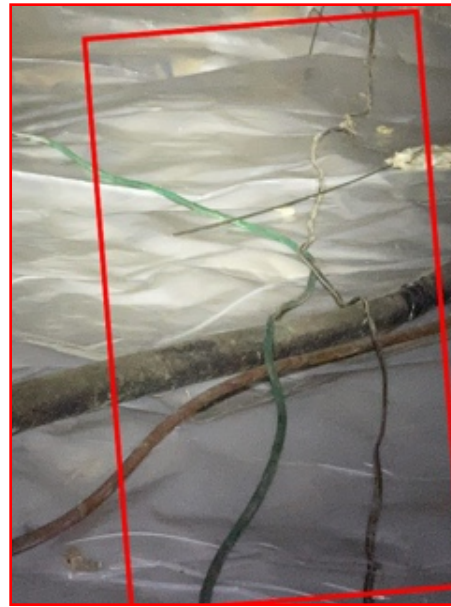
Figure 7-2

7) I noticed improperly concealed electrical cables inside the crawl space, they should be properly concealed in a junction box. This is a safety hazard and all wires should be secure to the floor joists. Recommend further evaluation and repairs by a foundation specialist.

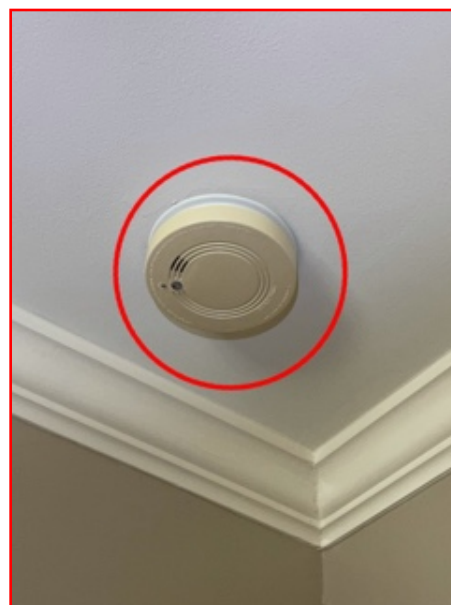
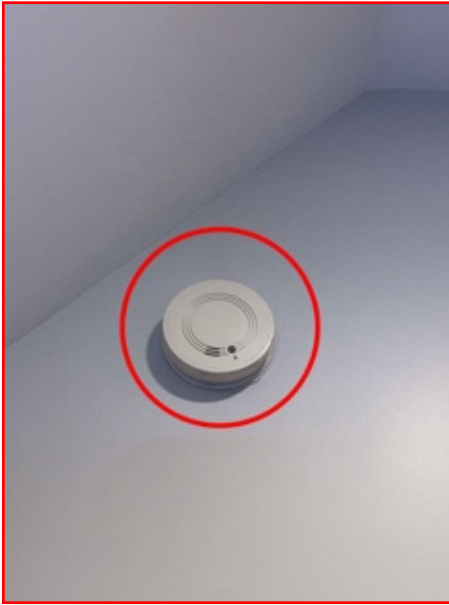
8) I noticed several smoked detectors in the house but according to the National Fire Protection Association (NFPA), smoke alarms should be installed on every level of your home. Fire detectors should also be installed inside of every bedroom and outside of each sleeping area as well as at least 10ft away from the kitchen. This is a major safety concern as failure to properly detect fires will allow further damage to occur and put lives in danger. Recommend installing more fire detectors by a general contractor.

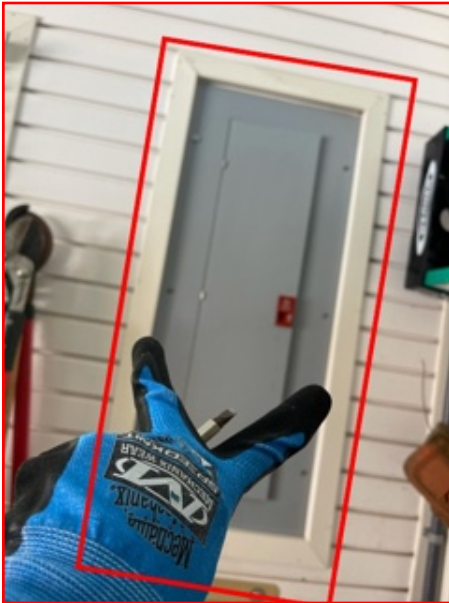
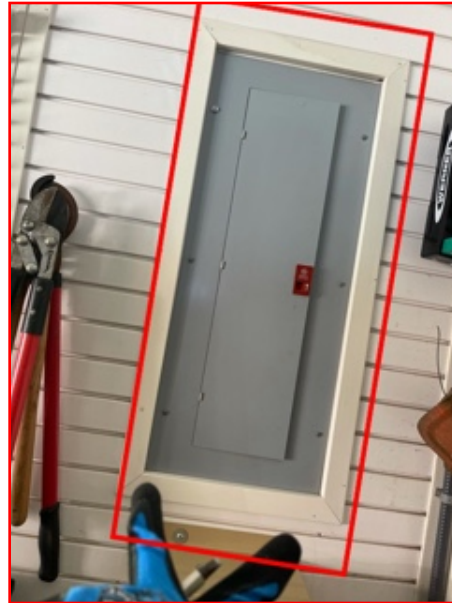
9) At the time of inspection I couldn't fully inspected the service panel. It had a molding that would not let me take out the door. Recommend further evaluation by liscense electrician.

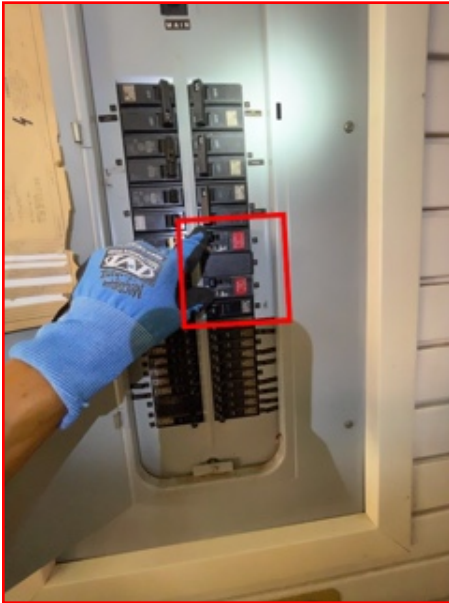
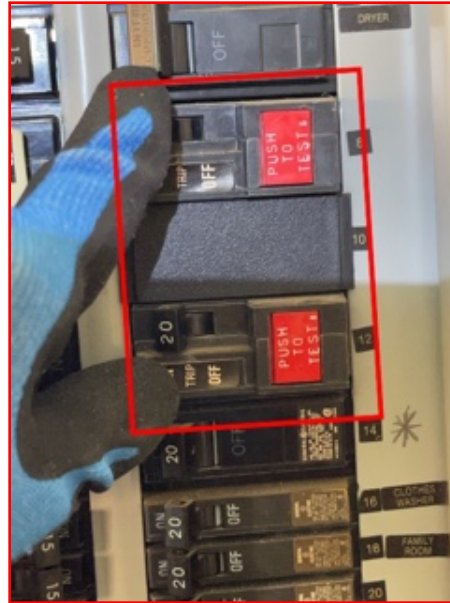
10) I noticed loose breakers in the panel. Loose and disconnected wires can become hot enough to start fires or can create serious shock hazards because the breaker doesn't always trip and shut off the power. Recommend further evaluation by a license electrician.

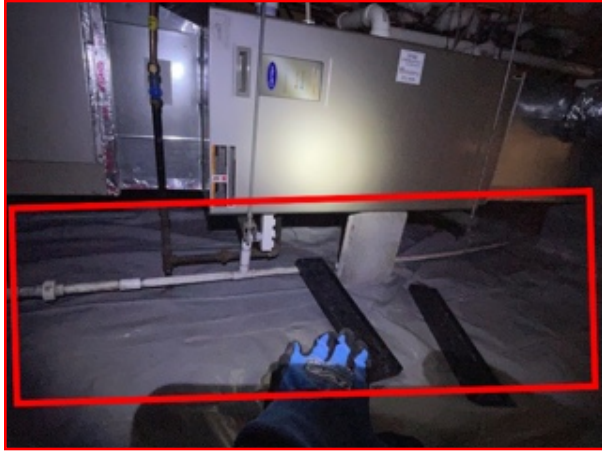
Figure 11-1

11) I noticed that the heat pump didn't have a water pan. This will allow moisture intrusion into the foundation and cause further damages. Recommend further evaluation by an HVAC specialist.

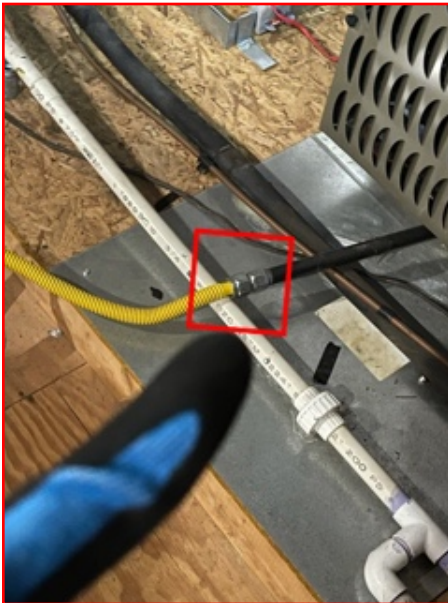
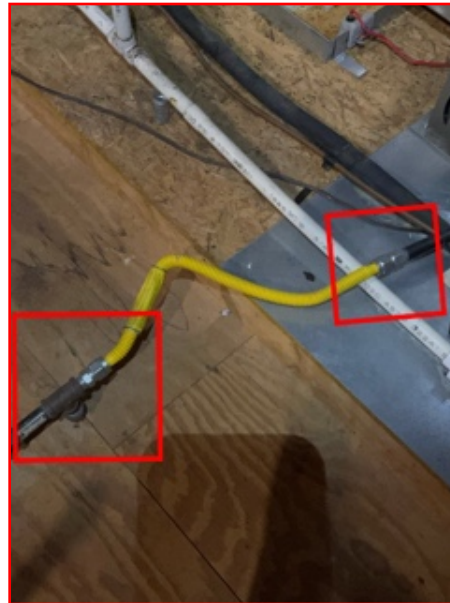
12) At the time of the inspection a shut off valve was not visible near the heat pump. This is a safety hazard. Recommend further evaluation by a heater contractor.

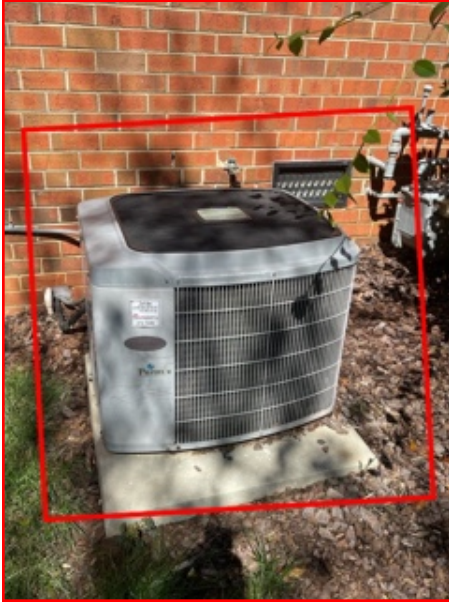
Figure 13-1

13) The HVAC system is past the expected life expectancy. Recommend further evaluation by a qualified HVAC specialist.

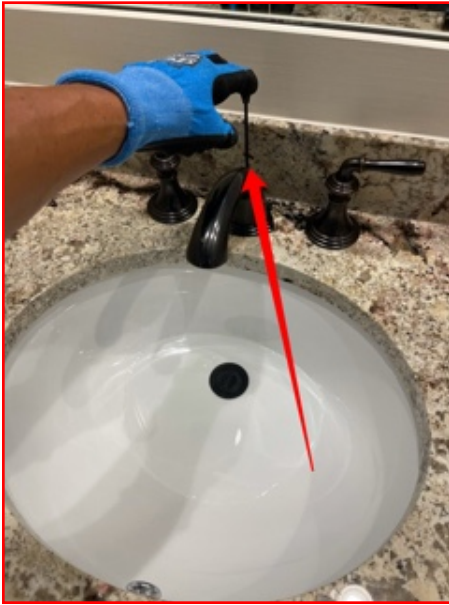
Figure 18-1

I noticed a malfunctioning water stopper. This is necessary in order to keep pipes from clogging with debris or objects. This may cause excessive consumption of water and moisture intrusion. Recommend repairs and further evaluation by a qualified general contractor or plumber.

14) I noticed a malfunctioning water stopper. This is necessary in order to keep pipes from clogging with debris or objects. This may cause excessive consumption of water and moisture intrusion. Recommend repairs and further evaluation by a qualified general contractor or plumber.

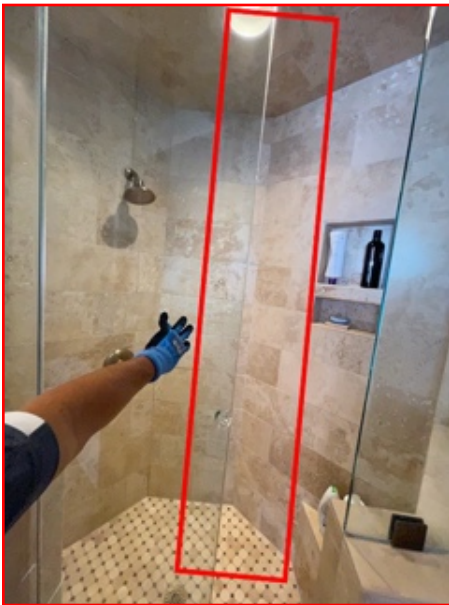
Figure 19-1

15) At the time of the inspection I noticed that the shower door had to be pulled instead of pushed to get out of the shower. This is a safety hazard. Recommend further evaluation by a general contractor.

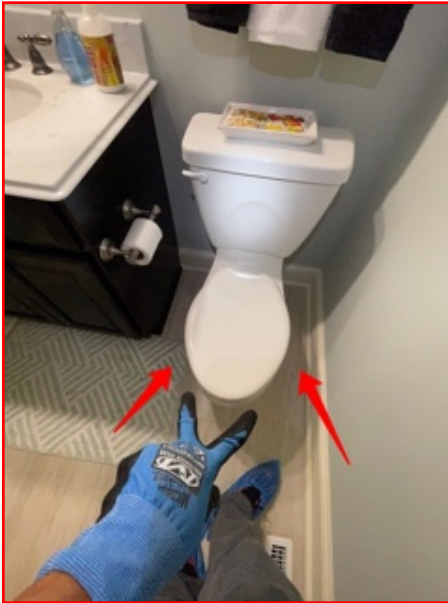
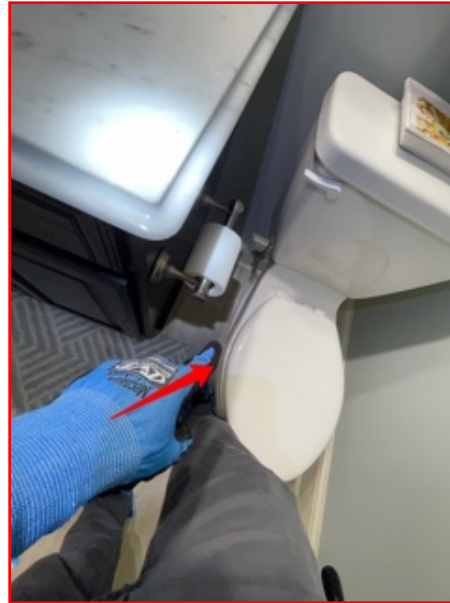
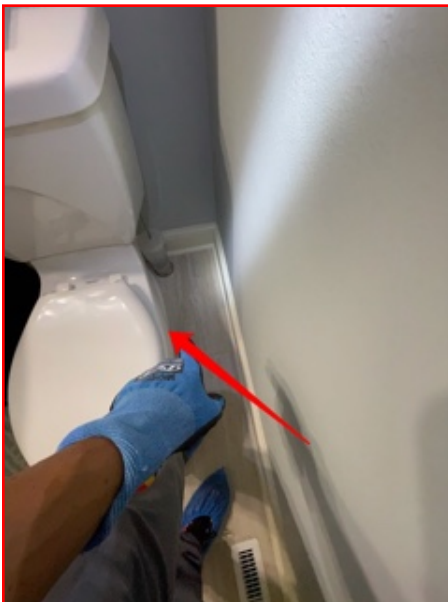
16) The toilet tank is not secured to minimize movement. This can cause leaks or deterioration by constant movement. Recommend further evaluation by a qualified plumber.

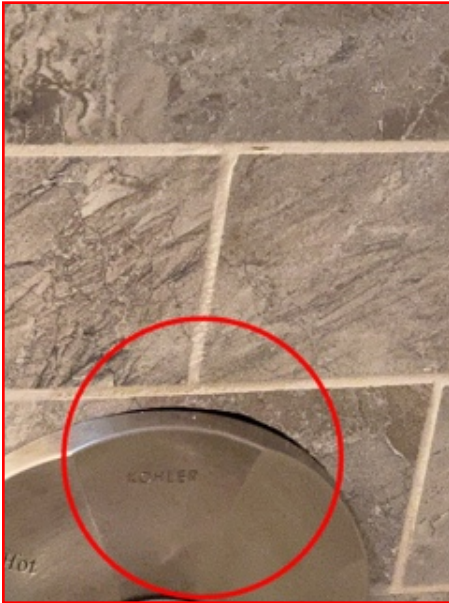
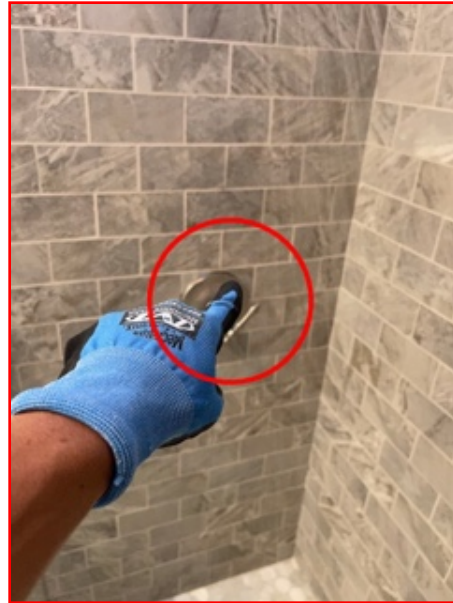
17) The escutcheon plates was not properly installed. These should be repair and caulked to keep water from infiltrating the walls. Recommend further evaluation and repairs by a qualified licensed plumber and a carpenter.

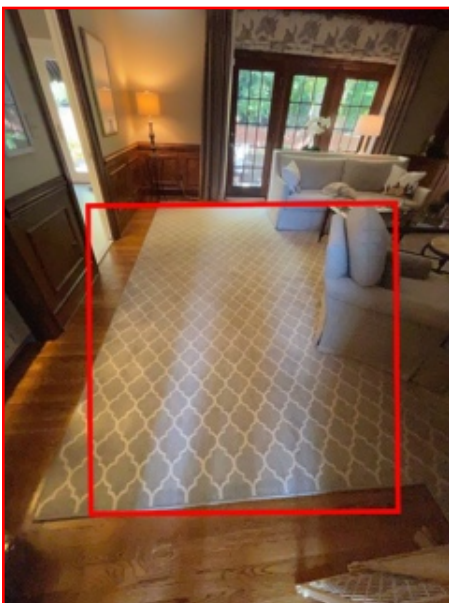
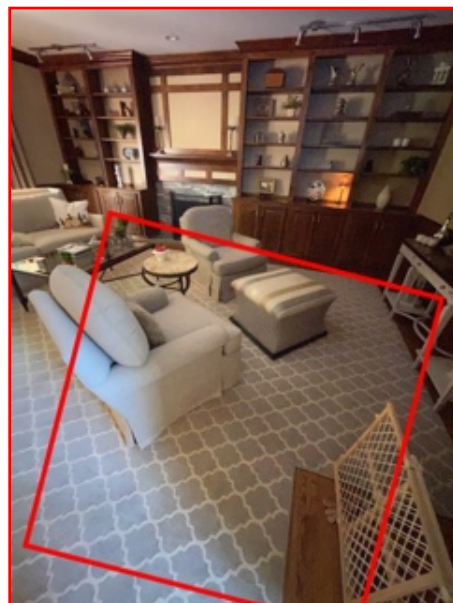
18) At the time of the inspection I could not fully inspected the flooring since a big carpet was covering most of it. Recommend further evaluation by a general contractor.

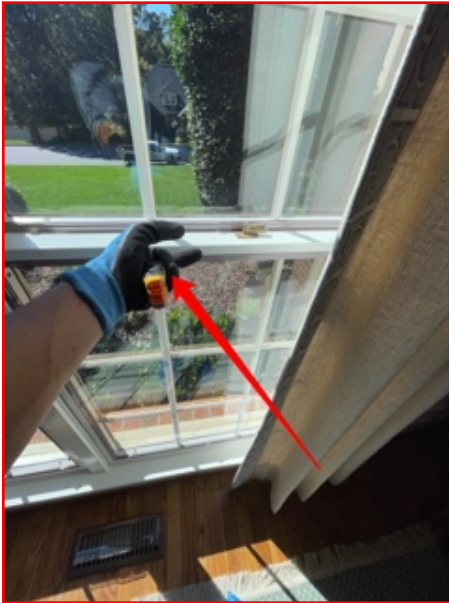
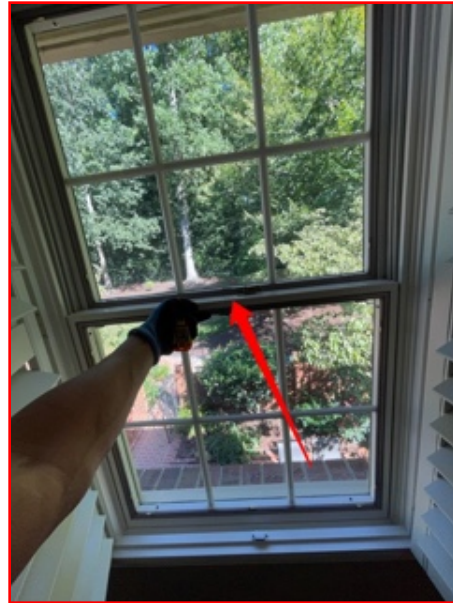
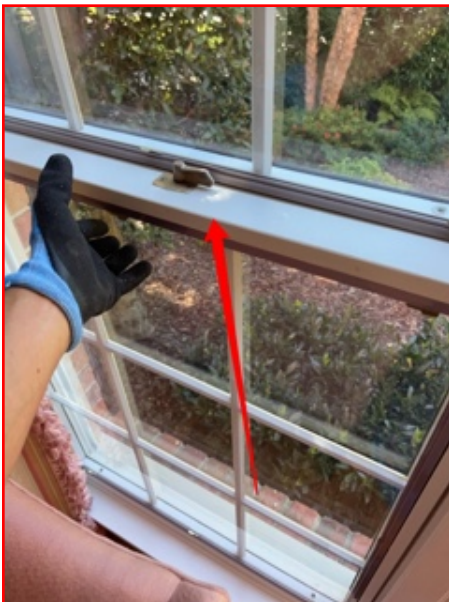
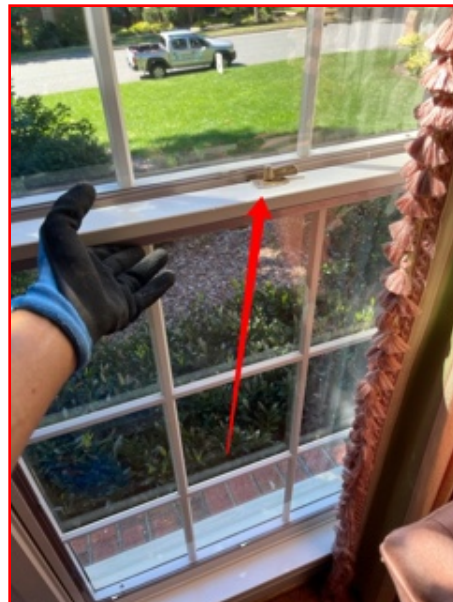
19) All windows were missing screens. This will allow unwanted insects inside the house. Also multiple windows didn't open. This is a safety hazard. Recommend further evaluation by a windows contractor.

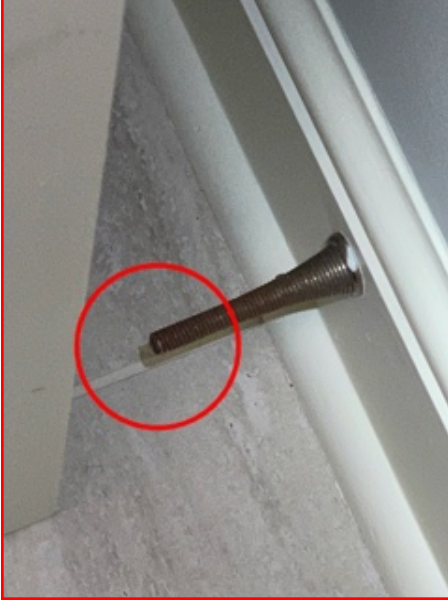
Figure 24-1

20) I noticed a door stopper that was missing the cap. This will damage the door. Recommend further evaluation by a handyman.
