Top Home Inspection LLC

Home Inspection Report

6307 Ballybay Dr

Inspected on Sun, Nov 10 2019 at 1:00 PM

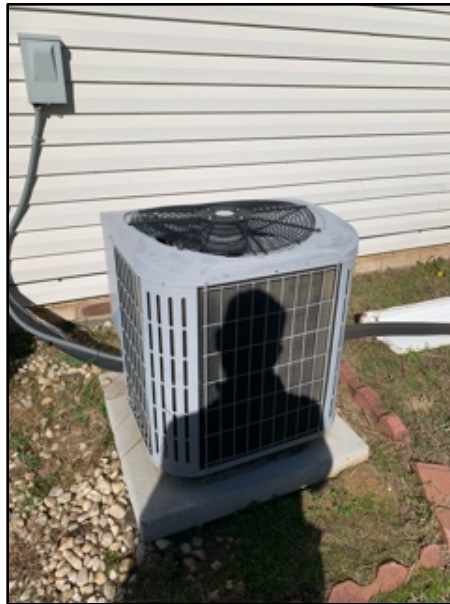
Comment 7:

There were exposed electrical wires coming from the left outside unit. This is a safety hazard and should be corrected. Recommend repairs by a licensed HVAC contractor.
