RE: Bank of Everglades Historical Report

BANK OF EVERGLADES DRAFT REPORT

EXISTING CONDITION DOCUMENTS
 BANK OF EVERGLADES
 201 Broadway, Everglades City
 COLLIER COUNTY, FLORIDA

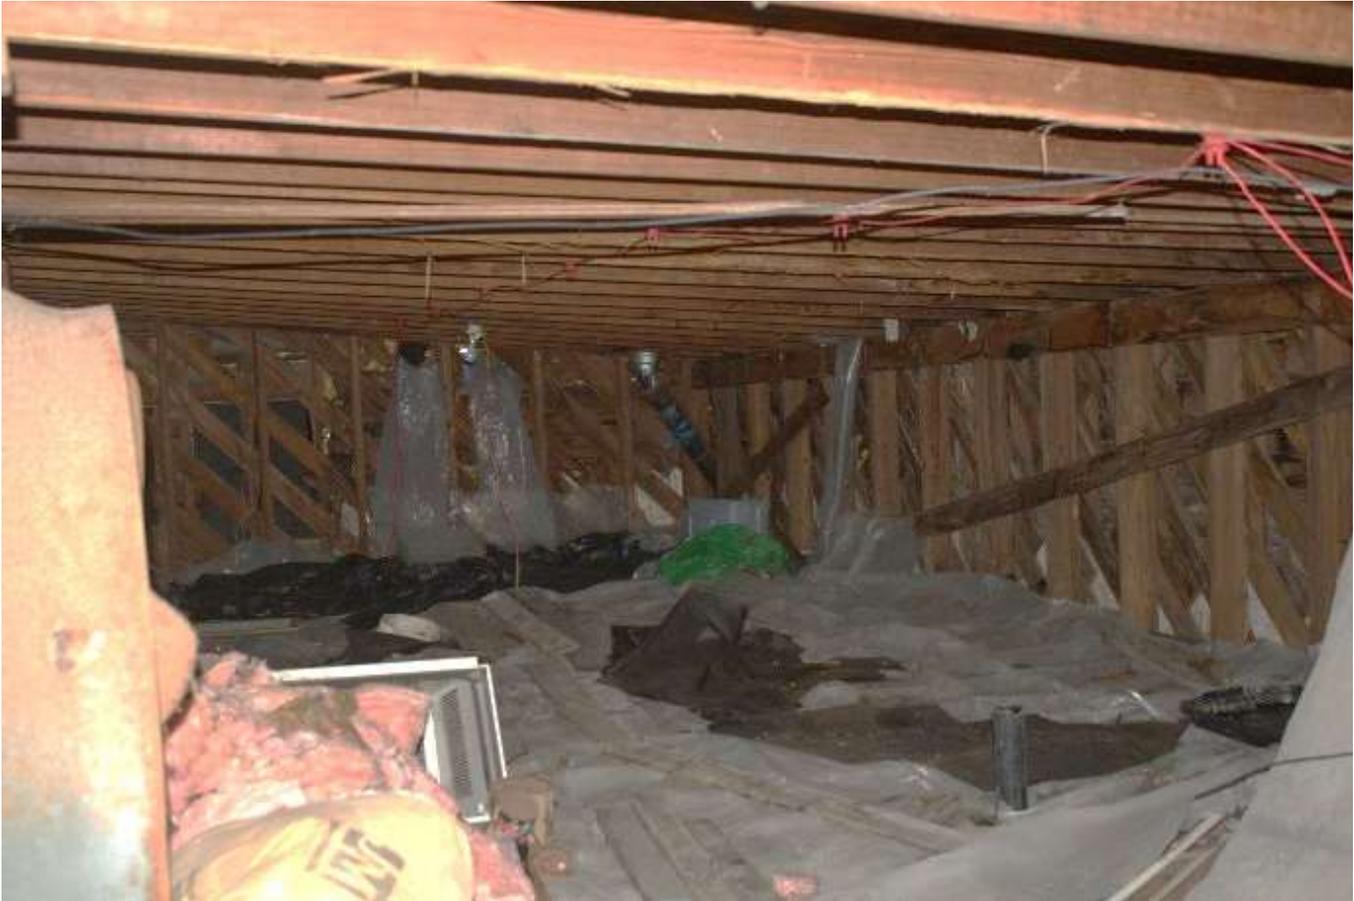
Attic area

All roofs are framed in wood with the upper wall structures exposed. The materials are in good condition with no evidence of distress identified except where the roof leaks. The exterior siding was set at a 45-degree angle for structural stability. There was no evidence of damage to wall studs, sheathing, or roof joists in the attic. There were some roof leaks that needed repairs.

Located within the attic, the standing water trapped in the plastic tarp needs to be removed along with the tarp. Moisture within the attic space will cause excessive humidity and increase the rate of wood decay. The tarp will be unnecessary once the re-roofing has been completed. Deteriorated second floor wood joists need to be repaired by sistering a new 2X framing member to the existing, and the associated decking needs to be replaced. Prior to completing the second-floor repairs, it is recommended the ceiling be opened by removing the plaster and exposing the coped, compromised 2-inch x 12-inch floor framing. It is recommended to sister an additional 2X to the compromised joists. A review of the plumbing is highly recommended to determine if there are still active leaks in the pipes. The plumbing review will help minimize the likeliness of future leaks and water damage to the framing. Access stairs linking the first floor to second floor at the northeast corner require demolition and reconstruction, preserving any salvageable historic framing.

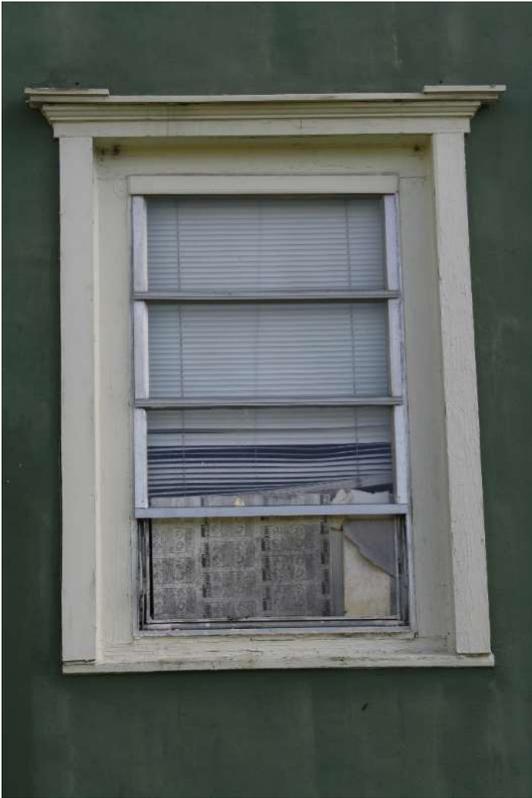
There are 30 aluminum windows on the building, 21 on the original building and 9 on the rear 1950 addition. All windows will require restoration, which will include replacing them with wood double hung sashes. The new windows should replicate the original wood double hung windows. Work will be required at sashes and framing. Some windows have been removed or altered to allow through window A/C units.

Exterior window

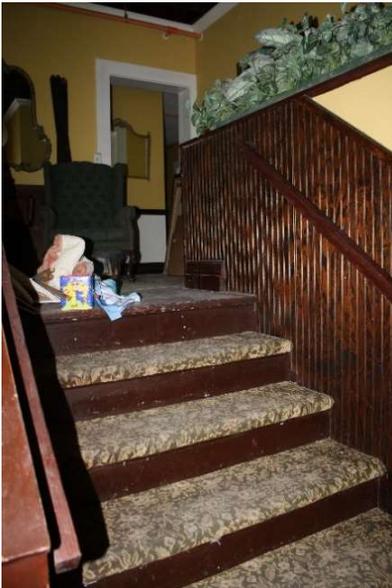
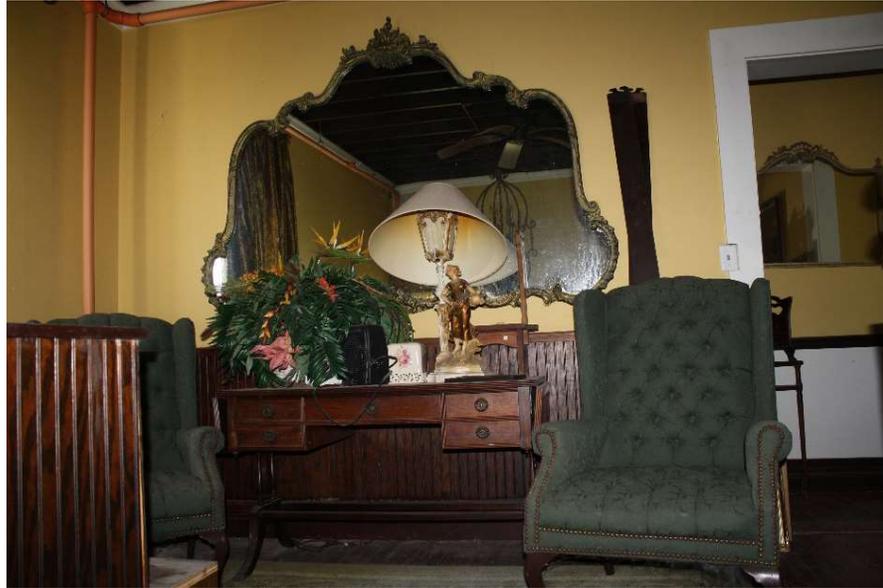
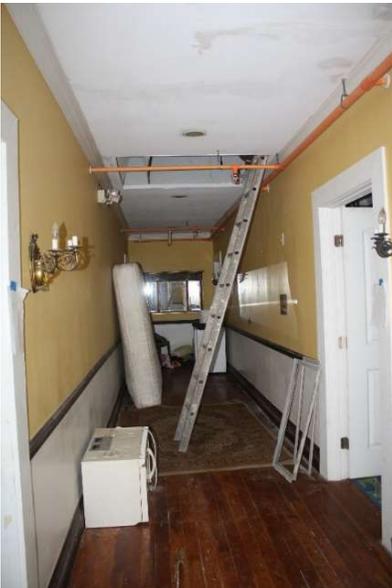
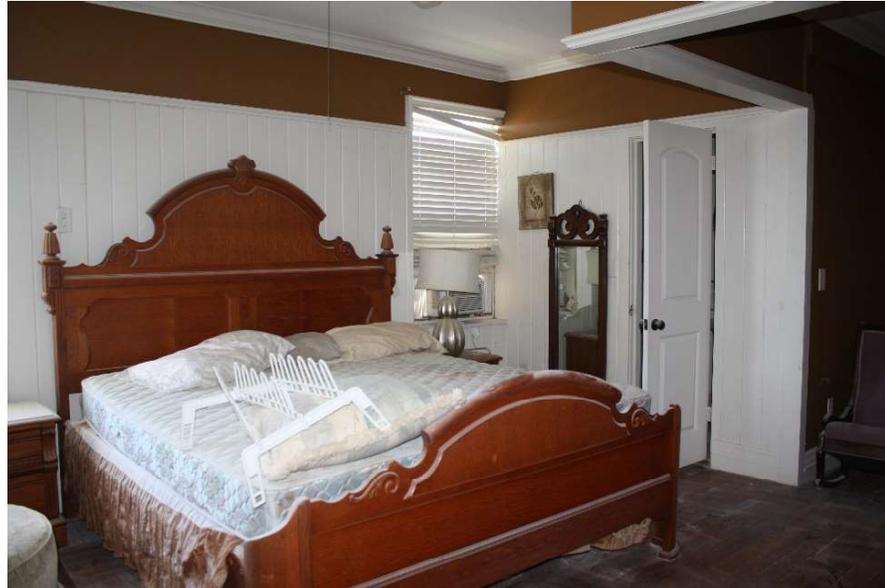
These photos show second floor areas. Top left is the stair. Top right is the upper landing. Lower left is the hall. Lower right is the bedroom.

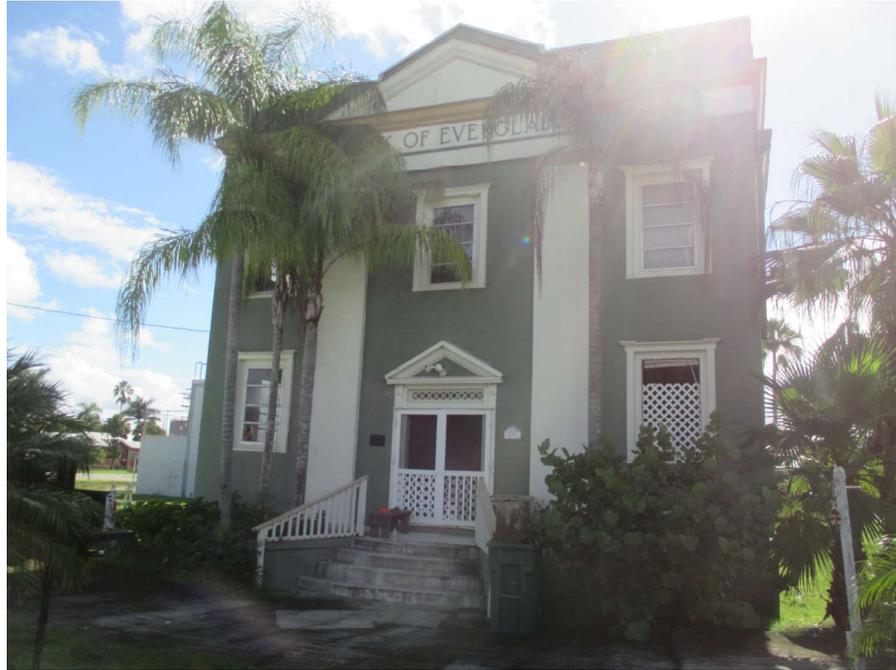
Photograph 1
West Facade

The structure located at 201 Broadway Avenue West was constructed circa 1926 and is a two-story, wood framed building bearing on masonry stem walls on concrete foundations. The original exterior walls are constructed of 2-inch x 6-inch wood studs and concrete stucco exterior. Approximately in 1950, a two-story addition was placed at the northeast corner and was constructed of 8-inch concrete masonry units (CMU) with concrete stucco exterior that bear on concrete foundations. The building is in the Classical Revival Style with pediments above the main entrance and at the roof line of the second-story (see Photograph 1). Pilasters with capitals are on all elevations except the west side (see Photograph 2).

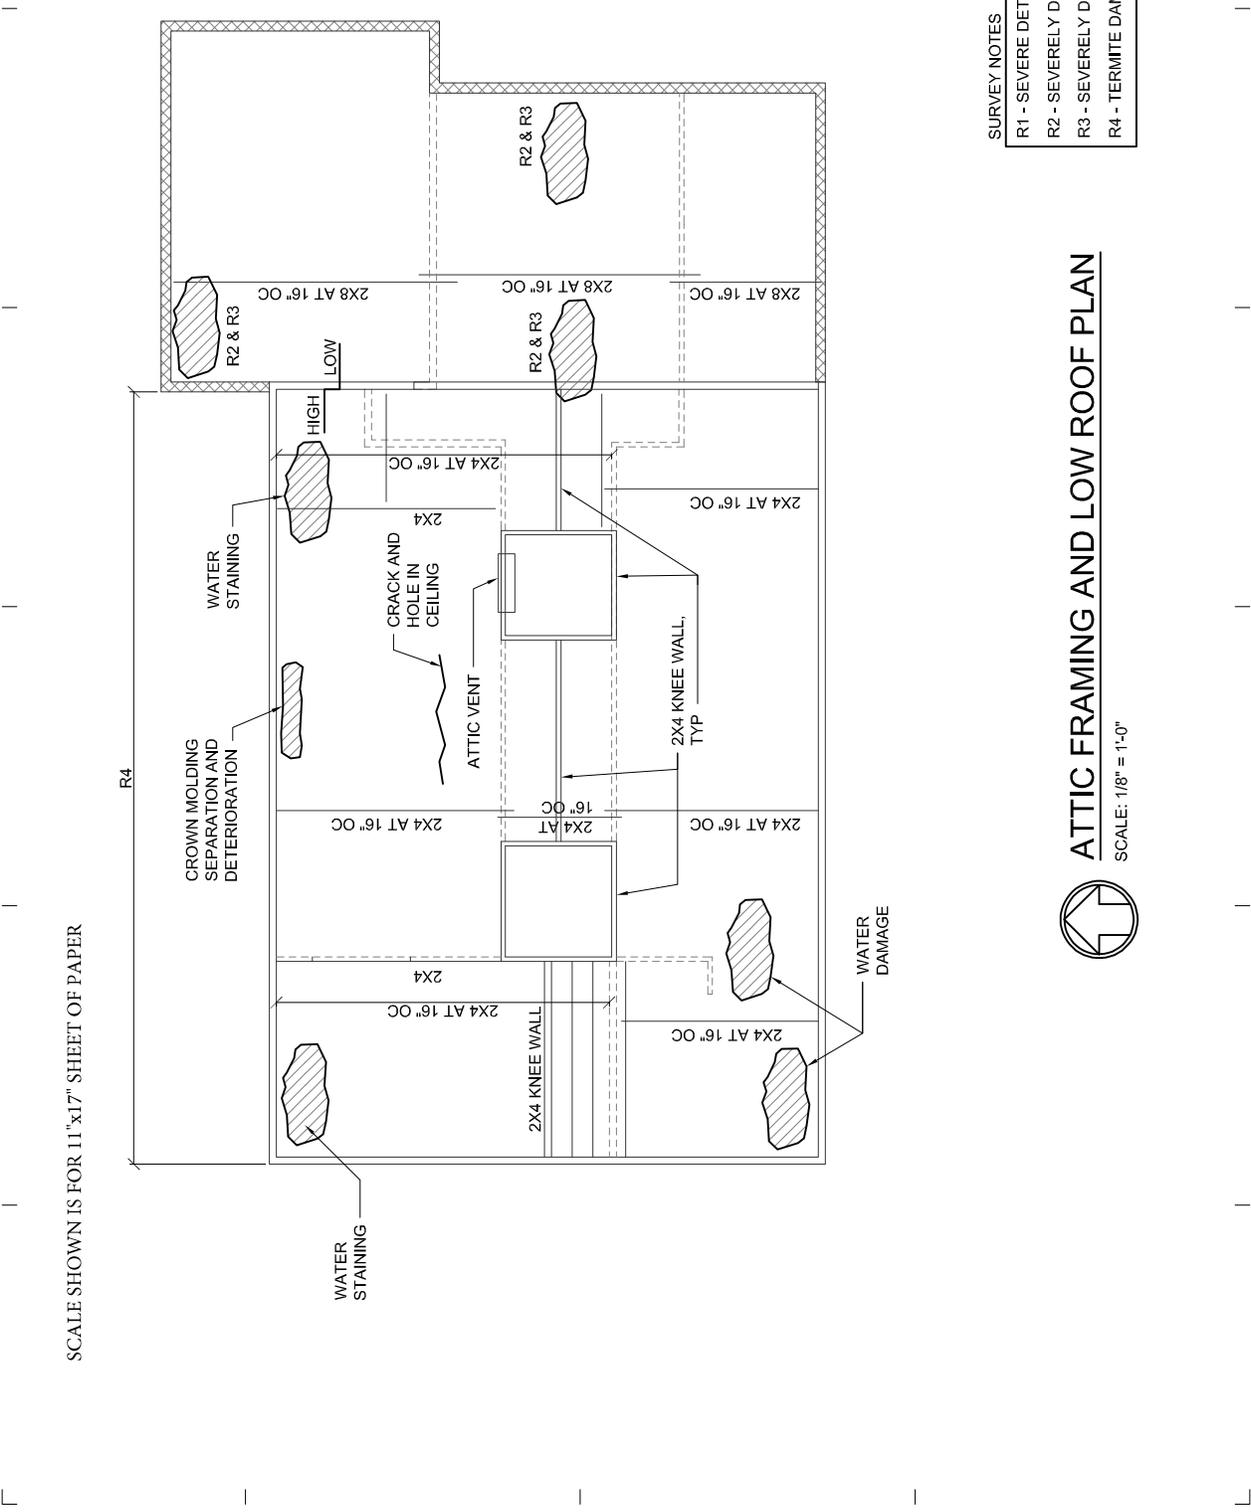
S-2
 of

SURVEY NOTES
 R1 - SEVERE DETERIORATION AT ROOF DRAIN
 R2 - SEVERELY DETERIORATED DECKING
 R3 - SEVERELY DETERIORATED JOIST
 R4 - TERMITE DAMAGE THROUGHOUT
