# ECO MONTHLY ENVIRONMENTAL MONITORING REPORT

Virginia Photo Voltaic (PV) Solar Facility 1, 2 and 3,  
Matjhabeng, Lejweleputswa District Municipality within  
the jurisdiction of the Free State Province.

January 2025

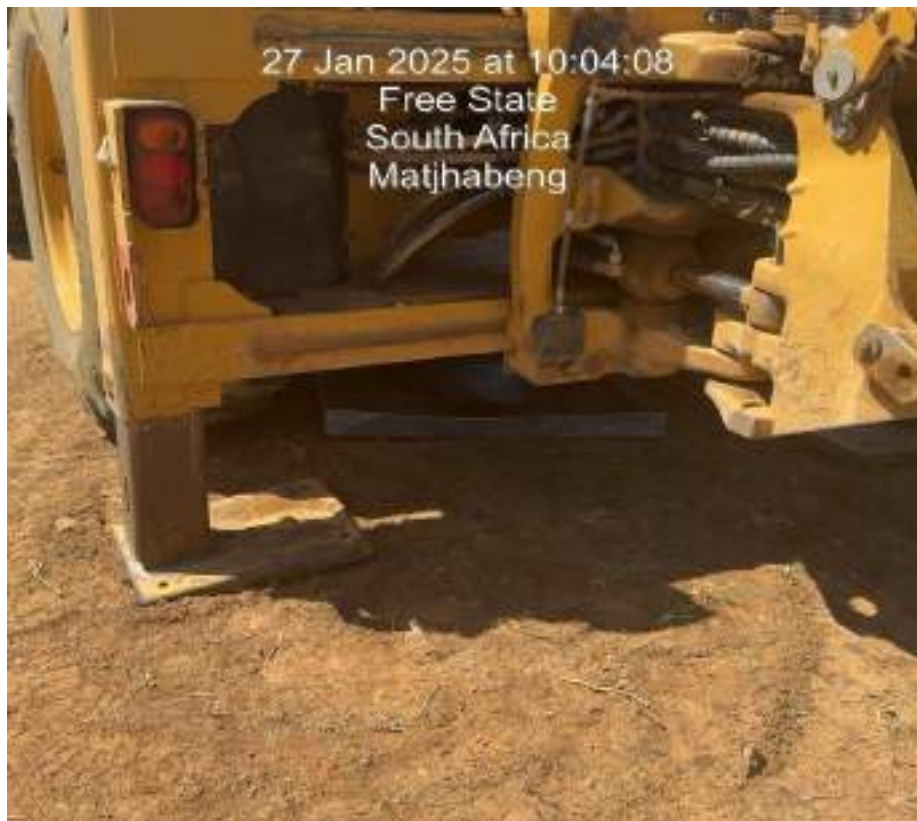
**Figure 3:** Standing Equipment with drip trays.

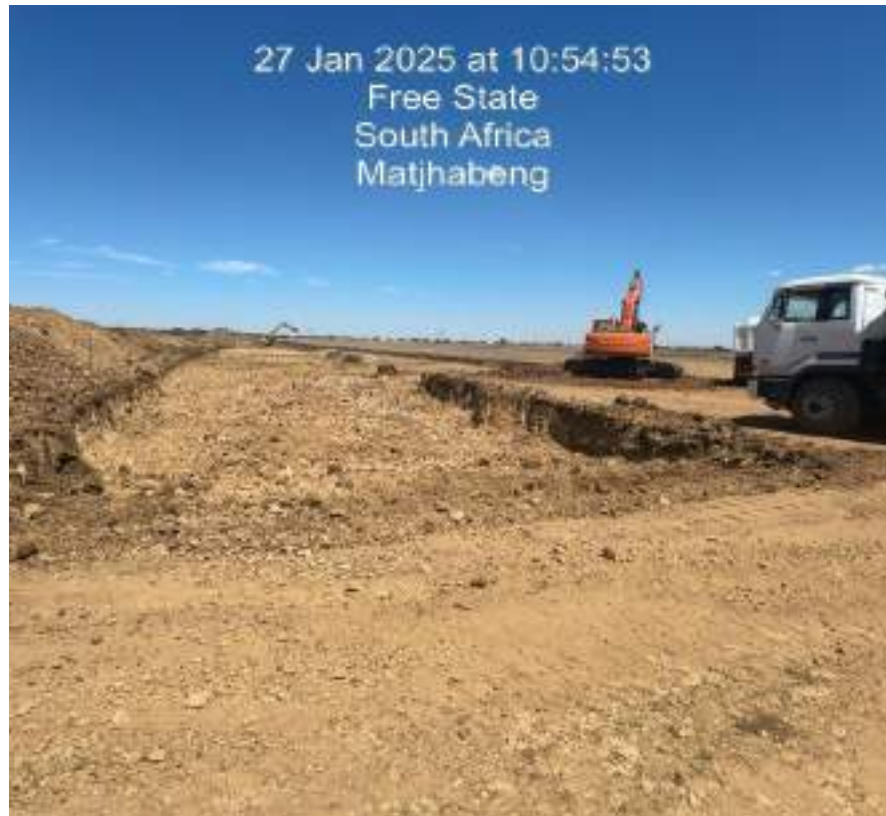
Figure 5: Open trenches must be barricaded.

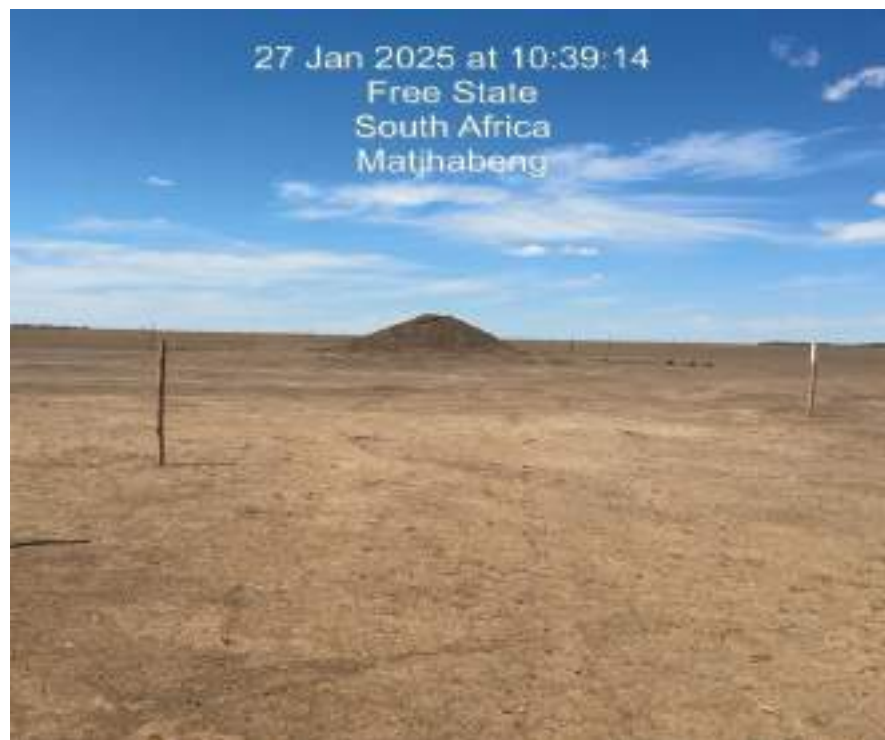
**Figure 6:** Stockpile height exceeding 2m.

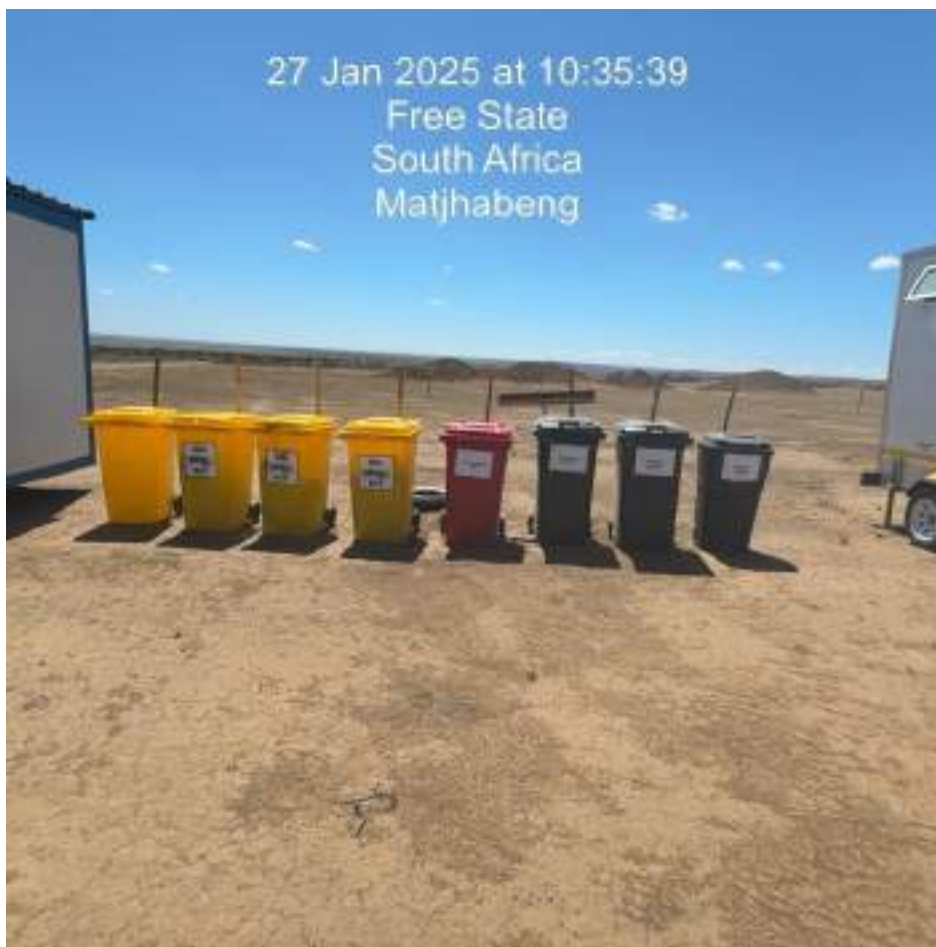
**Figure 7: Bins and Spill Kit onsite**

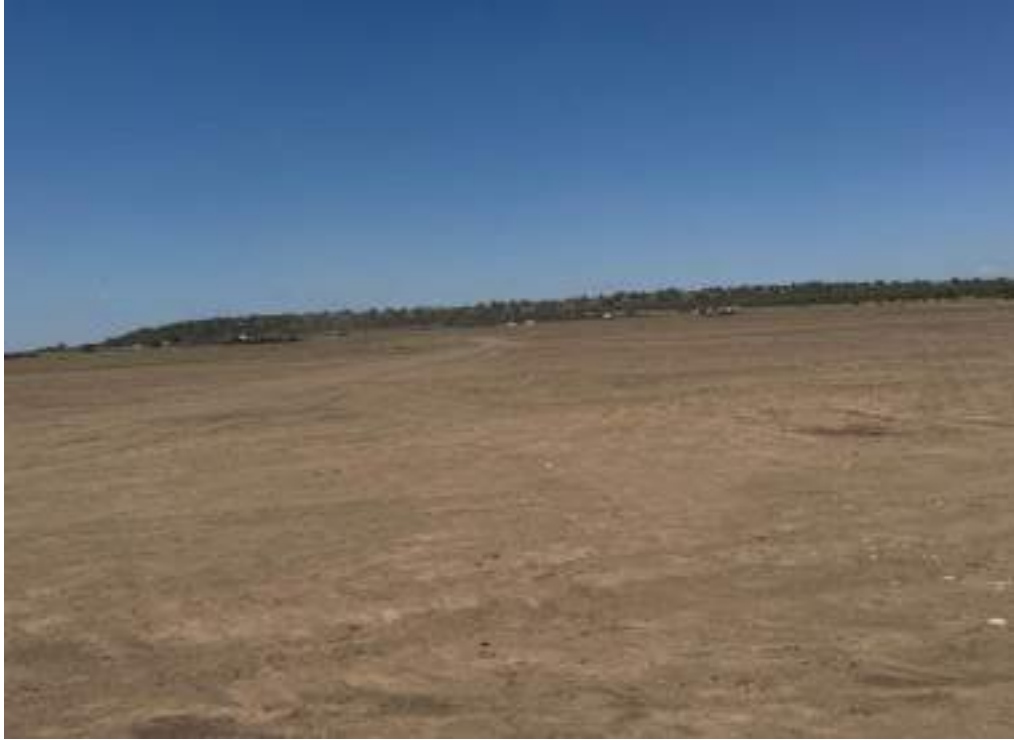
**Figure 1:** Extensive portion of the site that was cleared.

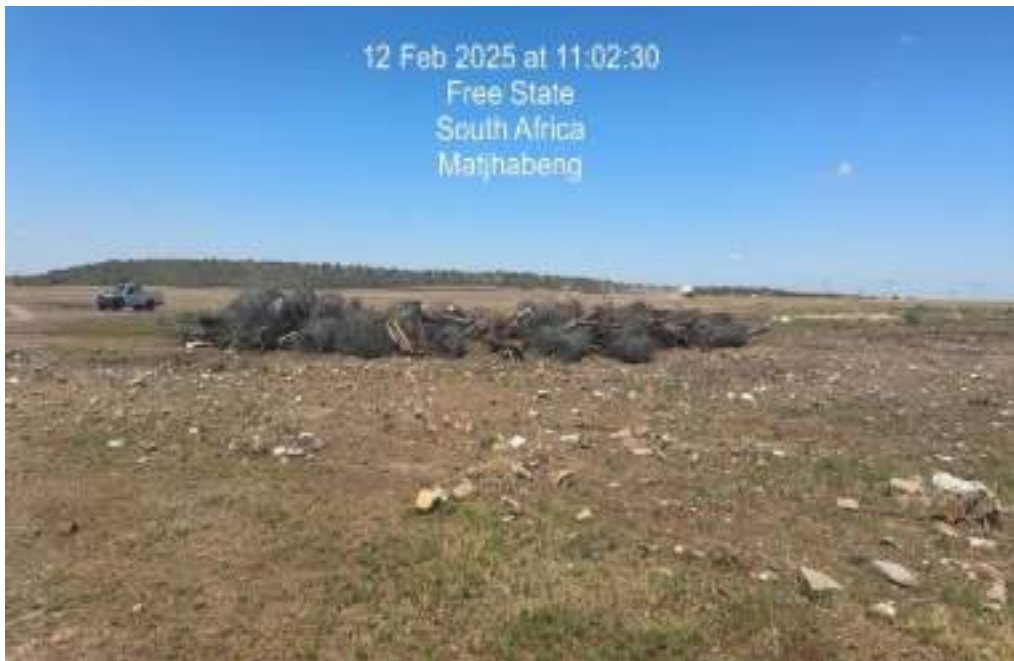
**Figure 2:** Removed fences must be reused or appropriately disposed of.

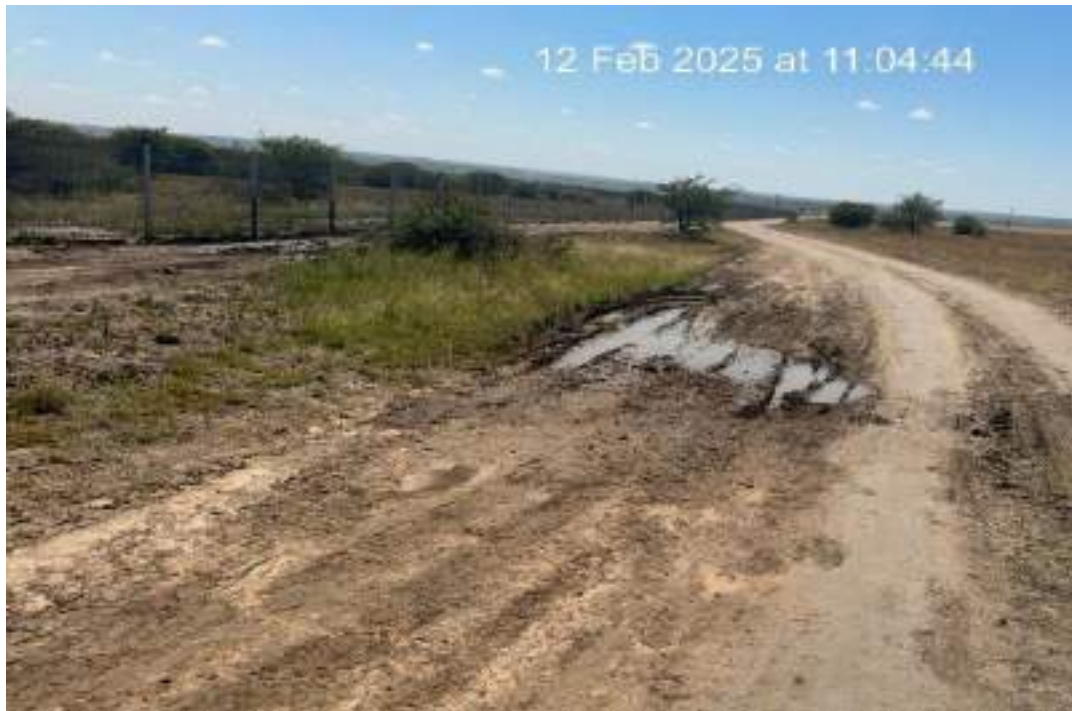
**Figure 3:** Access roads requiring regrading.

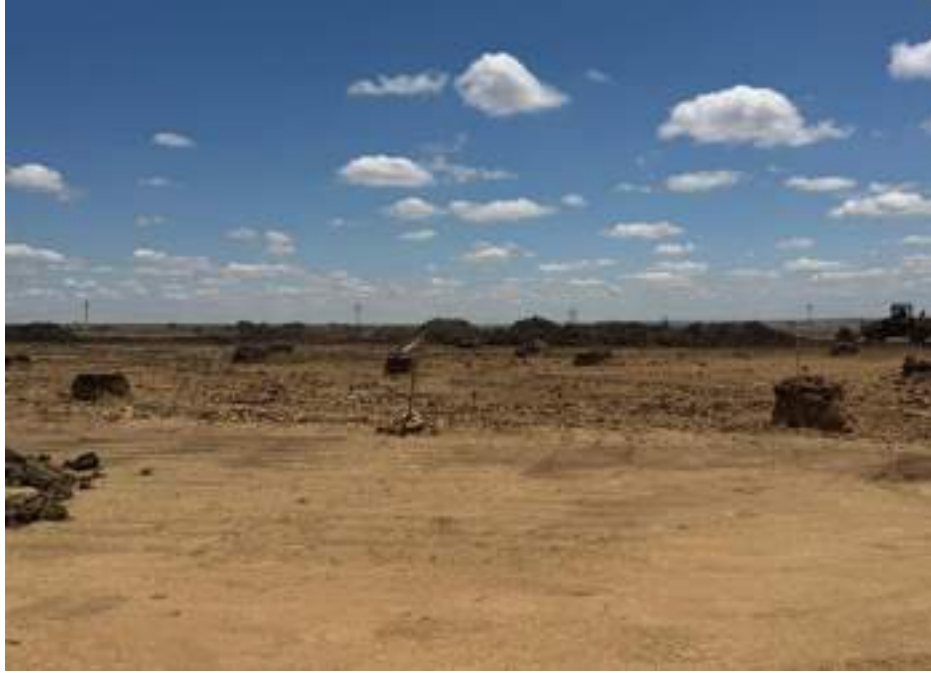
**Figure 5:** Stockpile height exceeding 2m.

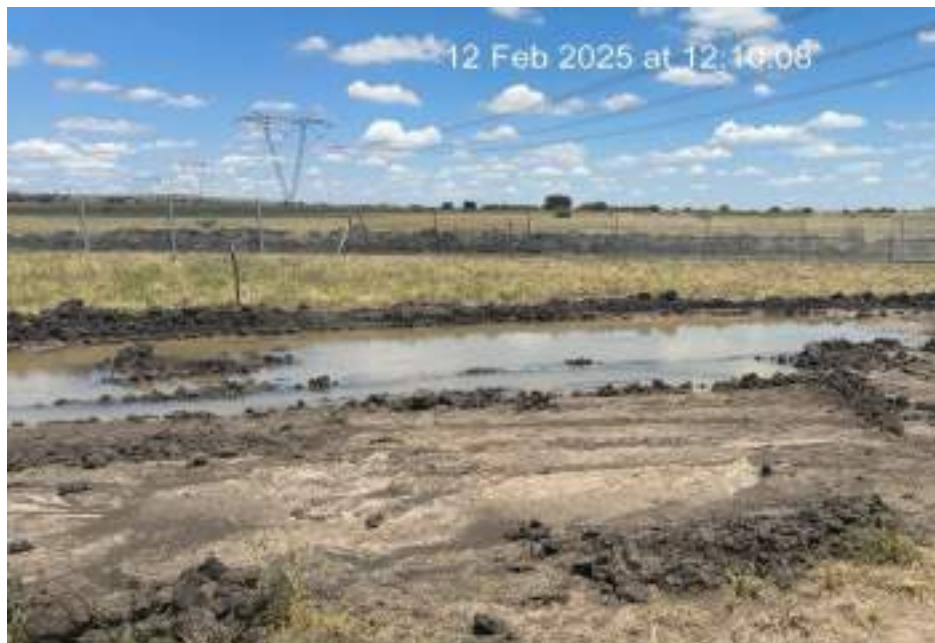
**Figure 6:** Water ponding onsite

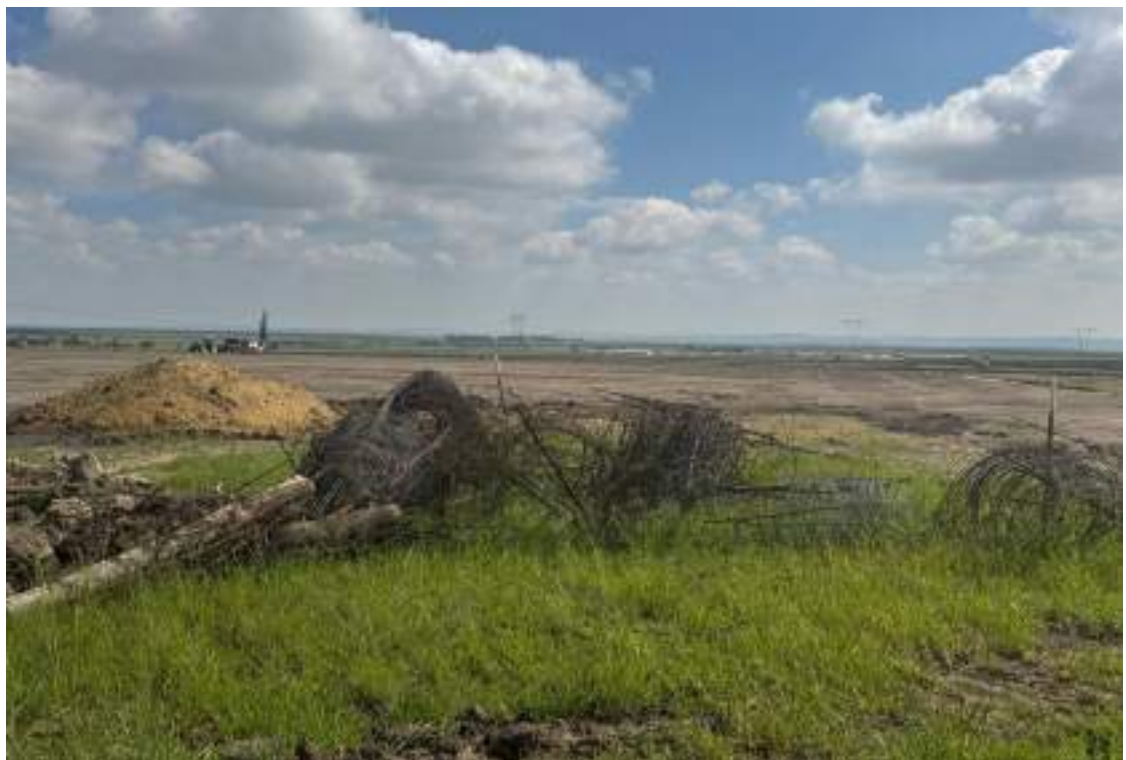
**Figure 2:** Removed fences must be reused or appropriately disposed of.

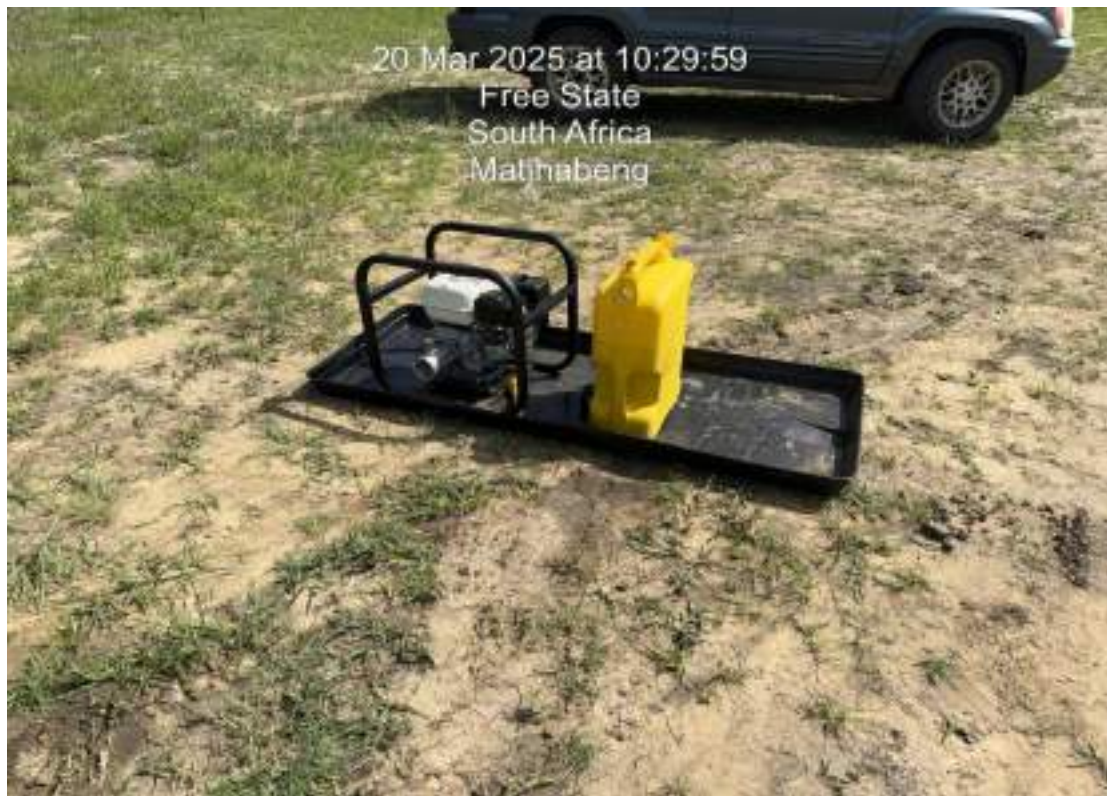
**Figure 3:** Drip Trays being used onsite.

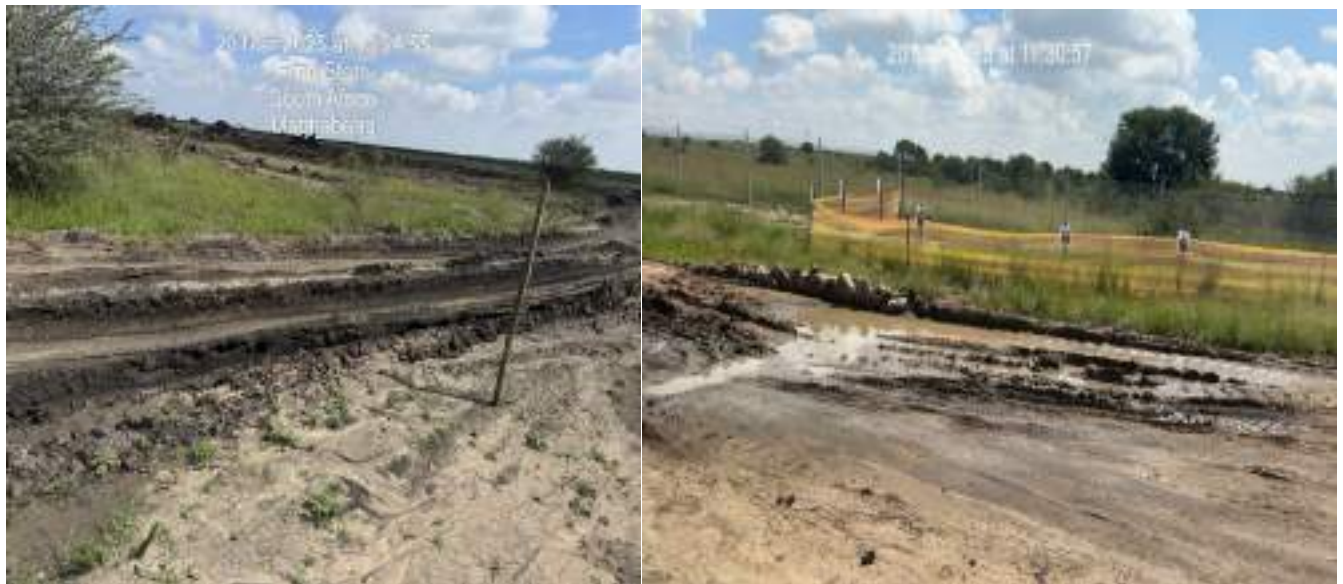
**Figure 4:** Roads requiring regrading

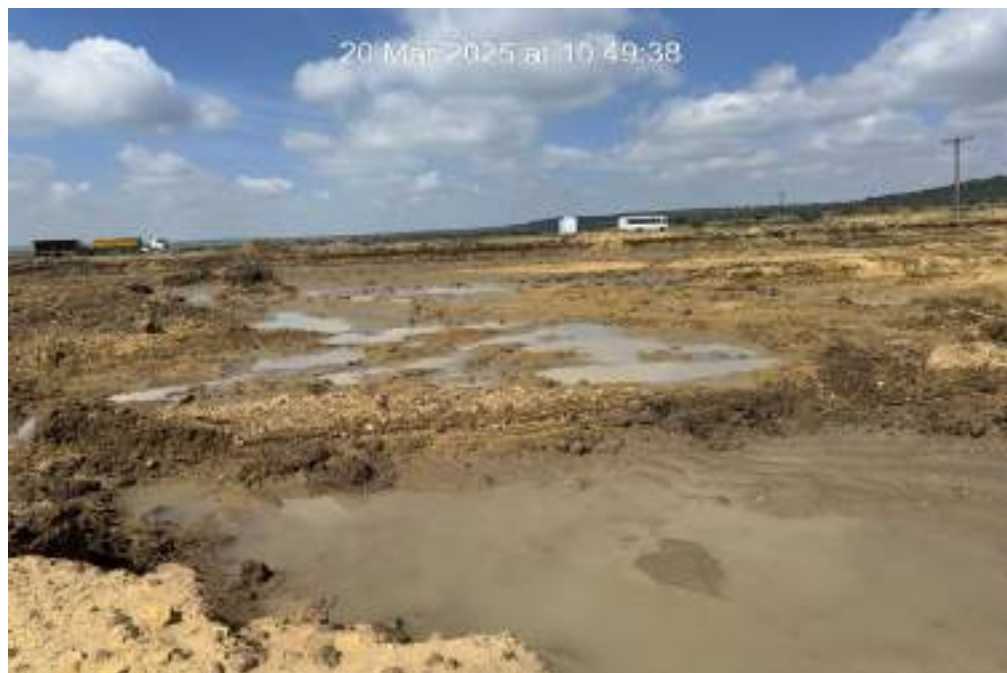
**Figure 6:** Water ponding onsite

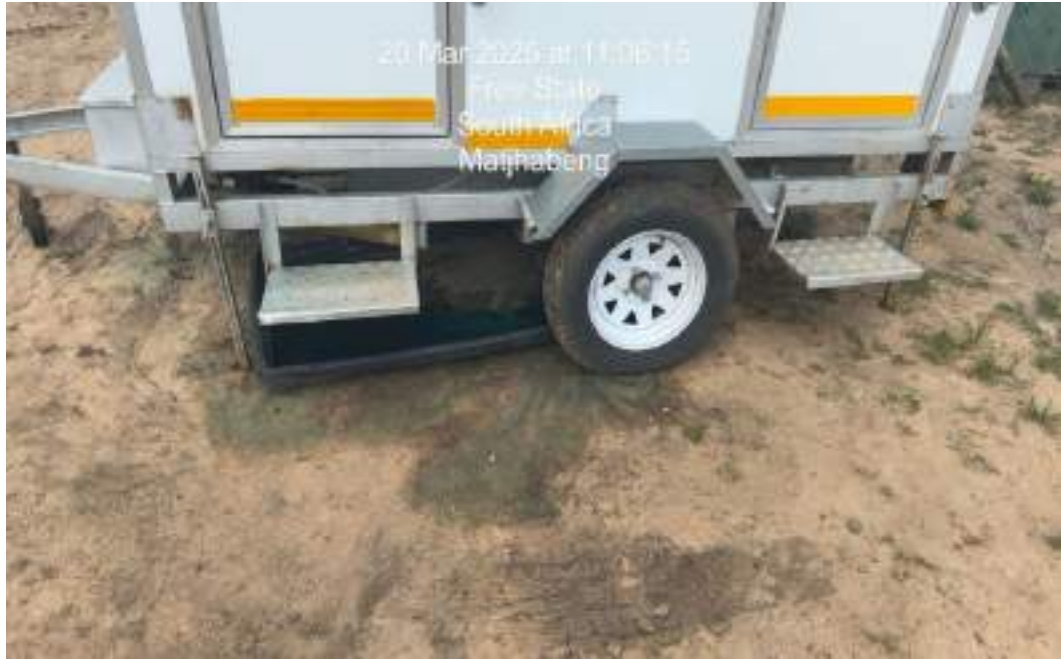
**Figure 7:** Spillage from the toilet

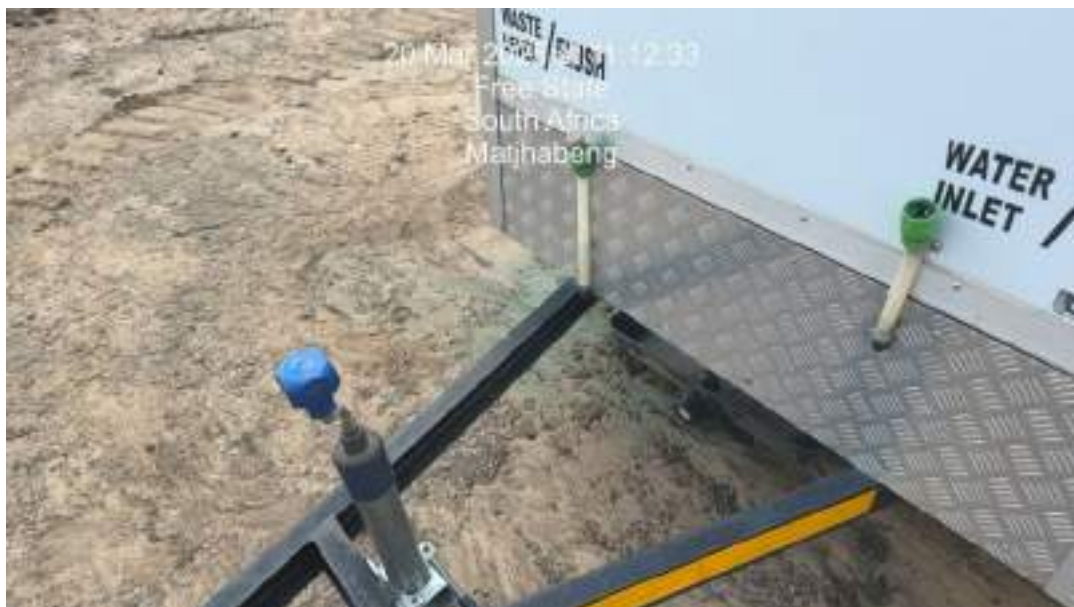
**Figure 8:** Spillages that were not removed.

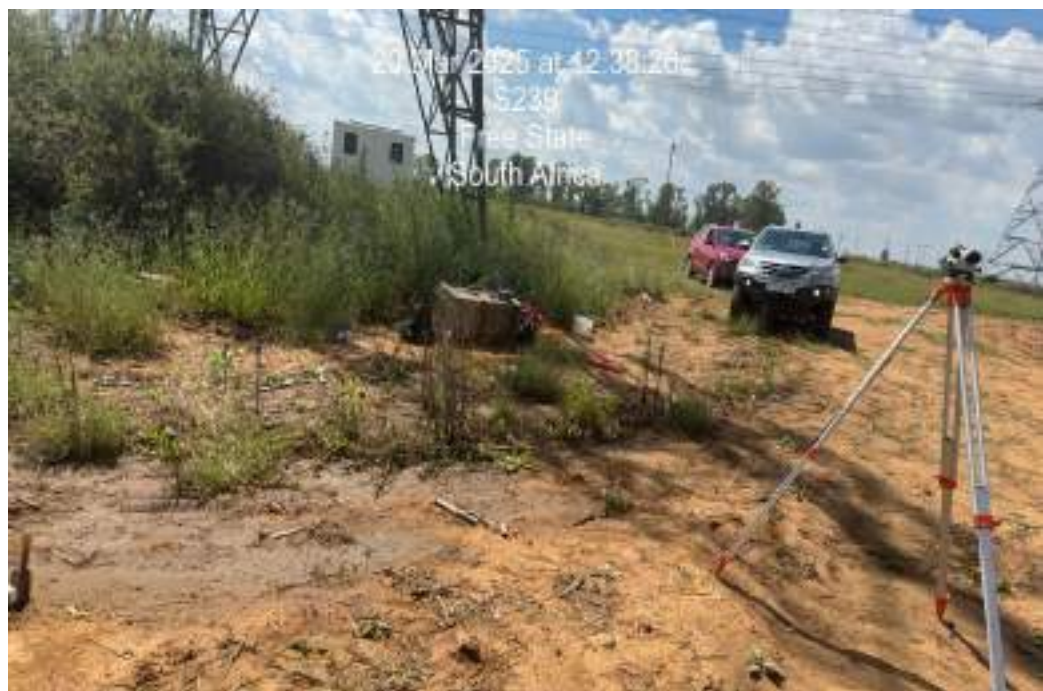
**Figure 10:** A Shaded area must be provided for people working on the powerline

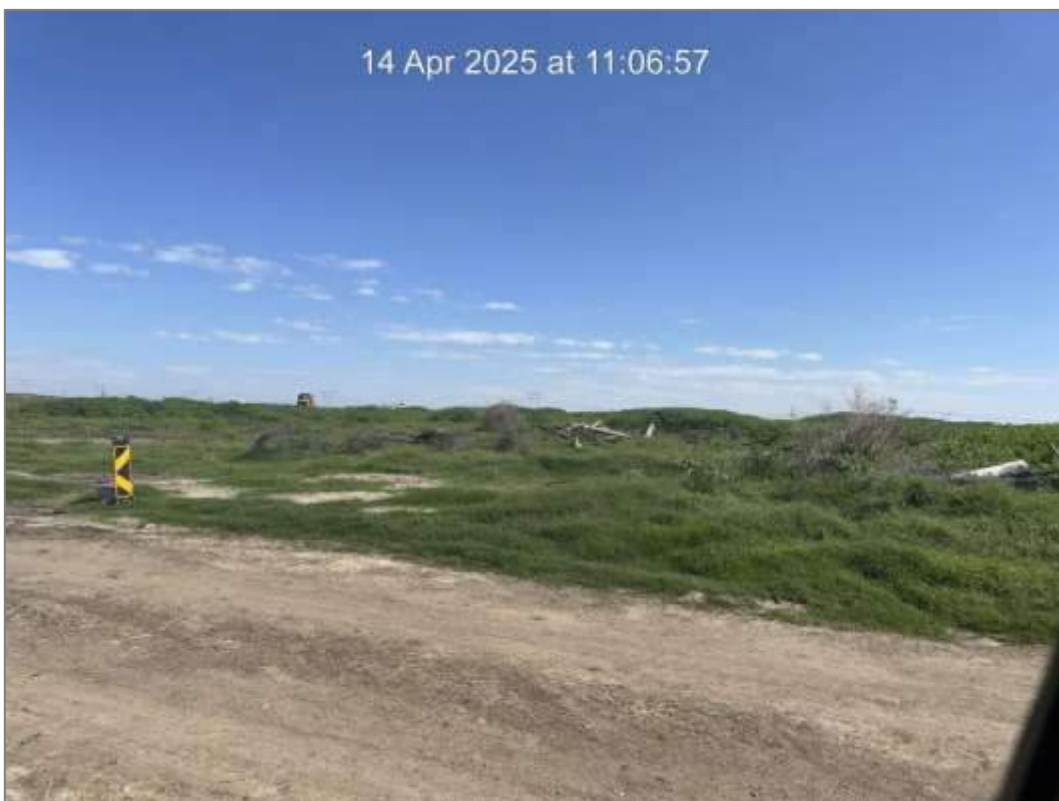
**Figure 2:** Removed fences must be reused or appropriately disposed of.

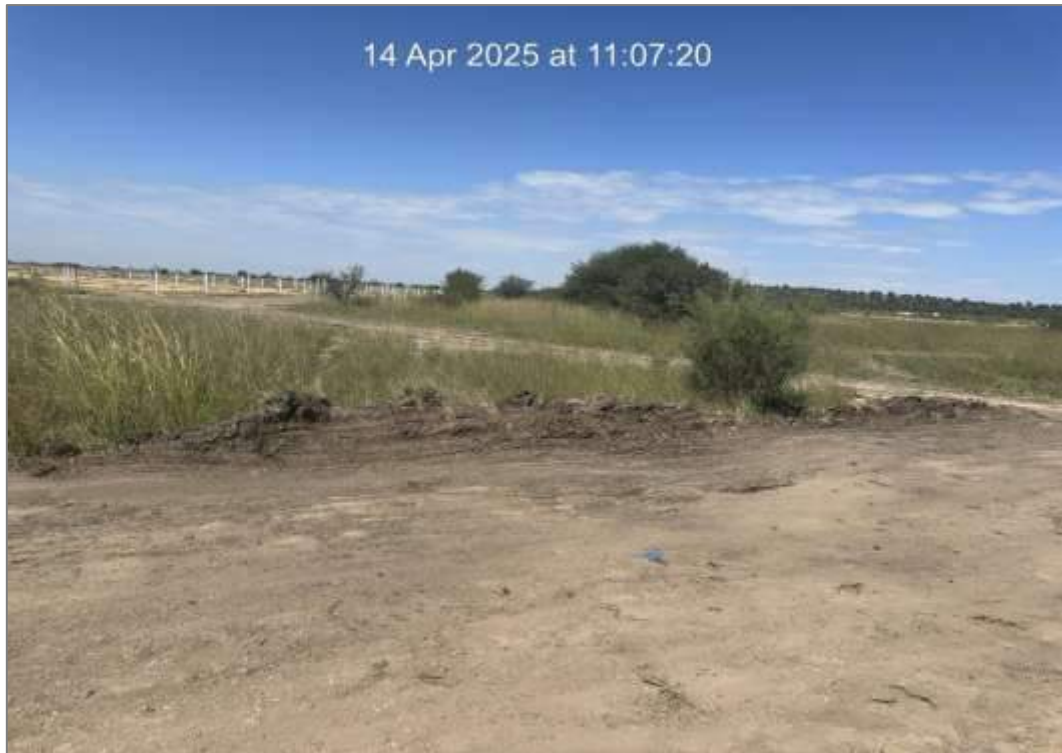
**Figure 3:** Roads requiring regrading

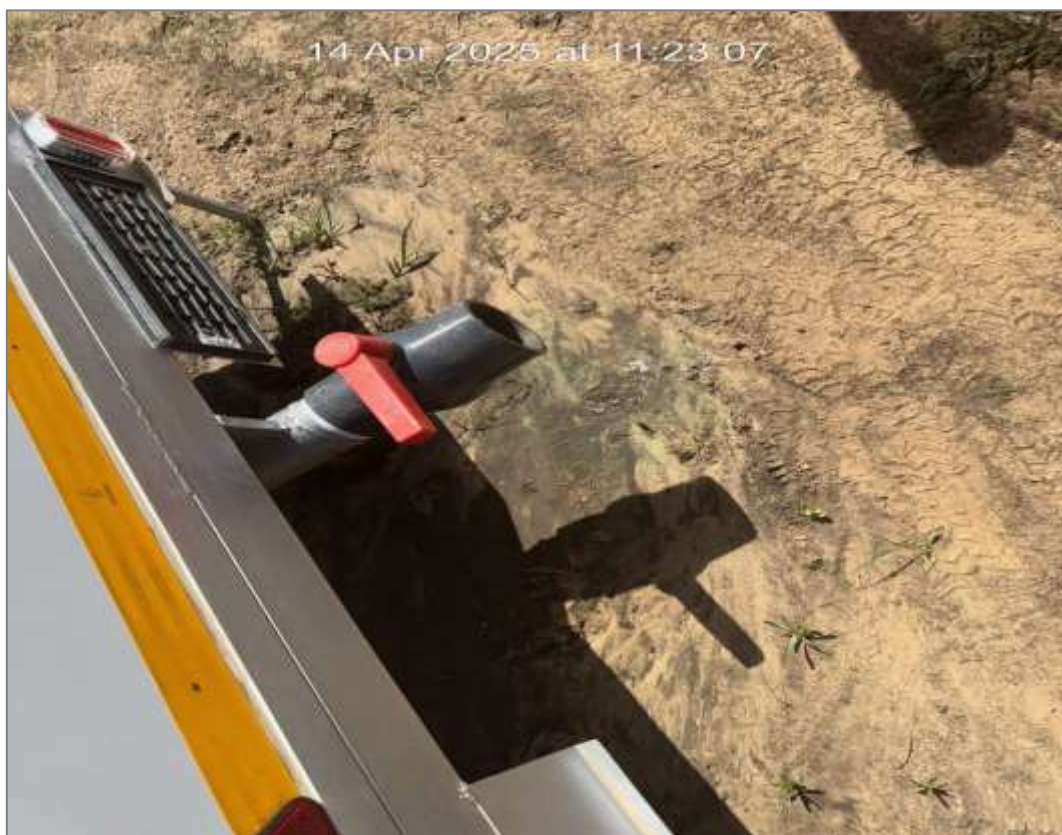
**Figure 4:** Spillage from the toilet

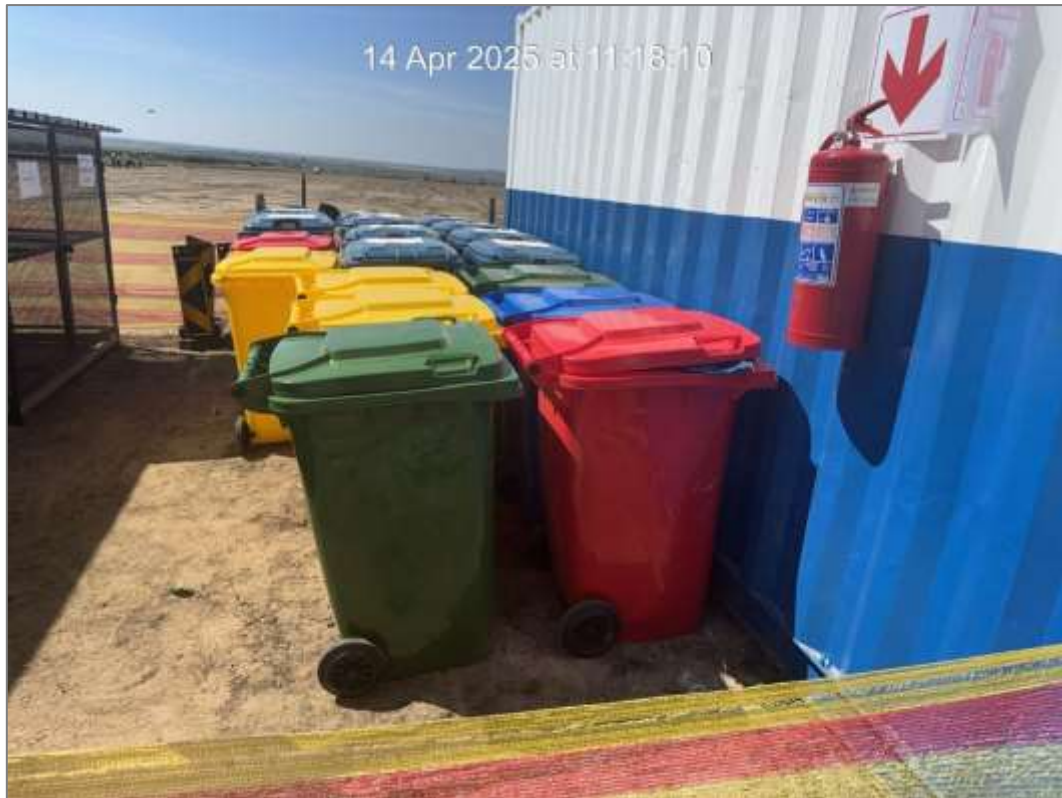
**Figure 5:** Bins and Spill kits provided onsite.

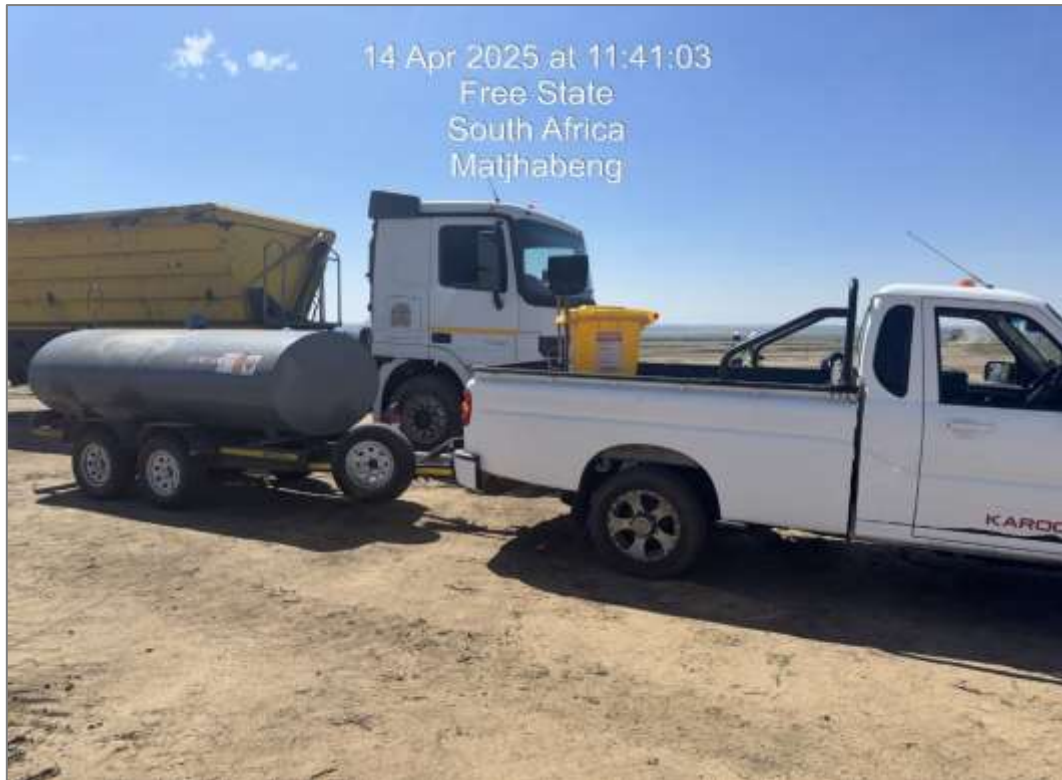
**Figure 7:** Drip trays being used for refuelling.

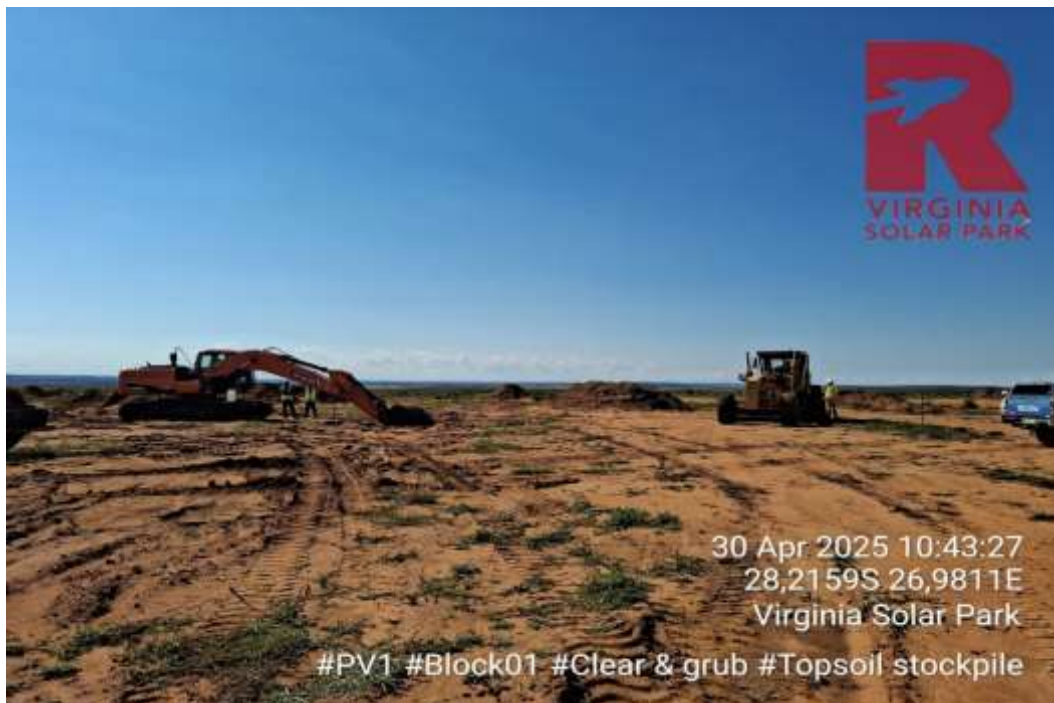
**Figure 8:** Ongoing alien vegetation clearance

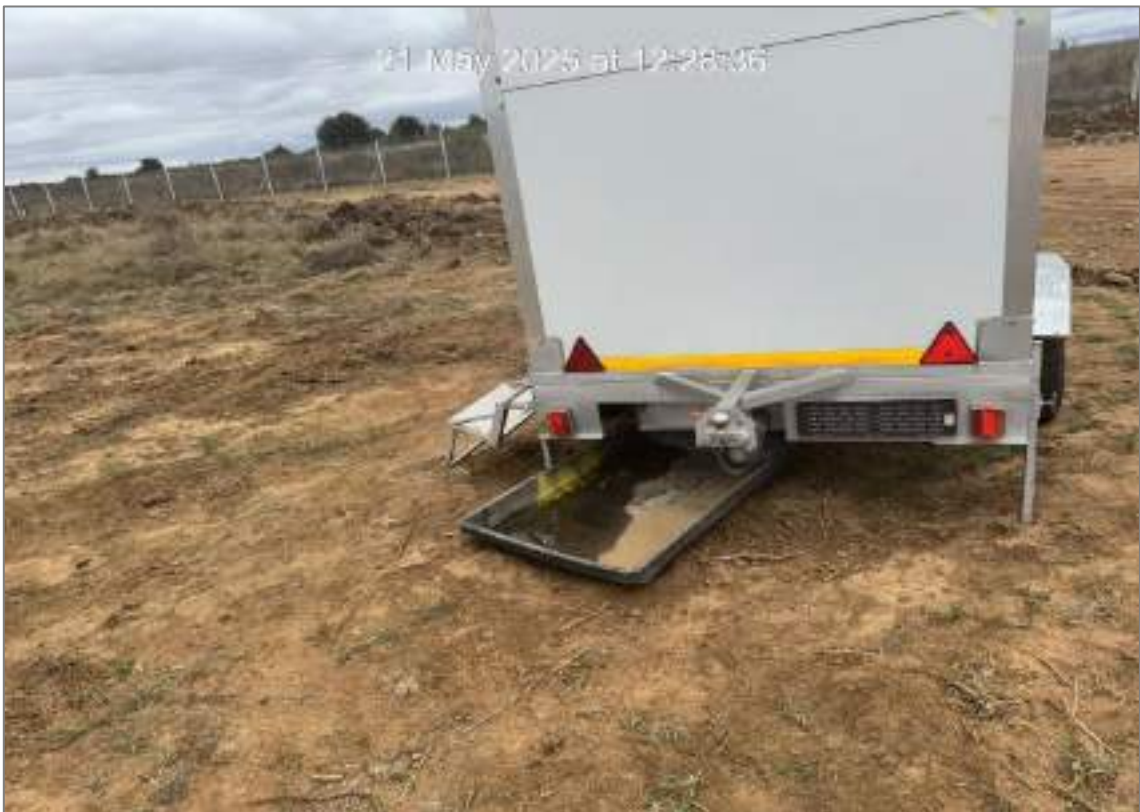
**Figure 4:** Drip tray provided for on the chemical toilet.

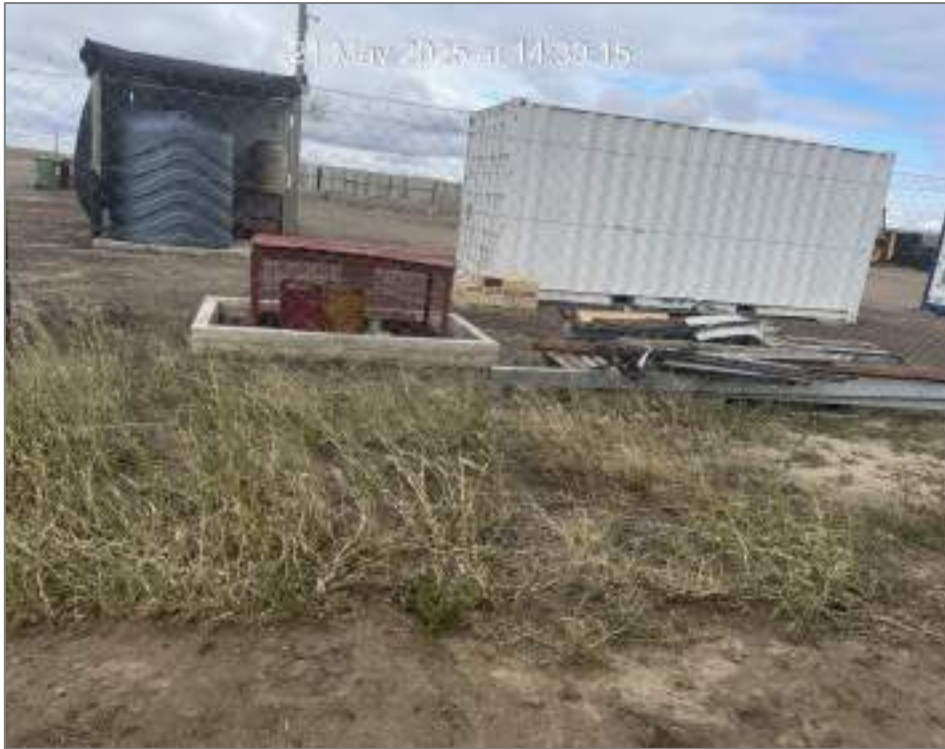
**Figure 1:** Chemical bund onsite.

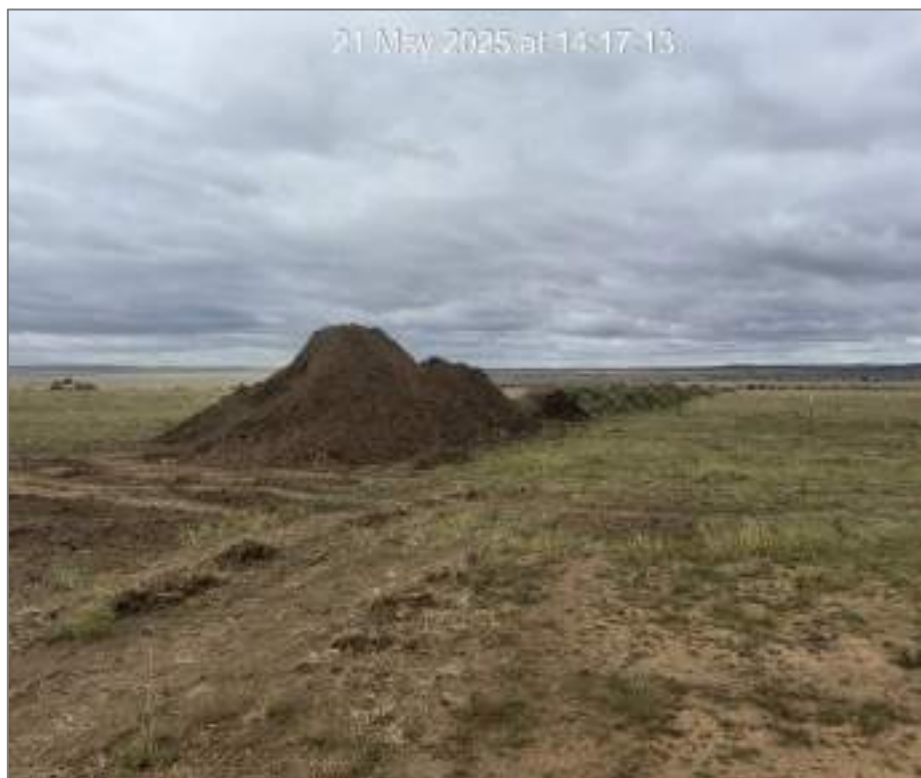
**Figure 2:** Stockpile exceeding 2m in height.

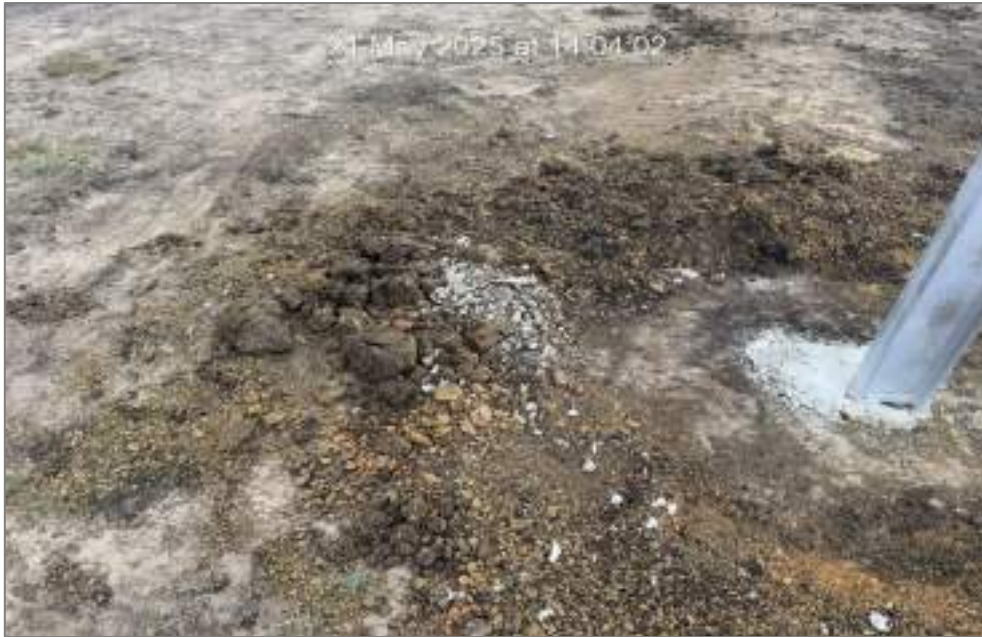
**Figure 3:** Concrete spillages that must be removed and not buried.

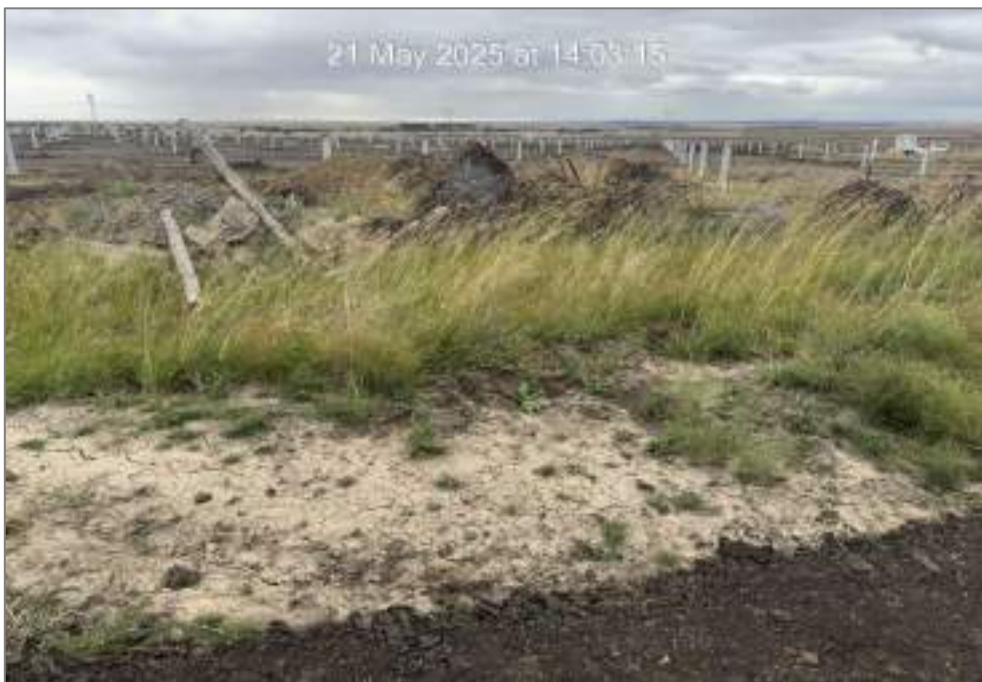
**Figure 4:** Old fences that must be removed.

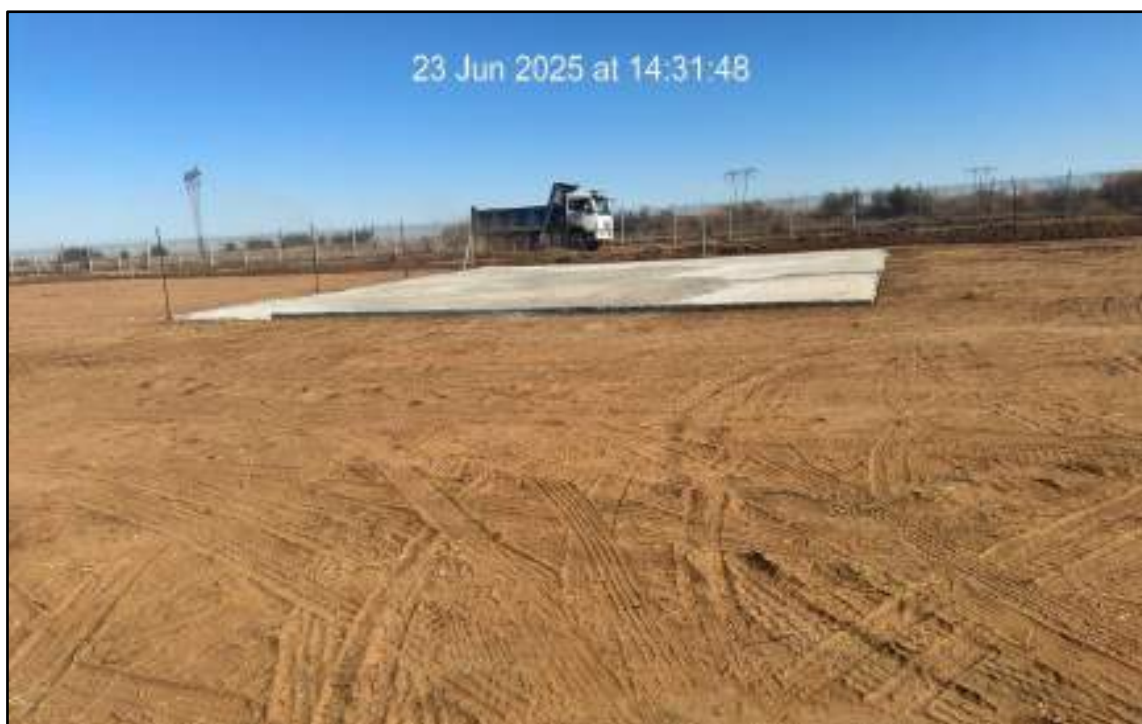
**Figure 1:** Incomplete concrete bund for the waste area.

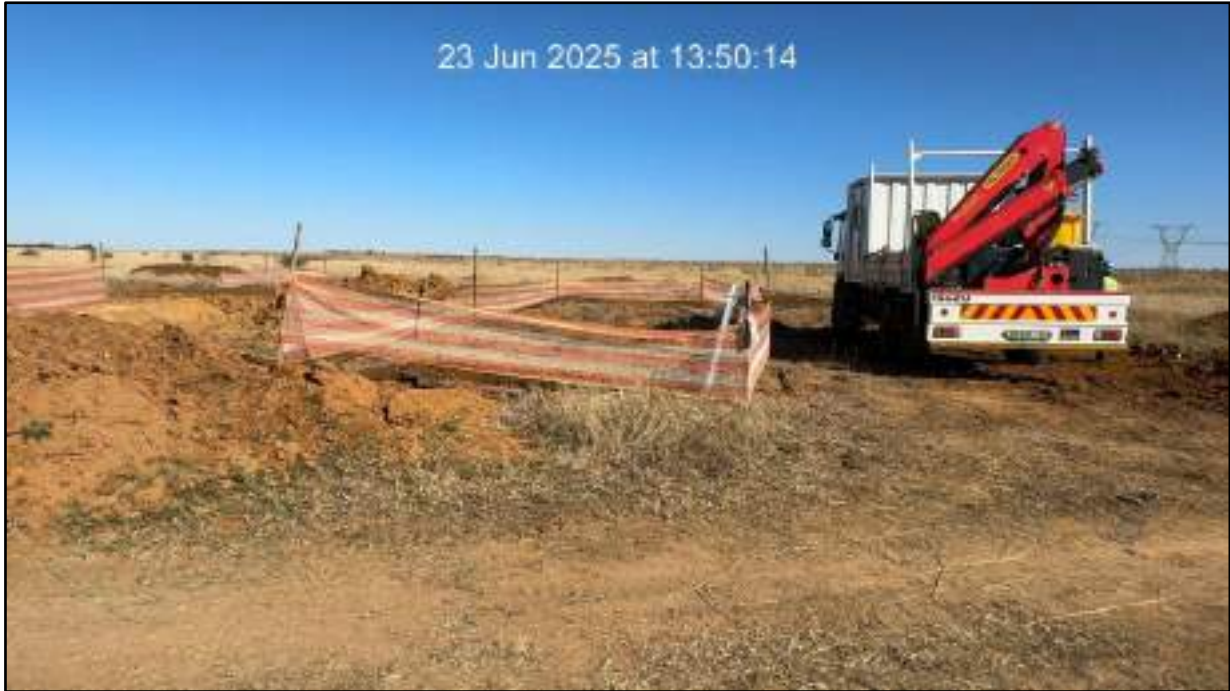
**Figure 3:** Barricaded excavation along the line.

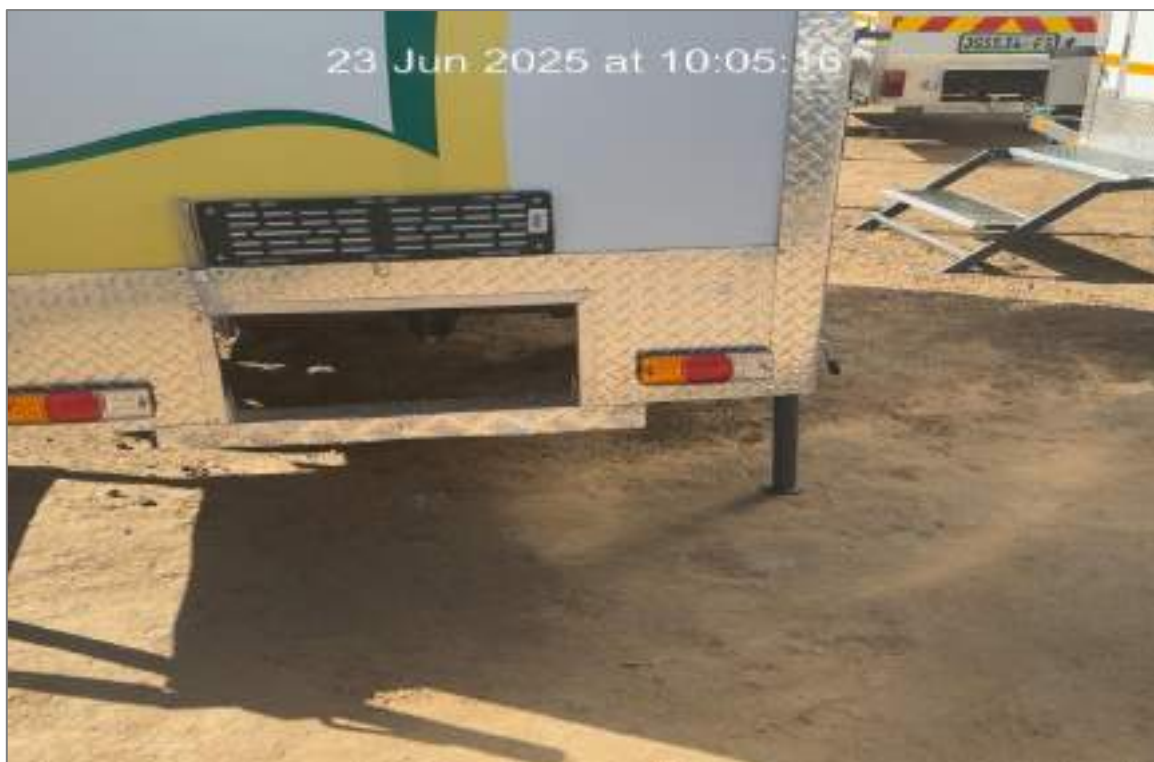
**Figure 3:** Chemical toilet with no drip Tray underneath.
