# ECO MONTHLY ENVIRONMENTAL MONITORING REPORT

Virginia Photo Voltaic (PV) Solar Facility 1, 2 and 3,  
Matjhabeng, Lejweleputswa District Municipality within  
the jurisdiction of the Free State Province.

January 2025

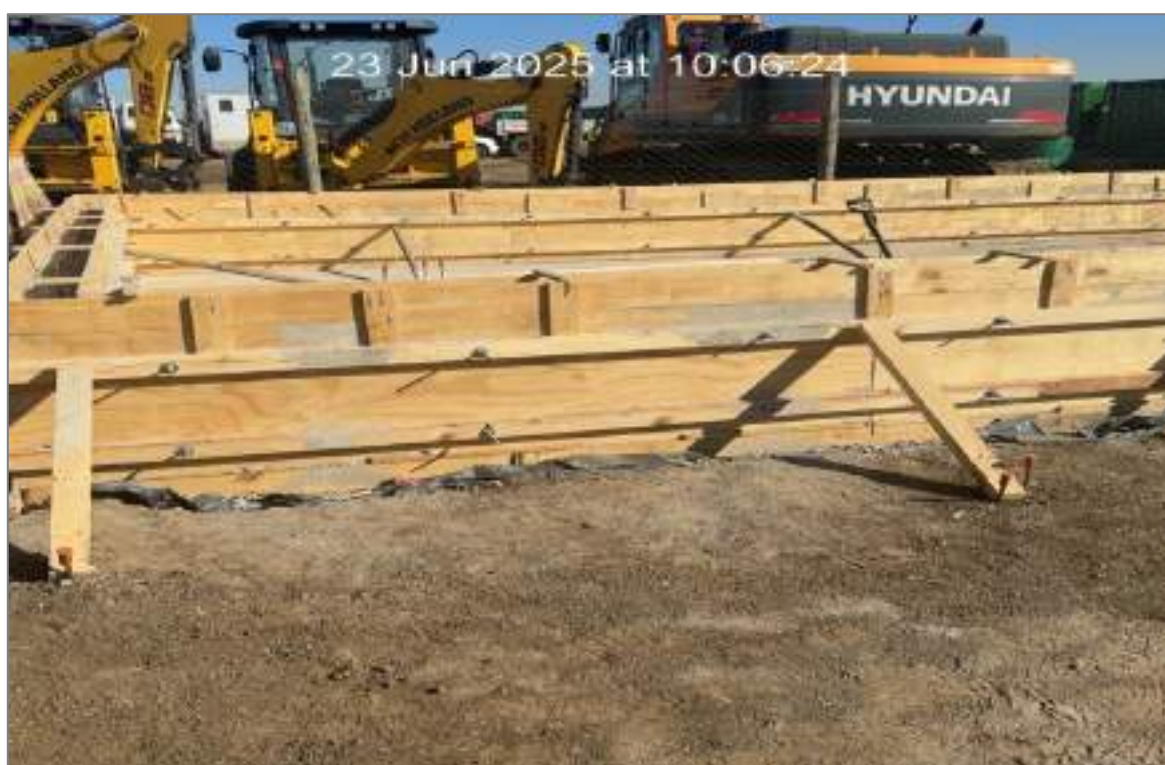
**Figure 4:** Diesel and Chemical bund under construction

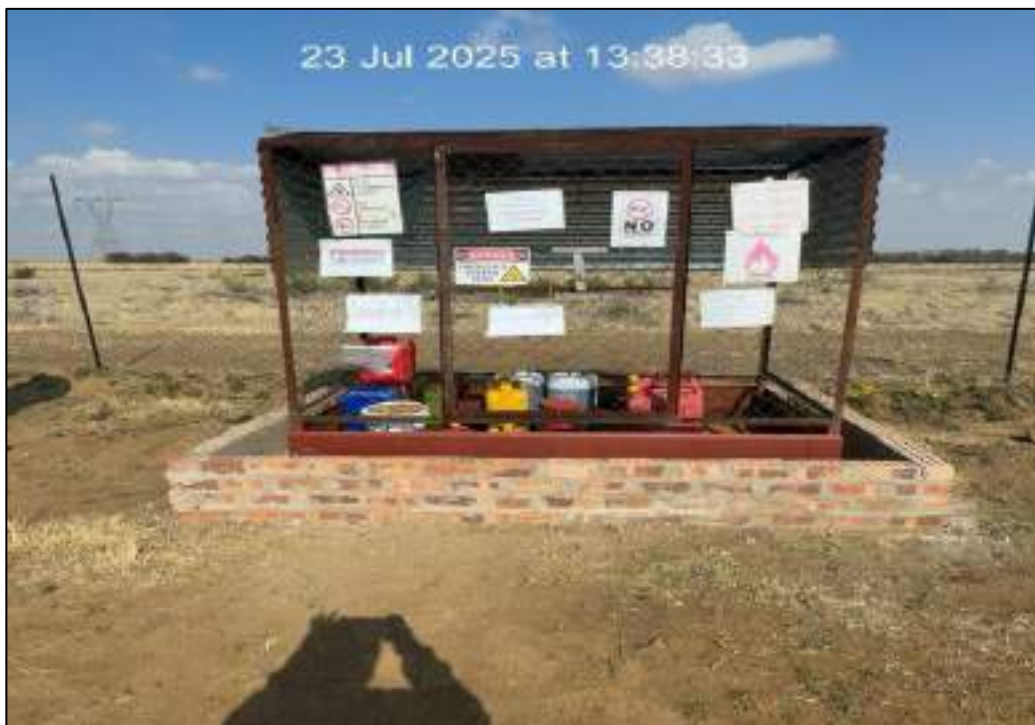
**Figure 4:** Bund and roofed chemical storage area.

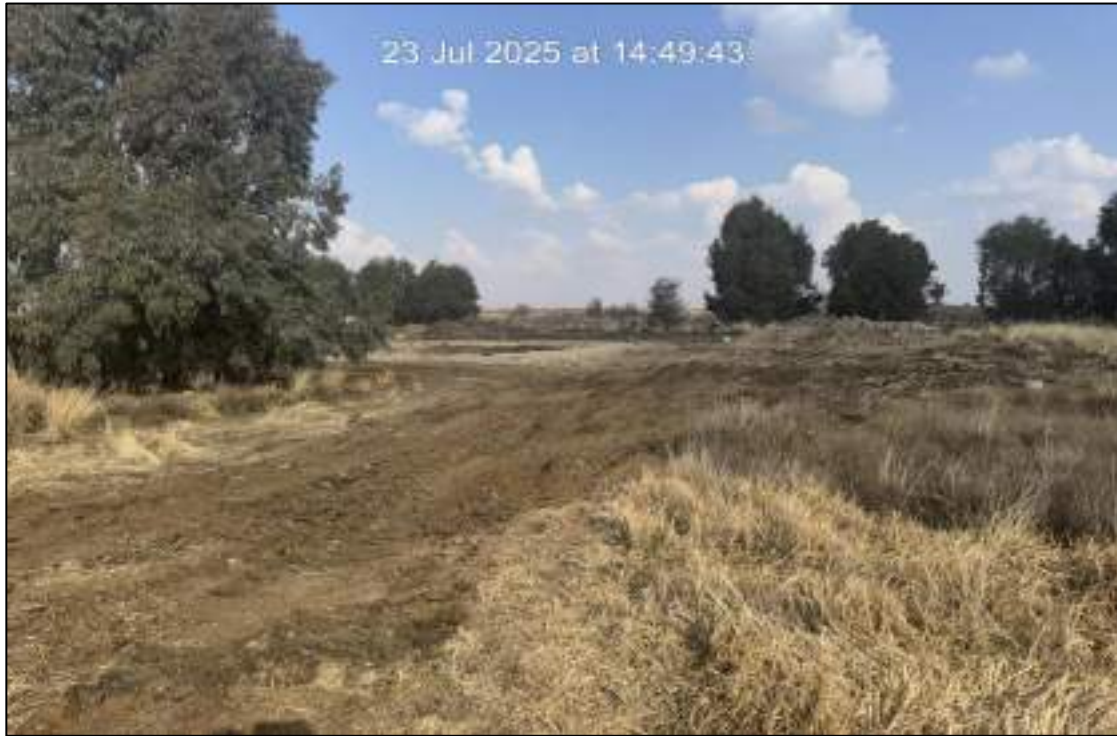
**Figure 5:** Clearance of vegetation on the sensitive must be confined to where activities are taking place.

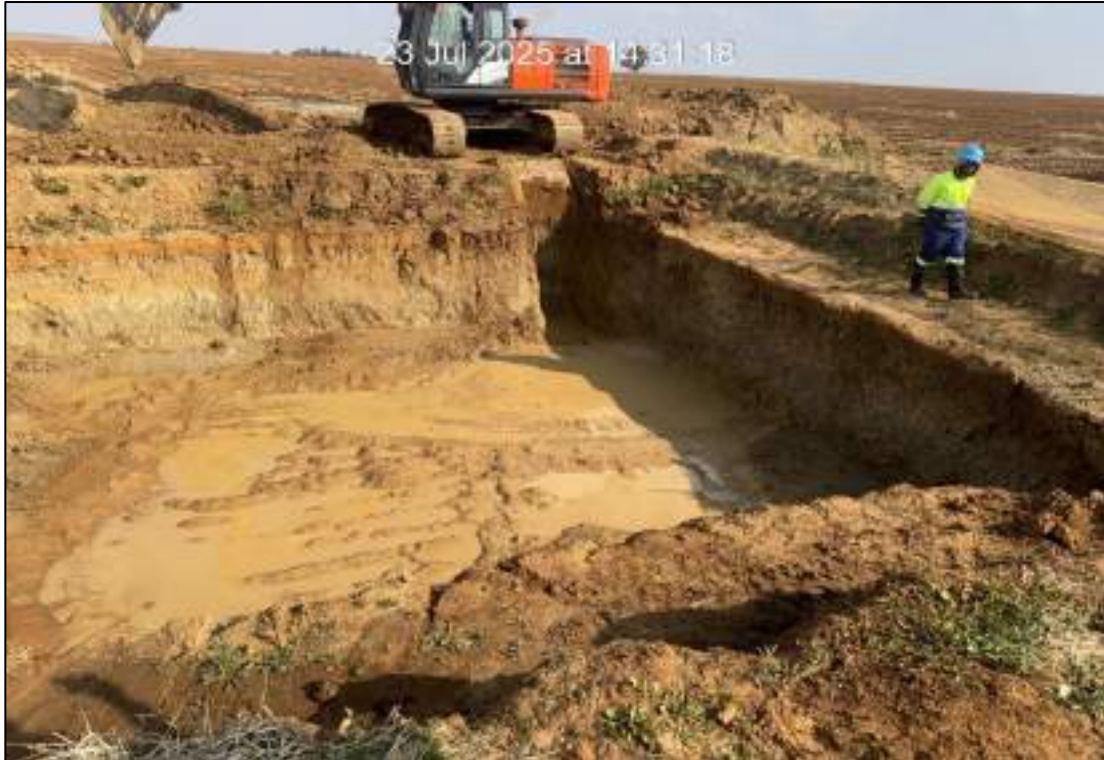
**Figure 6:** Groundwater that must be pumped out before concrete is poured.

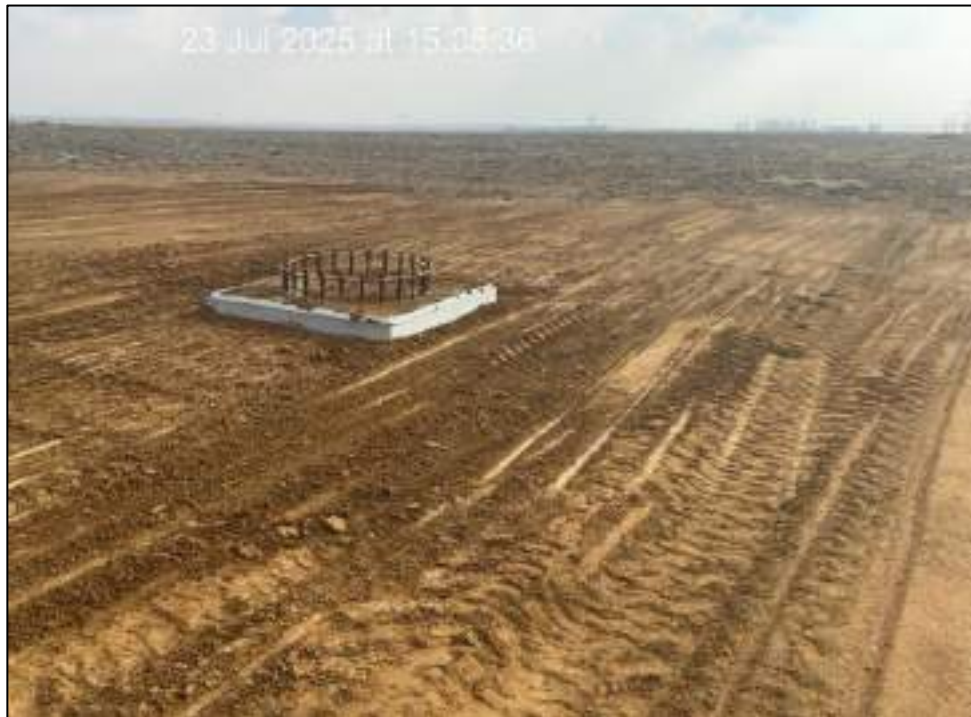
**Figure 7:** Filled in pits where topsoil must only be spread after completion of structures

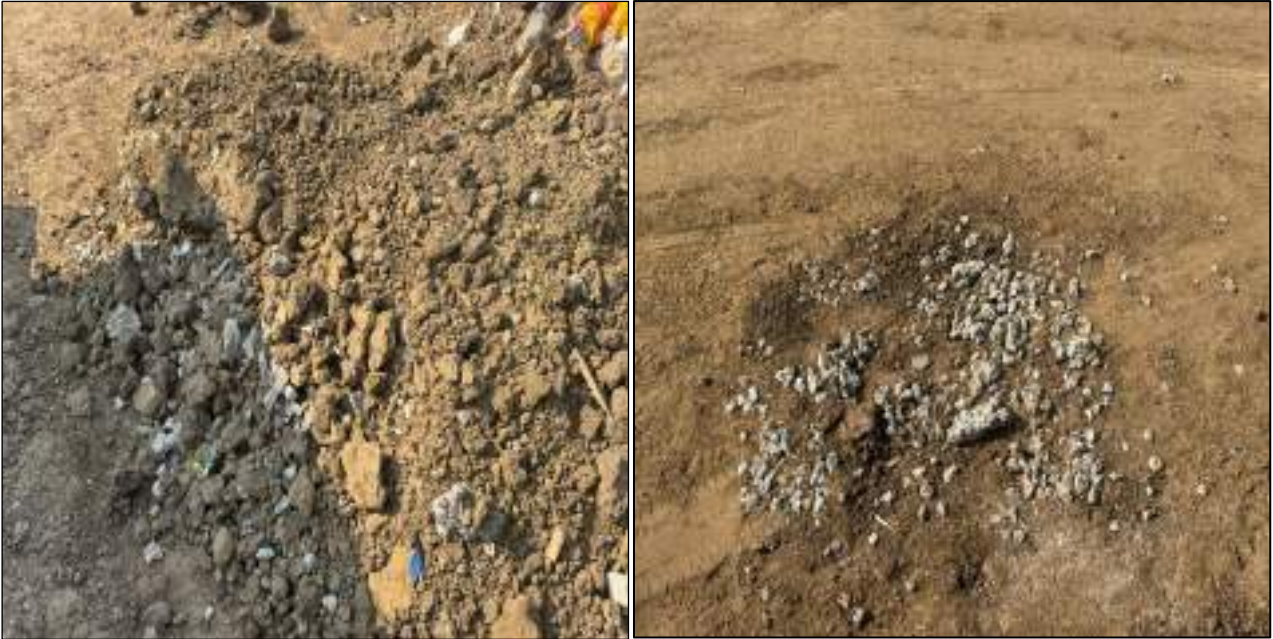
**Figure 3:** Concrete that must be removed from the construction area for disposal.

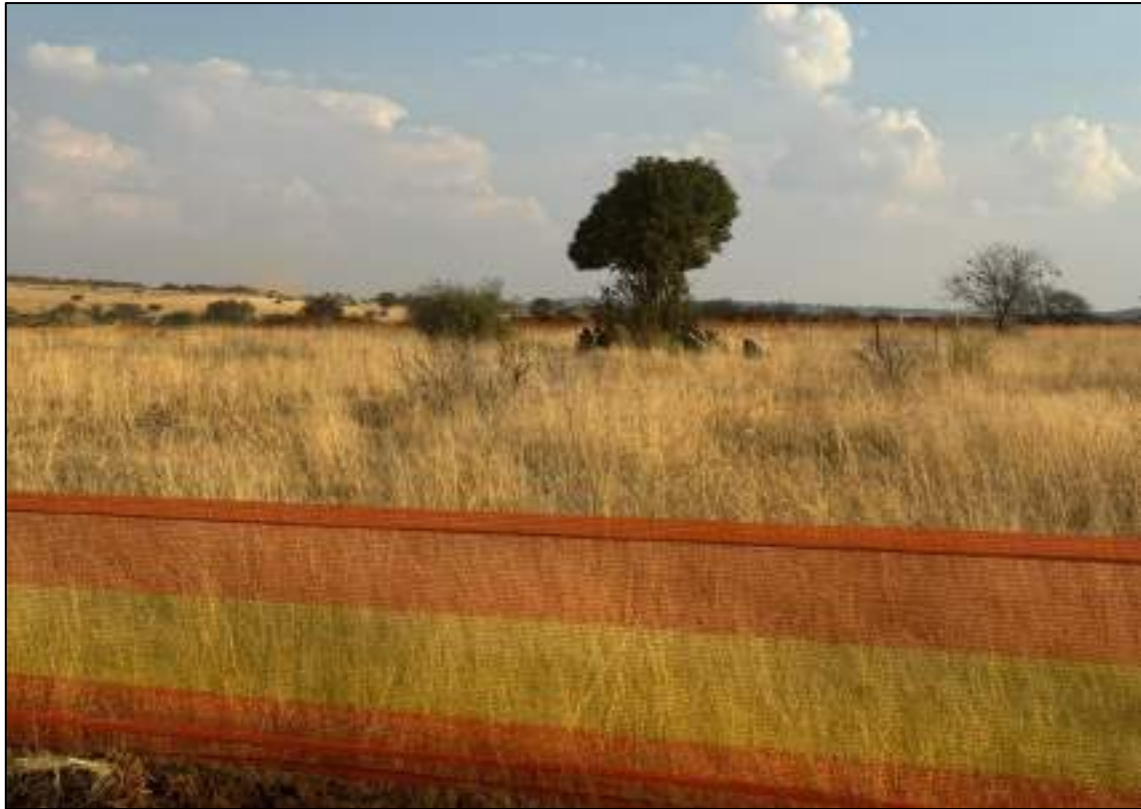
**Figure 5:** Barricaded heritage area

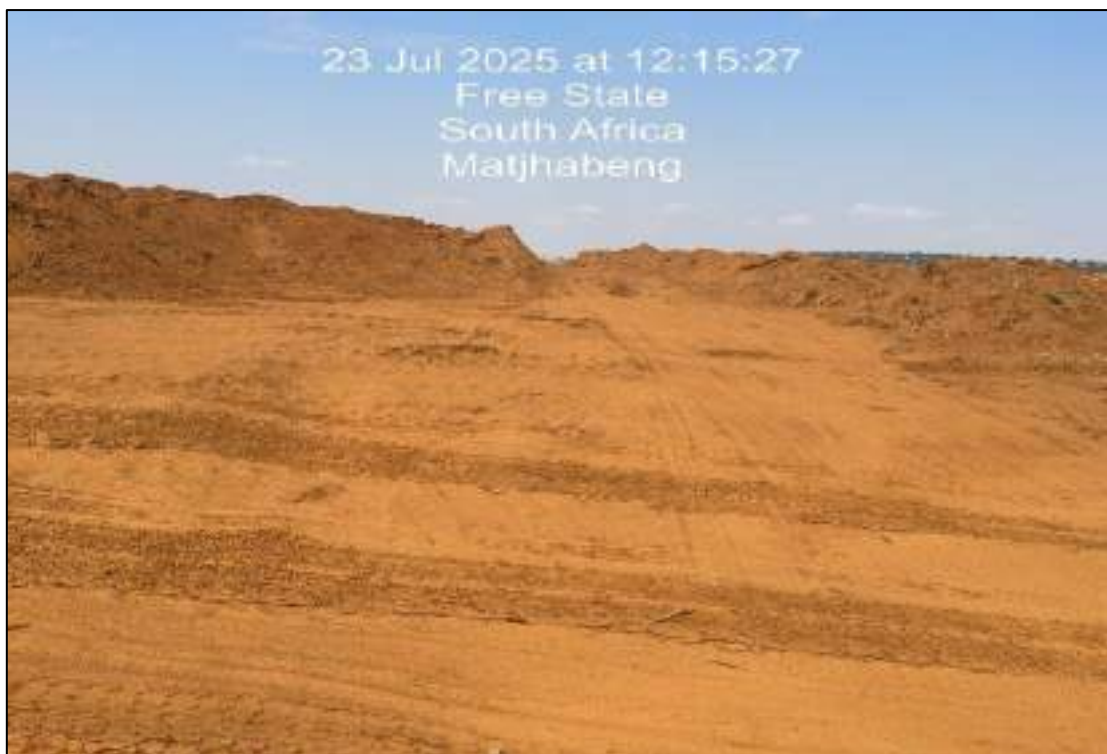
**Figure 7:** Truck driving over topsoil stockpile.

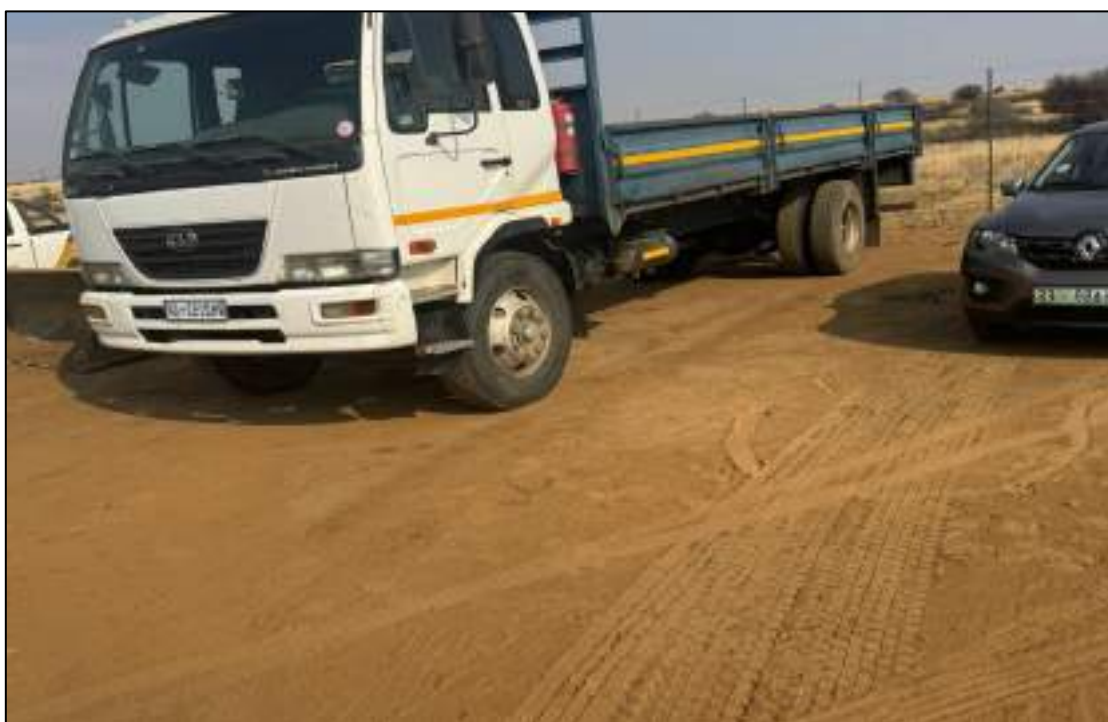
**Figure 8:** Trucks with no drip Trays

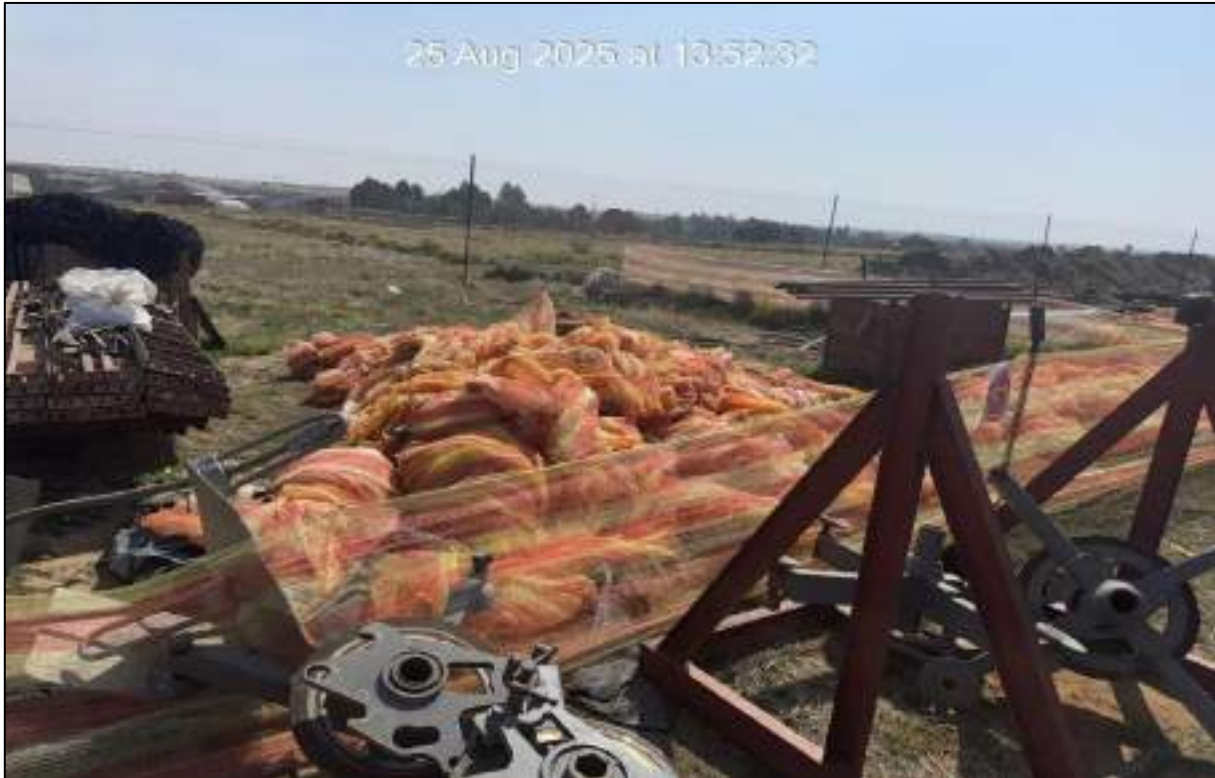
**Figure 7:** Stored barricade material to be used at the trenches.

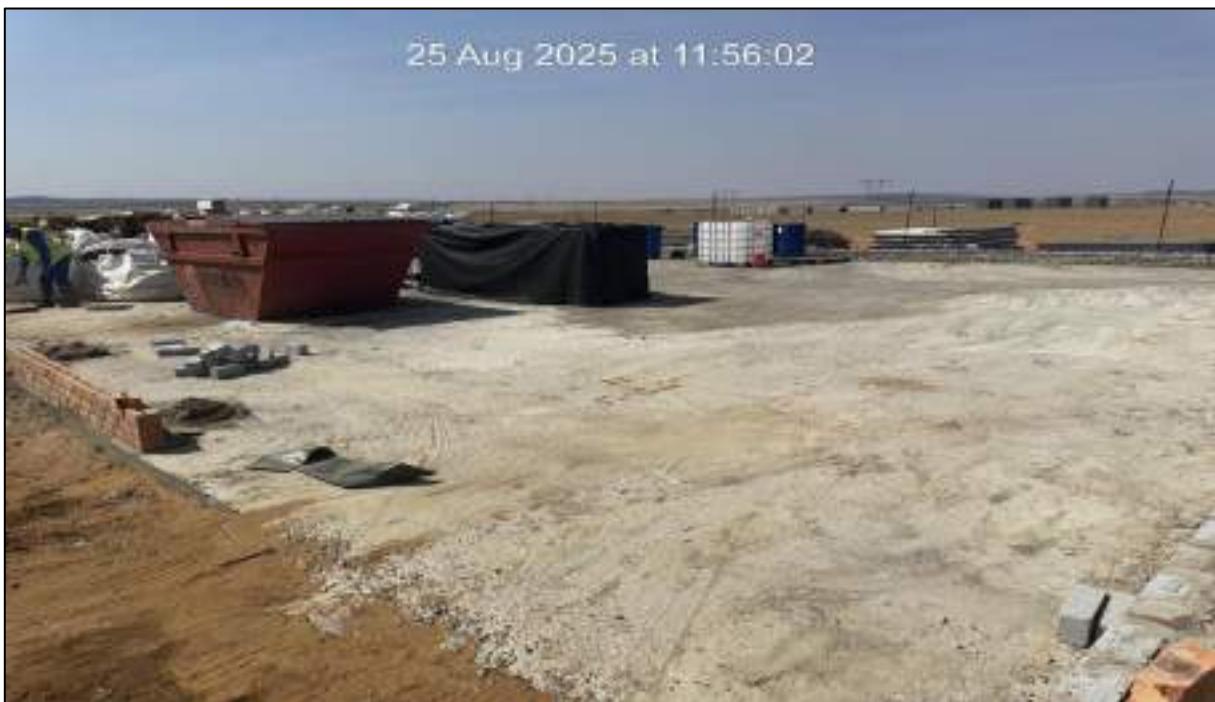
**Figure 8:** Waste bund construction in place

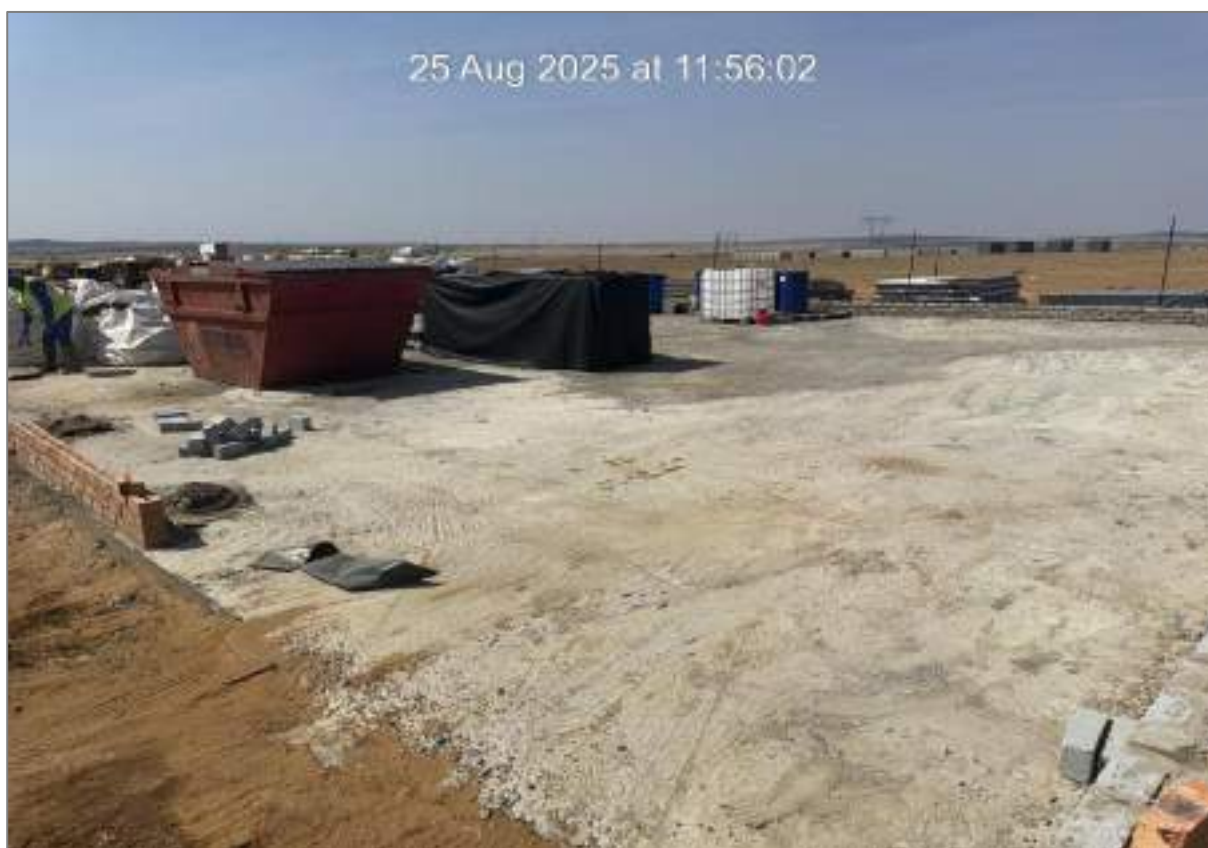
**Figure 6:** Bundled waste area

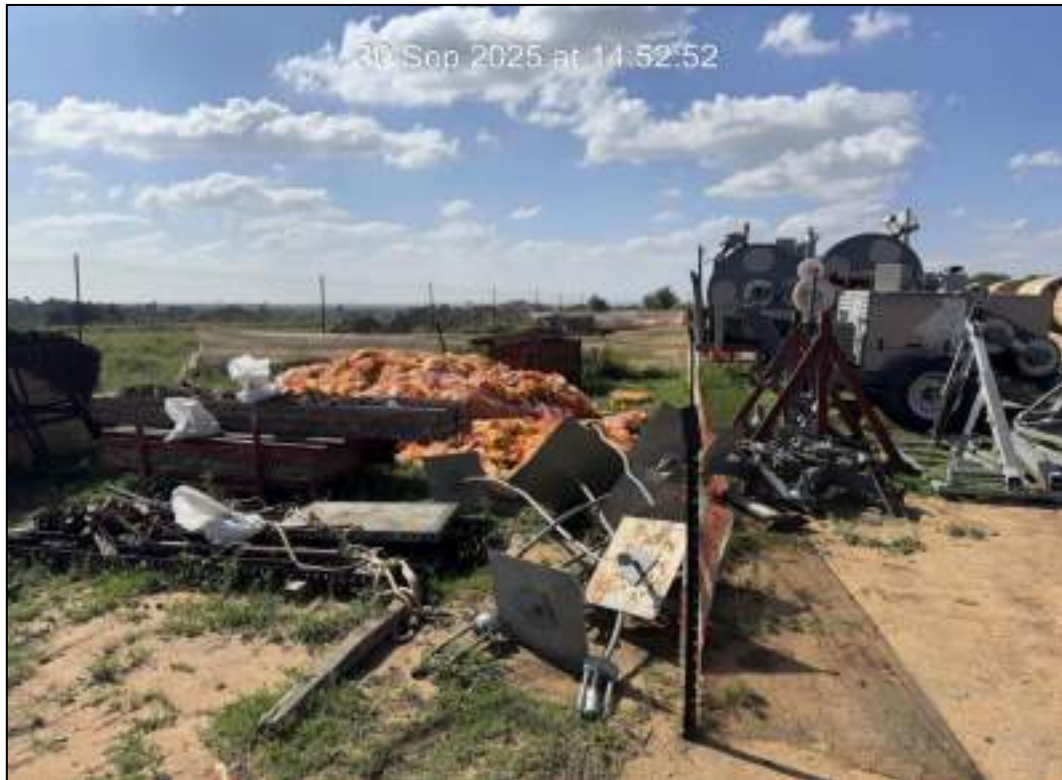
**Figure 3:** Torn barricade must be recycled.

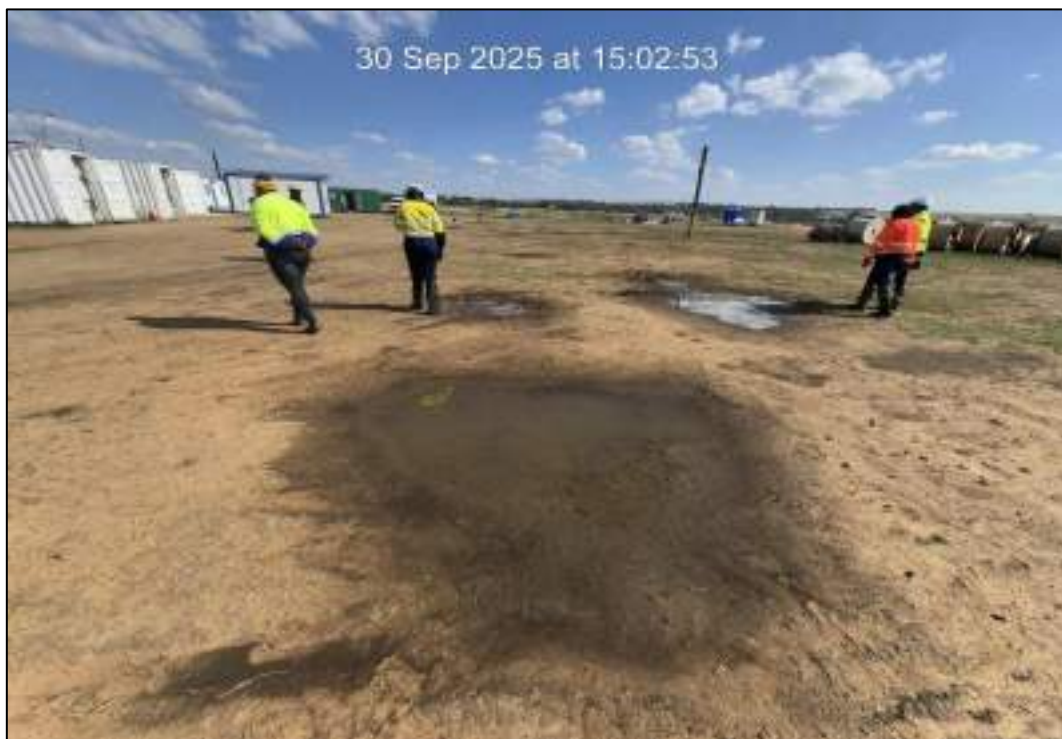
**Figure 4:** Water ponding on the laydown area.

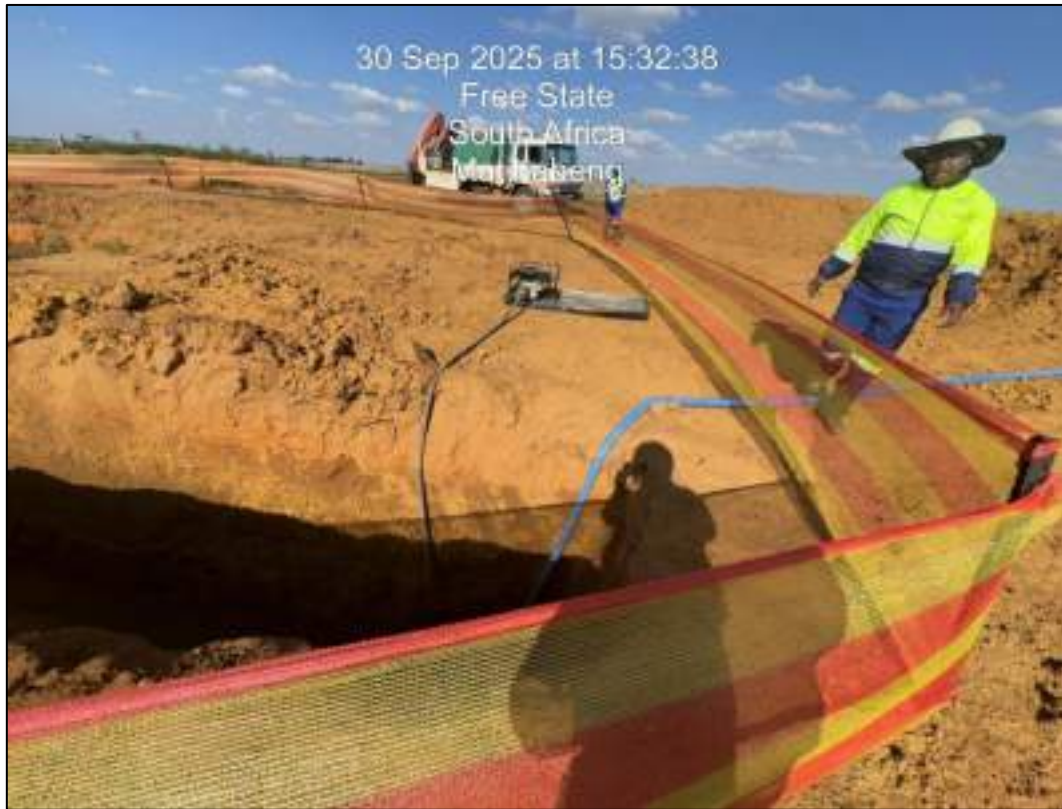
**Figure 5:** Groundwater being pumped out of excavations.

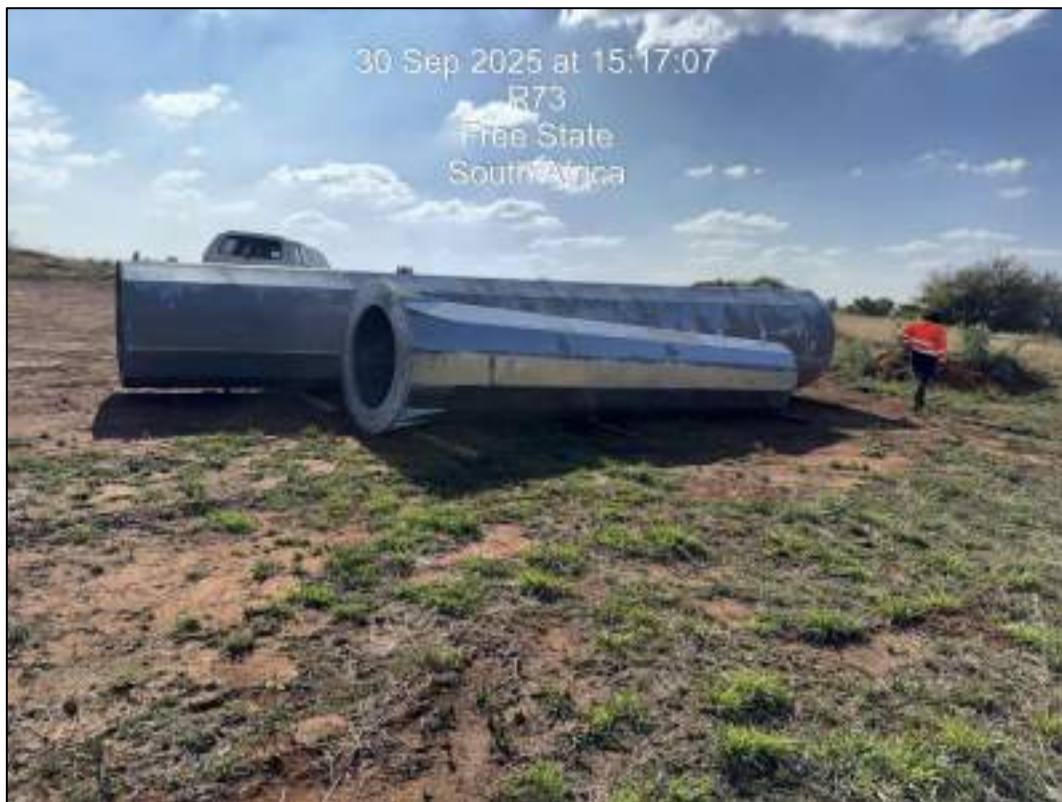
**Figure 6:** Pylons (material) onsite.

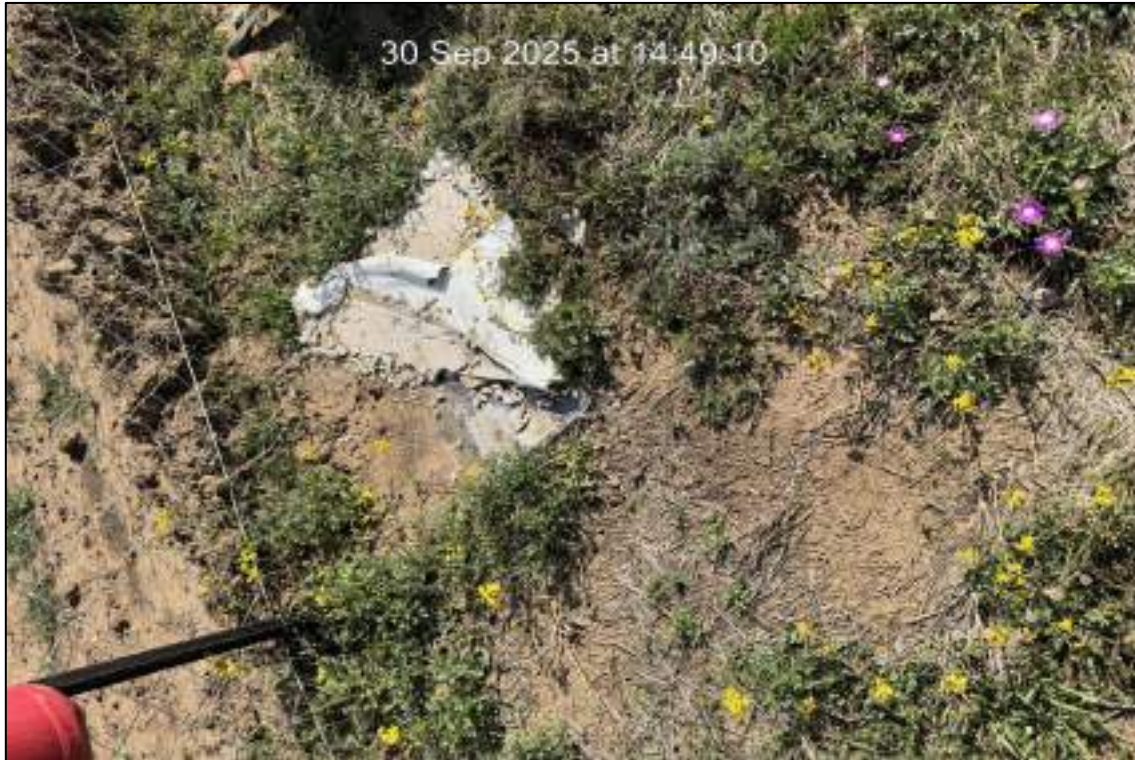
**Figure 7:** Concrete must be disposed correctly.

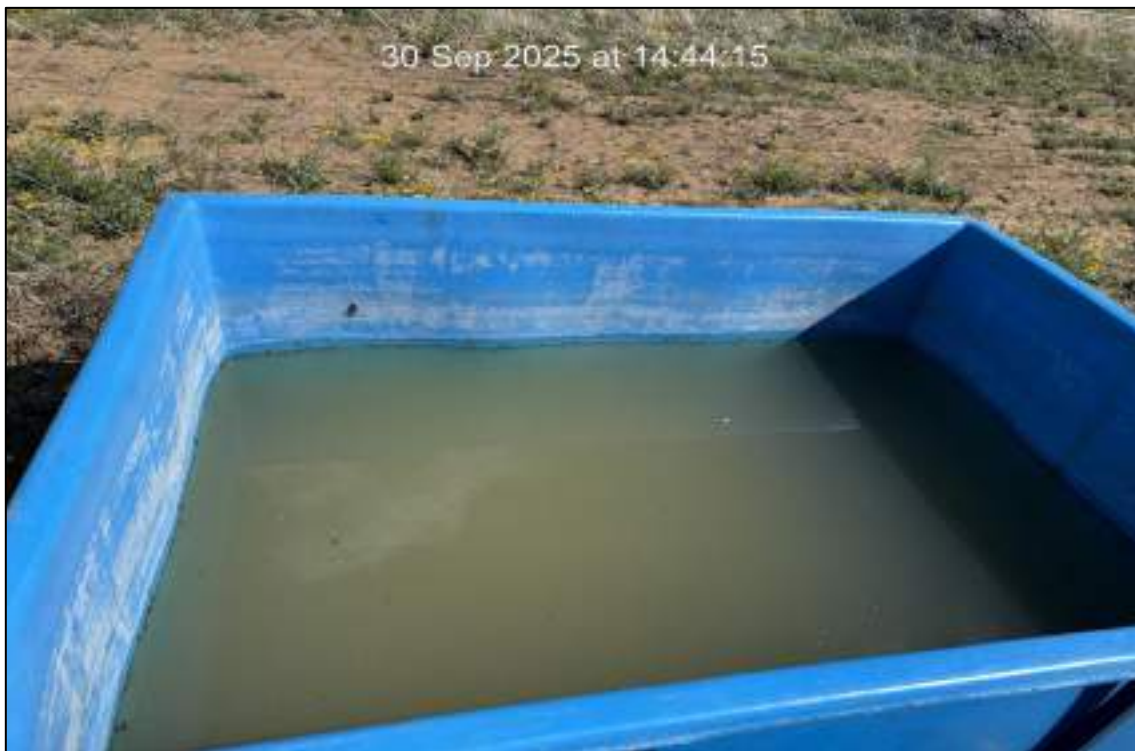
**Figure 8:** Wastewater in the concrete casting container must be disposed correctly.

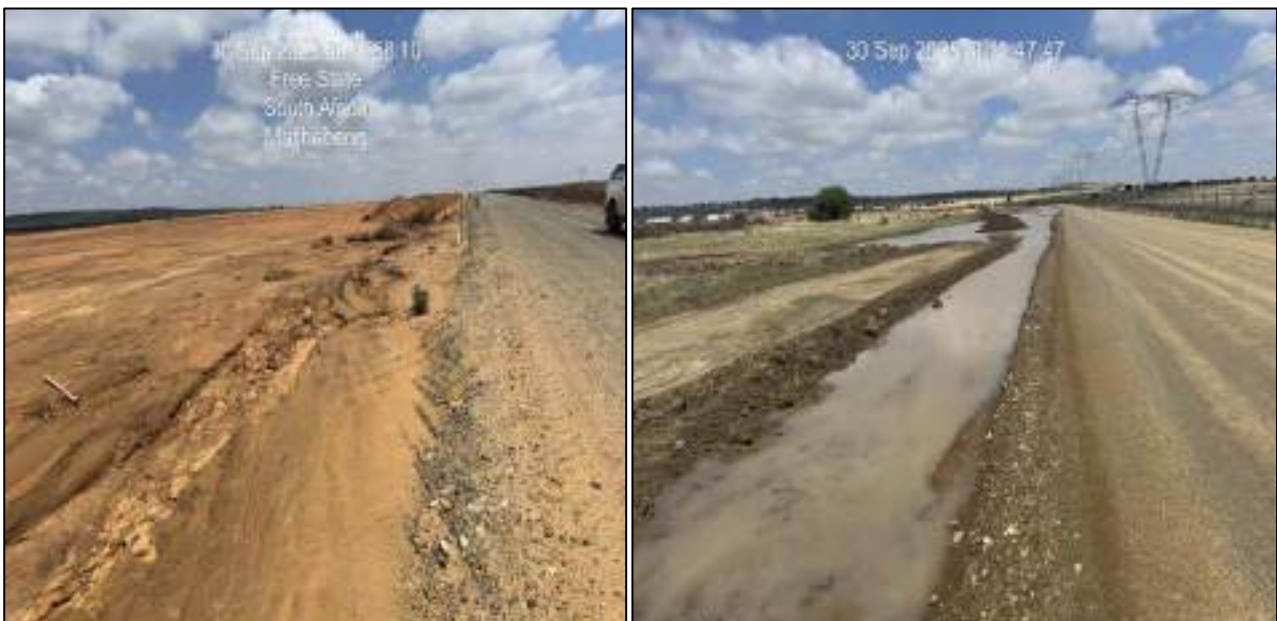
**Figure 2:** Sign of Erosion and water ponding onsite.

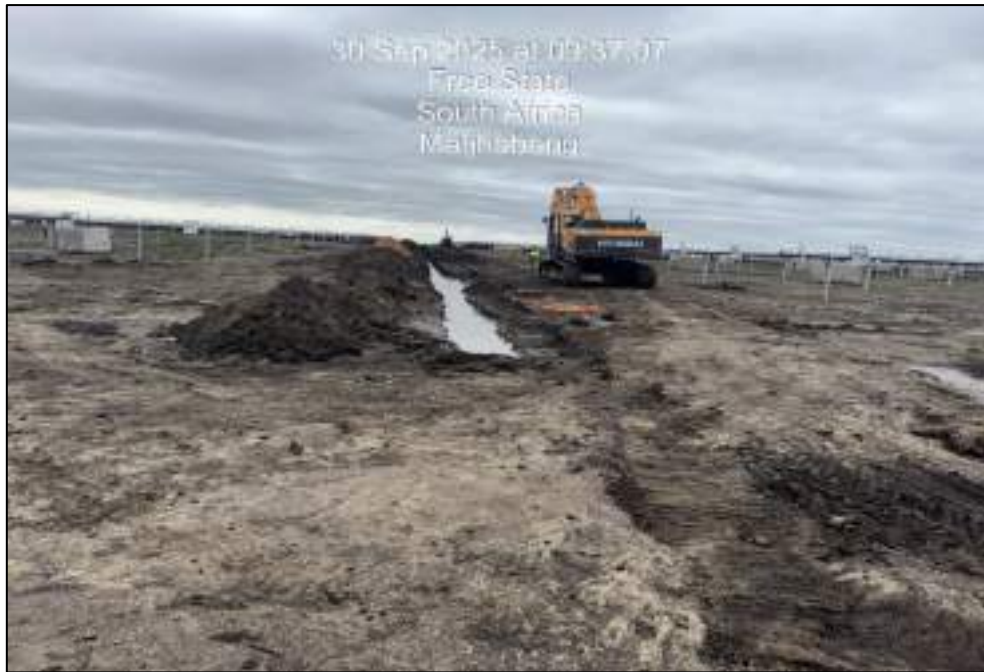
**Figure 3:** Unbaricaded trenches with water.

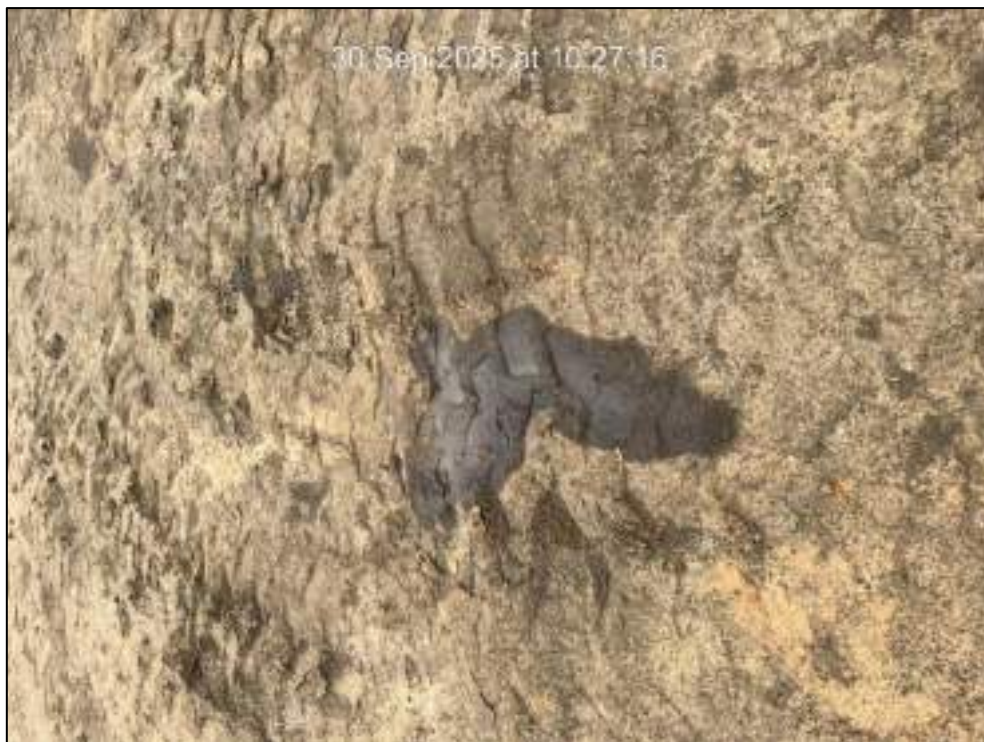
**Figure 4:** Small oil spillage.

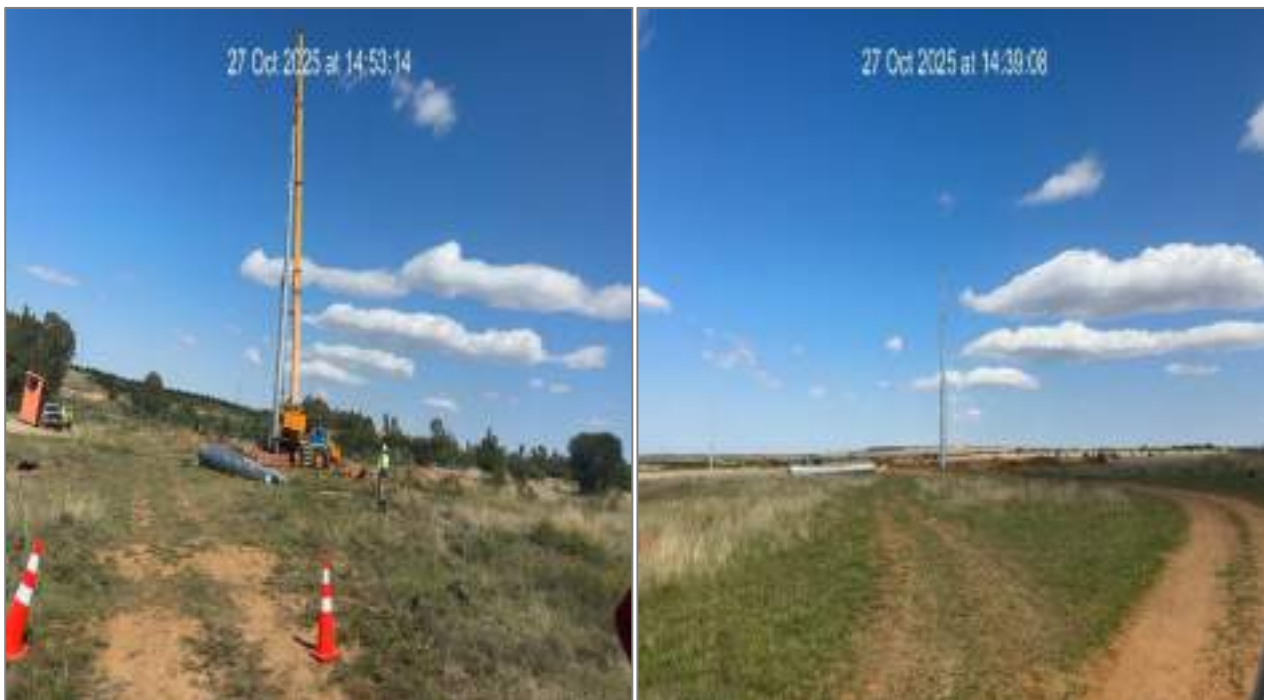
**Figure 5:** Erected Monopole Tower.

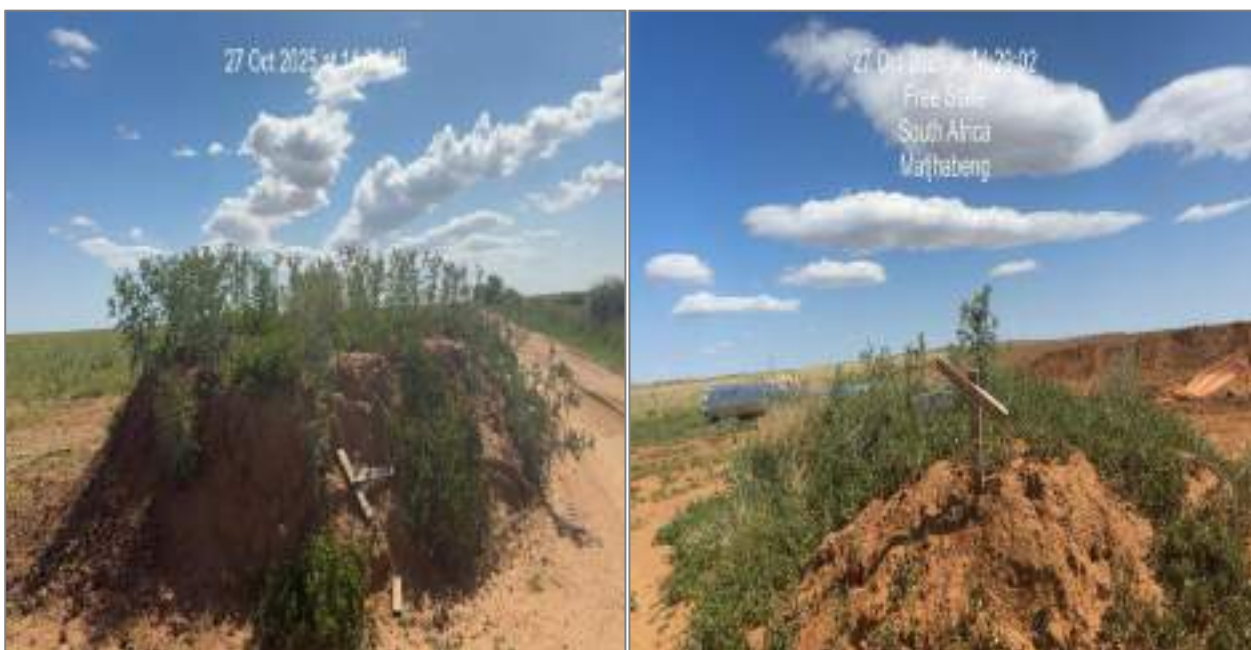
**Figure 6:** Alien vegetation on the stockpiles

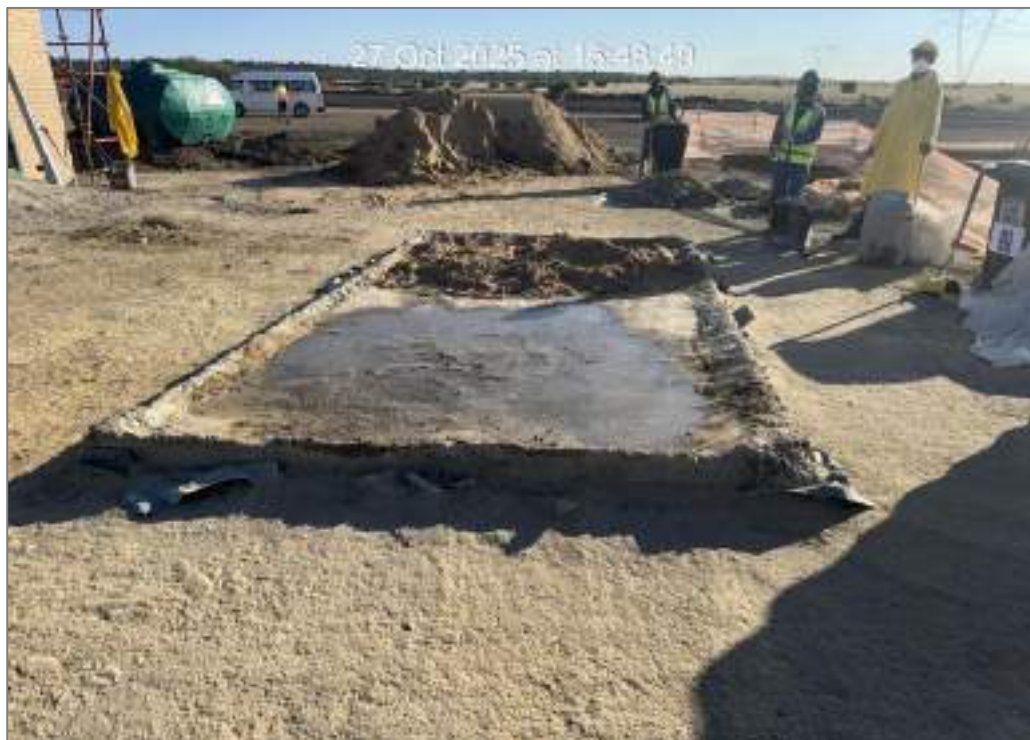
**Figure 9:** concrete being mixed on a concrete slab.

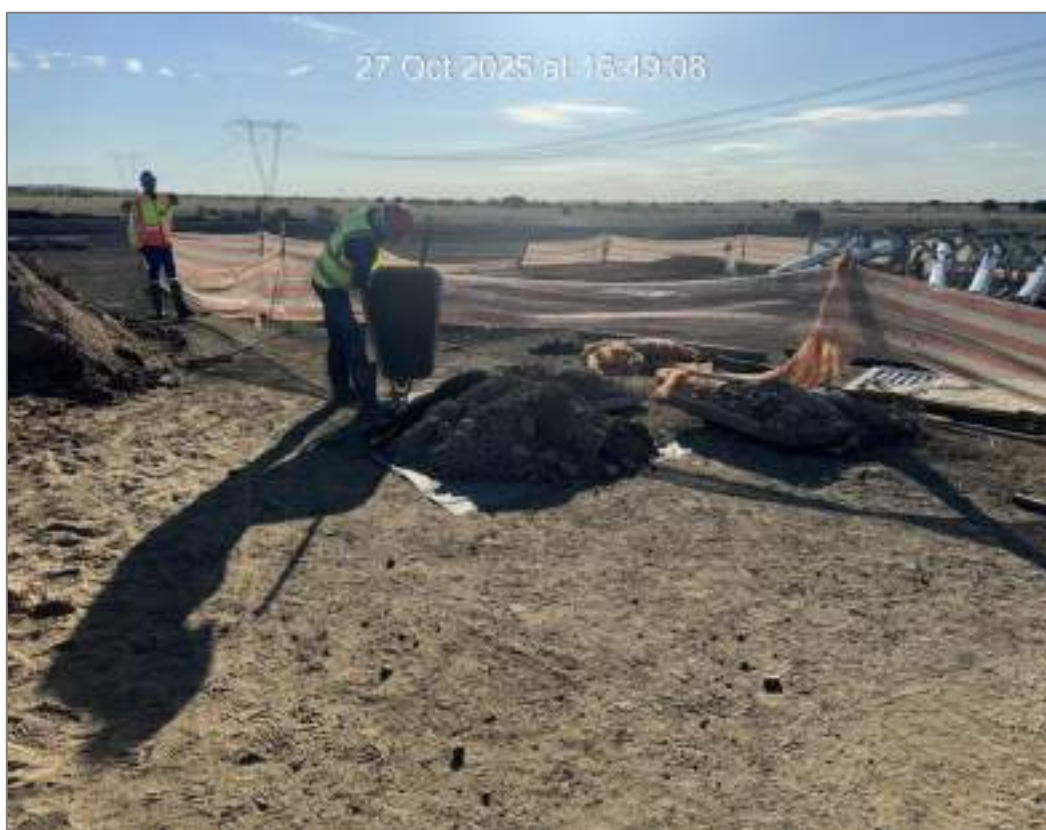
**Figure 10:** Concrete being placed on plastic bags.

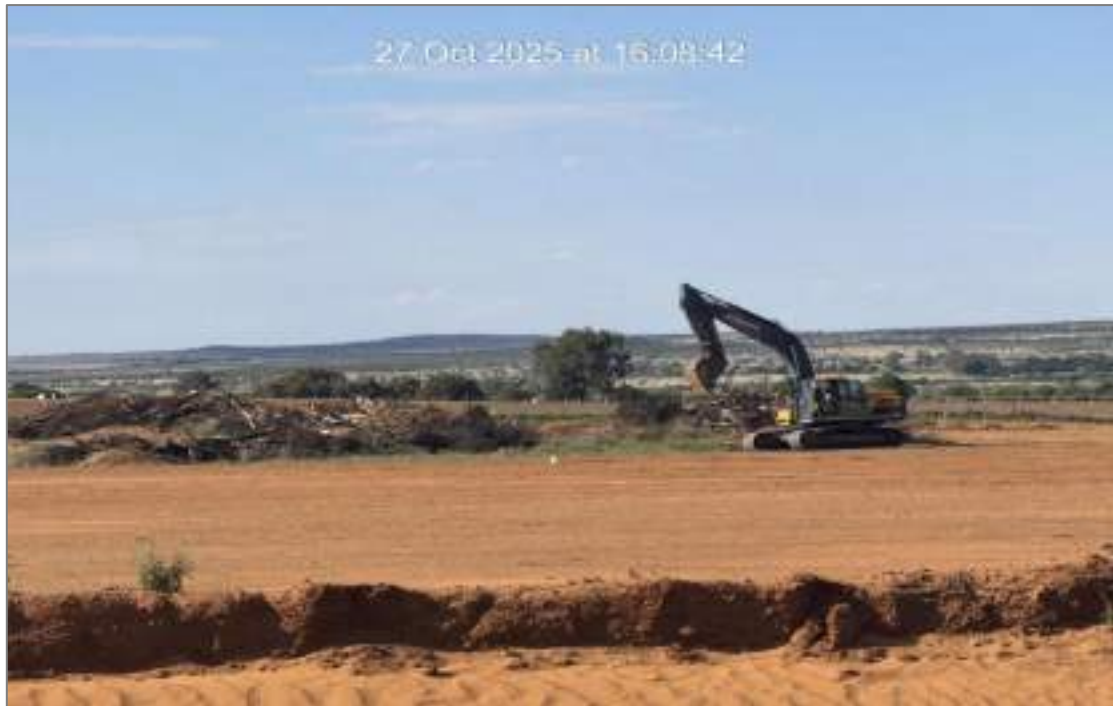
**Figure 5:** Cleared vegetation being moved from site.

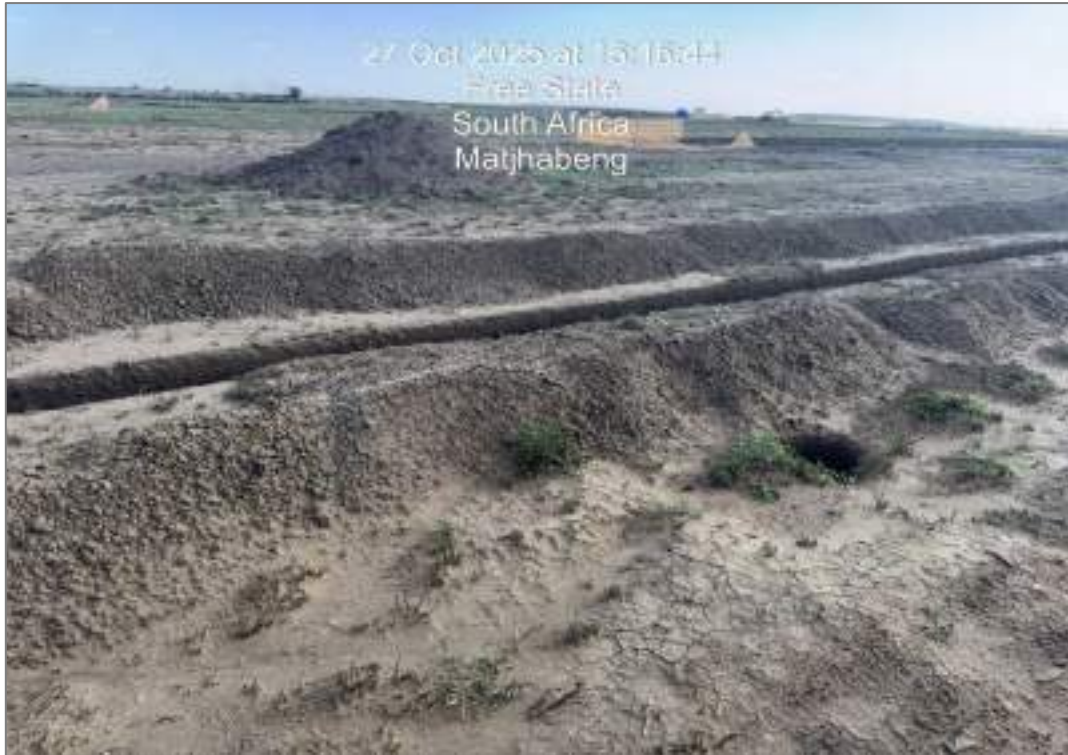
**Figure 9:** Open trenches left open unbarricaded.
