# ECO MONTHLY ENVIRONMENTAL MONITORING REPORT

Virginia Photo Voltaic (PV) Solar Facility 1, 2 and 3,  
Matjhabeng, Lejweleputswa District Municipality within  
the jurisdiction of the Free State Province.

January 2025

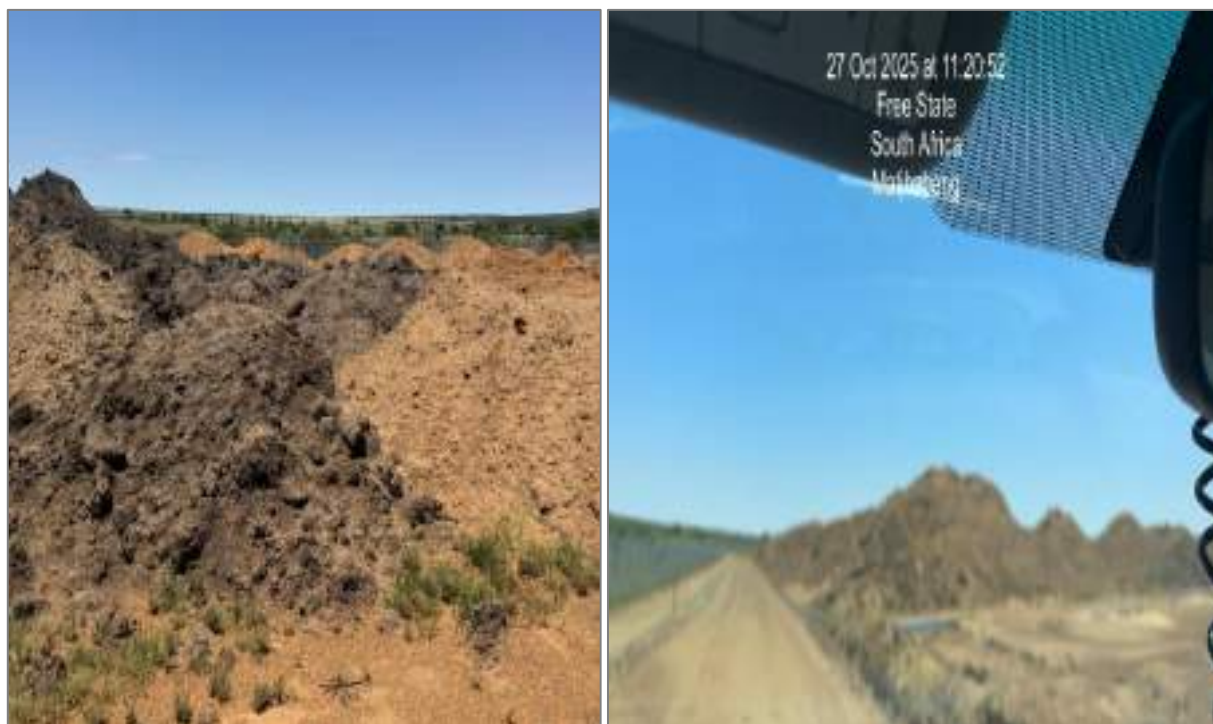
**Figure 12:** Stockpile height exceeding 2m.

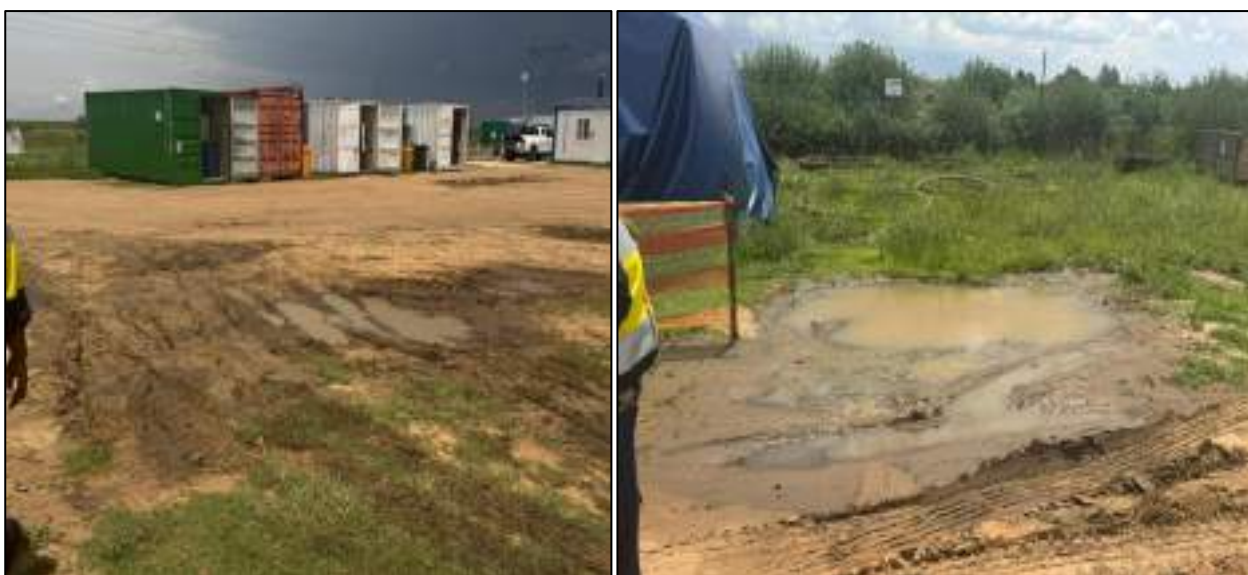
**Figure 4:** Water ponding at the laydown area

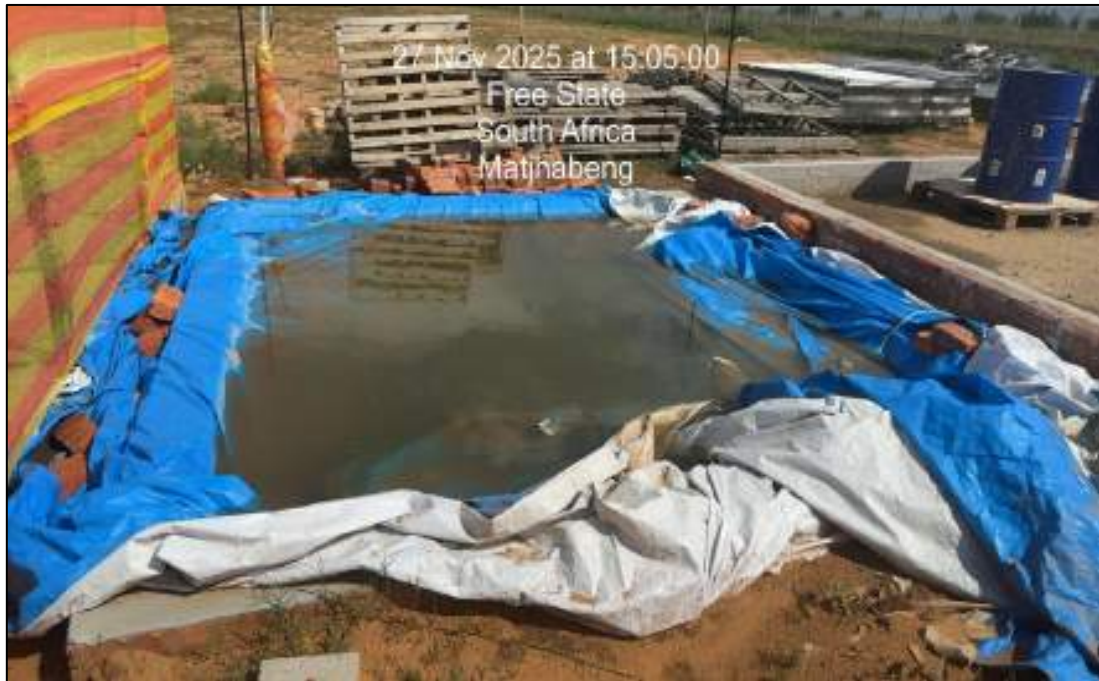
**Figure 5:** Overflowing sump at the waste area.

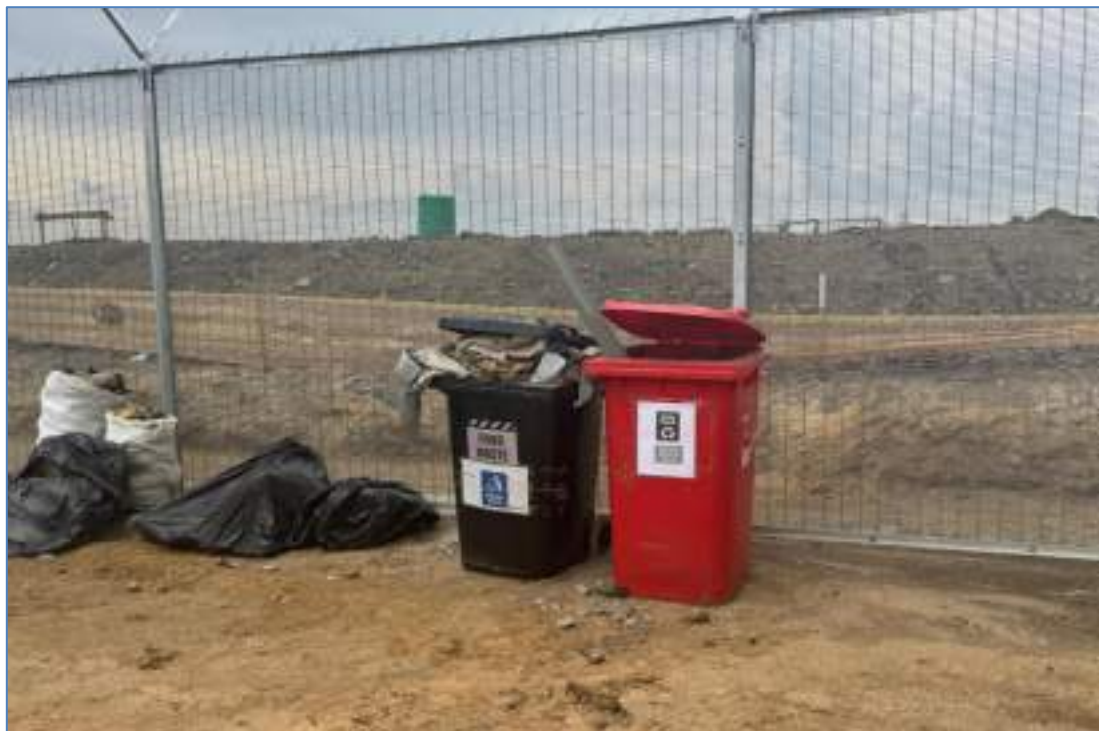
**Figure 6:** Bins overflowing with waste at the switching station

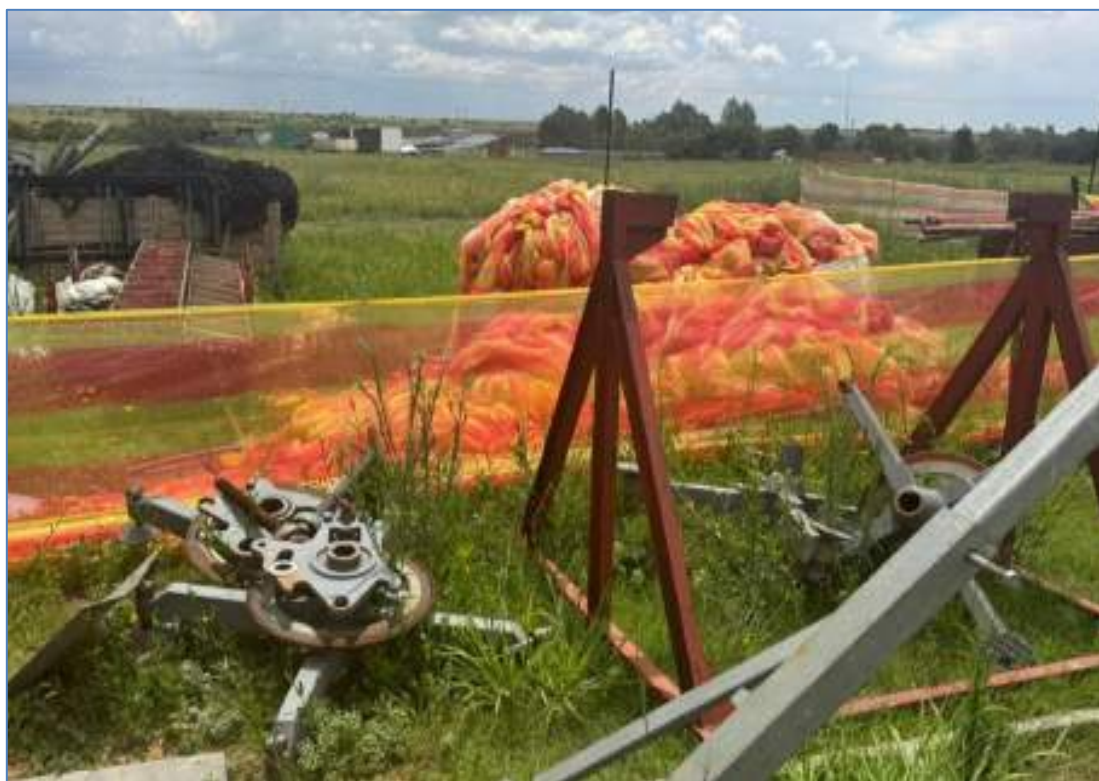
**Figure 8:** Torn barricading nets must be taken for recycling.

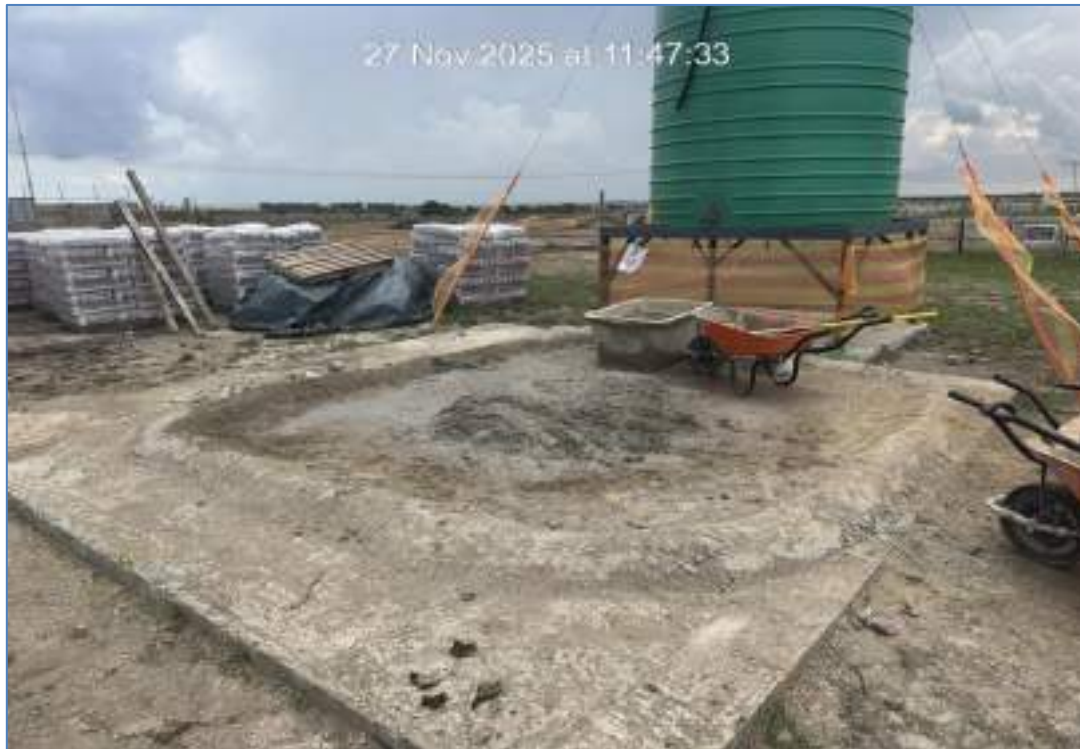
**Figure 9:** Concrete slab for concrete mixing

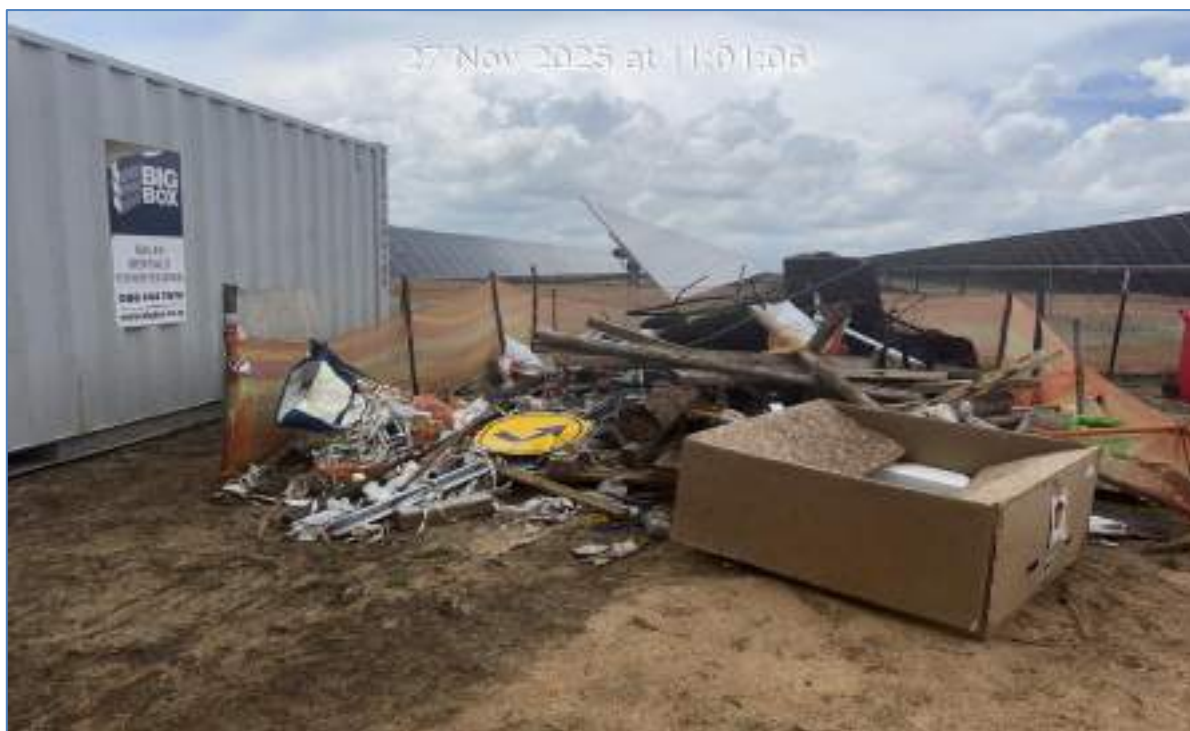
**Figure 3:** Poor waste management practices

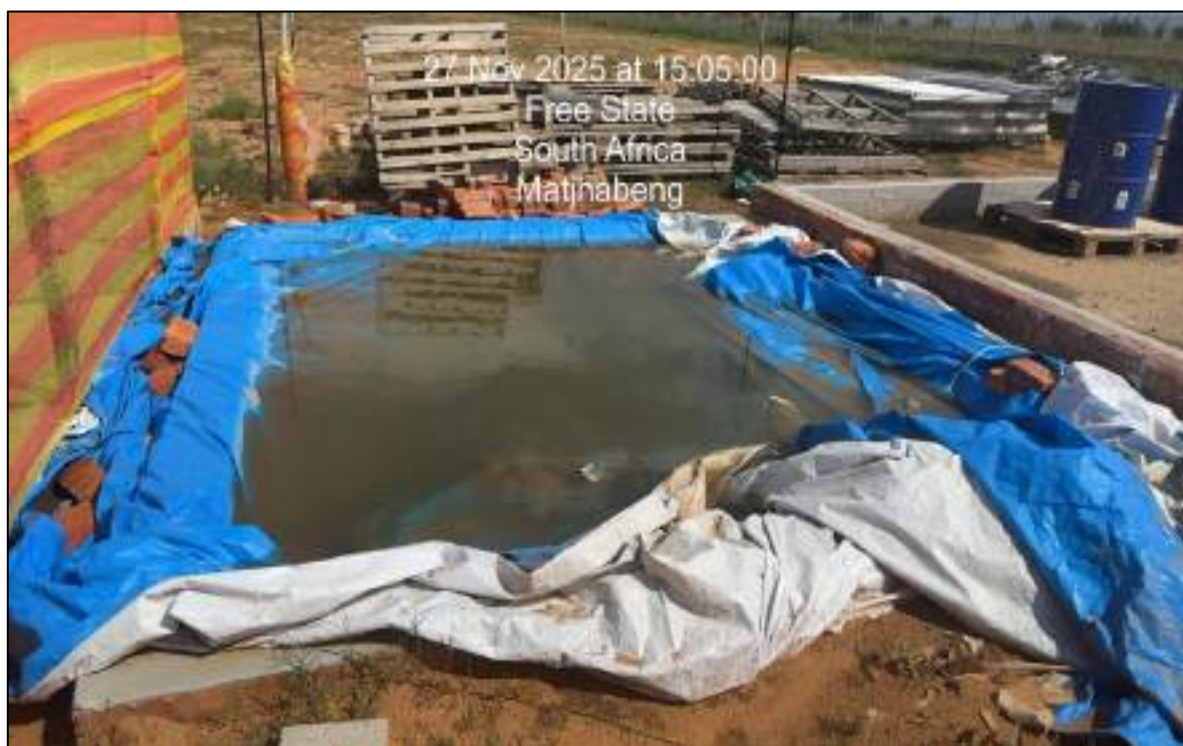
**Figure 4:** Overflowing sump at the waste area

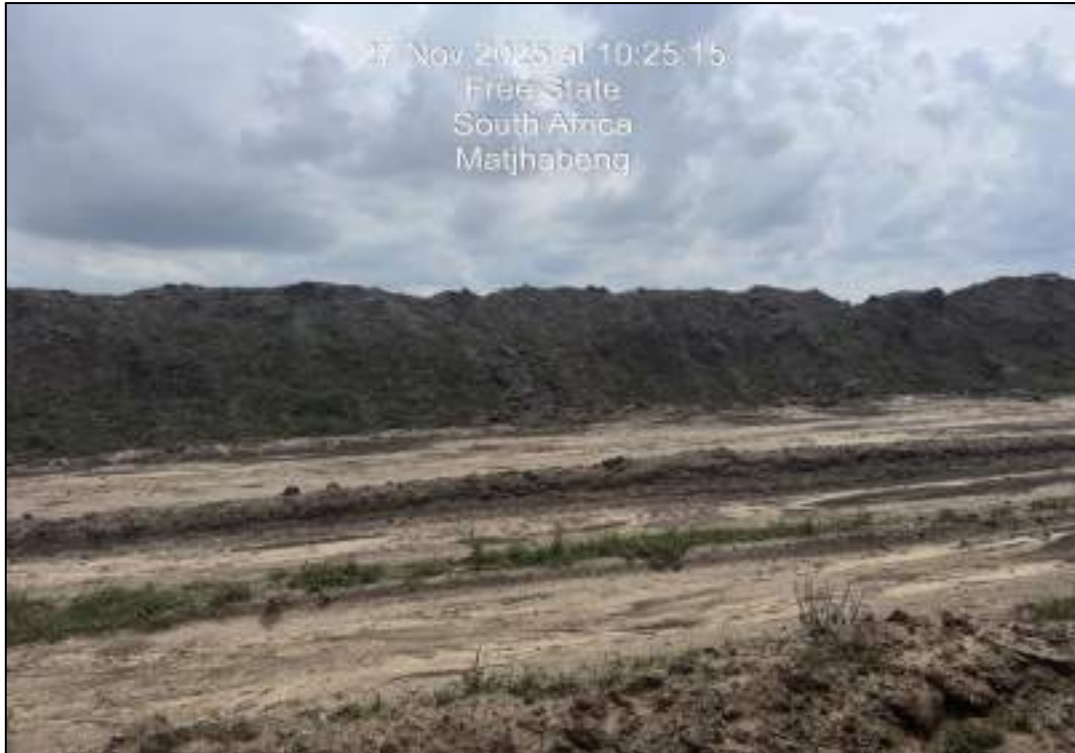
**Figure 9:** Open trenches left open unbarricaded.

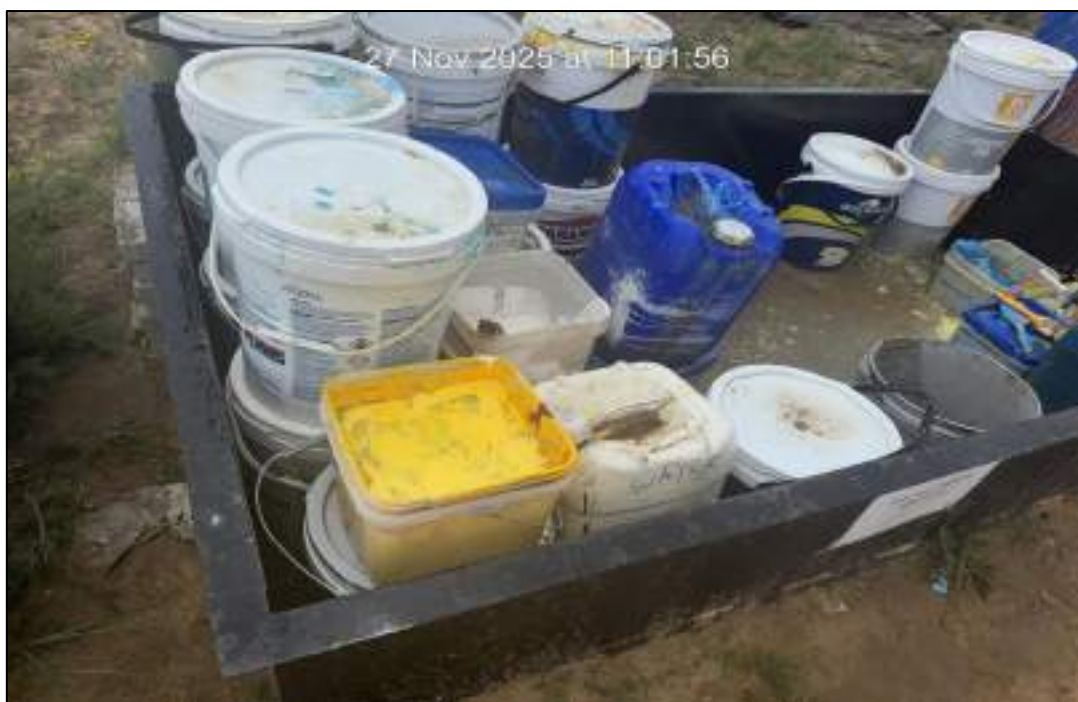
**Figure 10:** Paint container left open in the rain

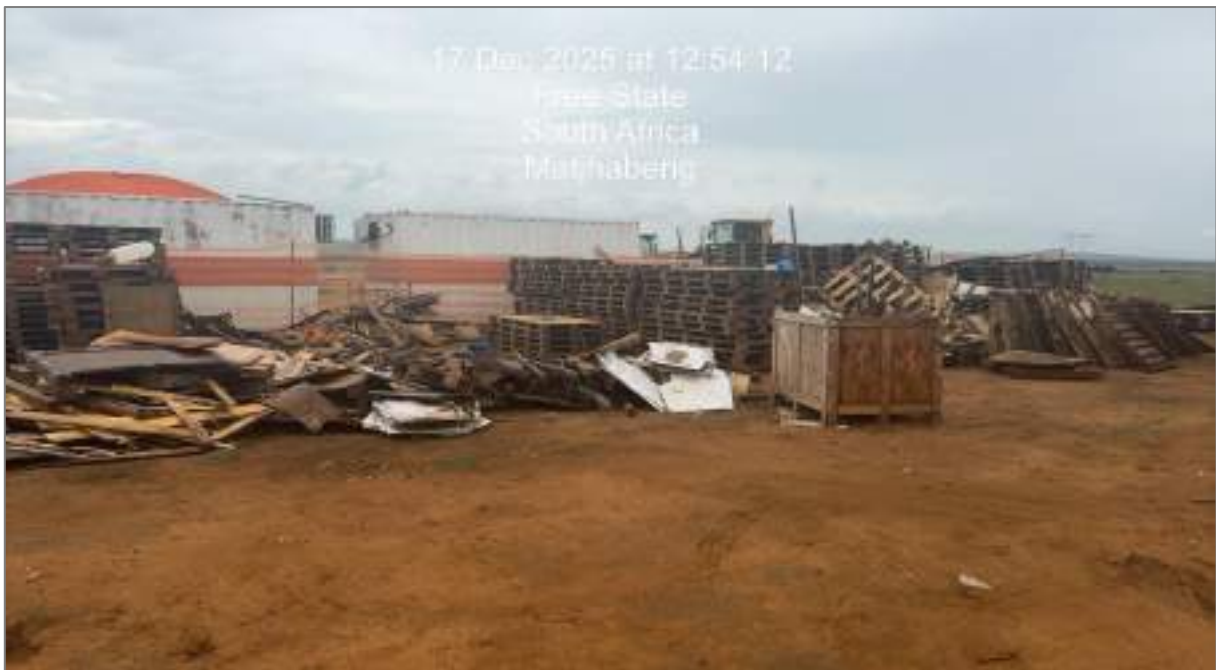
**Figure 2:** Large quantities of wood pats at the waste area

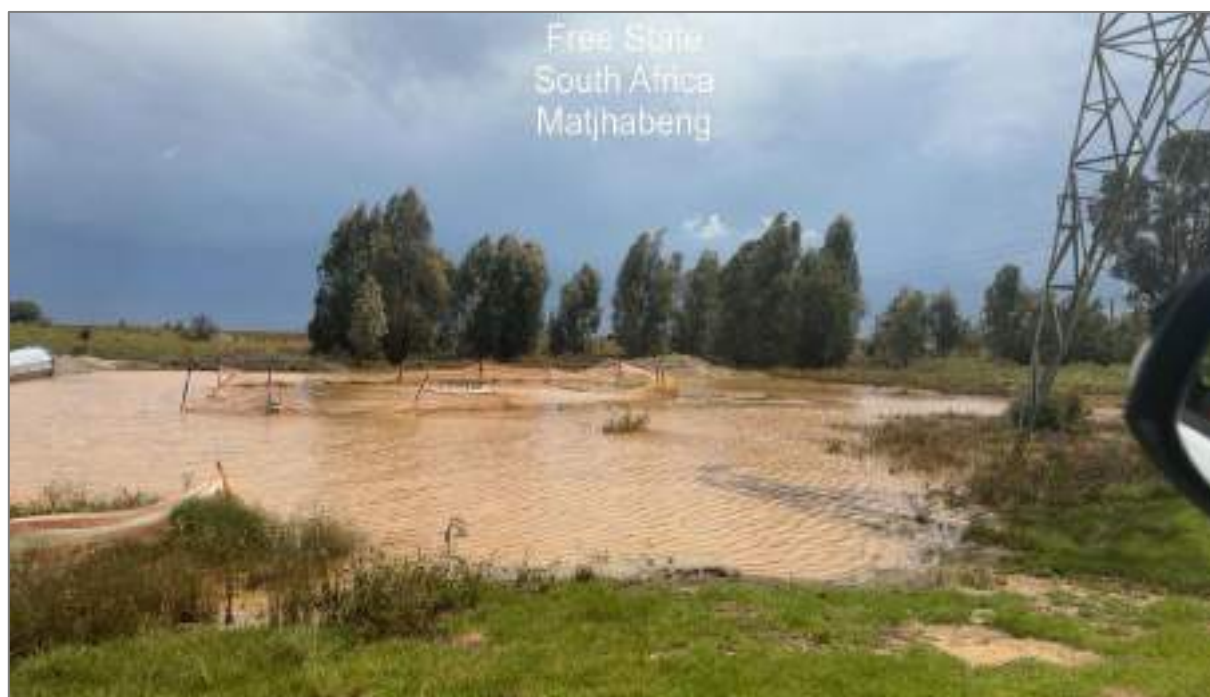
**Figure 3:** Rainwater accumulated at Tower No. 13

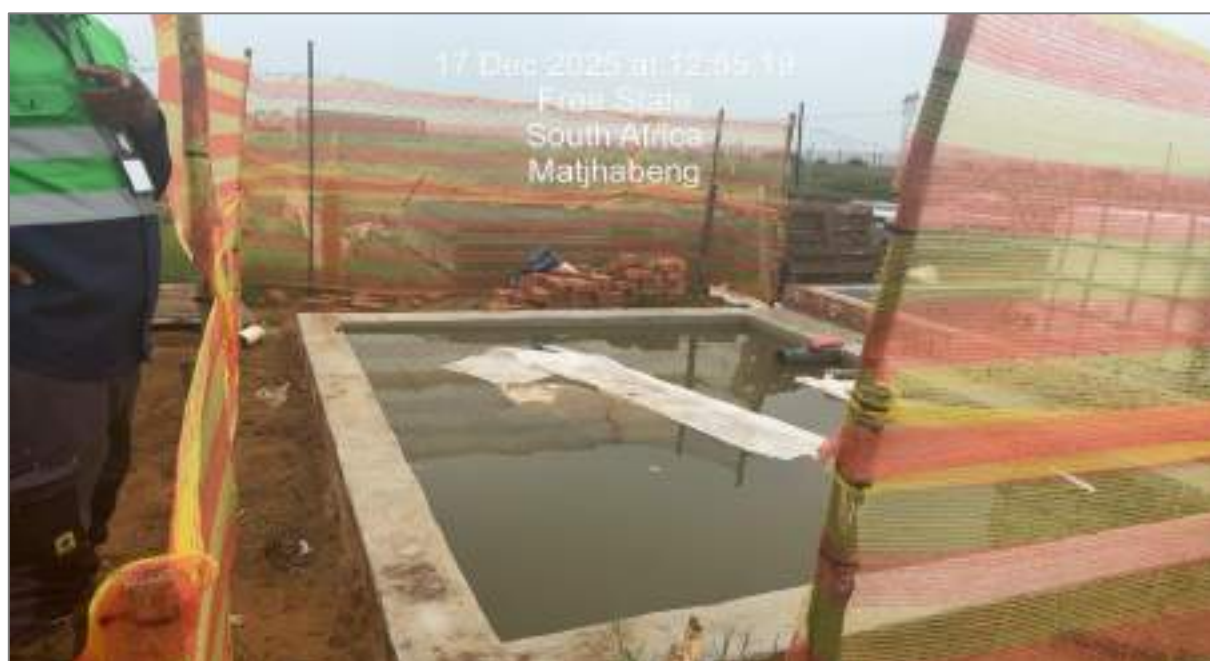
**Figure 4:** Overflowing sump at the waste area.

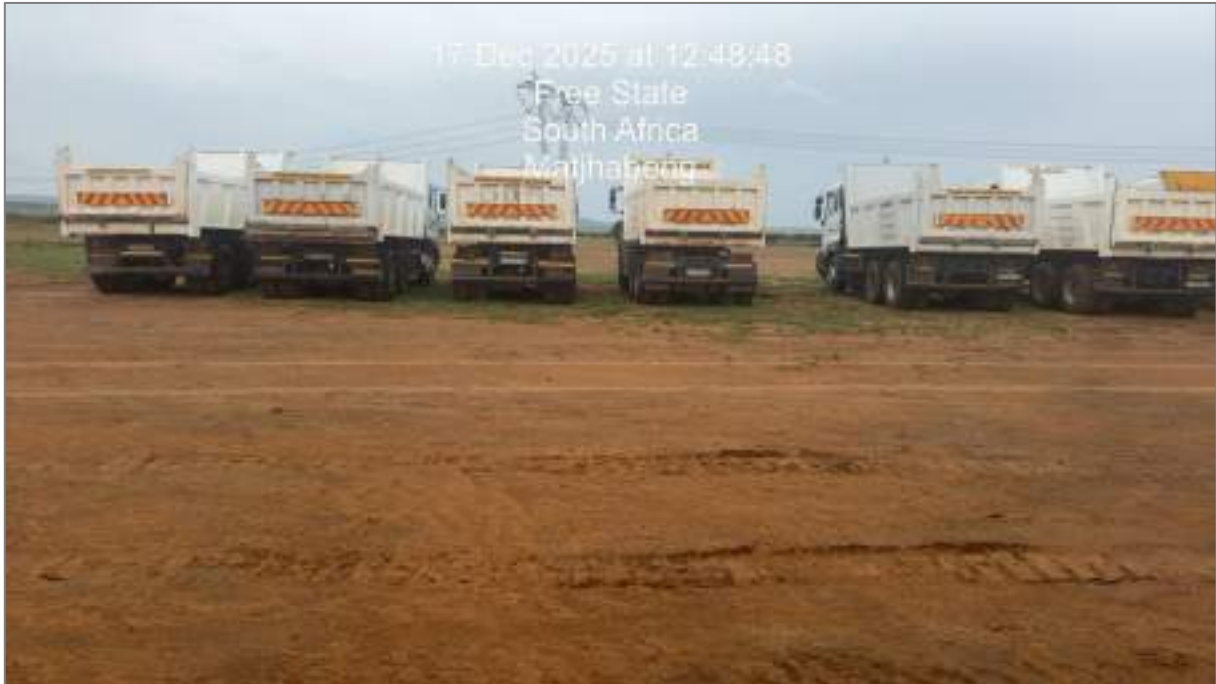
**Figure 5:** Trucks standing without drip trays.

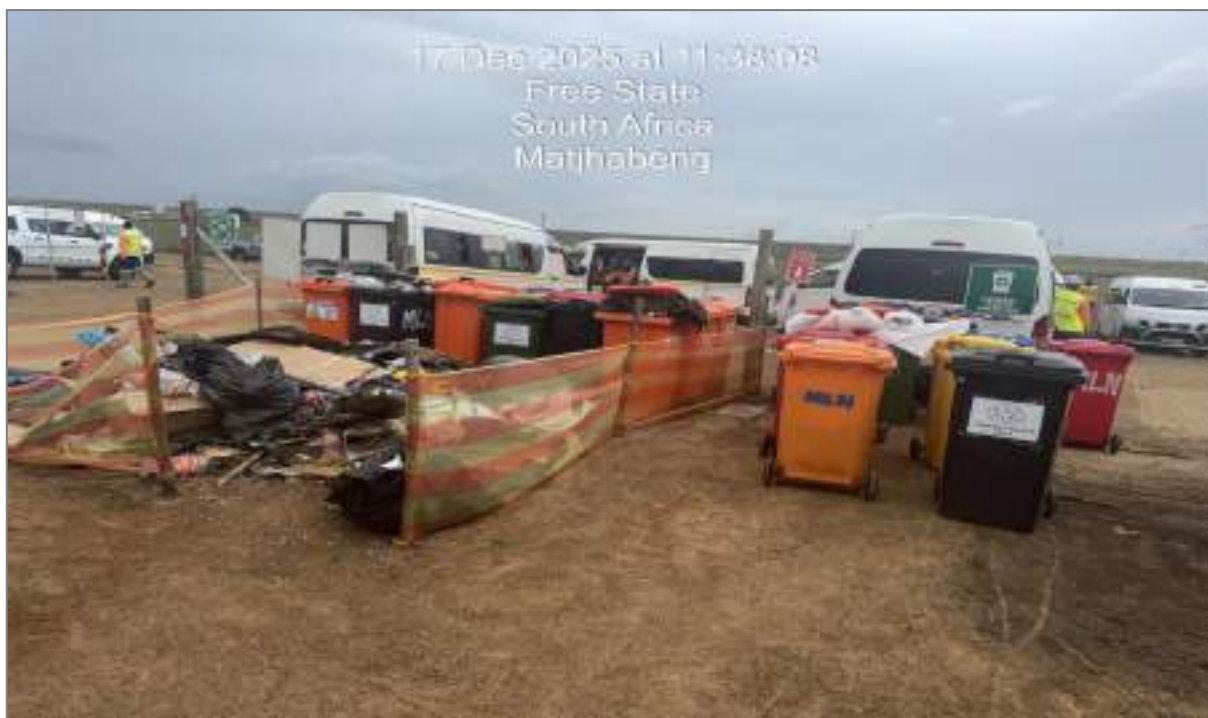
**Figure 3:** Poor waste management practices.

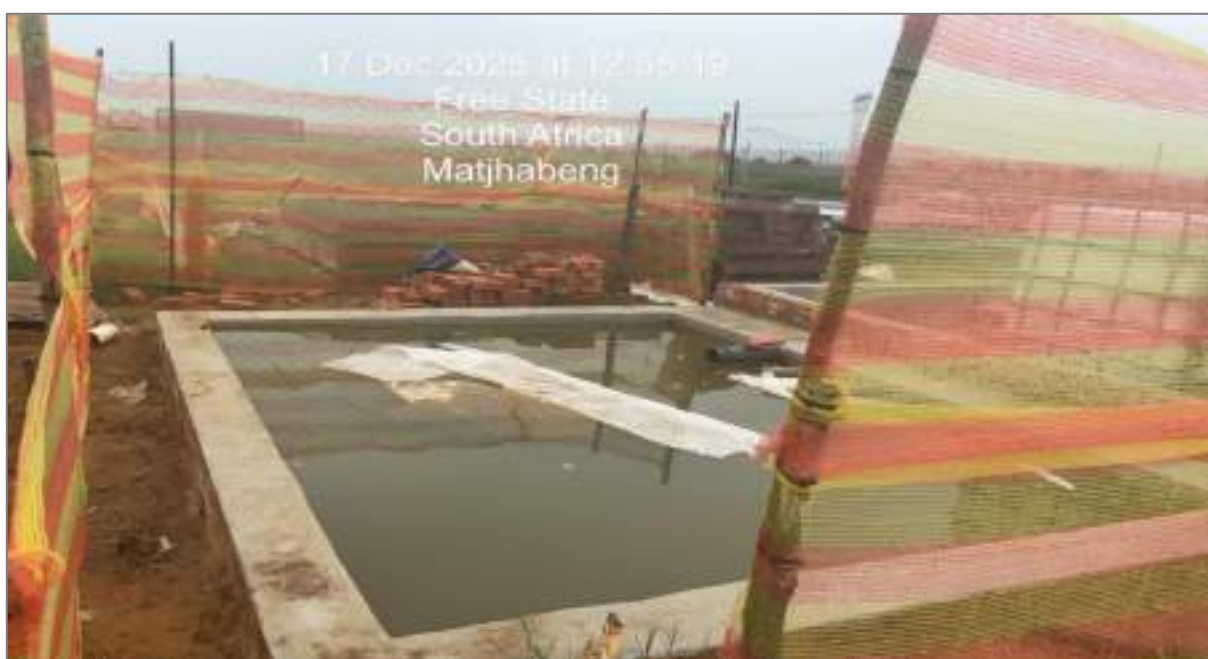
**Figure 4:** Overflowing sump at the waste area.
