KRS
KENNY RELF SURVEYORS

Survey Report

123 The Street, Town, County AB45 6CD

Address of the Property 123 The Street, Town, County AB45 6CD
Name of the Client A Client
Report Reference 12345
Date of Inspection Monday 22 September 2025

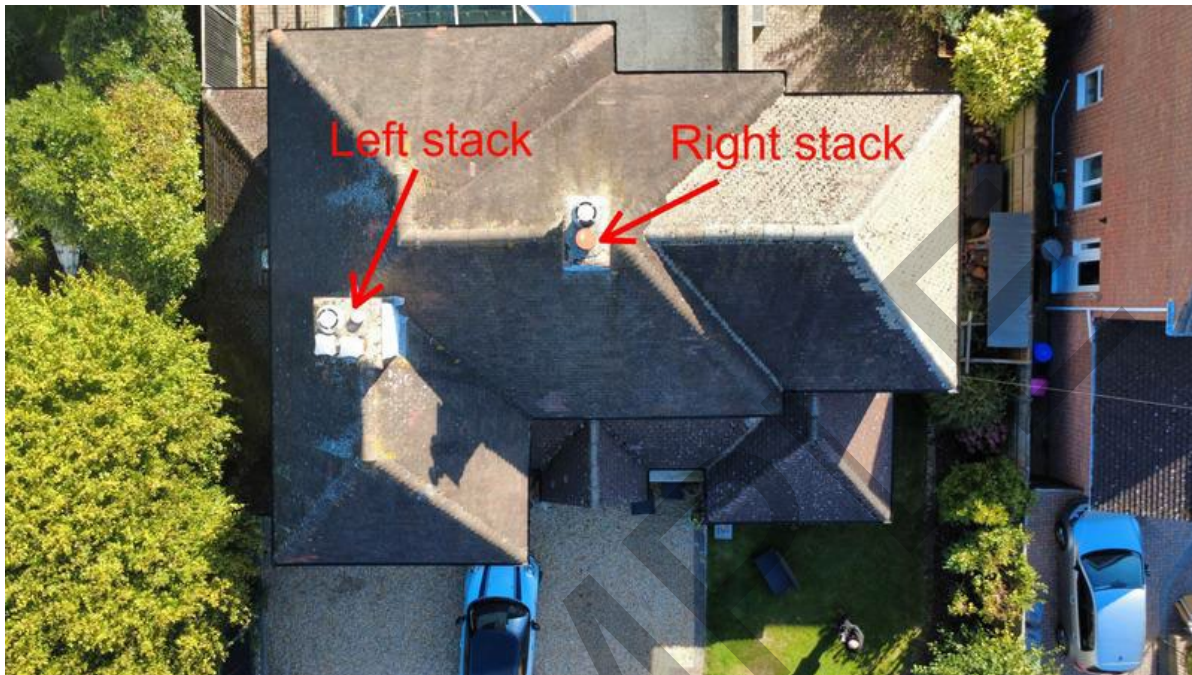
Left stack

The flashing of the right stack (cement layer on top) was noted to be damaged. The render or paint coating on the brickwork was very worn.
