# Damp Report

A Property

21393

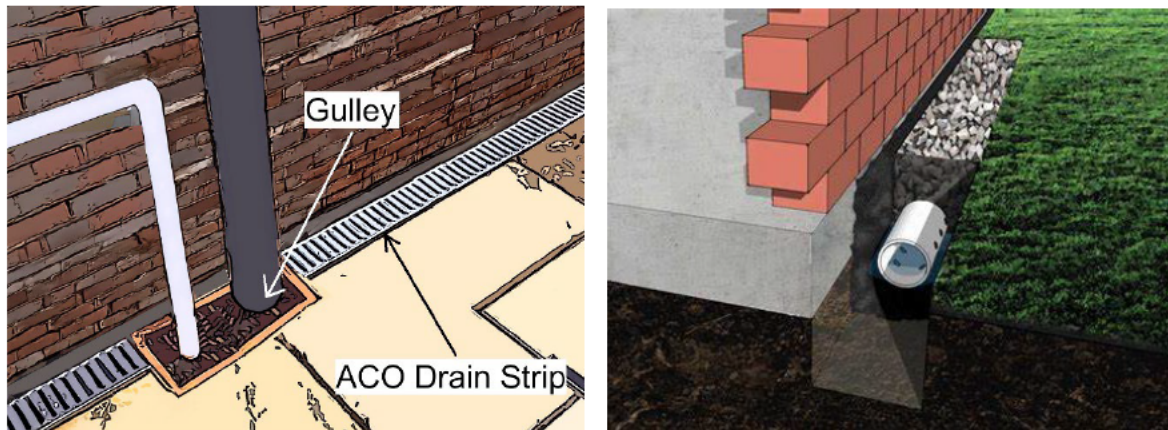
## Examples

**Location 1** - The dampness in the ground floor cloakroom appear to be caused by rainwater pooling in the courtyard and penetrating the base of the external wall.

I recommend that a drainage channel is installed at the base of the wall to allow rainwater to drain in to the adjacent gully:
