9 April 2020

Reference No. 1896230-046-L-Rev0

Broken Hill Operations Pty Ltd
Eyre Street
Broken Hill
NSW

LIQUEFACTION ASSESSMENT OF TAILINGS – RASP MINE TAILINGS STORAGE FACILITY 1

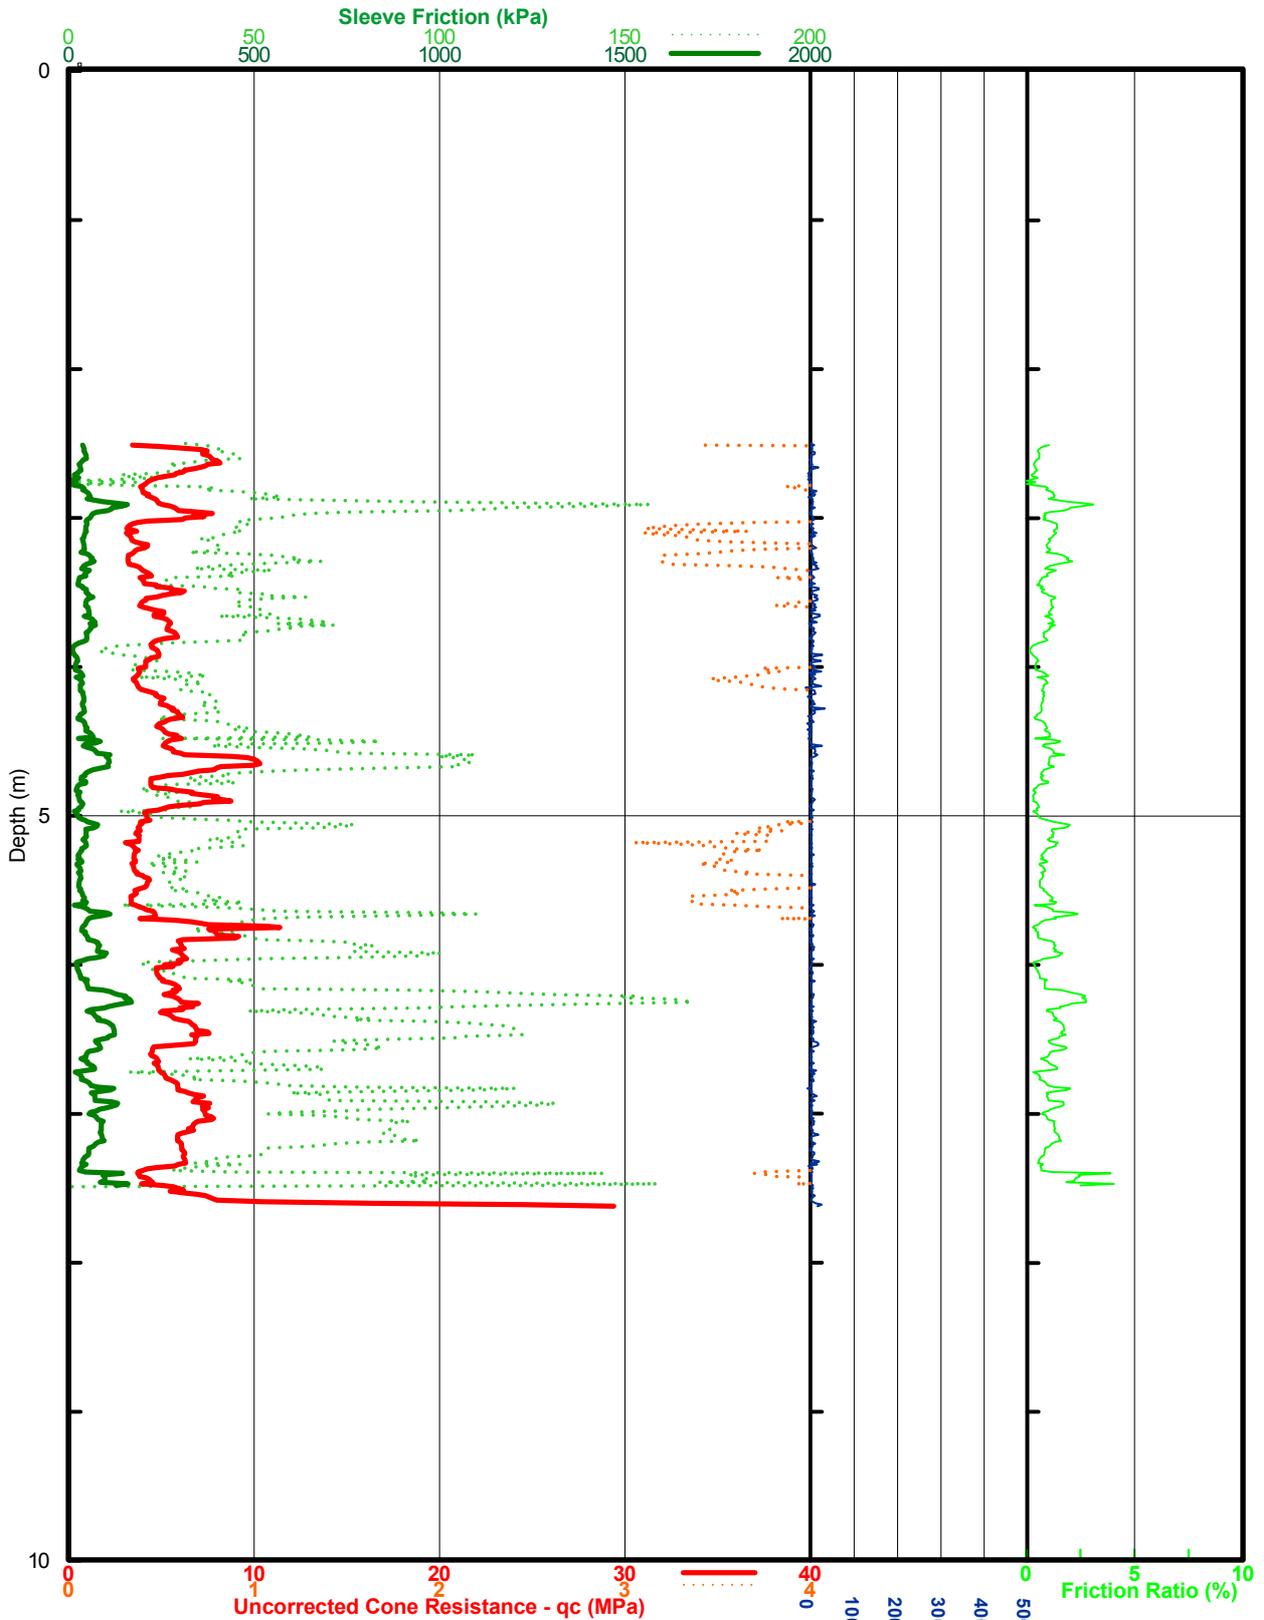
CPT5C

The first investigation comprised 5 CPT locations (CPT01 to CPT05) and the second investigation comprised another 4 CPT (CPT06A to CPT09) probe locations along the eastern edge, plus two locations (CPT4 and CPT5) on the eastern bench of Mt Hebbard. In the vicinity of the two locations on the eastern bench of Mt Hebbard numerous attempts were made to penetrate the subgrade in the general areas labelled CPT 4 and CPT 5C, but all attempts except one (CPT5C) refused near the surface. CPT 5C penetrated approximately 8 m before also refusing.

It is noted that historical photographs of the site suggest that Mt Hebbard is at least partly an old sand dump, which would be supported by the results of the results of the CPTu 5C measurements. The sand dumps are understood to have been typically formed by end tipping of sandy materials, resulting in a relative dry mound of material. The historical data also suggests that some residue dams were formed near the eastern side of the dump. The lateral extent to the east of the sand dump has not been established and more detailed review of historical data may assist in refining the data related to the eastern edge details of Mt Hebbard.
