## **TECHNICAL REPORT**

**Identification of Potential Inrush and Inundations Pathways from present and future TSF Facilities into Rasp Mine Underground Workings (with a focus on Kintore Pit proposed TSF3).**

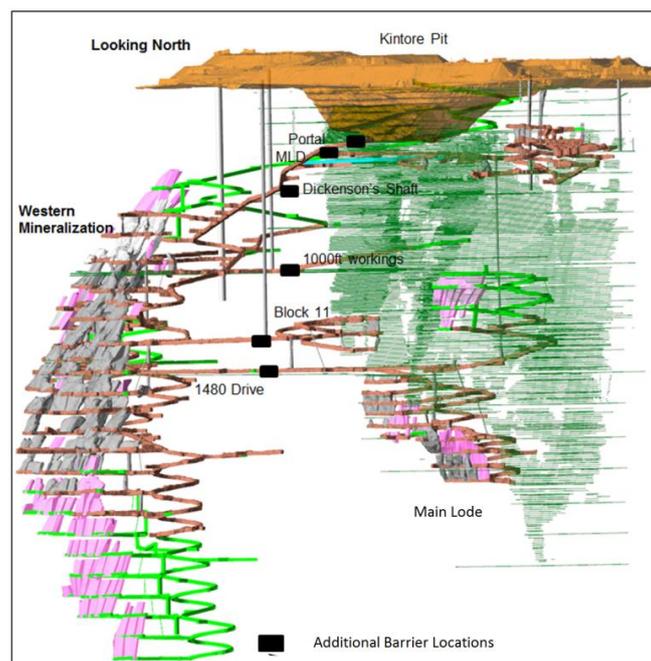
**Figure 2- Additional Barrier Locations**

This report details the potential pathways between Rasp Mine's underground workings and Kintore Pit. Also detailed are the locations of the additional barriers required to effectively isolate these pathways from current or future active mine working, if required (Figure 2).

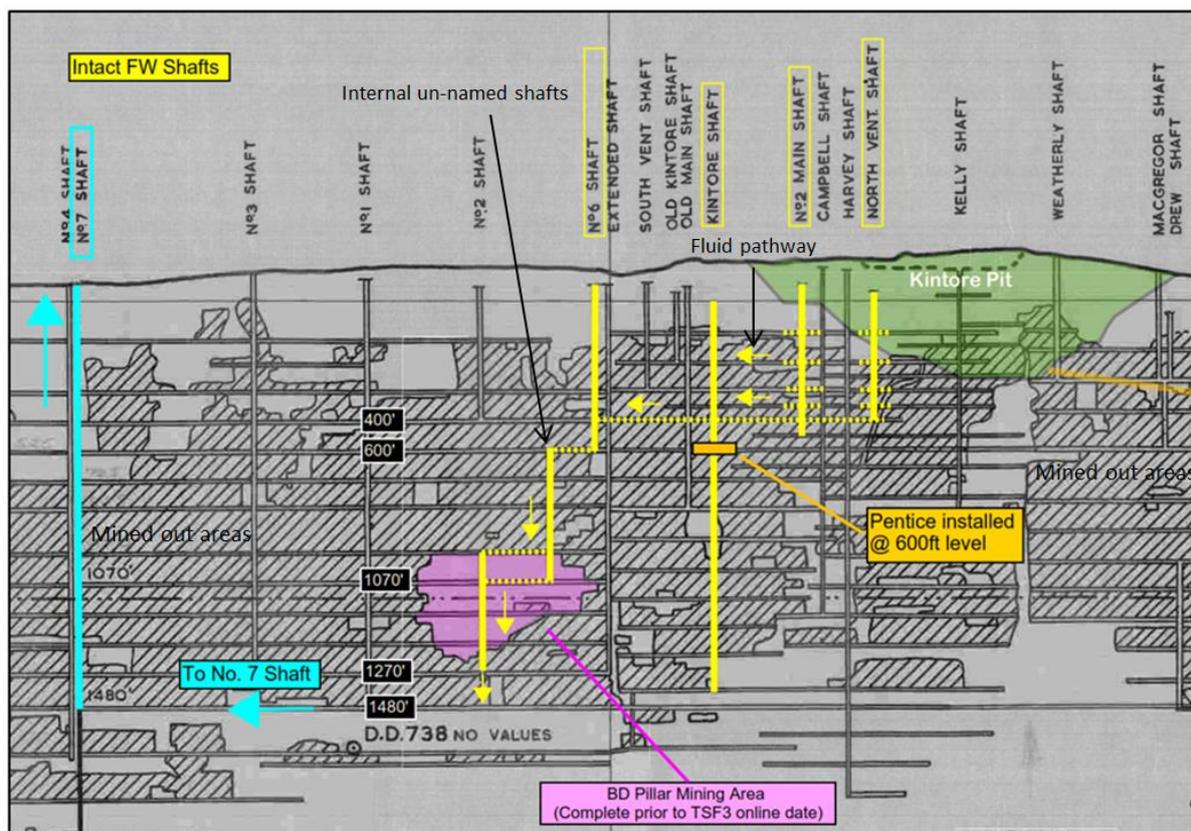
Figure 6- Cross section looking West – “Southern Impoundment” pathways

installed on the 600ft, (confirmed by CMS), it is unlikely that this will block the continued trend of the open diversion of water vertically down, (see Figure 6), however the presence of the pentice, would likely impede the travel, momentum and speed of a substantial inrush of sand and water event.

There are two remaining open pathways that will allow flow above the pentice, the 400 ft and the 600 ft Kintore levels. These openings connect the Block 9 workings to the Block 8 and 7 historical workings (425 ft /625 ft). These provide secondary pathways to No 6 Shaft and thus a vertical pathway to the 1070 ft level and the No 2 Shaft.

The BD Pillar incline is in this pathway, and the water may then traverse down the incline into the 1480 level along the concrete drains laid on a grade of 1 in 400 and drain to No 7 Shaft as shown in Figure 6.

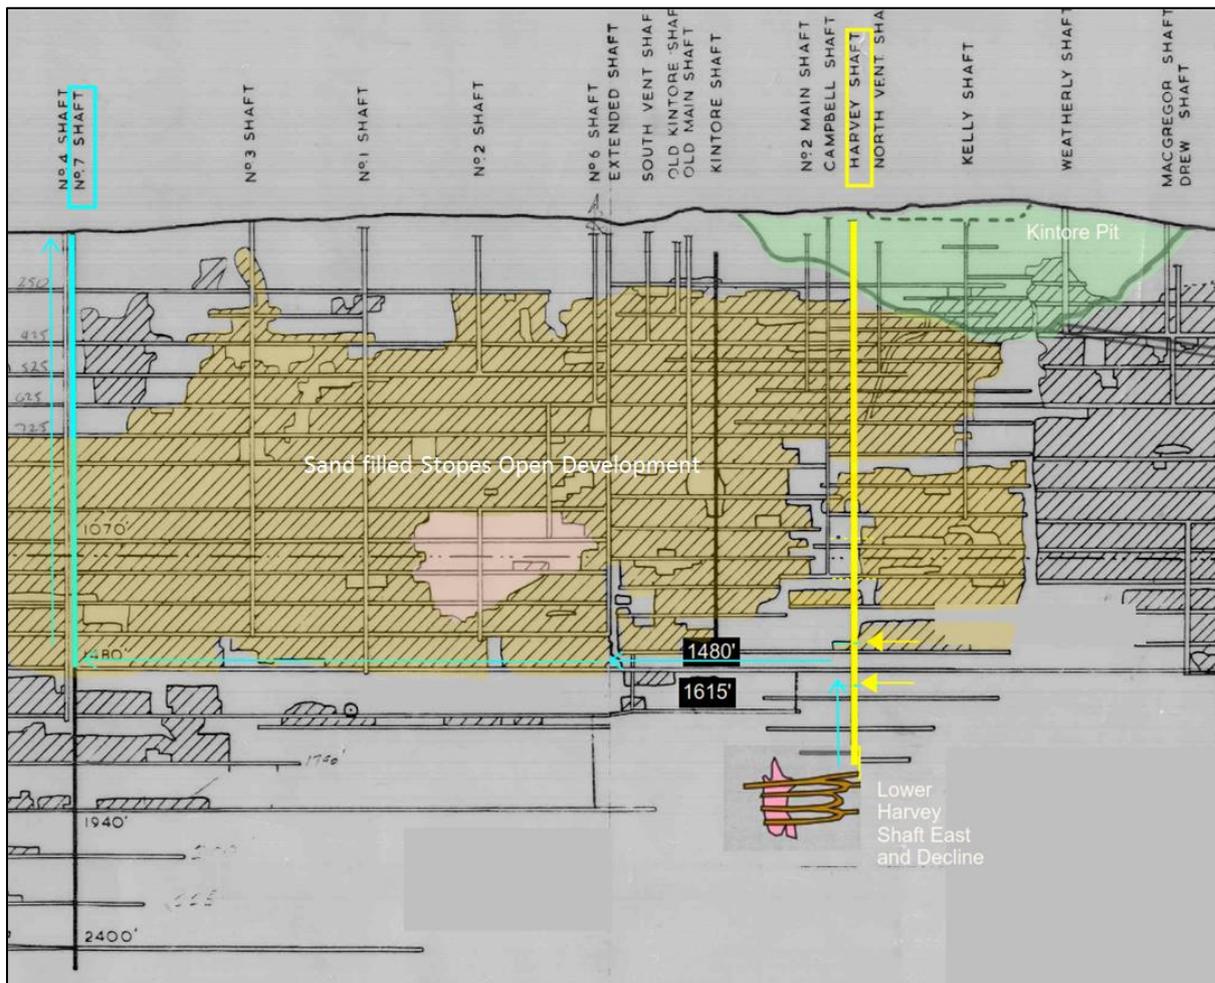
Figure 7- Harvey shaft cross section potential fluid pathway

The primary levels where no fill or the drives contain partial fill are the 1480 ft and 1615 ft levels. These are regions in which the crosscut to the Harvey Shaft may still act as an open water channel, see Figure 7. These provide immediate drainage to the Lower Harvey Shaft East (LHSE) decline levels. Water will report to the area due to its lower elevation. Once the LHSE area reaches full inundation water will rise to the 1480 ft drive and drain to No 7 Shaft.

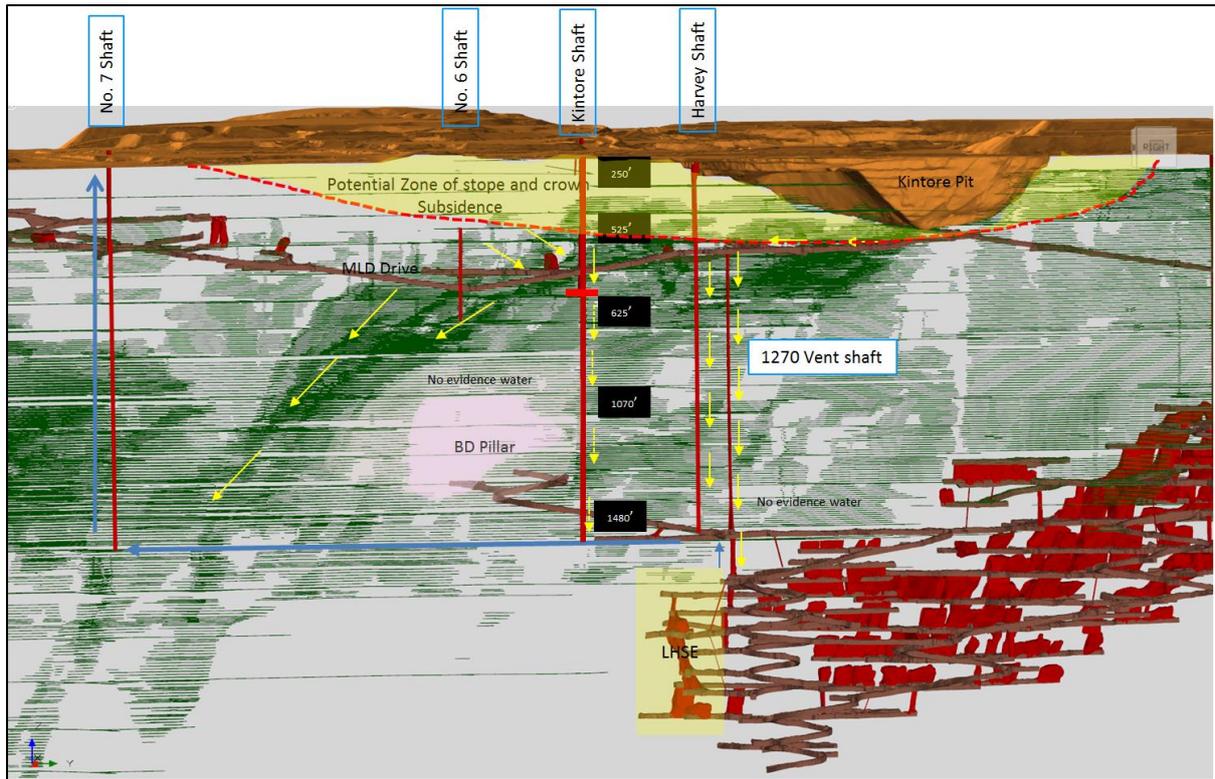
Figure 10- Zone of potential subsidence down to 525' level underneath Kintore Pit (looking west)

These pathways are linked to the mined excavations in Kintore Pit, shown in Figure 9 denoted as 435' workings and above. These historical filled stopes and crowns, include known and unknown natural voids and potentially large vughs (Beech. G, 1895) which are thought to have suffered significant relaxation, resulting in subsidence, (see Figure 10). In September 2012 it was reported that development into the Crown (of a stope called ML-4S Crown 1) encountered a fall zone (i.e. presumed a zone of rockfall) which had not been recorded on the historical plans. Diamond drilling prior to commencing the development did not highlight the fall area.

This known fall zone identified in the 1920's at the southern end of Block 9 (zone of yellow shading in , Figure 10) appears to have propagated further north than shown in the records.

The subsided sand filled stopes and crown zones have the potential to hold water or leak water over time. The flow path of this water would be typically down the Main decline, captured by current mine pump infrastructure and / or down the 1270 vent raise and or / down the Harvey Shaft and / or Kintore Shaft (it is not thought that the pentice in place at 600 ft level was designed as a water holding barrier). Kintore Shaft is connected to the 1,480 ft level haul drive by a 600 ft long cross cut and a vertical ladderway, (Newton, 1962). It should be noted that no water is seen or observed at the 1270 ft level at present. If this pathway does make water then the water would lead to Shaft 7 via the 1480 ft level and then be pumped out of the mine. If the fluids made it below to the LHSE without being intercepted then the LHSE would fill over time due to its lower elevation and eventually making its way to the 1480 ft level.

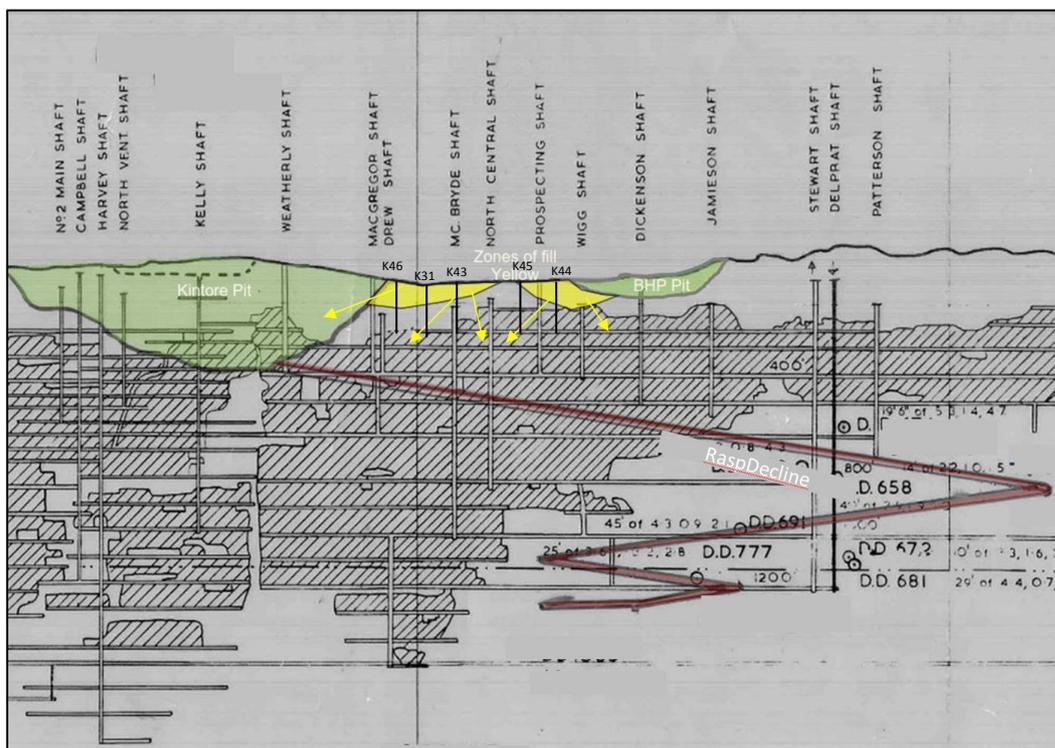
Figure 12- Potential fluid pathway related to historical fill between the BHP Pit and Kintore Pit. Note the 5 percussion drill holes drilled by MMM (locations approximate)

of the ground conditions and the presence of fill that could aid in water transfer into BHP Pit or the Kintore Pit indicate this pathway may require further clarification and definition see Figure 12. In the event that water is seen at the base of the existing tailings in the north east wall of the Kintore Pit (through regular and documented geotechnical inspections) then an action plan based upon the Risk Assessment framework, would be developed to address the issue. It is considered that any seepage would be collected by the proposed sump collection system and returned to underground to be pumped out using the existing pumping infrastructure.

Percussion holes drilled by MMM (including holes K46, K31, K43, K45 and K44, see Figure 12) indicate poor ground conditions and the presence of fill material in this zone. In addition, percussion intercepts match the depth of the fill in the north eastern wall of the Kintore Pit, see Figure 13. It is important to note that no seepage has been observed at the base of the existing tailings within the Kintore Pit.

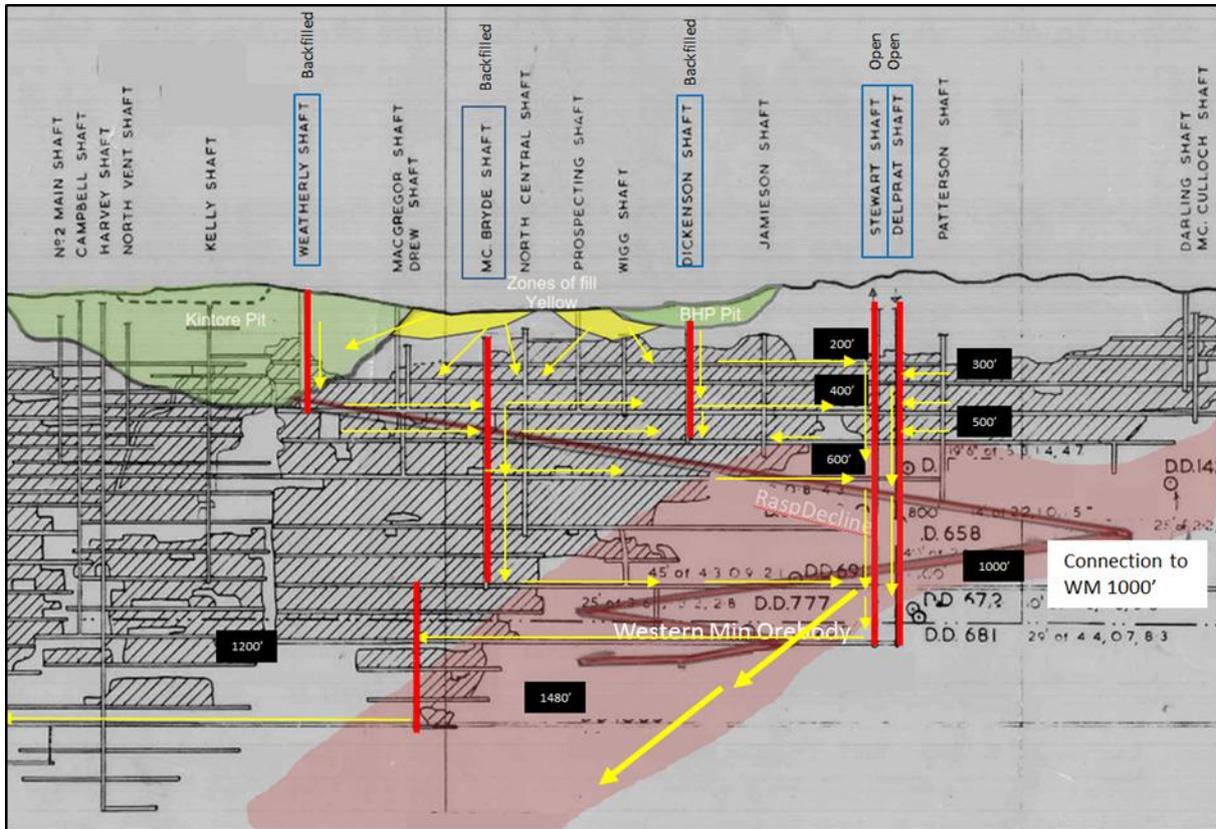
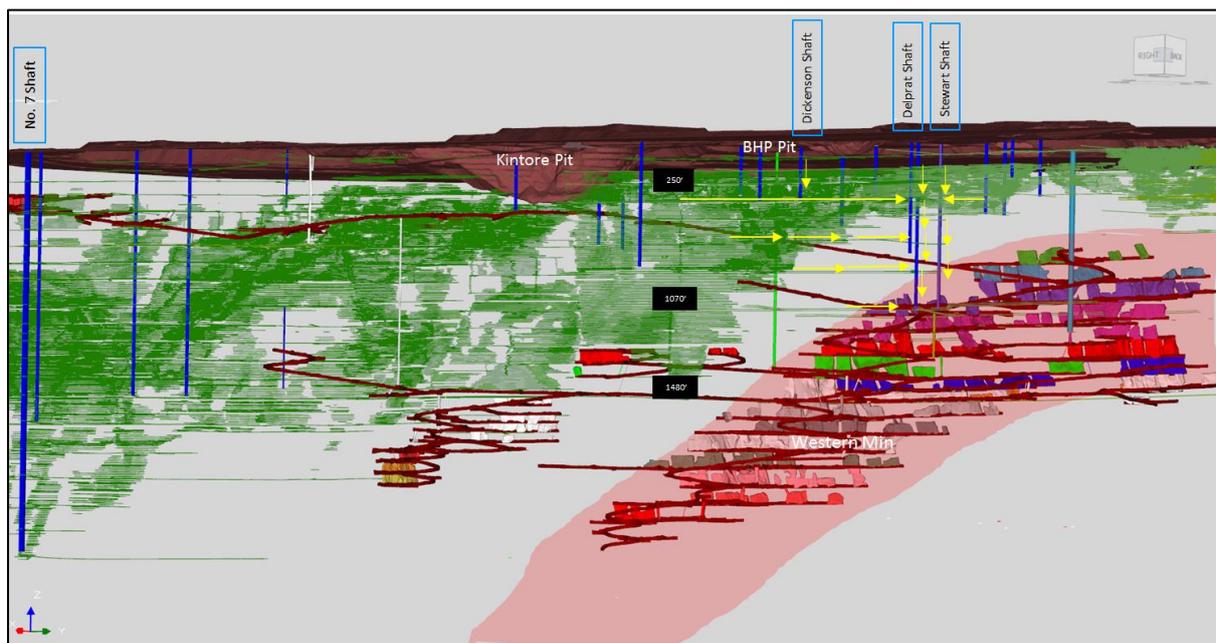
Weatherly Shaft is the main shaft located in the eastern part of Kintore Pit. It has the capacity to divert water through possibly still intact footwall drives within Block 11 through Mc Brydes Shaft and primarily through the 400 ft, 500 ft, 600 ft, 1000 ft (Western Mineralisation 7 Sub) connection and 1200 ft Levels. These connections lead to Delprat and Stewart Shafts (Figure 14, Figure 15 and Figure 16) which have a connection to the Western Mineralisation workings through the 1000 ft level. Because the 1000ft level is open, this is the potential main pathway for water to future mining in the Western Mineralisation.

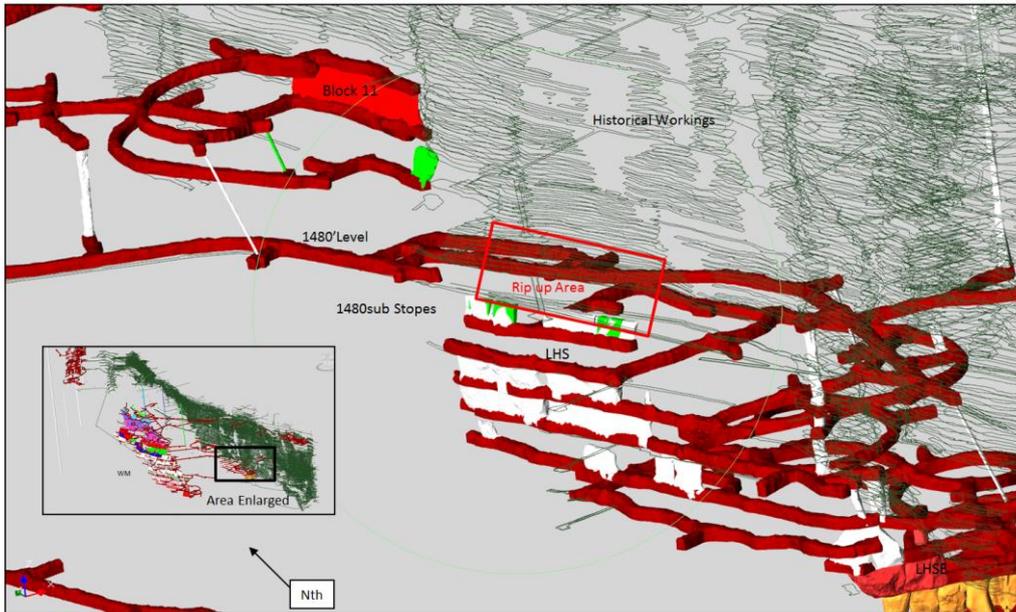
Figure 19- Oblique view showing locations of 1480sub stopes in relation to Western Min.

A series of stopes were attempted to be mined in 2015 from the 1480 ft sub level. These stopes called the 1480 sub stopes were mined as blind uphole stopes and due to the relatively long strike lengths the stope crowns failed (see Rip up area in Figure 19). In addition to the crown failure, reports of large rocks, water and timber preferentially reporting to the drawpoints were observed prior to abandonment. The presence of large amount of timber and water (derived from stormwater seepage and sand fill) indicate that the stopes have breached up dip of the Main Lode shear into the historical workings, 1480 ft and above. The total estimated maximum void in this area is 4,404m<sup>3</sup>, see Figure 19.

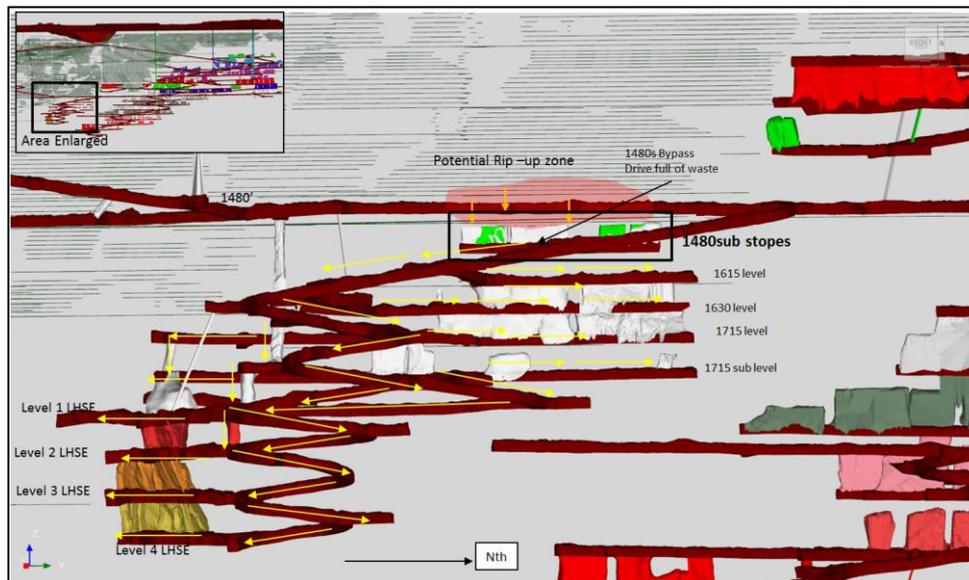
Figure 20- Pathways associated with ingress from the 1480sub stopes to LHS and LHSE.

These stopes were not backfilled and left to subside, the 1480 sub drive itself was backfilled with waste. A total maximum unfilled void potential of 4,404m<sup>3</sup> in Main Shear hosted ore could potentially exist however reports indicated that draw points were choked with large rocks prior to abandonment. Water generated (arising from stormwater seepage and sand fill seepage) from the stopes is pumped out utilising the current mine pumping system. In the event that an water generated from flows derived from the 1480 ft level the fluid pathway would move down the MLD Decline and report to the 1615, 1630, 1715 and 1715sub levels, (see Figure 20).

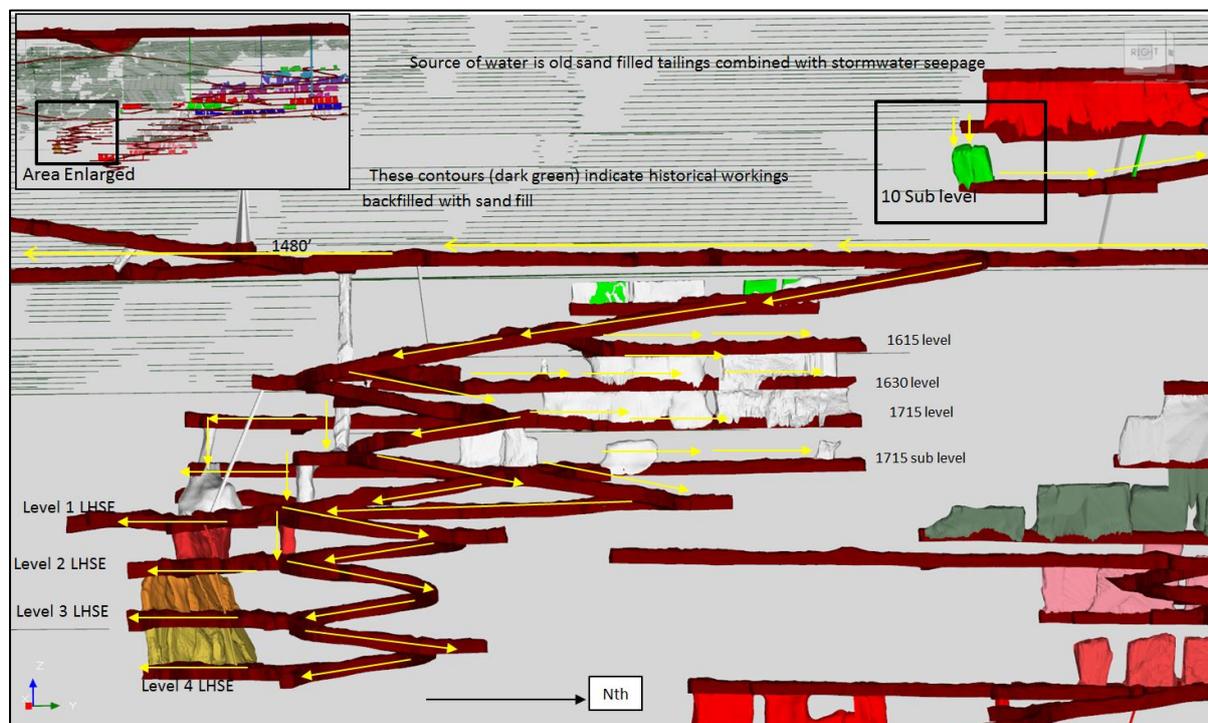
Figure 21- Block 11 10sub stope illustrating fluid connectivity with the 9sub failed stopes.

The 10sub Block 11 stope represents a total maximum open unfilled void of 4,161m<sup>3</sup>, see Figure 21, (denoted by rectangular box in upper right hand quadrant of diagram). These stopes could not be filled due to the 9sub downhole stopes being taken first.

Water derived from stormwater seepage and saturated sand fill would accumulate in the 10sub level drive and fill up the drive eventually moving up the 10 sub level drive onto the 1480 ft drive and then report to the Shaft 7 pump as described in Figure 10. An additional pathway may also be evident as per Figure 18.

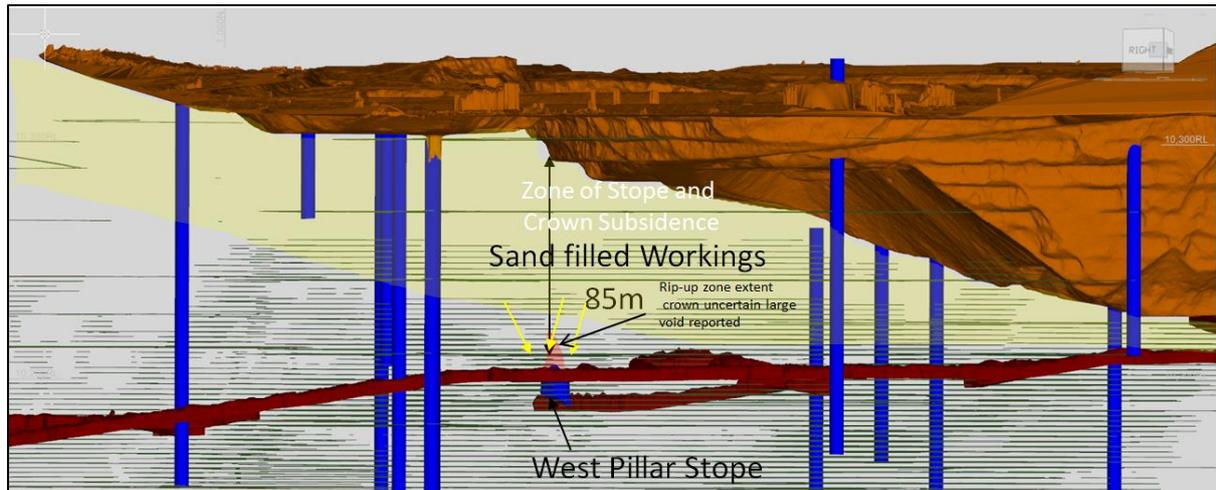
**Figure 22- Potential pathway from Kintore Pit to West Pillar stope below the historical 3L workings**

The “West Pillar” stope off the MLD drive under the historical 3 level workings was taken in 2014. This stope was left as a planned open void (954m<sup>3</sup>) and the crown rapidly deteriorated as a result of a large open void immediately above the stope. This stope crown dropped revealing a large historical mining void as a result of the intersection (see Figure 22). This area is close to the boundary of the zone of subsidence noted in Section 2.1.3. Within this zone of subsidence it was customary underground to fill the historical stopes with sand fill. It is unsure if the large void above the West Pillar stope was filled with sand, however erosion of this sand fill could become a potential channel way for fluids from the Kintore Pit and destabilise the southern wall of the Pit.

In the event of a liquefaction event the potential resulting fluid pathways would be the same as defined in Figure 10.

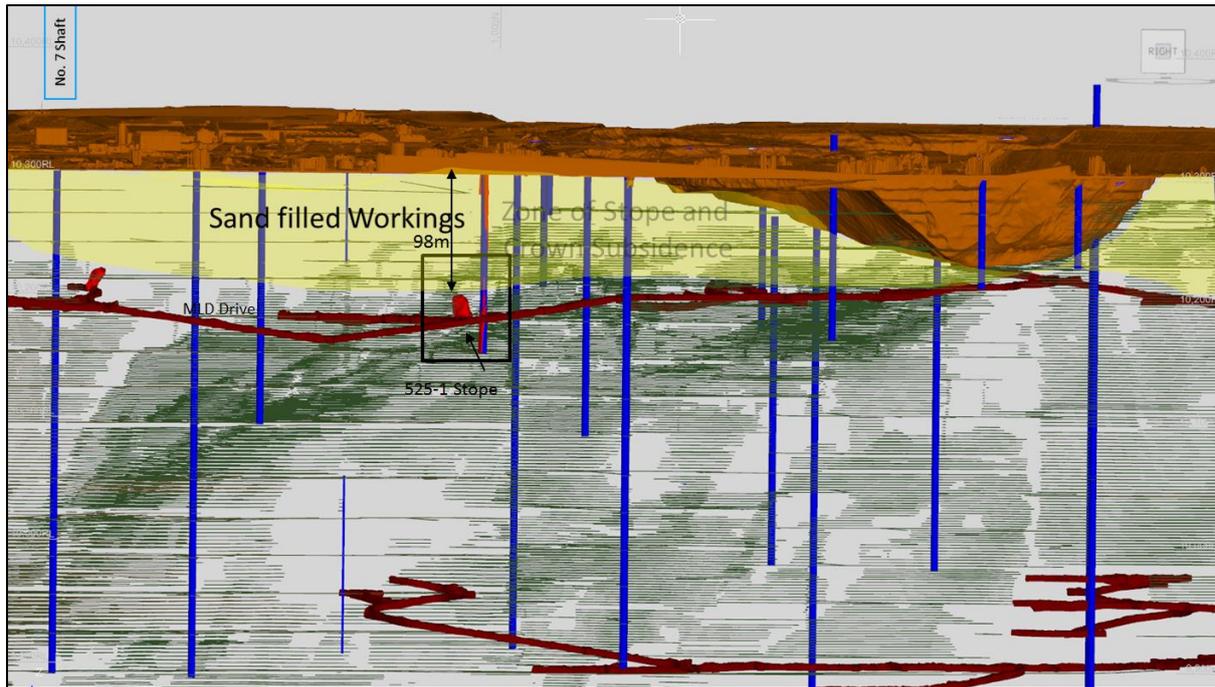
Figure 23- Potential pathway to 525-1 stope below the historical 3L workings

A final potential fluid pathway identified is the open / partially open MLD 525-1 stope, (see Figure 23). This stope lies off the MLD drive and was fired and mined in 2013. This stope performed poorly from the outset due to firing issues, with stope inspection reports from that time period indicating an abundance of loose sandfill. The original void shape volume immediately post extraction was 2,440m<sup>3</sup>. In an attempt to recover remaining economic ore the sand was extracted. However, it is unknown how much sand was extracted after the CMS.

The potential fluid pathways would be the same as those identified above in Section 2.3.3.

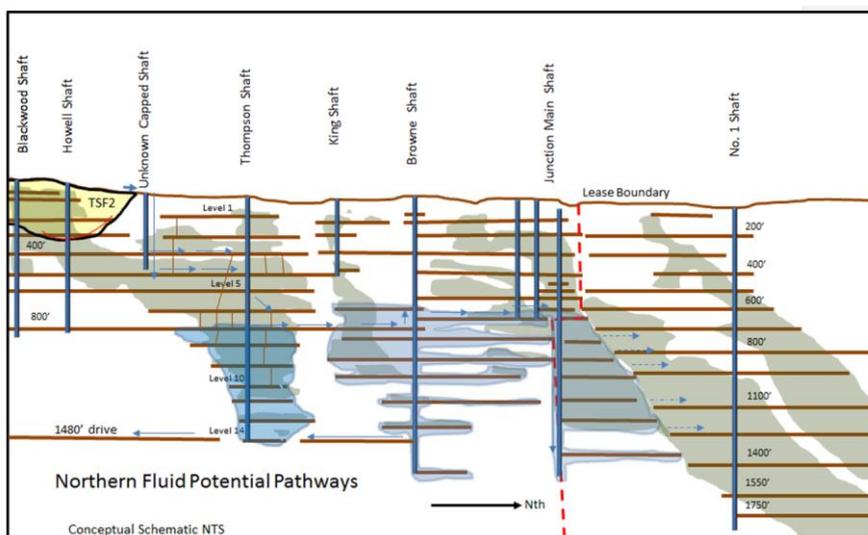
Figure 26- Thompson and Browne Shaft Potential Fluid Pathways

Golder Associates Pty Ltd have completed a Dam Break Assessment for the installation of embankments of TSF2, indicating that the Thompson Shaft would not be inundated in the event of a failure of embankment 2 of TSF 2 (Parker M, Jan. 2020). In the unlikely situation where the embankment experienced an H6 failure event (an event that results in conditions that are unsafe for vehicles and people. All building types are considered vulnerable to failure), the water would flow

Figure 26) adjacent to the TSF2. The water could then inundate the lower working levels of the Thompson Shaft area and saturate all of the levels up to an including the 800 ft level, (see

Figure 26). It is assumed that the water would then fill the 800 ft level and form a connection with the Browne Shaft.

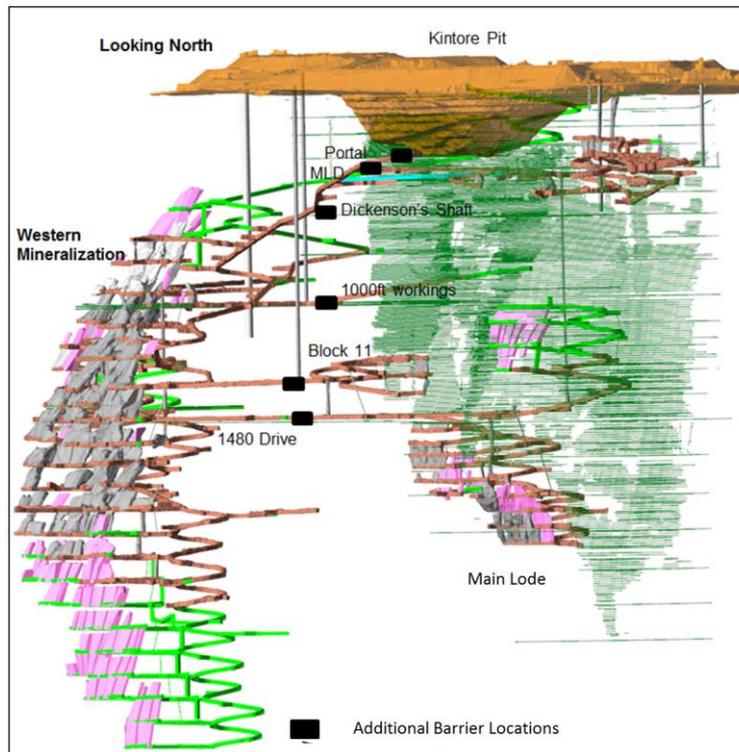
**Figure 27- Proposed Barrier Locations**

Preliminary design work highlights the following locations as the minimum required to isolate the inrush potential. This involves a separation between the Main Lode and Western Mineralisation workings. As mentioned previously, if access to specific Main Lode areas is critical for the Life Of Mine strategy, additional barriers and strategies will be required. All pathways are defined in Section 2.

The barrier positions are illustrated above in Figure 27. In addition to the construction of the barriers above, two internal rises have been identified as an inrush risk if left open. These are the MLD-1270 rise and the BLK 11 exhaust rise. The 1480 drive barrier will control the risk posed by the two raises if they are open when Kintore Pit tailings / waste rock co disposal placement begins.

Barriers will require engineered designs to ensure they are adequate to control the identified hazards
