2006 50' Jefferson Rivanna 50 SE

Report of Marine Survey

Inspection performed on: 07/19/23 with Report submitted on: 07/21/23.

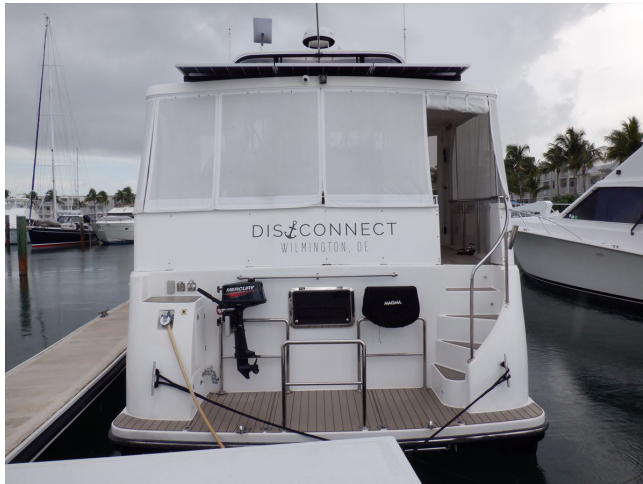
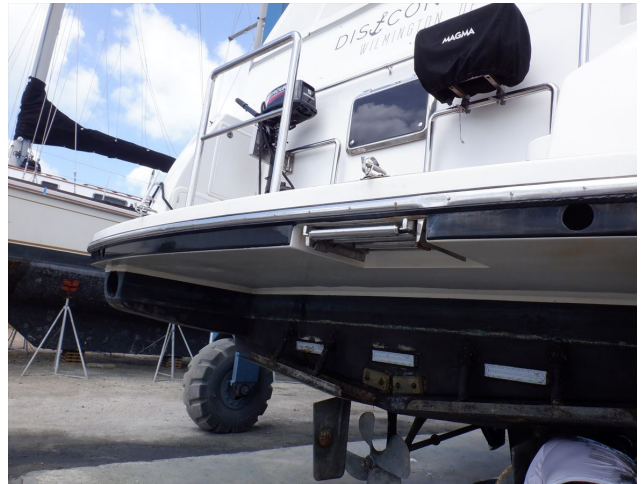
A three-step telescoping stainless steel boarding ladder is mounted underneath the starboard-side of the swim platform. The ladder was visually inspected and tested for normal use and found to be in normal working condition. The swim ladder had minor amounts of corrosion along the telescoping poles as well as the mounting hardware. The swim platform was put into operation and properly stowed which meets the requirements of ABYC H-41 for means of reboarding the vessel.

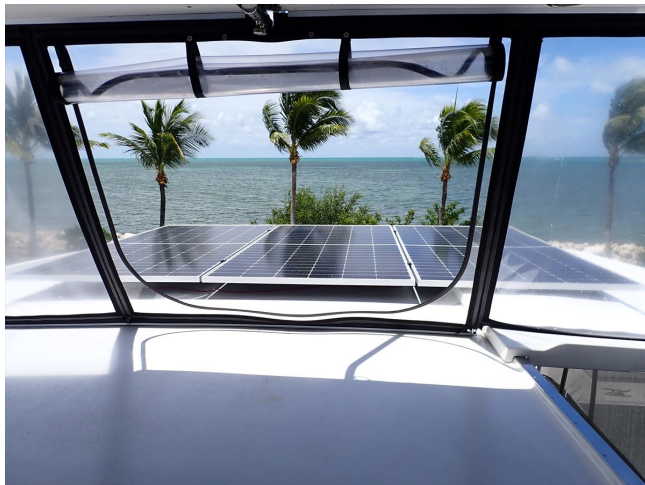
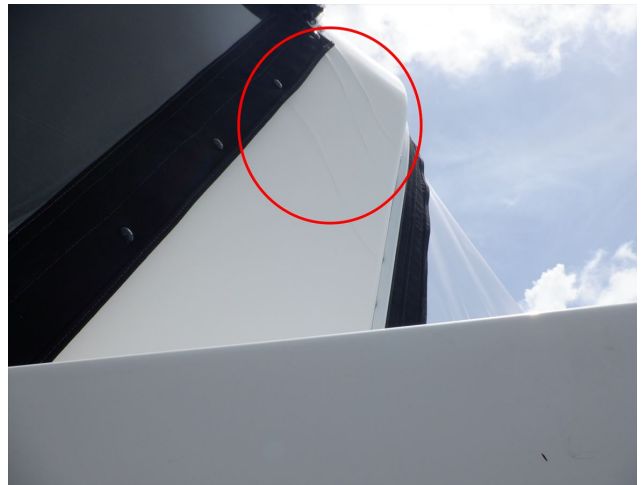
FINDING C-1

The vessel is fitted with a FRP hard-top. The FRP hard-top includes six (6) Canadia Solar bifacial solar panels and a radar arch that secures the Raymarine Q24C Quantam Radome Scanner. The hard-top and radar arch were not sounded with a phenolic hammer and conductivity readings were not taken due to access and location of solar panels. Stress cracking was found on the port-side radar arch after a visual inspection. No other anomalies or defects were noted.

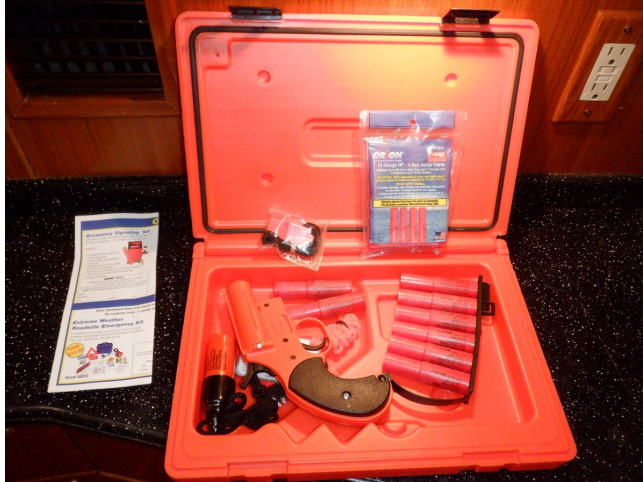
A distress signal kit consisting of one (1) 12-gauge pistol with twelve (12) Day/Night Visual Distress Signal cartridges were sighted onboard in the galley. Four (4) of the cartridges for the 12-gauge pistol will expire in August 2027 and eight (8) cartridges expired in August 2017. Expired cartridges should be stored separately from unexpired flares.

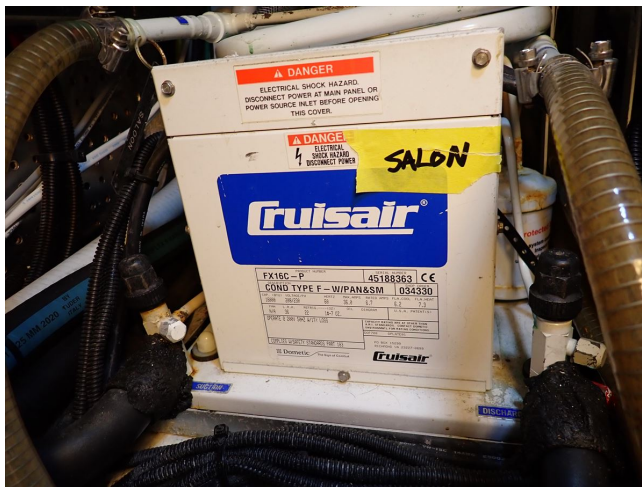
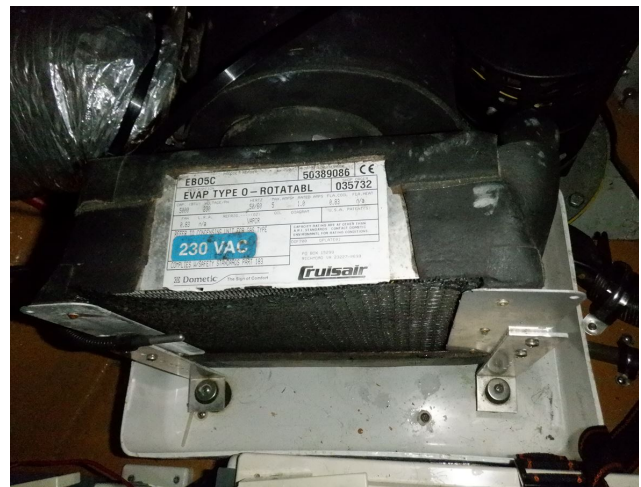
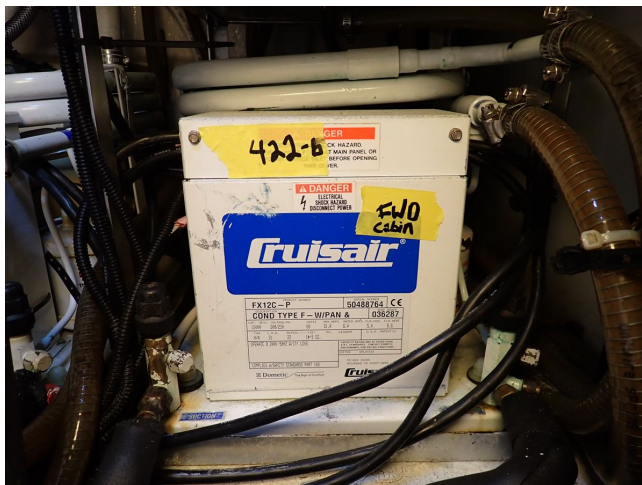
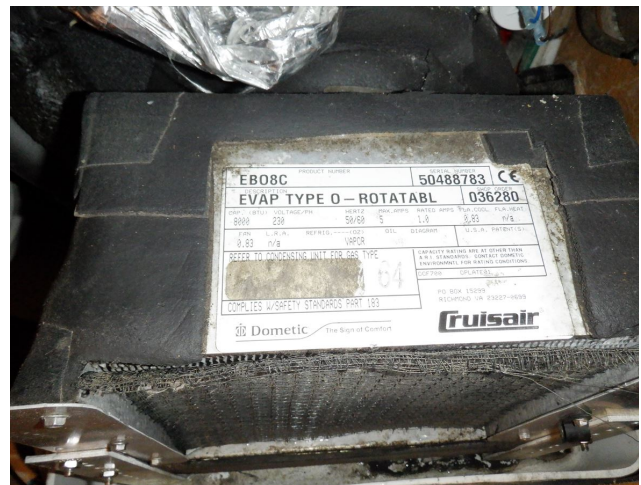
Cabin ventilation was provided by one (1) deck hatch fitted over the v-birth and one (1) deck hatch fitted in the master stateroom. Four (4) port lights were located in the v-birth (one (1) on the port-side, two (2) on the starboard-side, and one (1) on the starboard side head). Additionally, four (4) port lights were located in the master stateroom (two (2) on the port-side, one (1) on the starboard-side, and one on the starboard-side head). The gaskets/sealing surfaces were examined and found in good condition.

The cabin was also equipped with three (3) Dometic Cruisair air-conditioning units for the enclosed accommodations. One (1) AC unit was located underneath the v-birth bed (SN: 50389086), One (1) AC unit was located in the master stateroom (SN: 50488783), and one (1) AC unit was located in the salon (SN: 50488784). All three condensing units were located within the starboard-side of the engine room. Each room was also equipped with digital climate controls. Lastly, all systems were powered up and adequately cooled with the amount of traffic coming and going from the salon.

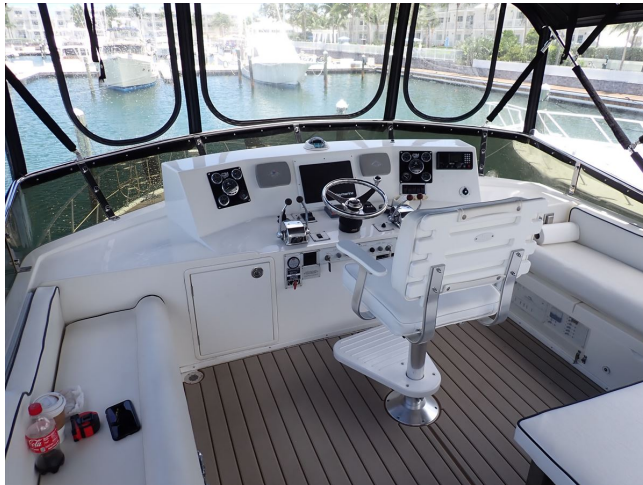
The vessel is outfitted with a ICOM VHF Marine IC-M602 fitted at the helm station. The radio was flush-mounted and secured. Lastly, the radio was powered up; however, no radio check was conducted.

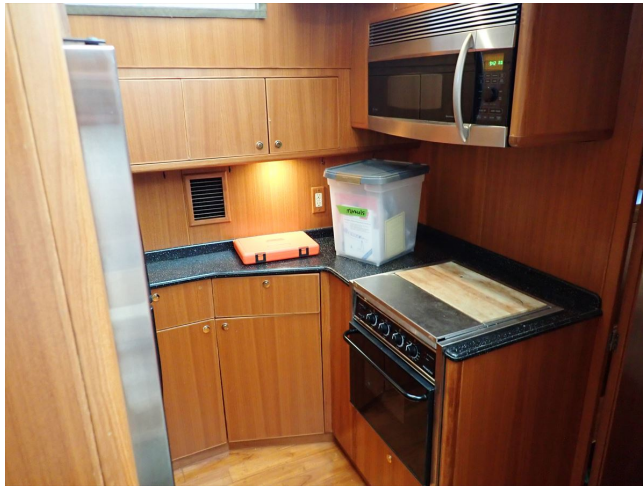
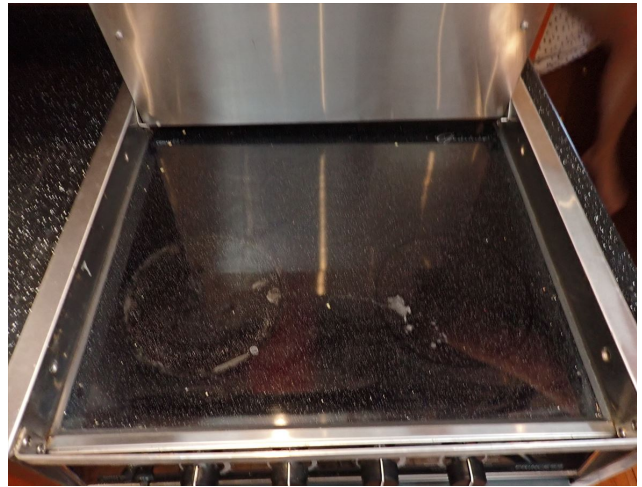
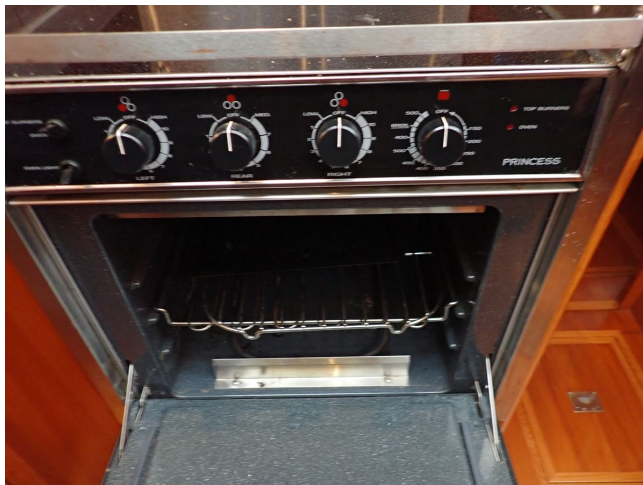
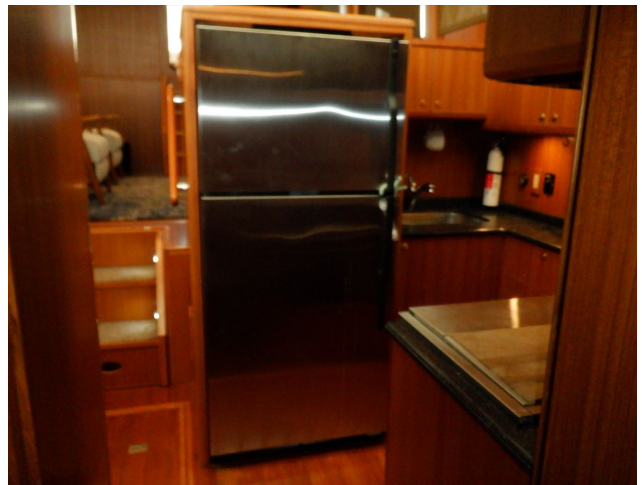
The galley is located on the port-side of the salon aft of the forward stateroom. The galley is outfitted with a Princess 3-burner electric range with oven, a GE convection microwave, and GE upright refrigerator/freezer, and a portable counter-top icemaker. All equipment was powered up with no issues noted. No visible damage or corrosion was noted and all fittings were found tight.

A gas powered grill is mounted to the transom. The grill was not tested for functionality since the portable propane tank was not connected to the grill.

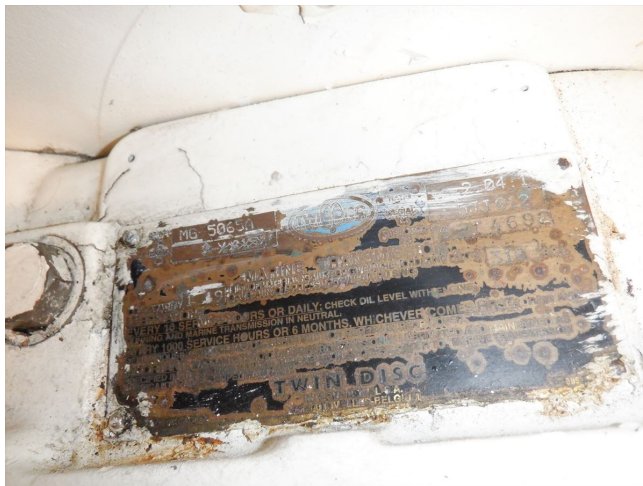
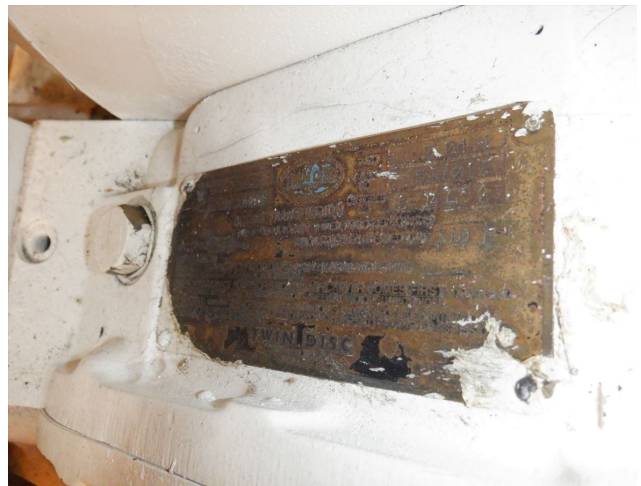
The vessel is fitted with two (2) Twin Disc MG 5065A transmissions. The gear ratio for the both port and starboard transmission is 2.04:1. The serial number for the port transmission is 5JJ012 and the serial number for the starboard transmission is 5JJ013.

Both transmissions exhibited no unusual noises or vibrations during the limited trial run. Transmission fluid samples were not taken during the time of the survey.

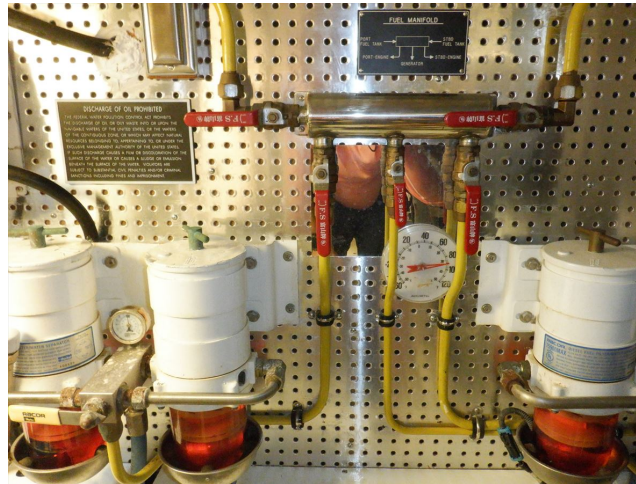
The vessel is outfitted with two (2) aluminum fuel tanks with fills located on the port and starboard-side of the vessel (forward of the aft deck). The tanks are mounted on both sides of the engine compartment. The fuel tank data label indicates the capacity is 210-gallons each. Visually, the tanks were in good condition and no evidence of fuel leakages were sighted in the surrounding structure or bilges. The tanks were tested with an IDEAL 61-337 Digital Multimeter and found to be properly grounded in accordance with 33 CFR 183 and ABYC H-32.

The vessel utilizes rubber fuel hoses to supply diesel fuel from the tanks to the engines/generator. The hoses could not be verified to confirm they were U.S.C.G. Type A1. No evidence of leakage or deterioration was noted where accessible. Lastly, the engine has an external fuel/water separator secured to the aft portion of the engine compartment.

The fuel fill hoses could not be visually inspected or confirmed as U.S.C.G. Type A2.

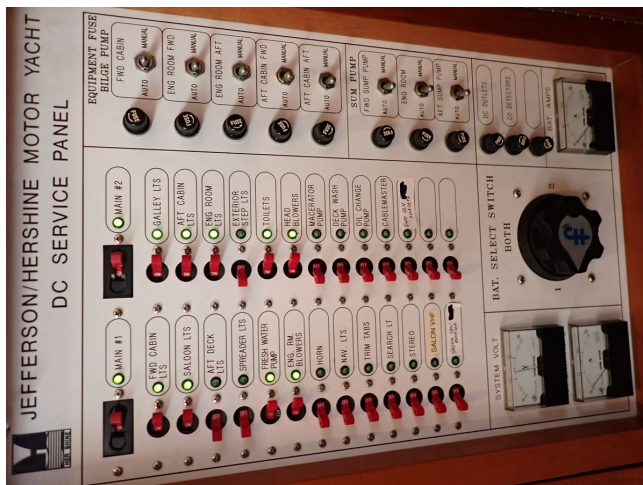
The DC electrical system is a 12-Volt system. The distribution panel is located in the salon on the starboard-side aft of the dinette table. The main DC breakers were installed in the DC panel. The branch breakers were labeled appropriately. The DC panel and its accessible components were in good condition and functioned as intended.

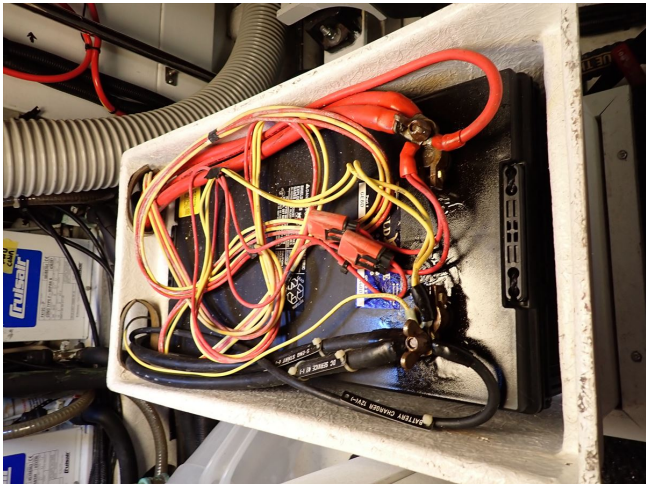
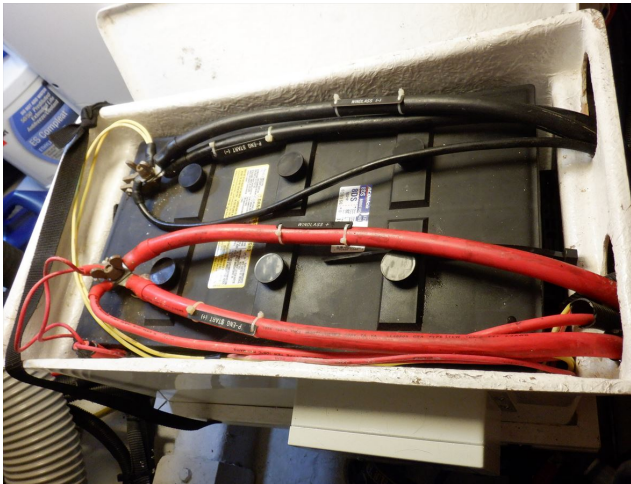
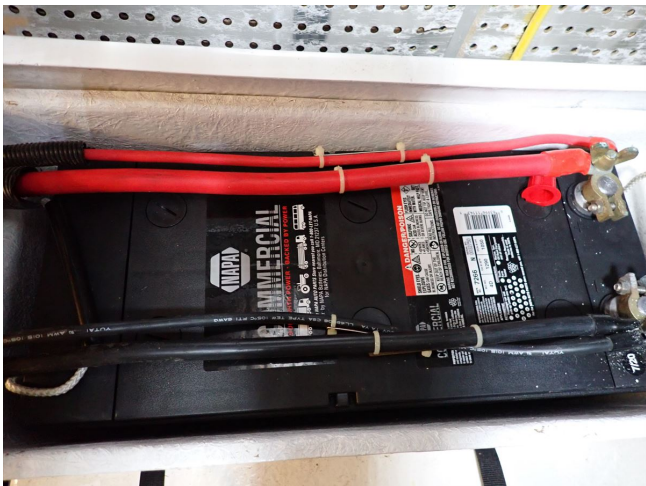
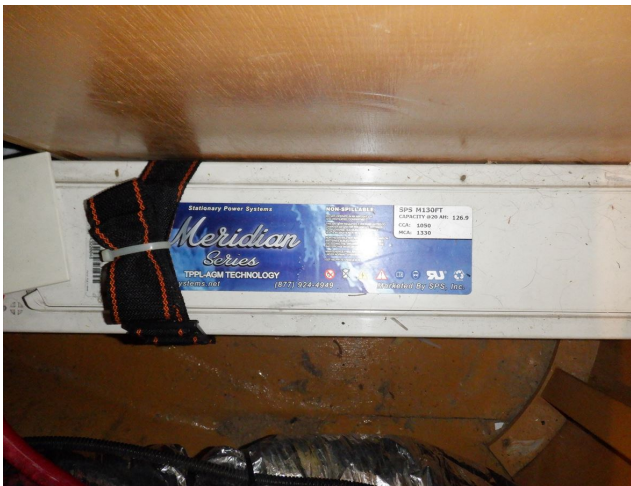
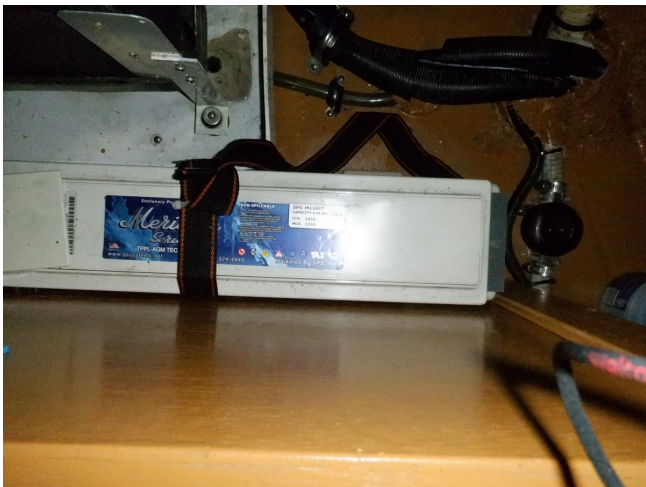
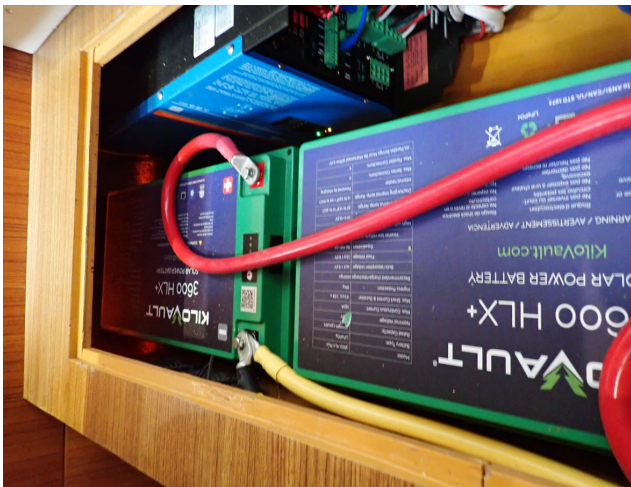
The vessel is outfitted with six (6) total batteries. The starboard starting battery is a Gold Eagle Flooded Lead Acid Battery (Part# GE8D, CA: 1750, CCA: 1400, Location: Engine Compartment). The port starting battery is a ACDelco Flooded Lead Acid Battery (Part# S021P, CCA: 1210, RC: 420, Location: Engine Compartment). The Generator battery is a NAPA Commercial Flooded Lead Acid Battery (Part# 7266, CA: 1290, CCA: 1050, Location: Engine Compartment). The two (2) bow thruster batteries are Meridian Series TPPL-AGM Technology Batteries (Part# SPS M130FT, MCA: 1330, CCA: 1050, Location: V-berth). Lastly, the two (2) house batteries are KiloVault HLX+3600W 12.8 DC 200Ah Deep Cycle Lithium Batteries (Location: Beneath dinette seating). All batteries were installed in accordance with U.S.C.G and ABYC standards and all batteries functioned properly during the inspection.

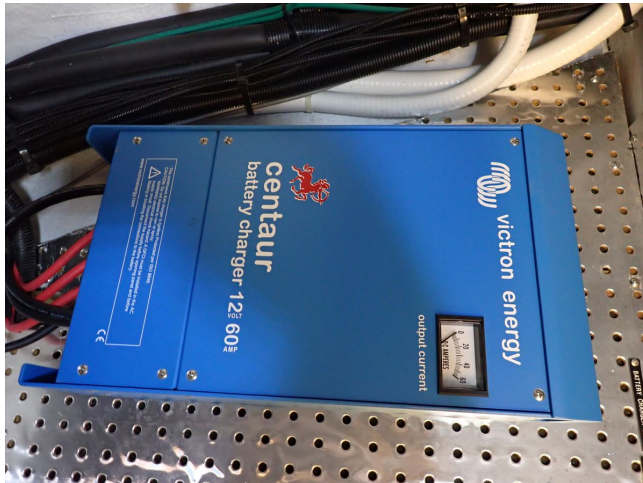
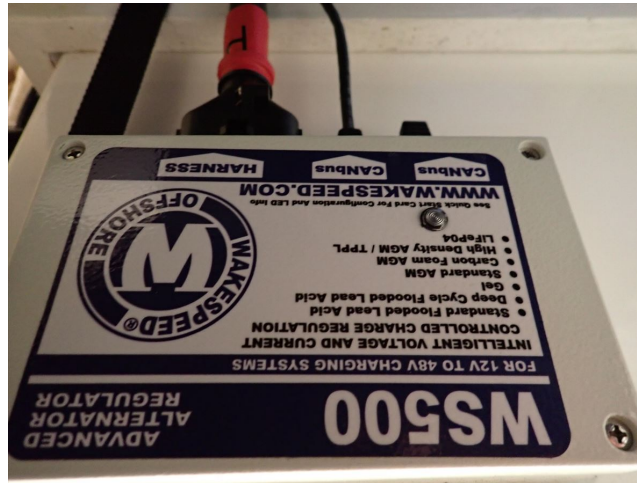
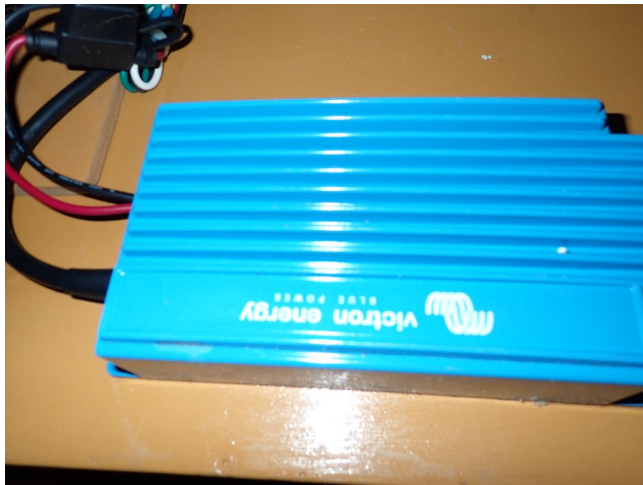
The vessel is outfitted with a Victron Energy Centaur 12-Volt 60 AMP Battery Charger that is tied into the vessel's solar system. The vessel also had a Victron Energy Blue Power Battery Charger to assist in charging the AGM Bow Thruster batteries located in the forward V-Birth. Lastly, in August 2022, the owner installed a Wakespeed Offshore WS500 Advance Alternator Regulator to the port alternator for charging the lithium house batteries while underway.

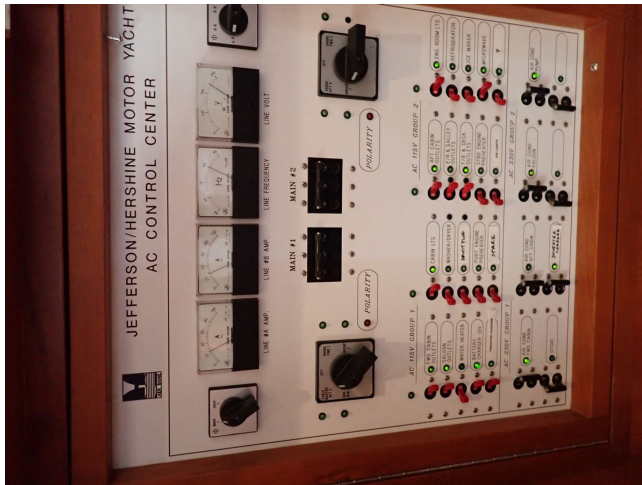
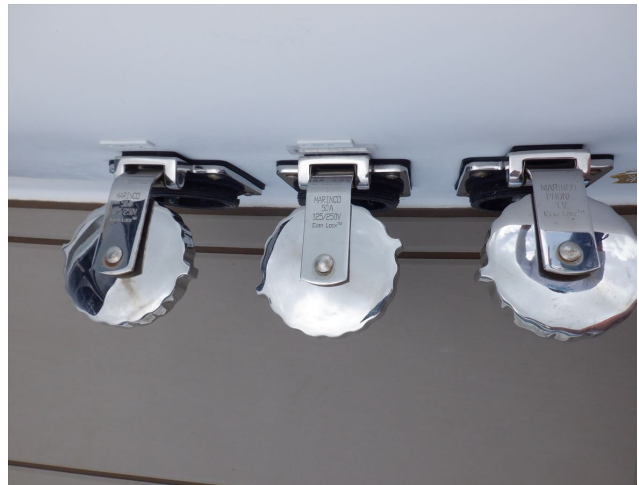
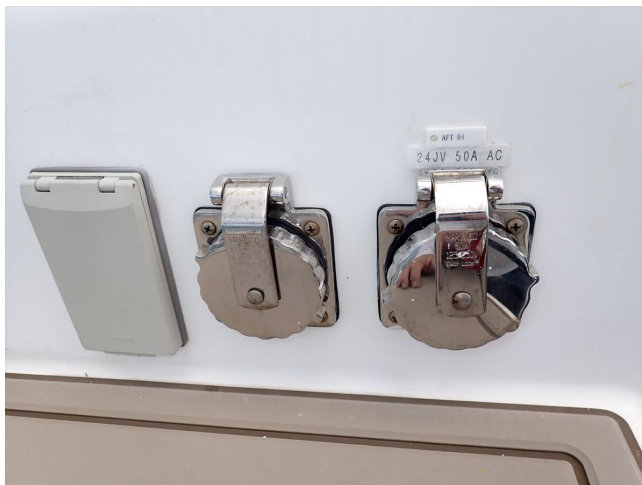
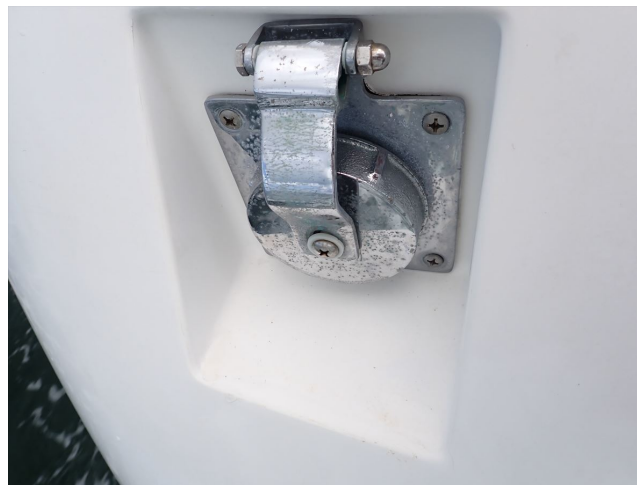
The vessel is equipped with 240-Volt, split phase AC system with four (4) 50 AMP shore power inputs. No ELCI was sighted onboard during the inspection. The outboard connection located on the starboard bow deck labeled SHORE FWD 1 and SHORE FWD 2 each provide 120-Volts of AC power to the MAIN #1 and MAIN #2 located in the AC panel within the salon. The outboard connected located on the transom (port) labeled CABLE MASTER AFT 3 and SHORE AFT 4 each provide 120-Volts of AC power to the same MAIN #1 and MAIN #2 if the rotary switch is adjusted appropriately.

The main AC breakers were installed in the AC panel and the branch breakers were labeled appropriately. The AC panel and its accessible components were in good condition and functioned as intended.

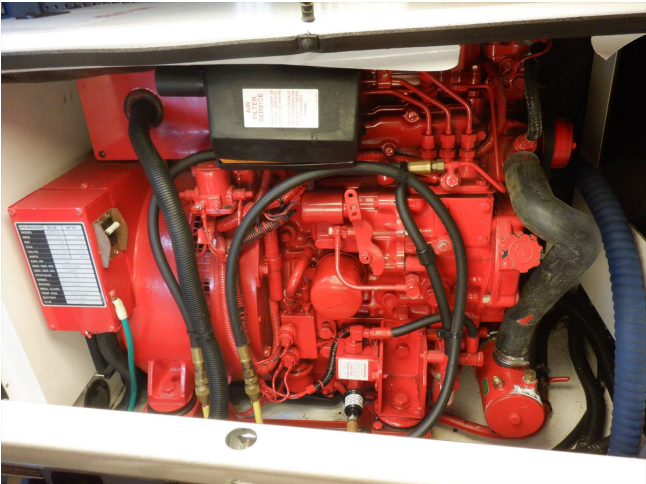
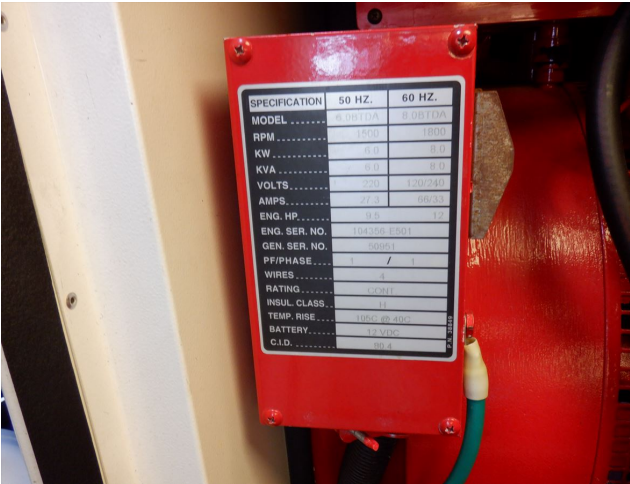
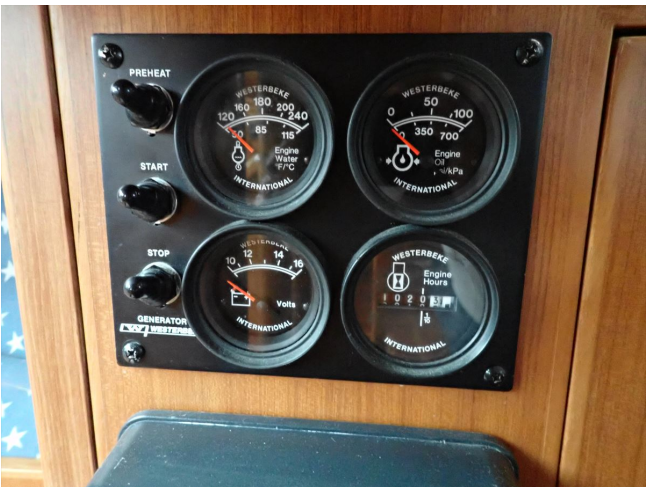
A 8.0kW diesel-powered Westerbeke 60HZ BTDA marine generator (serial number: 50951) was installed in the forward port-side portion of the engine compartment with 1020.3 hours according to the meter mounted on the starboard-side panel in the salon. The most recent service date was the 30th of May 2023 by Matt's Mobile Marine Key West Stock Island, FL. The generator was remotely started from the main Westerbeke generator panel in the salon during the in-the-water inspection. All large AC powered loads were run on the generator with no issues noted.

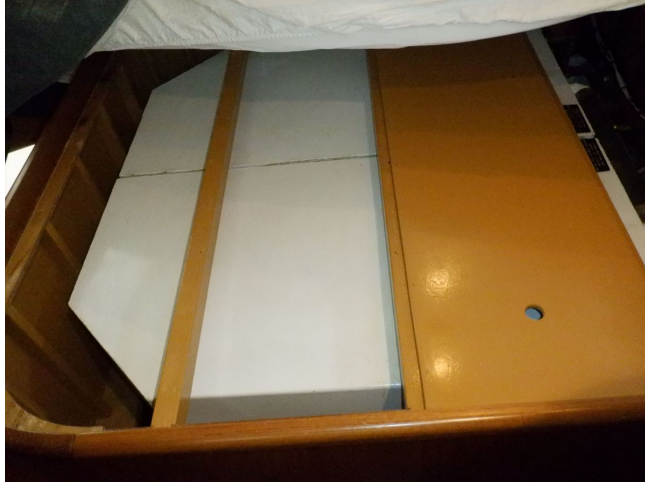
The vessel is outfitted with two (2) 100-gallon stainless-steel water tanks located beneath the master stateroom bed. The tanks were visually examined for cracks and other deformations; however, no evidence of leakage could be determined since the tanks were empty. The water fill is located on the port-side aft deck.

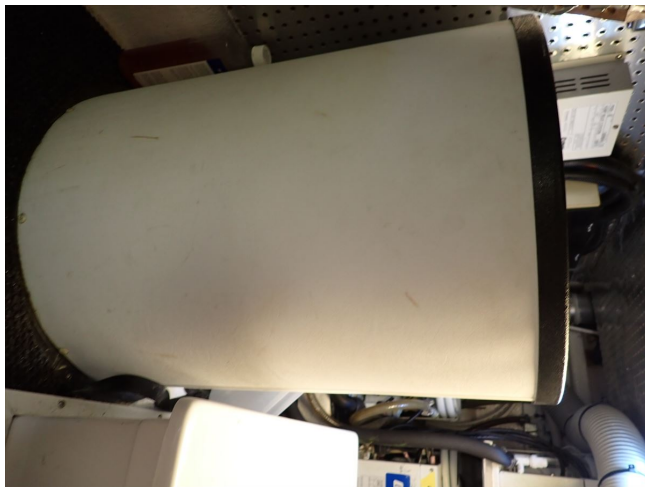
An unknown size and brand 120-volt Electric AC hot water heater was mounted on the starboard-side of the engine room. The pressure relief valve setting, or valve could not be sighted. No evidence of water leakage was noted. The unit was not tested onboard since both water tanks were empty.

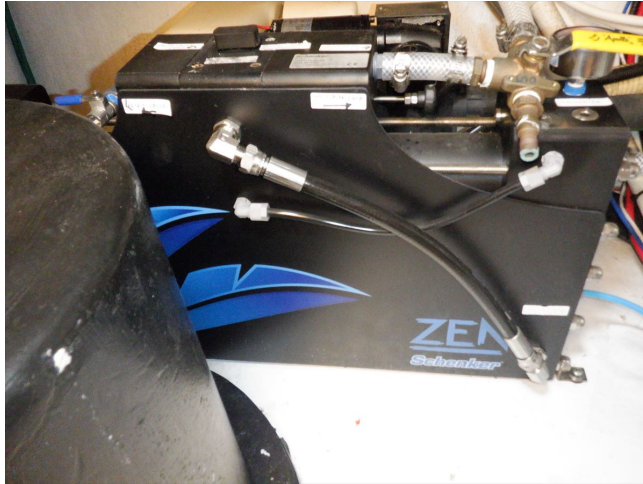
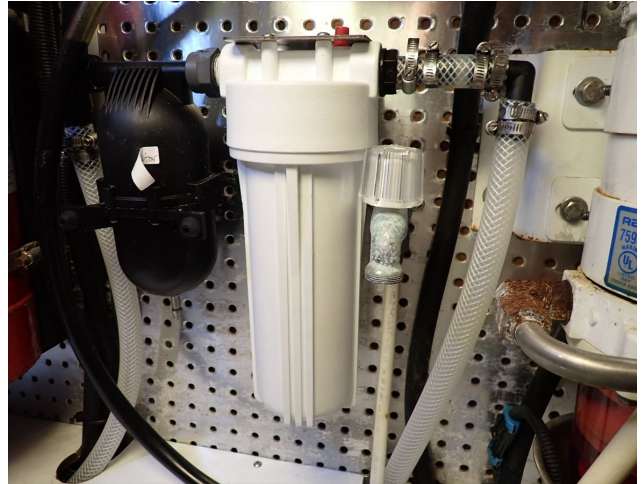
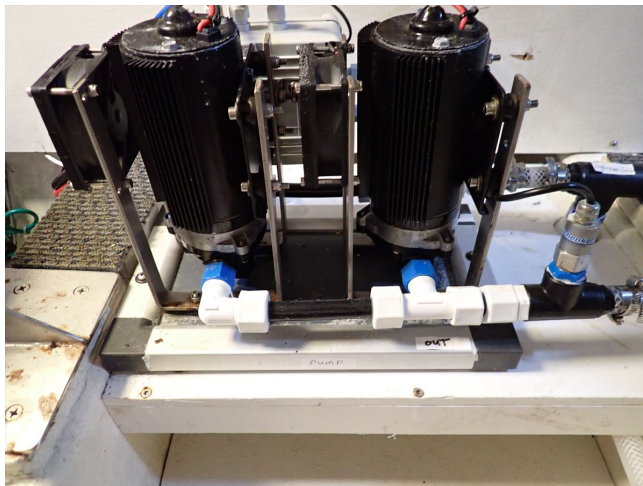
The vessel is outfitted with one (1) 12-Volt Schenker Zen 50 14-gallon/50L Water maker located aft of the engine compartment. The water maker was visually examined for leaks or cracks in the plumbing; however, no evidence of leakage could be determined.

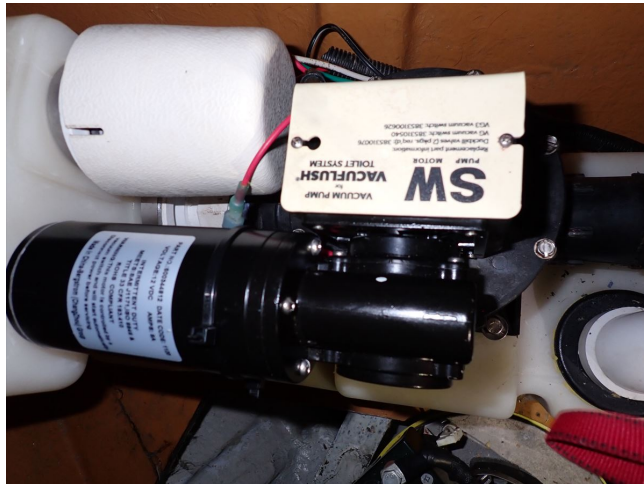
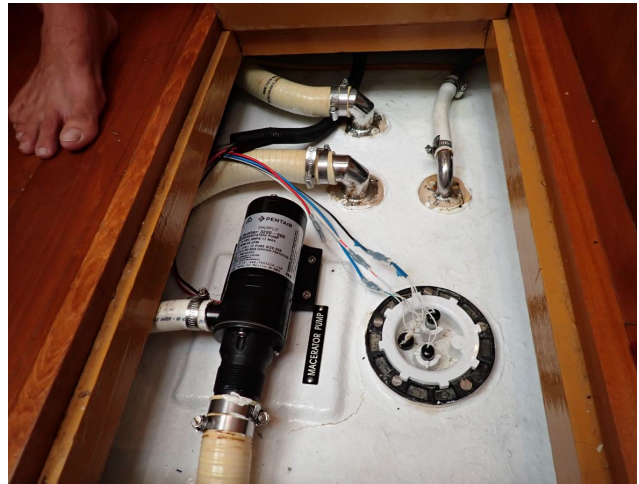
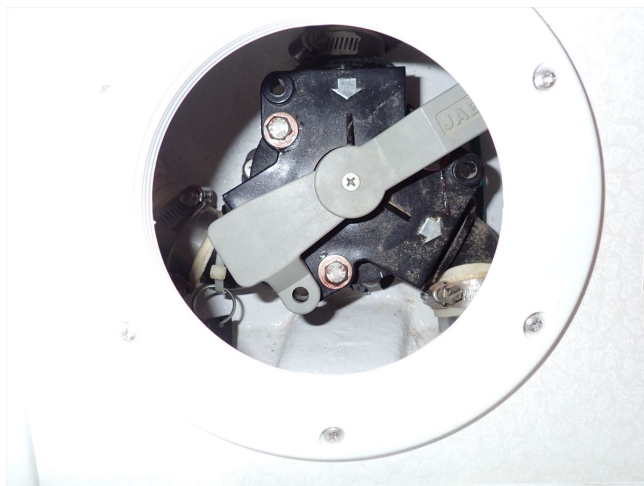
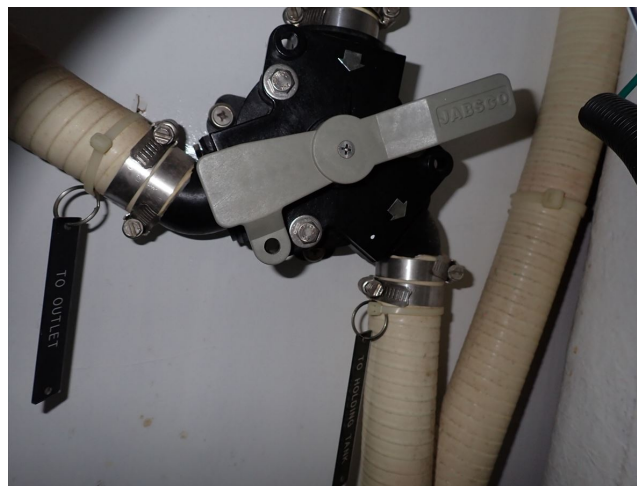
The vessel is outfitted with a Type III MSD Waste System (utilizes a holding tank or similar device that prevents the overboard discharge of treated or untreated sewage). The MSD is plumbed to a 60-gallon (according to vessel listing) metallic holding tank located amidship beneath the salon deck. The tank is also plumbed to a pump out location located on the port-side deck. The tank was visually examined to the extent possible and found to be sound with no leaks, cracks, or other evidence of damage. The macerator was not tested as the vessel was in a no discharge zone and no pump out was available. The Y-valve was not secured which is a violation of 33 CFR 159 requirements. The seacock must be secured in the closed position and the Y-valve must pointing to holding tank and secured when inside 3 nautical miles or other discharge zones.

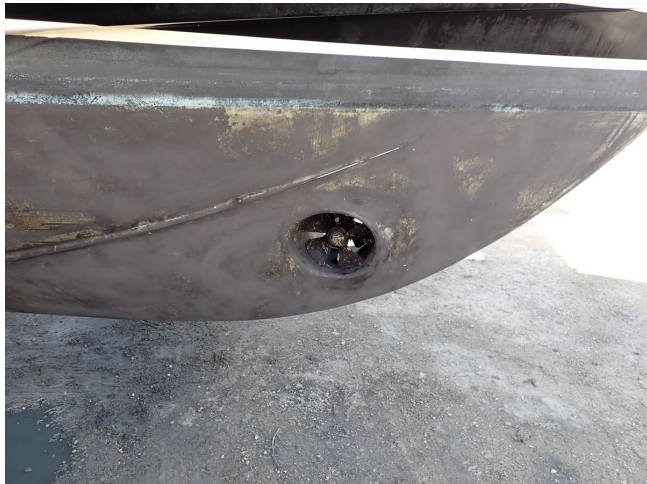
Unit is equipped with LEWMAR 24V Bow Thruster. Bow Thrusters were tested while docking following the limited trial run. Bow thrusters performed as expected.

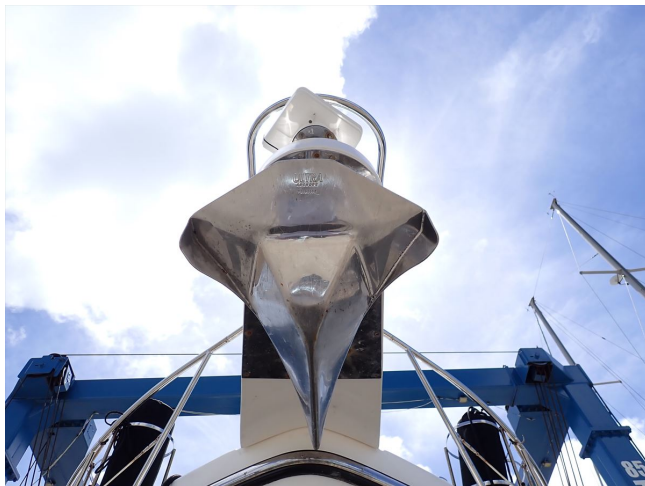
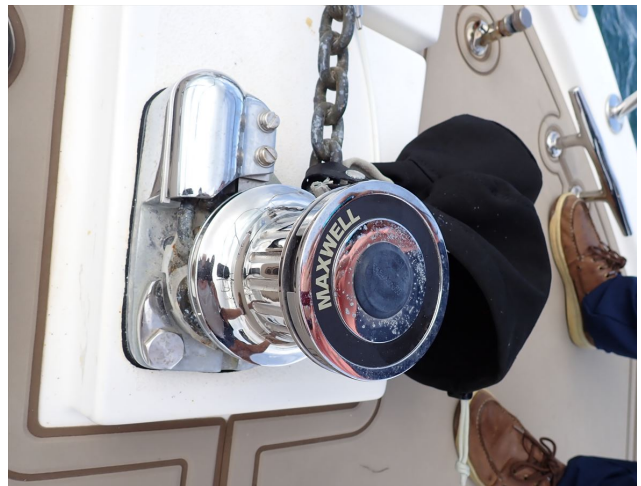
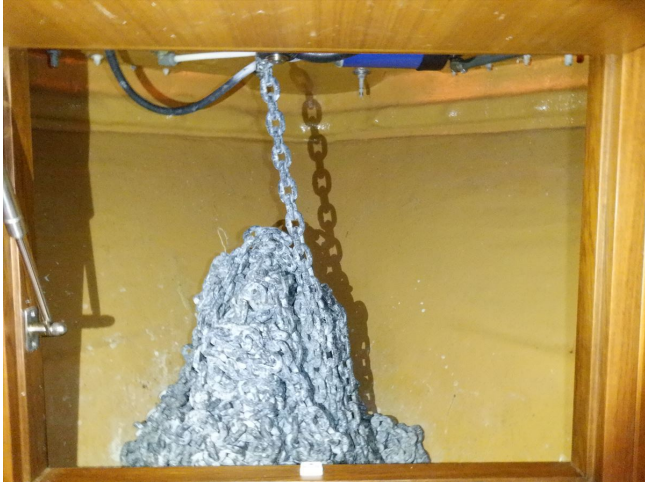
The vessel is fitted with a single Ultra UA-35 77lb stainless-steel plow anchor hung in a stainless-steel anchor roller. The anchor was visually examined, and no damage or corrosion was noted. A Maxwell VWC1500 Windlass with remote operation located at the flybridge helm and foot pedals located next to the windlass on the bow. The installation of the windlass was visually examined with no issues noted. Additionally, the windlass is fitted with 300ft of 3/8" galvanized chain and has a proper connection point that is free of corrosion. Lastly, the windlass was tested for operation from the helm station/foot pedals on the bow and functioned properly.

Highly recommend at least one additional spare anchor and rode for emergencies and added anchoring options.
