Technical Report

| Client | Evil GT | Your File Ref | HY52DLJ |

| Make & Model | BMW M3 |

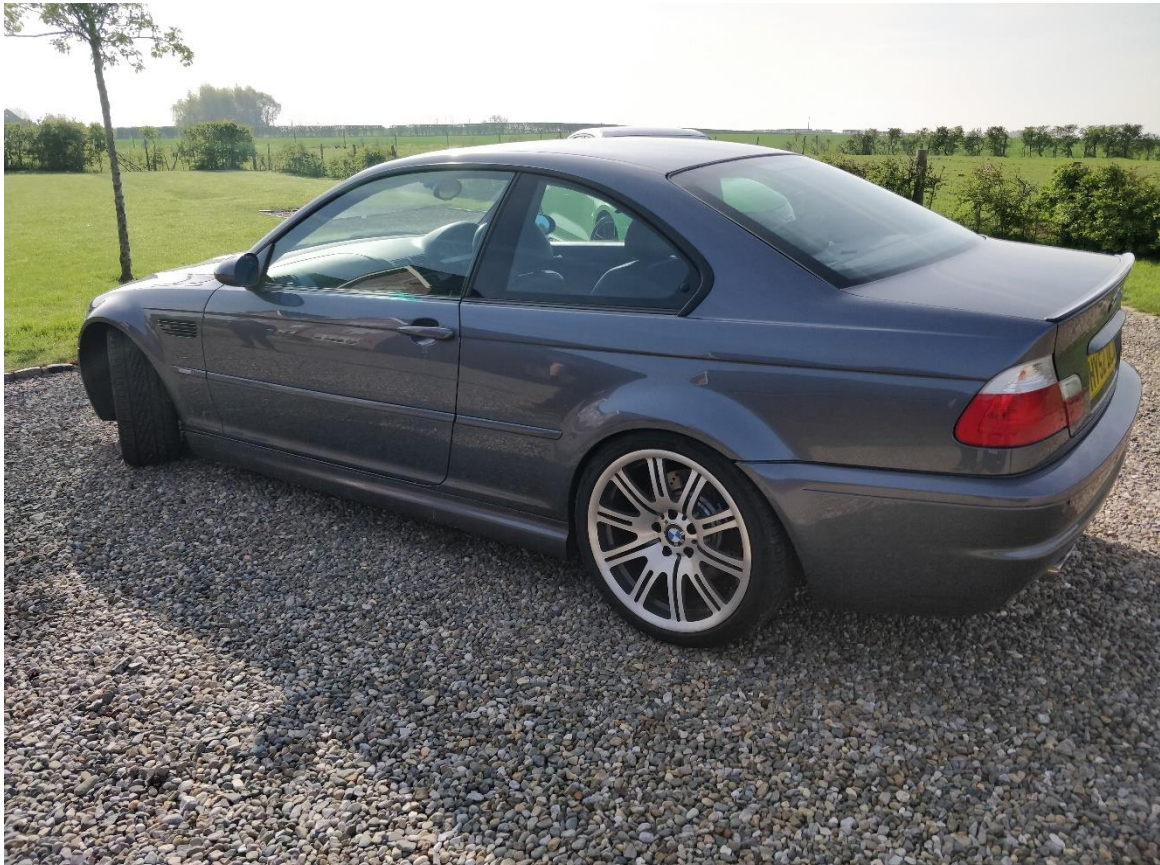
Vehicle Overview

We proceeded our physical examination of the vehicle and can confirm that it initially appeared to be in a cosmetically average condition for the age and reported mileage.
