PROPERTY INSPECTION REPORT

Inspection Prepared For: Preferred Customer

Date of Inspection: 1/18/2021

Year Built: 1972 Size: 1744

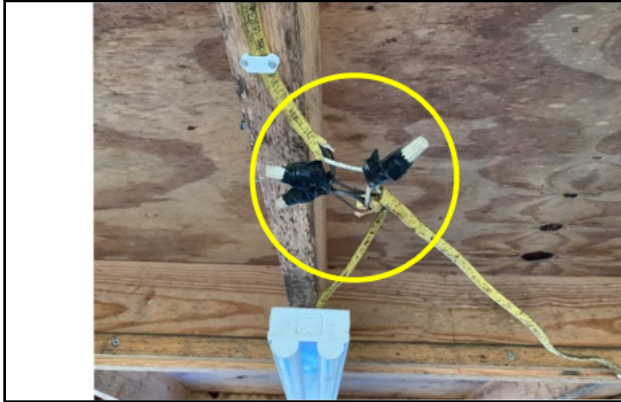
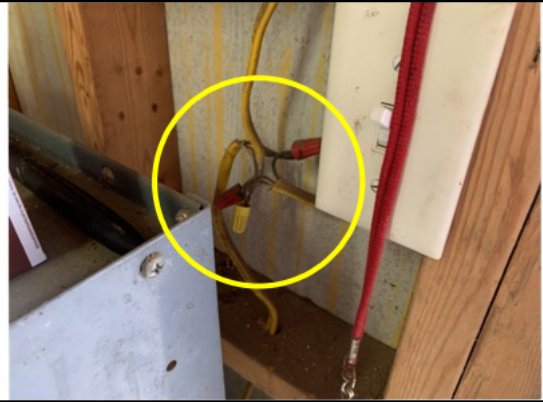
Driveway cracks		Driveway cracks
Outdoor Electrical		
Page 15 Item: 1	Outdoor Electrical Condition	<ul style="list-style-type: none">• REPAIR: Outbuilding overhang light and interior switch has wire splices made outside of junction boxes. Back flood light not properly installed. Recommend licensed electrician to properly install with junction box.• REPAIR: No Ground Fault Circuit Interrupter (GFCI) protection outdoors, or anywhere throughout the home at the time of inspection. Although GFCI protection may not have been required at the time the home was built, for safety reasons, consider upgrading the electrical system to include GFCI protection at all wet area locations (kitchen, bathrooms, carport, outside, etc).

Improper wiring

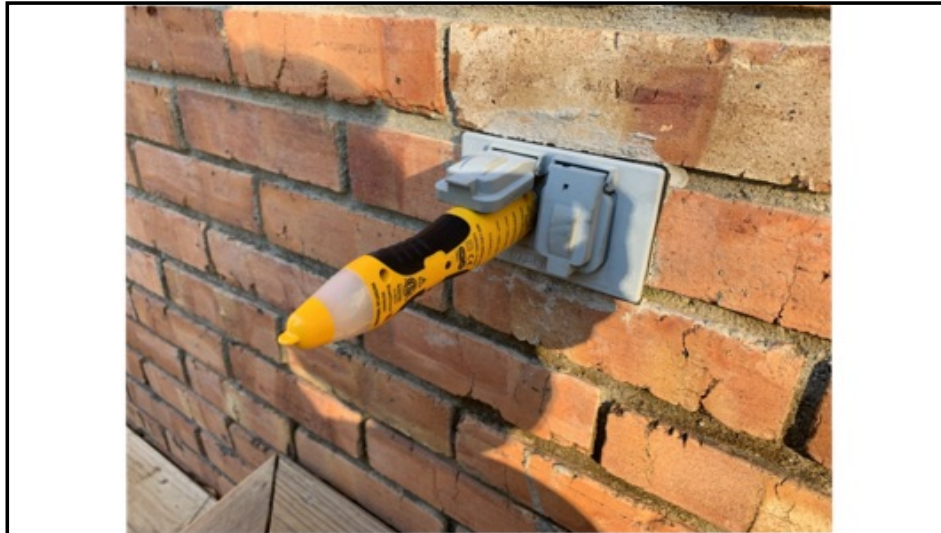
No GFCI protection

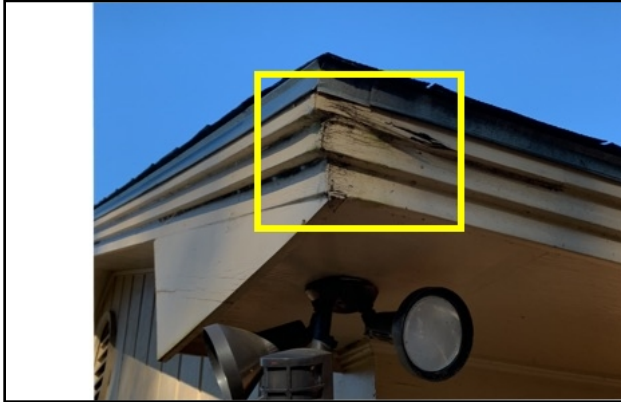
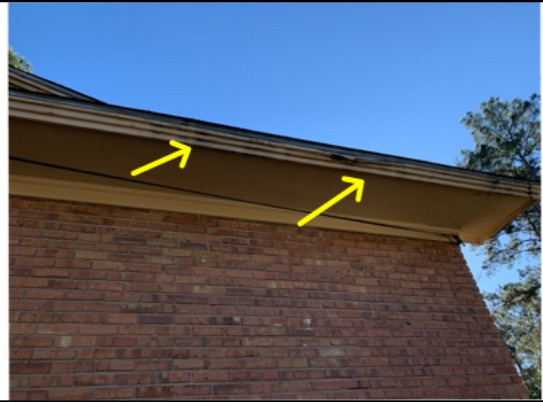
Page 17 Item: 2

- **REPAIR:** Moisture damage noted to facia and soffit areas in numerous places around home. Recommend repair and replacement as necessary.

Moisture damage

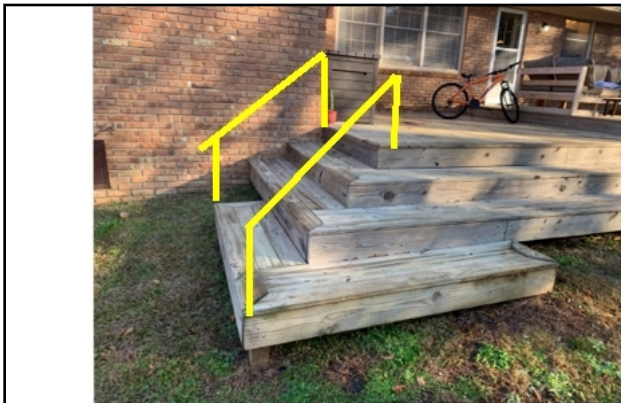
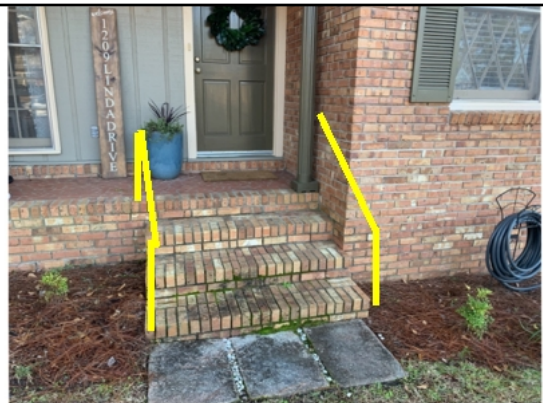
Page 18 Item: 3

• **SAFETY:** Handrails- There were no railings installed at the steps both at patio in back or porch stairs in front. This is a potential tripping hazard. Recommend installing protective railings.

Missing handrails

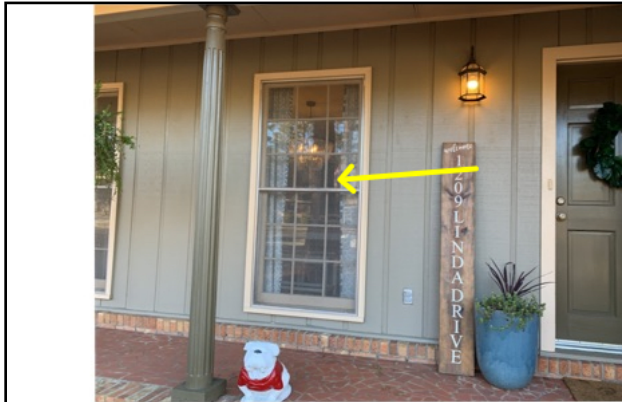
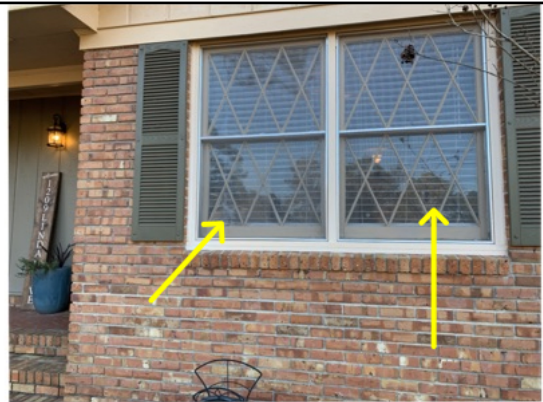
Page 19 Item: 5

• **REPLACE:** Multiple windows at front of house broken. Replace as necessary.

Broken window

Broken windows

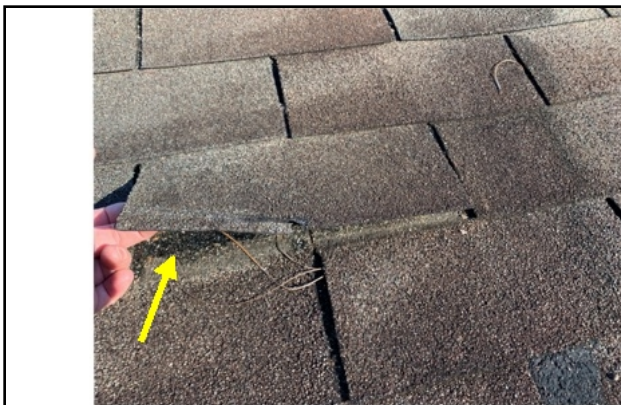
Page 38 Item: 1	Roof Condition	<ul style="list-style-type: none"> • REPAIR: Shingles are starting to curl and they are brittle and some shingles loose when tested. Could not access majority of the attic space due to personal items and duct work blocking access which prevented underside decking inspection. Unable to determine age due to no permit on file. Some roofing wet from condensation. Dry parts did not have many granules. Recommend further evaluation/repair from qualified roofer as necessary.
-----------------	----------------	---

Loose

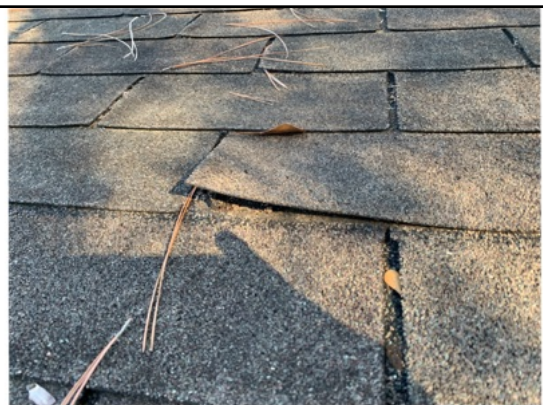
Shingles cupping

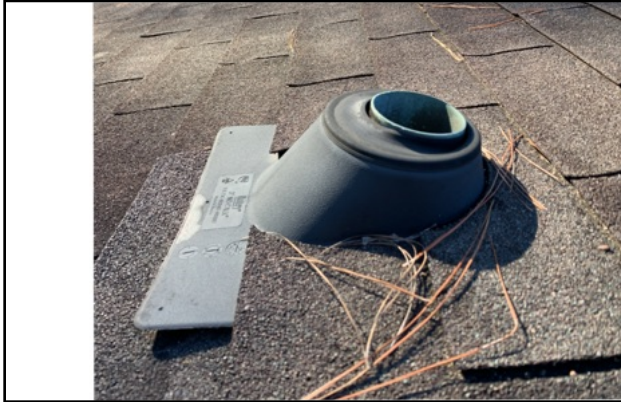
Page 40 Item: 2	Flashing	<ul style="list-style-type: none"> • REPLACE: Rubber plumbing vent boots are at the end of there life and should be replaced to prevent moisture damage to interior areas. • REPAIR: Vent pipe too low, which should be a minimum of 6" high where it comes through the roof.
-----------------	----------	---

Vent stack too low

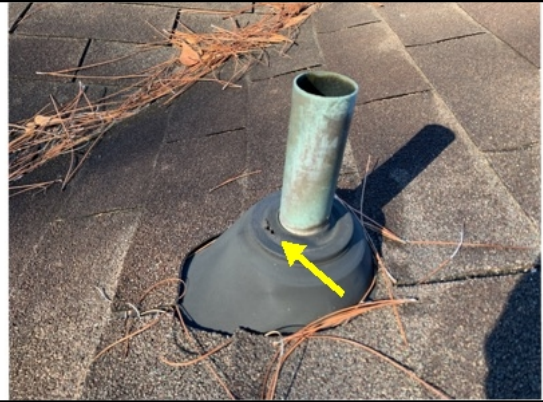
Rubber flashing/boot worn

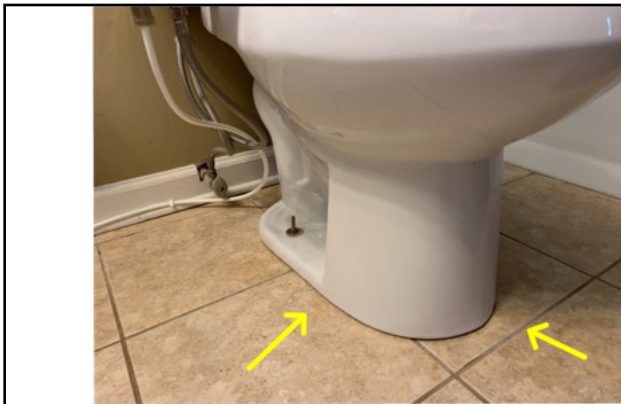
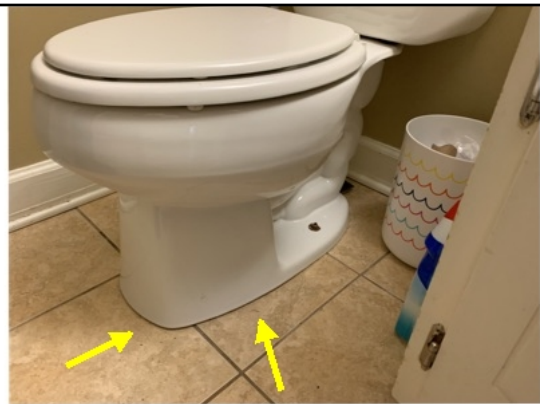
Page 48 Item: 7	Toilets	<ul style="list-style-type: none">• The toilet bowl is loose at floor anchor bolts in both bathrooms. The wax ring inside the unit must have a snug, secure fit in order to keep from leaking. Properly resealing and re-securing this unit is suggested to prevent water leakage and damage to the sub-floor area. This type of damage is not always visible or accessible to the inspector at time of inspection.
-----------------	---------	---

Master bath toilet loose

OK bath toilet lose

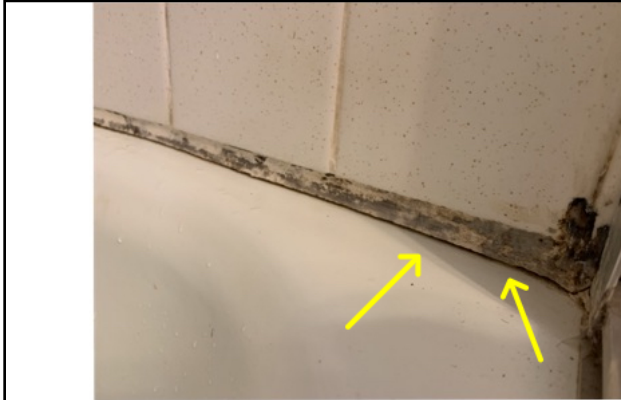
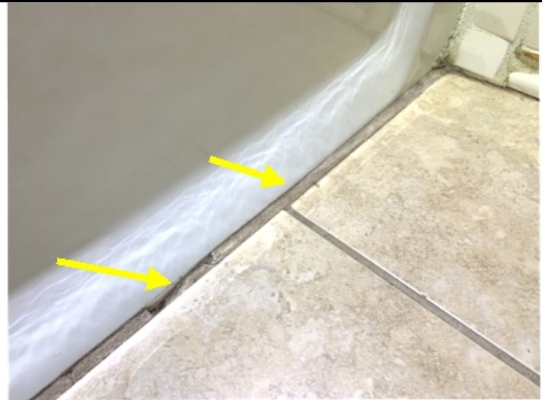
Page 48 Item: 8	Bath Tubs	<ul style="list-style-type: none">• REPAIR: Grouting/caulking around both tubs requires re-sealing. Water penetrating these areas can cause water to leak into and down the walls into the sub floor.
-----------------	-----------	---

Needs caulking - master bath

Hallway- tub/floor needs sealing

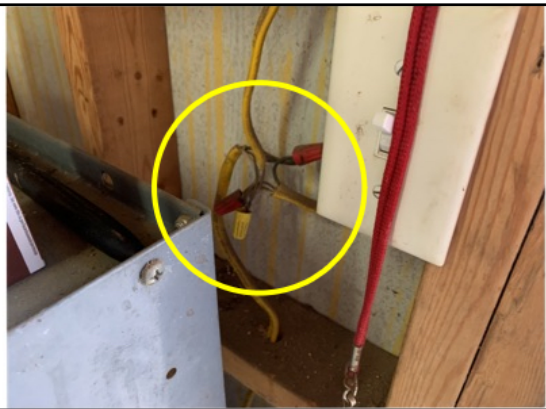
- **REPLACE:** Front porch outlet cover weather seal worn.
- **REPAIR:** Outbuilding overhang light and interior switch has wire splices made outside of junction boxes. Back flood light not properly installed. Recommend licensed electrician to properly install with junction box.
- **REPAIR:** No Ground Fault Circuit Interrupter (**GFCI**) protection outdoors, or anywhere throughout the home at the time of inspection. Although GFCI protection may not have been required at the time the home was built, for safety reasons, consider upgrading the electrical system to include GFCI protection at all wet area locations (kitchen, bathrooms, carport, outside, etc).

Improper wiring

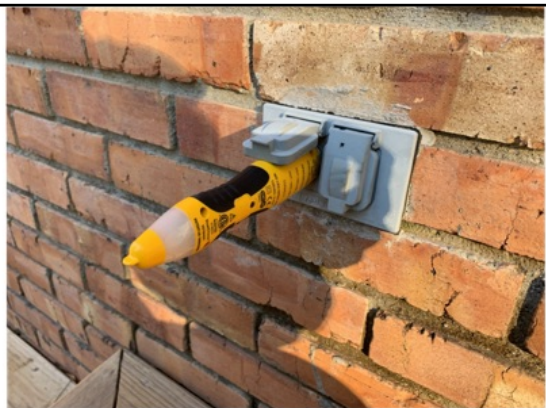
No GFCI protection

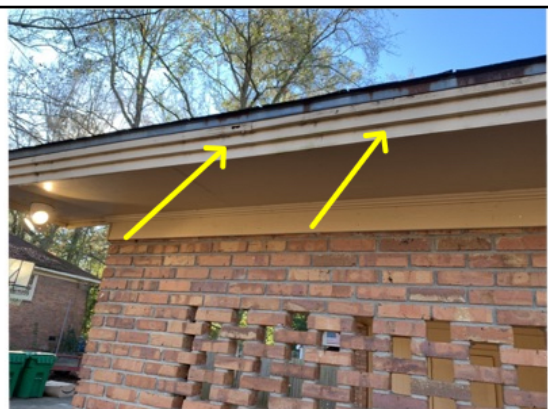
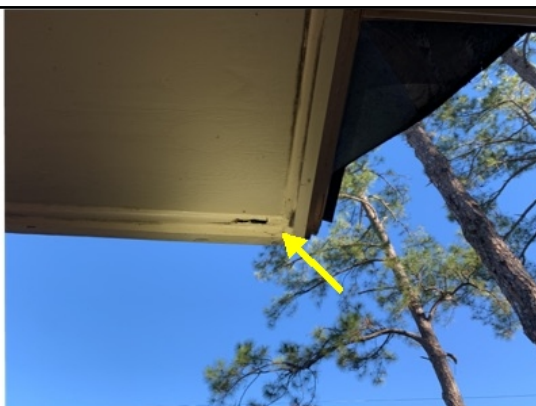
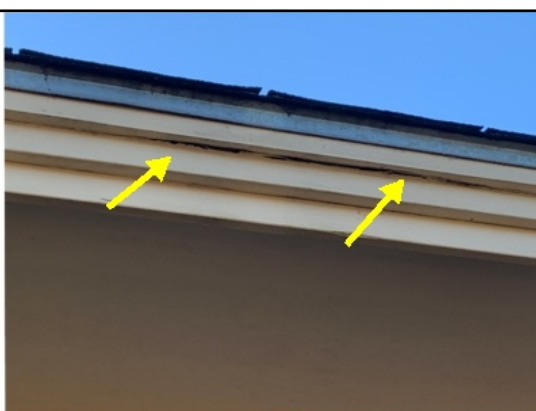
- Soffits are non-ventilated and made of wood or wood-like material
- Fascia is made of wood or wood-like material
- **REPAIR:** Moisture damage noted to facia and soffit areas in numerous places around home. Recommend repair and replacement as necessary.

Moisture damage

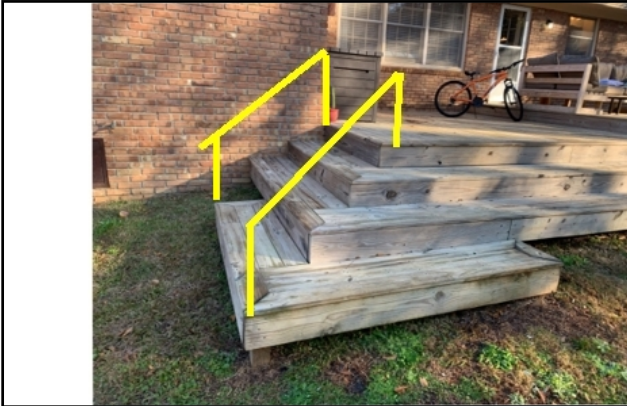
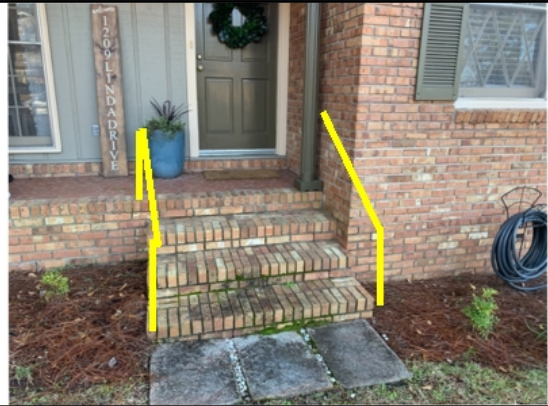
- **SAFETY: Handrails-** There were no railings installed at the steps both at patio in back or porch stairs in front. This is a potential tripping hazard. Recommend installing protective railings.

Missing handrails

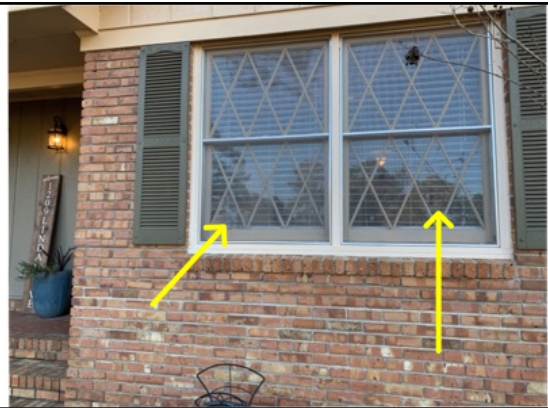
- ROUTINE MAINTENANCE: Paint - Windows are weathered; paint is chipping and peeling away. Any exterior wood must be protected from the elements as best as possible. Suggest scraping and painting as necessary.
- ROUTINE MAINTENANCE: Suggest sealing/caulking and as necessary for part of routine maintenance to prevent further deterioration.
- REPLACE: Some window screens missing/torn/damaged. Repair/replace as necessary.
- REPLACE: Multiple windows at front of house broken. Replace as necessary.

Broken windows

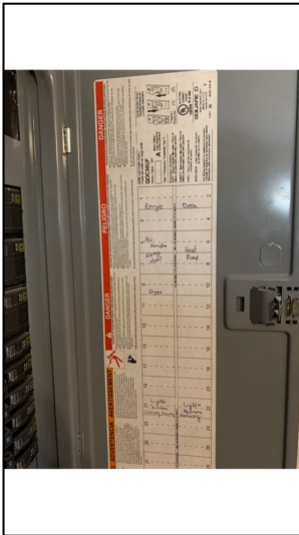
- 120/240V - 200 amp
- OBSERVATION: Panel schematic is not fully filled in or legible. Recommend correcting this for quick and accurate access.

Panel schematic

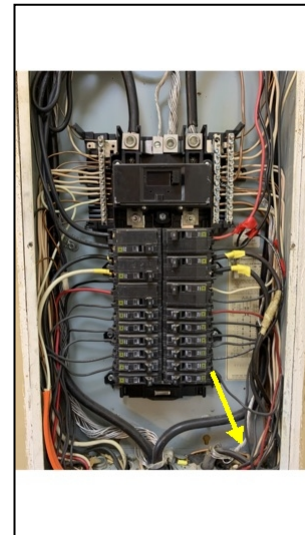
- REPAIR: Several screws are stripped and will not tighten. Cover is secure but should have all screws able to be tightened.
- REPAIR - Bushings/cable connector missing from panel box where wires enter/exit the panel. The sharp edges of the box can chaff the wires becoming a hazard.

Bushing missing

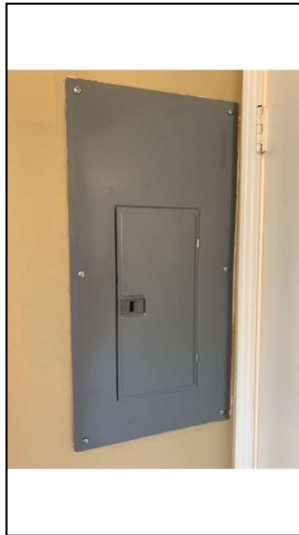
Panel screws stripped

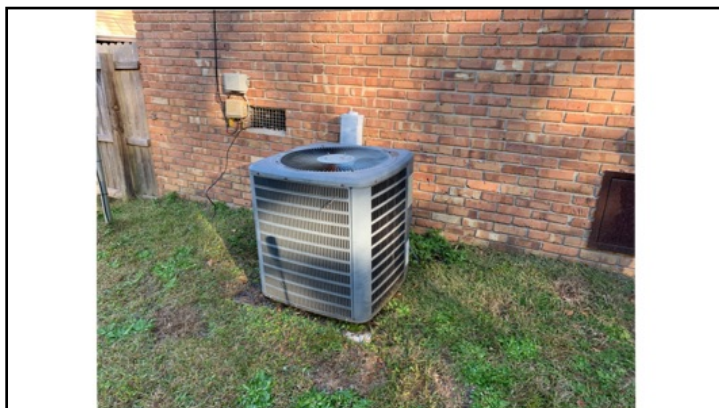
Condenser/Compressor

- Condenser Manufacturer: Goodman
- Condenser Manufactured: 2007
- Condenser Energy Source: Electric
- Heating, Ventilating Air Conditioning Type: :Heat Pump
- The Condenser is located outside on the South of the house.
- MONITOR: R-22 - Be advised that the HVAC system uses R-22 refrigerant. Production of this type of unit stopped in 2010 and use of the R-22 refrigerant was phased out as of 2020. Future repairs are likely to be expensive.
- MONITOR: Older Unit - The AC condenser is an older unit. The service life is expected to be approximately 10-15 years. Any component of a central cooling and heating system which is over 10 years old is categorized as being in fair condition, primarily due to its increased likelihood of breakdown and need for replacement in the future. Any service life in excess of 13 years is in the realm of good fortune only and should be viewed as such.

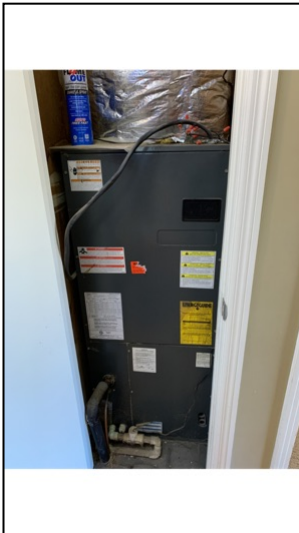
Air Handler

- MONITOR: Older Unit - The air handler is older. Heating systems of this type have expected service lives of 10-15 years. Any component of a central cooling and heating system which is over 10 years old is categorized as being in fair condition, primarily due to its increased likelihood of breakdown and need for replacement in the future. Any service life in excess of 13 years is in the realm of good fortune only and should be viewed as such.

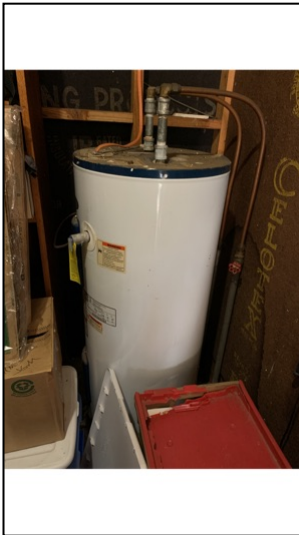
- Water Heater Manufacturer: Whirlpool
- Water Heater Manufactured In: 2007
- Water Heater Capacity (Size): 50 Gallon
- Water Heater Type: Electric

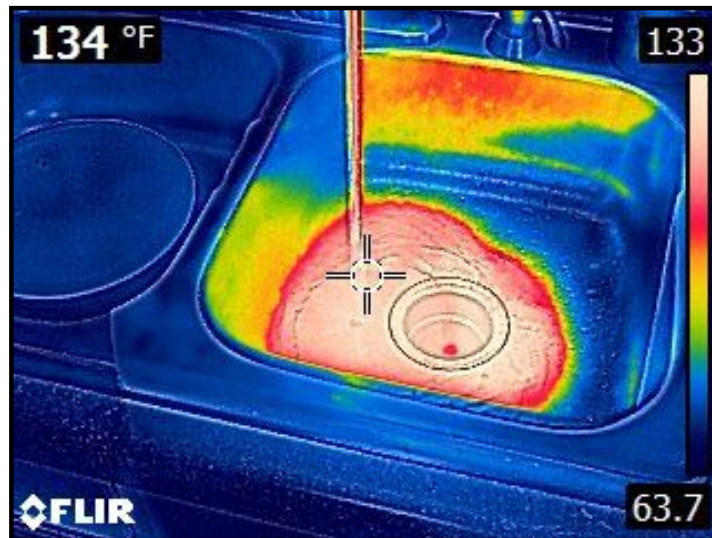
Condition: **SAFETY ISSUE: Temperature - Water temperature observed to be: 134 degree F. This is unsatisfactory and too hot. Recommended temp should be set at 118-122 degrees F. to prevent scalding, extend water heater life, and improve energy efficiency and conservation.**

Water temperature

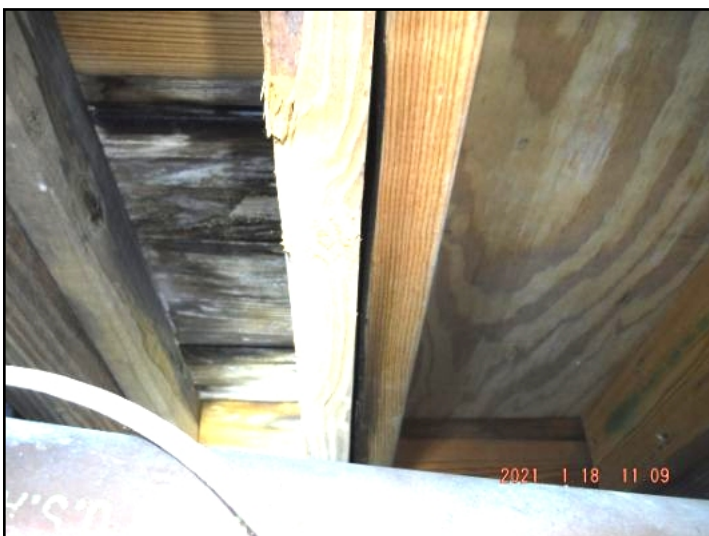
- Sub-floor decking material: Diagonal plank sub-floor
- Additional sub-floor decking material: Plywood sheathing sub-floor
- **OBSERVATION:** Evidence of past repairs to sub-floor noted.
- **FURTHER EVALUATION:** Elevated moisture noted at both bathroom areas and kitchen, along with some moisture damage and staining under air handler unit. No active leak observed at time of inspection, but due to elevation in moisture readings, further evaluation and repairs by qualified plumber is recommended.

Sub-floor repairs

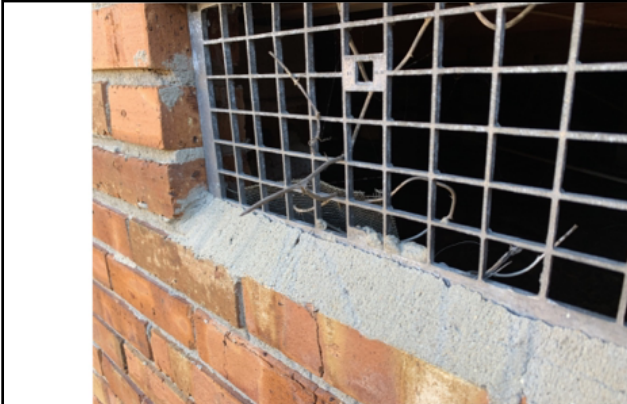
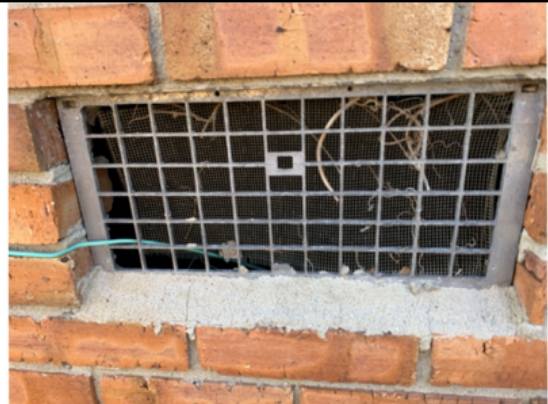
- **REPAIR:** Vent screens are damaged or missing. Suggest repairing or replacing screens as necessary.

Missing screen

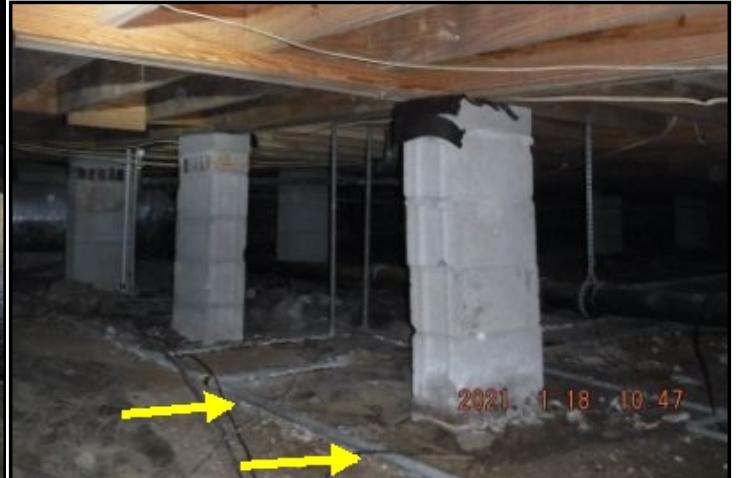
- **REPAIR:** Crawl space had plumbing that was unsupported and laying in dirt/on ground. Recommend repair to properly support plumbing.

Plumbing unsupported

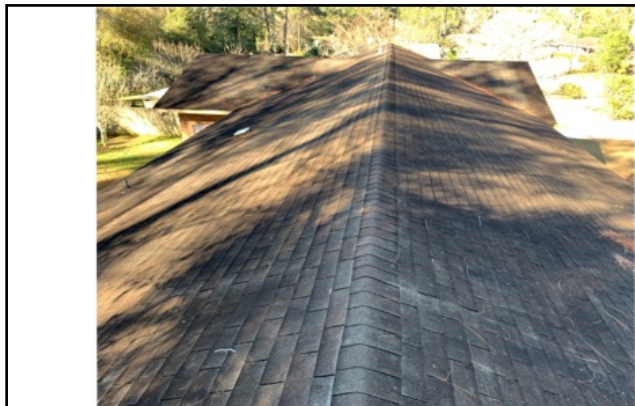
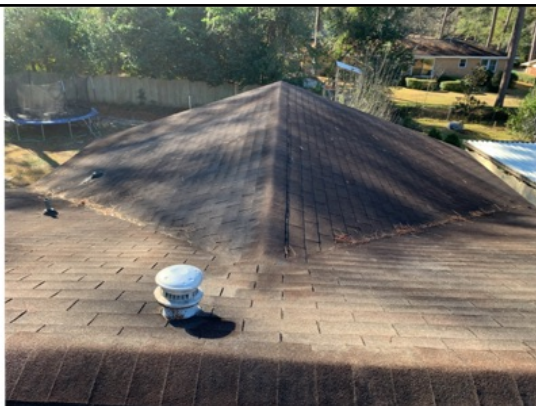
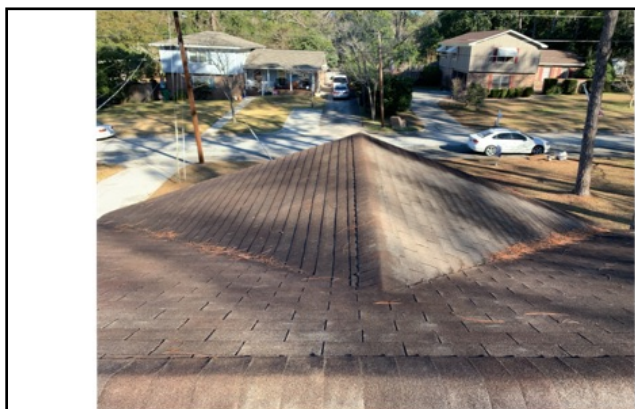
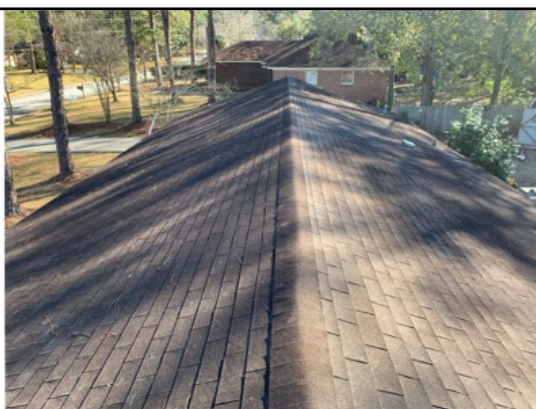
Roof

- **REPAIR:** Shingles are starting to curl and they are brittle and some shingles loose when tested. Could not access majority of the attic space due to personal items and duct work blocking access which prevented underside decking inspection. Unable to determine age due to no permit on file. Some roofing wet from condensation. Dry parts did not have many granules. Recommend further evaluation/repair from qualified roofer as necessary.

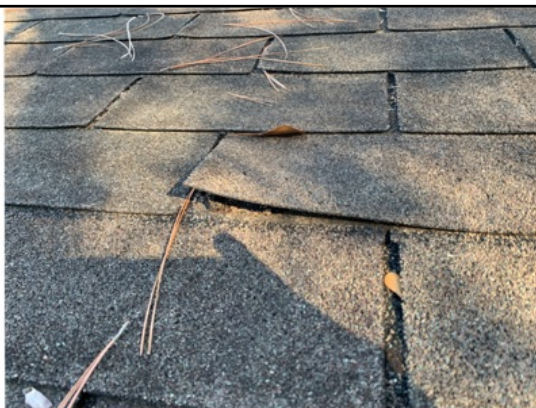
Shingles cupping

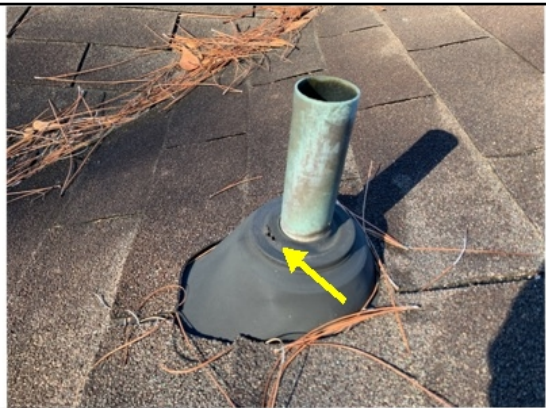
- Metal flashing present.
- Rubber/Plastic flashing present.
- **REPLACE:** Rubber plumbing vent boots are at the end of there life and should be replaced to prevent moisture damage to interior areas.
- **REPAIR:** Vent pipe too low, which should be a minimum of 6" high where it comes through the roof.

Rubber flashing/boot worn

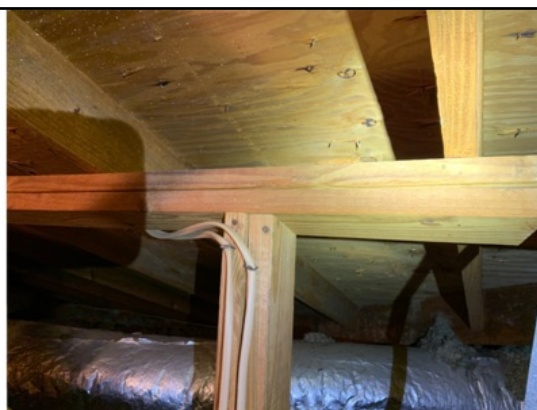
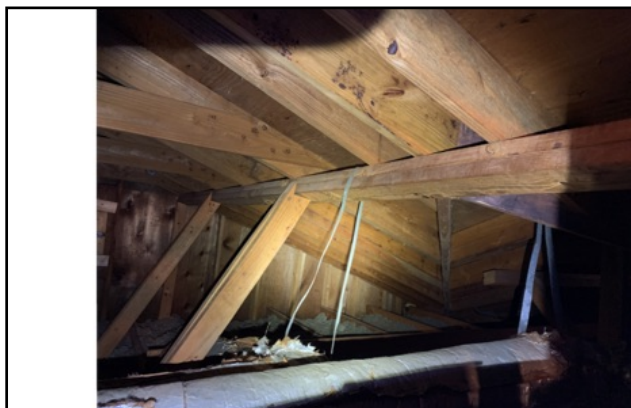
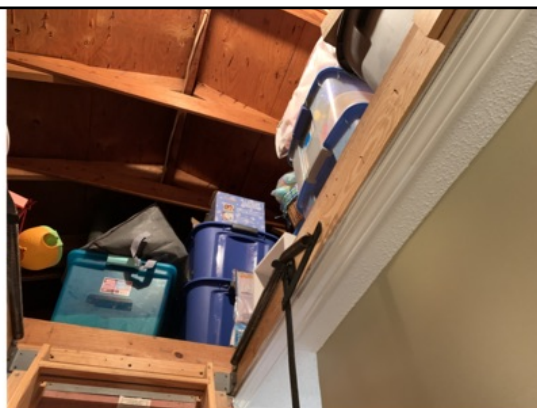
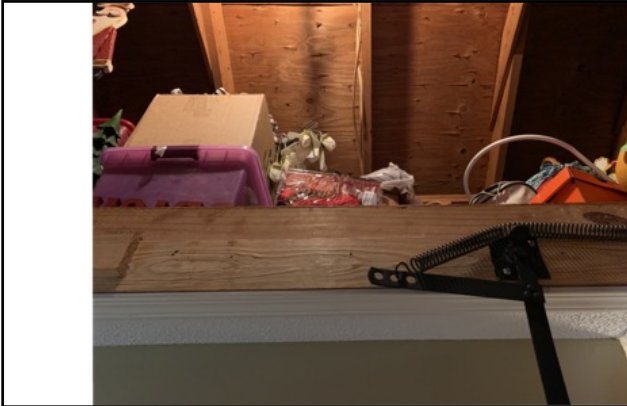
Attic - personal items

- LIMITATION: Did not inspect attic area, other than from small area at access ladder; unable to access attic due to heavy amount of personal items creating inaccessibility. Recommend review of the Sellers Disclosure Statement regarding the condition of the attic prior to close.

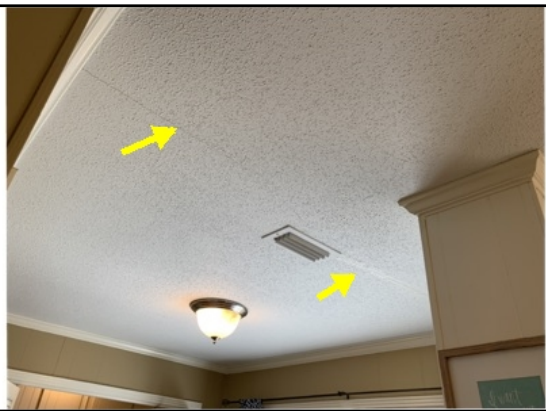
- There are drywall ceilings noted.
- **OBSERVATION:** Carport mechanical/storage room has drywall missing from ceiling.
- **OBSERVATION:** Crack noted in car port entry area ceiling. Unable to inspect attic above that area due to personally stored items blocking access. Typical crack noted along wall/ceiling in living room.
- **OBSERVATION:** Small stains noted on the ceiling. They tested dry at the time of the inspection. Paint peeling on ceiling around register.

Crack

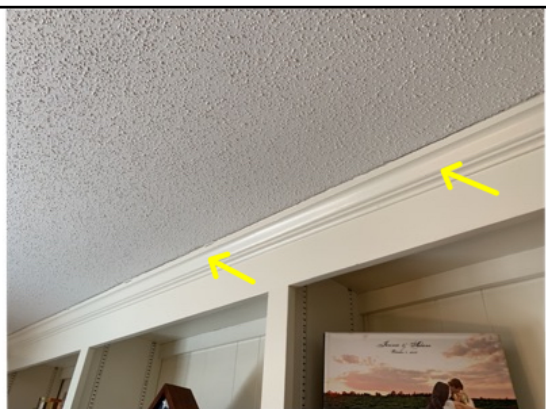
Typical cracking

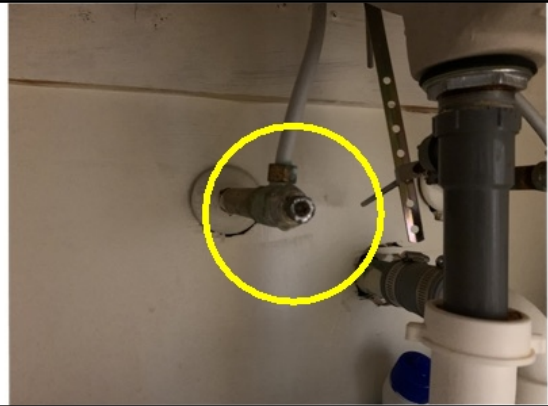
- **REPAIR:** hallway bathroom hot water shut off valve handle broken. Recommend replacing shut off handle.

Hallway- shut broken handle

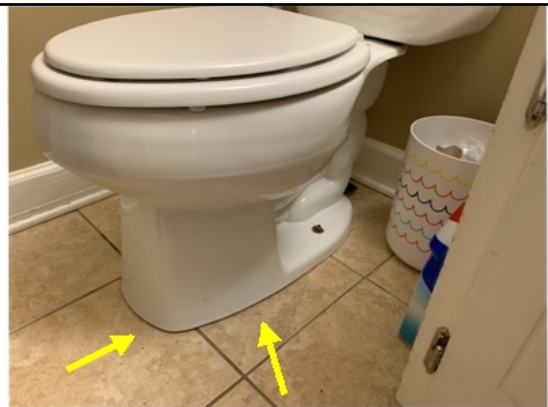
- The toilet bowl is loose at floor anchor bolts in both bathrooms. The wax ring inside the unit must have a snug, secure fit in order to keep from leaking. Properly resealing and re-securing this unit is suggested to prevent water leakage and damage to the sub-floor area. This type of damage is not always visible or accessible to the inspector at time of inspection.

OK bath toilet lose

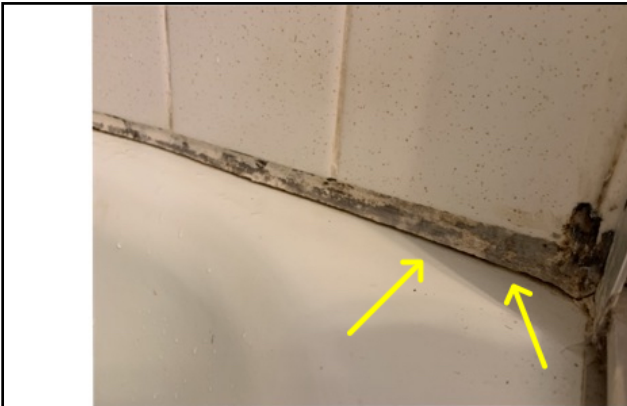
- **REPAIR:** Grouting/caulking around both tubs requires re-sealing. Water penetrating these areas can cause water to leak into and down the walls into the sub floor.

Needs caulking - master bath

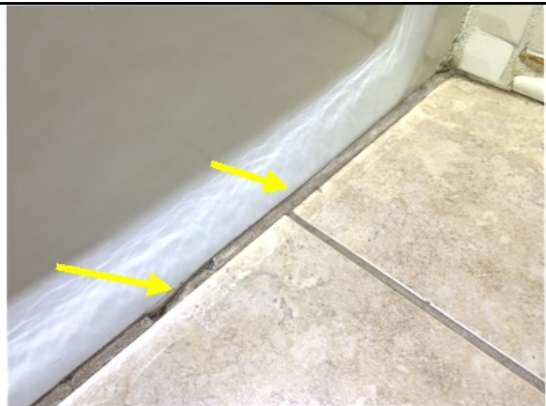
Hallway- tub/floor needs sealing

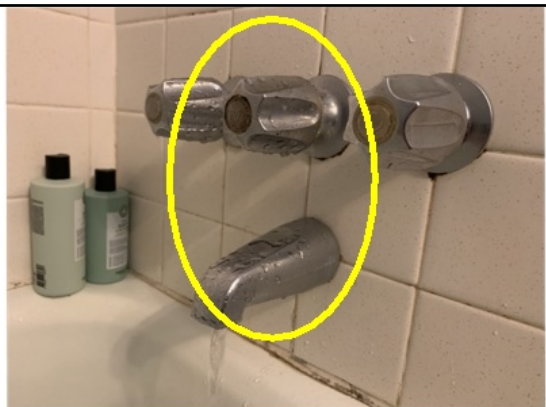
Leaking - master bath

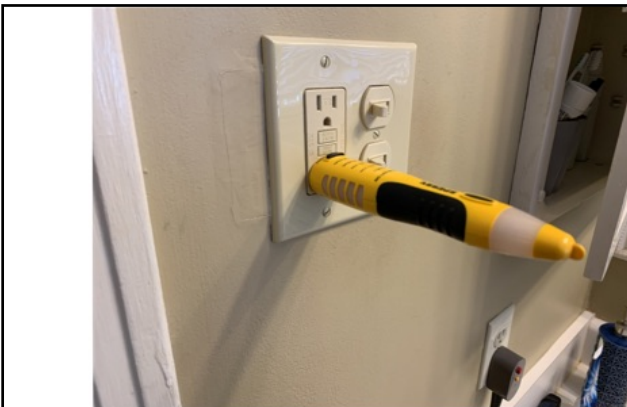
- **OBSERVATION:** Master bath top switch did not operate anything. Bottom light operated both fan and light.
- **REPAIR:** No Ground Fault Circuit Interrupter (GFCI) protection of home electrical outlets in bathrooms were provided at the time of inspection. For safety reasons, consider upgrading the electrical system to include GFCI protection.
- **REPAIR:** Master bath outlet does not have power.

Outlet no power

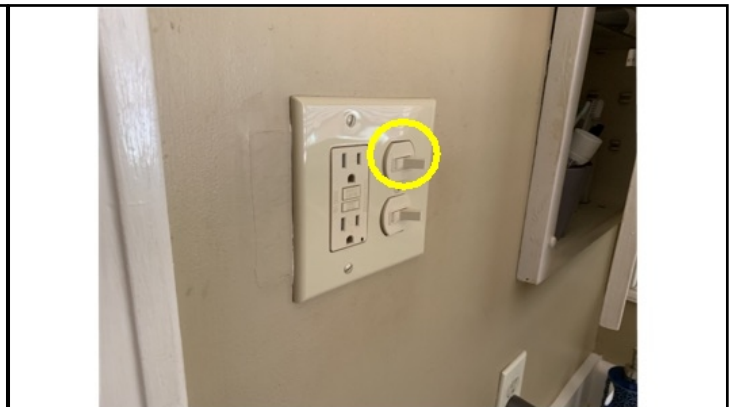
Top switch does not operate

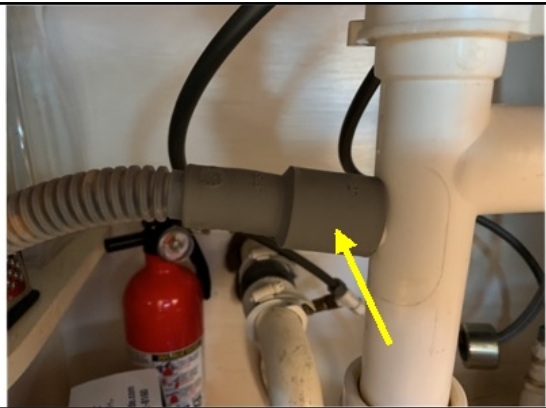
- REPAIR: Dishwasher hose connected to drain line missing hose clamp. Recommend installing hose clamp to prevent leakage.

Missing hose clamp

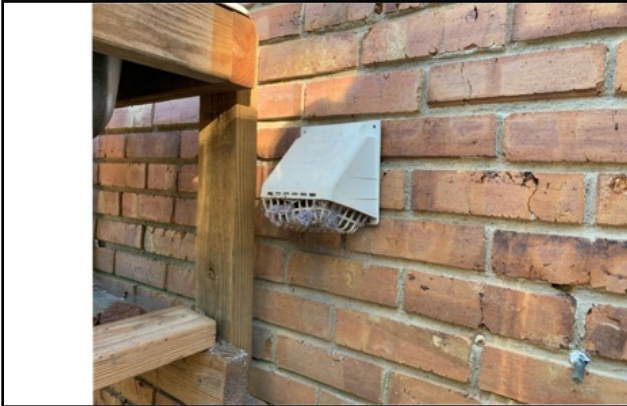
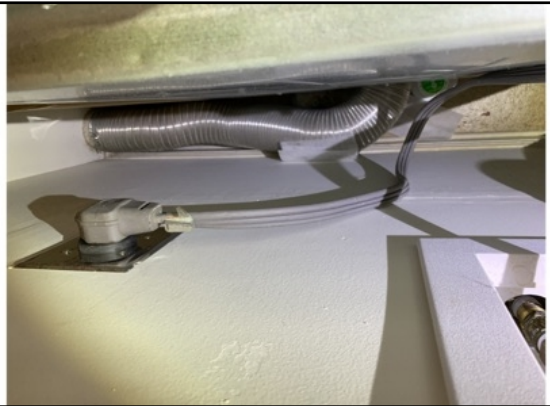
- REPAIR: Dryer vent appeared dirty with lint at time of inspection. Lint is flammable. Recommend cleaning dryer vent to prevent fire.

Dryer vent
