PROPERTY INSPECTION REPORT

Next Step Inspections

Date of Inspection: 1/1/2021

Year Built: 2021 Size: 1561

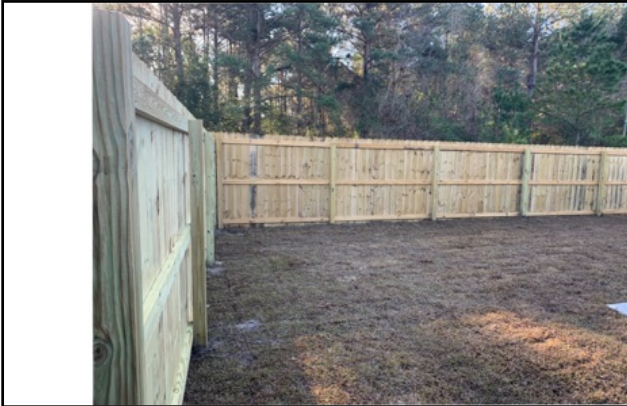
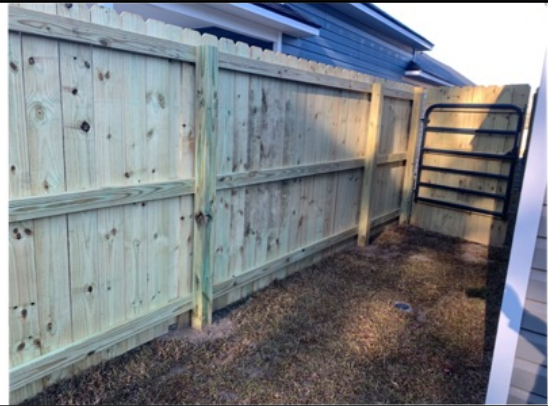
- Fence or wall material: wood
- Inspecting fences and/or gates are not within the scope of this inspection (except when in conjunction with a swing pool). Any observations/recommendations are courtesy. Recommend confirming that all fences and gates are in serviceable condition before the close of escrow.
- Fence/gates appeared serviceable at time of inspection.

Wood privacy fence

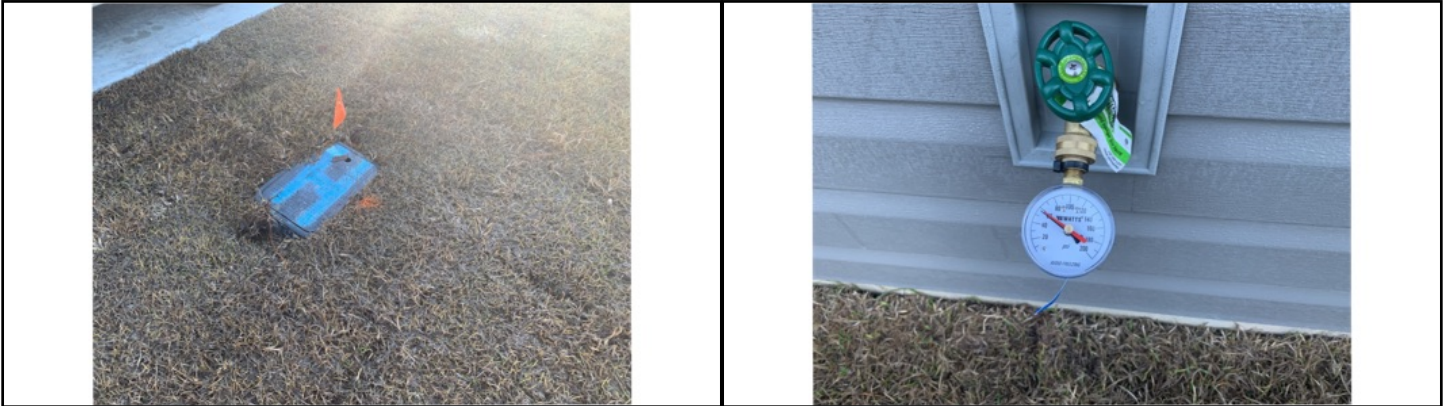
- Main water shutoff located at north side of house; valve not tested.
- Water pressure measured at an outside hose bib was 55 pounds per square inch (PSI).
- CPVC (Chlorinated Polyvinyl Chloride) piping present.
- PEX (Cross-Linked Polyethylene) piping present.
- **PVC** (Polyvinyl Chloride) piping present.
- Outdoor plumbing in operational condition; no major system leaks or function concerns observed at visible portions of outdoor piping at time of inspection.

Water shut off

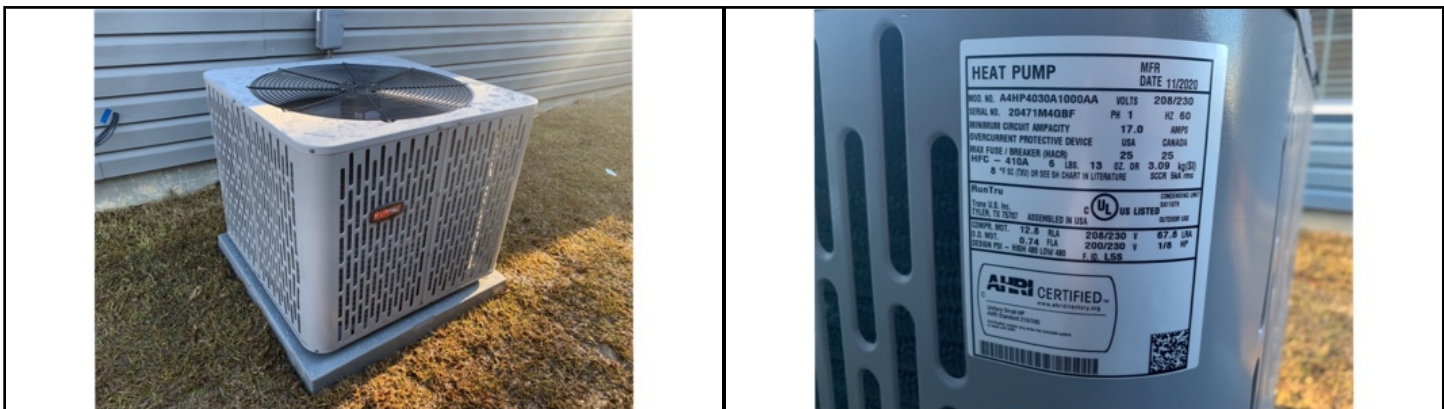
Manufacture label

- Condenser Manufacturer: Trane
- Condenser Manufactured: 2020
- Condenser Energy Source: Electric
- Heating, Ventilating Air Conditioning Type: :Heat Pump

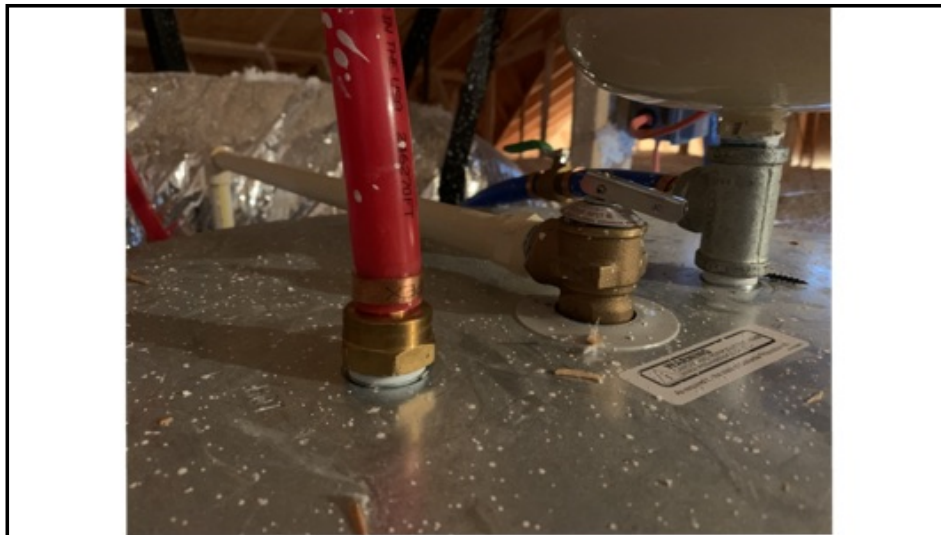
TPRV

- A Temperature Pressure Relief Valve (**TPR Valve**) present. This safety valve releases water (and thus relieves pressure) if either the temp or pressure in the tank gets too high. The TPR valve discharge tube must be made of copper, iron, or CPVC (NOT regular PVC). It must terminate within 6" above the floor--the end cannot be threaded or have a fitting.

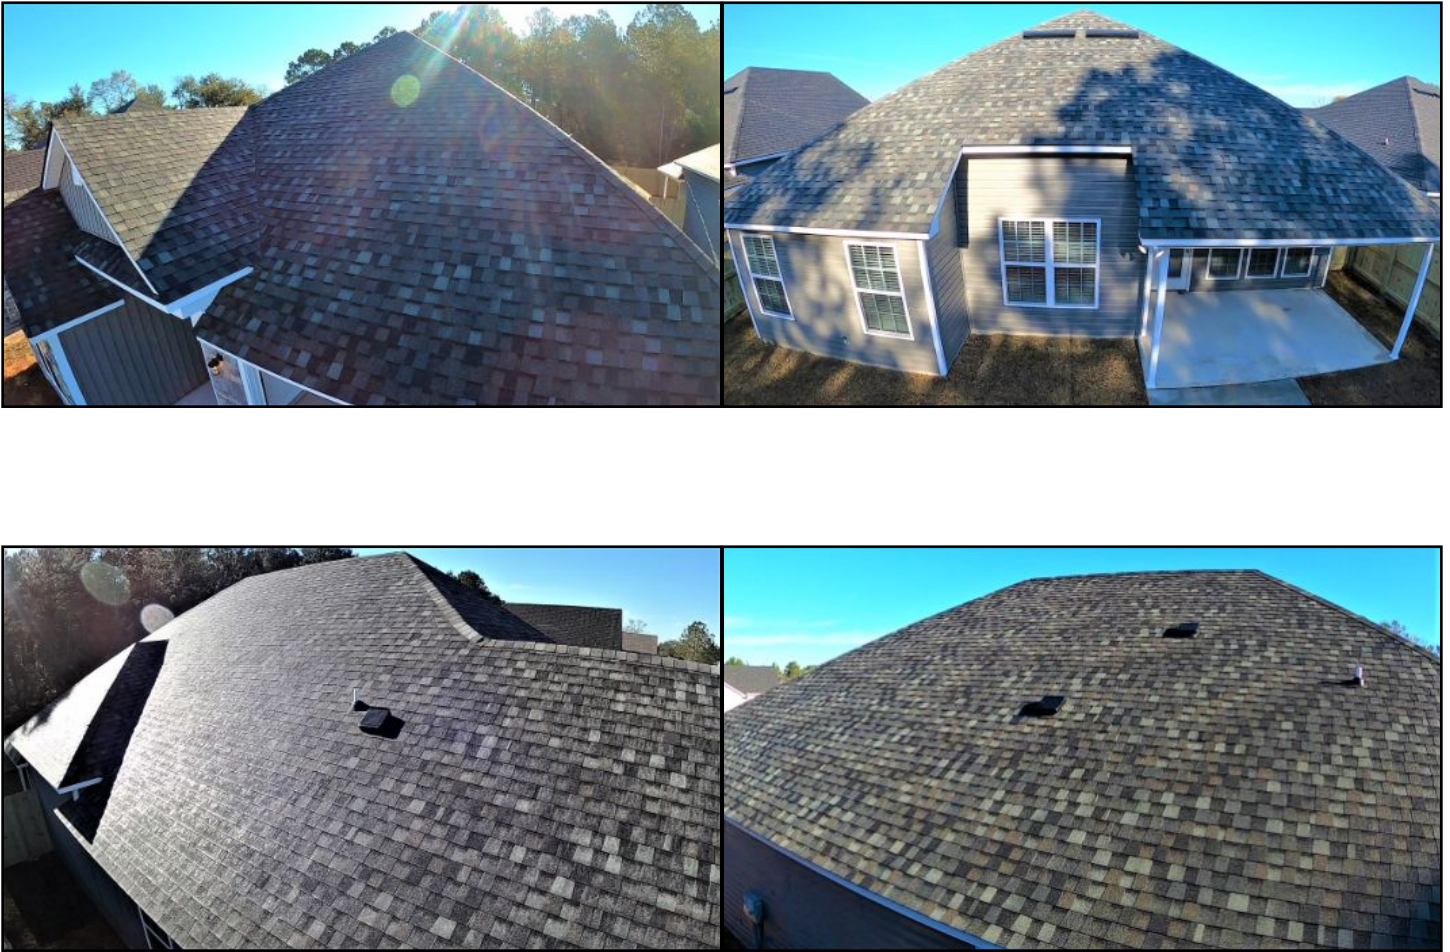
- **REPAIR:** Starter course (1st layer of shingles applied to roof) around eaves of roof not sealed. If the first course is not adhered, it is susceptible to blow-off in strong winds.

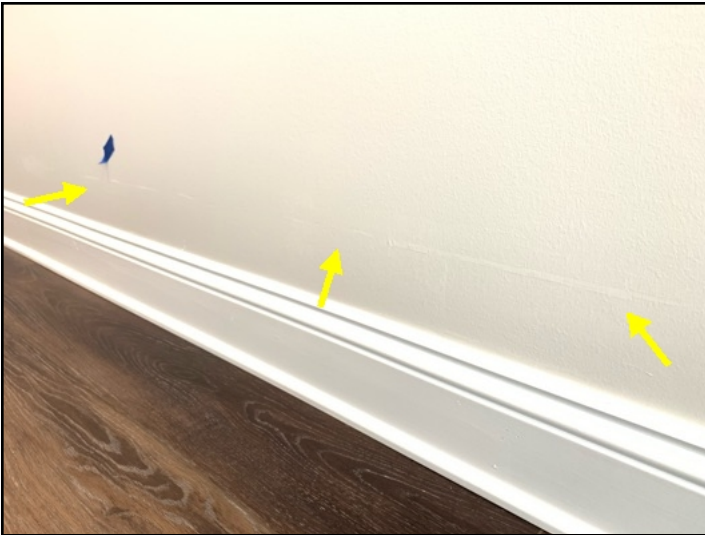
Main entry area

- Drywall walls noted.
- Walls appeared functional with no deficiencies observed at time of inspection.
- OBSERVATION: A few cosmetic defects noted. See pictures for details.

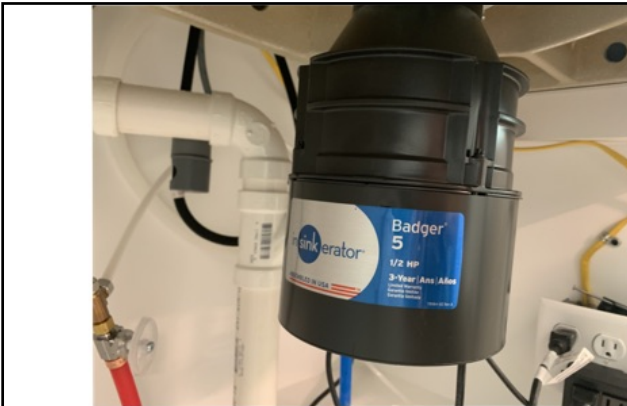
Disposal

- **REPAIR:** Wire strain relief clamp loose or missing. Recommend installing and securing wire per manufacturer's instructions.

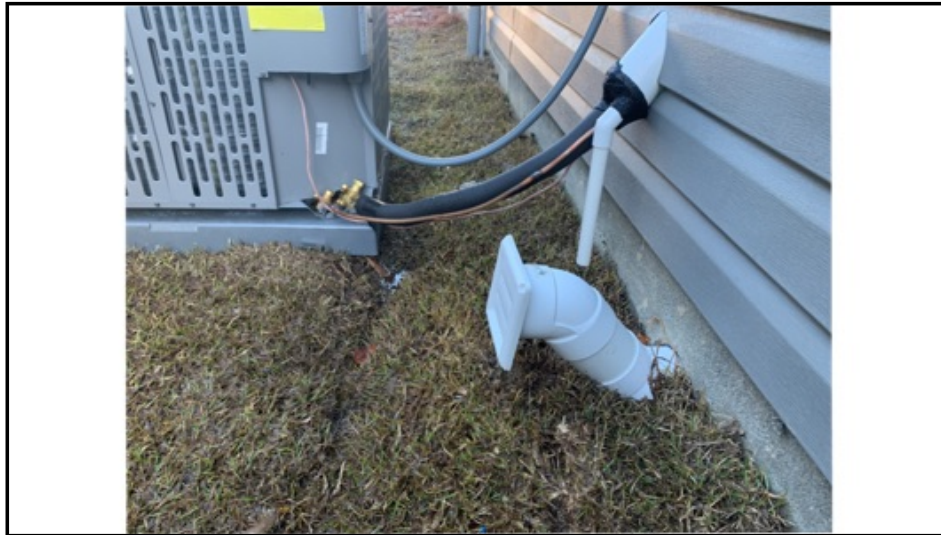
Dryer vent

- **Comment for vent within 3-feet of condenser is in condenser section.
