General Information

Report number: 20140302

Type of building: Single family

Age of main building: 61yrs. Built 1952

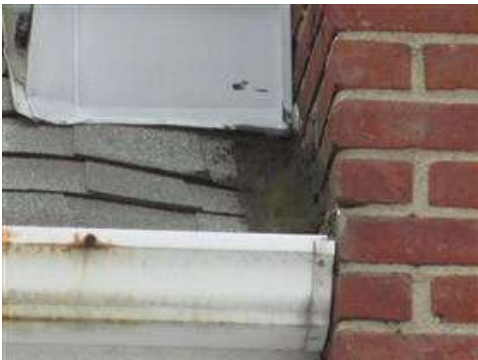
Photo 20-3

Flashing at the base of the chimney was missing, damaged, deteriorated, corroded or substandard. Leaks have occur as a result. This is a conducive condition for wood-destroying organisms. Recommend that a qualified contractor evaluate and repair as necessary.

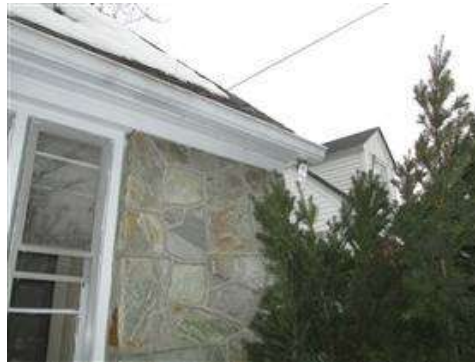
Photo 21-2

One or more gutters, downspouts were incomplete, missing, leaking, damaged. Rainwater can come in contact with the building exterior or accumulate around the building foundation as a result. This is a conducive condition for wood-destroying organisms. Recommend that a qualified person repair as necessary.

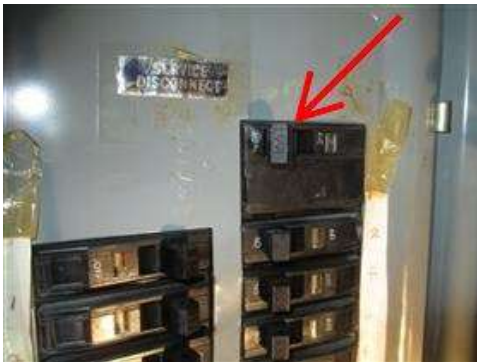
Photo X-1
Main electric shutoff

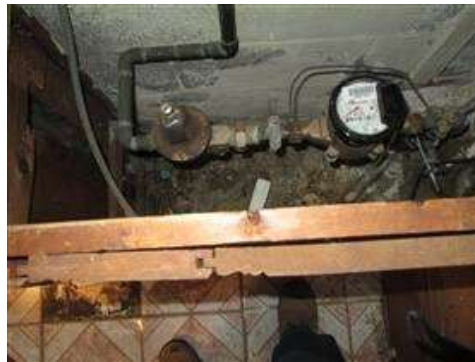
Photo X-2
Water meter and main water shutoff
