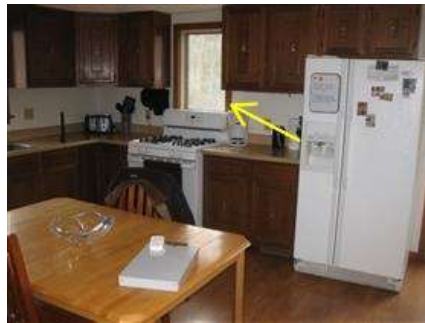
**Photo 106**  
Kitchen. Wouldn't close.

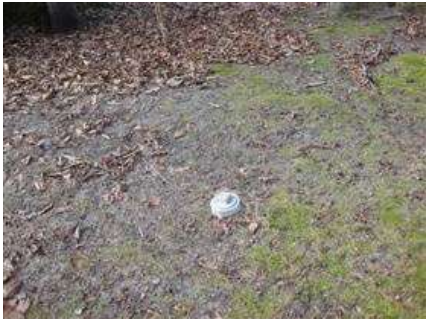
**Photo 22**  
Sewer clean-out in back yard

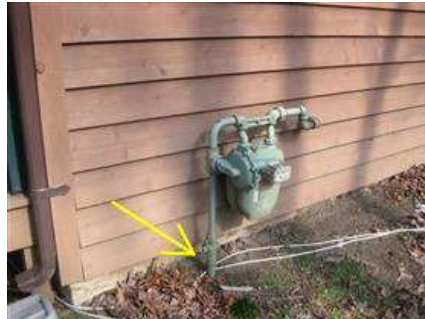
**Photo 27**  
Main gas shut-off

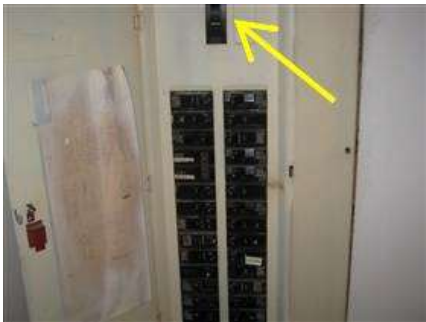
**Photo 40**  
Main electric shut-off

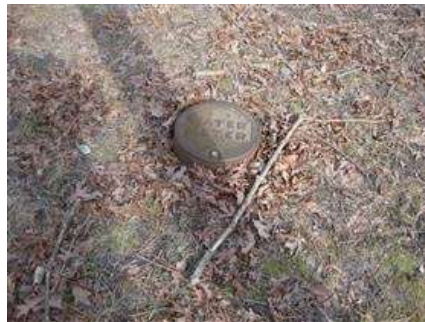
**Photo 104**  
Water meter in front yard
