THERMAL DRONE ROOF REPORT

Saginaw Chippewa Tribe - Soaring Eagle Casino

LIDAR Drone Services

Capture Date: 02/12/24
Created Date: 02/14/24

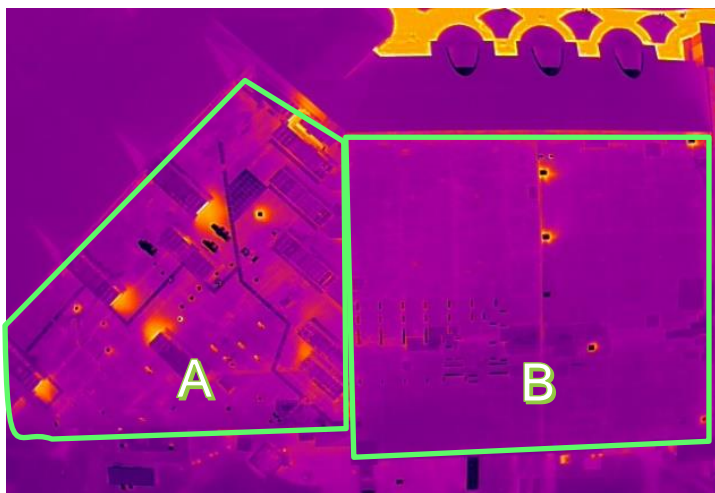
Roof Overview-Sections

The area of roof scanned is broken into two Sections, A & B. Those two sections are then broken down into numbered sub-sections. All images are labeled.

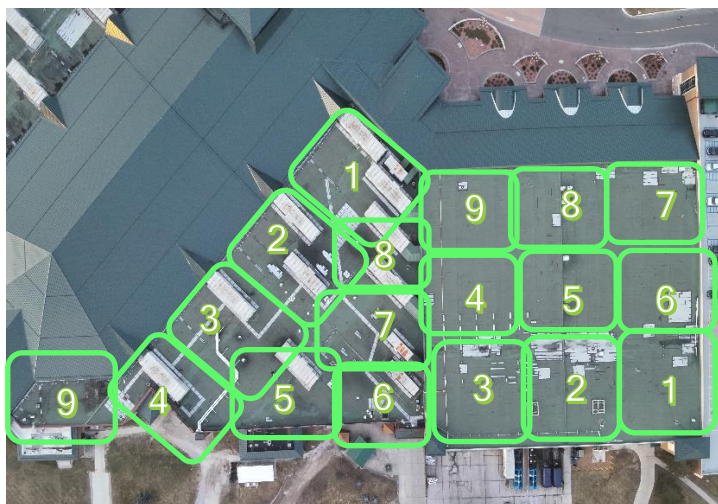
Roof Overview-Sub-Sections

All pictures are labeled with corresponding section and sub-section.
