Testing of Impact-Resistant Asphalt Shingles

By Steven R. Smith, PE;
Timothy P. Marshall, PE;
and Jonathan S. Goode, PhD, PE

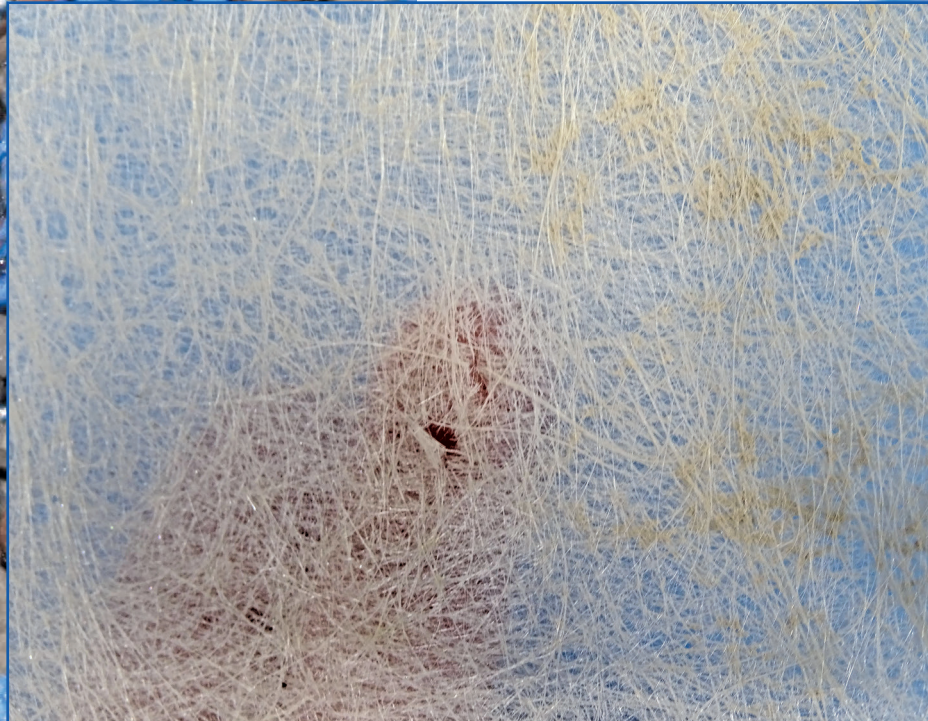
Figure 10 – Close-up of the fracture in reinforcement at the impact location.

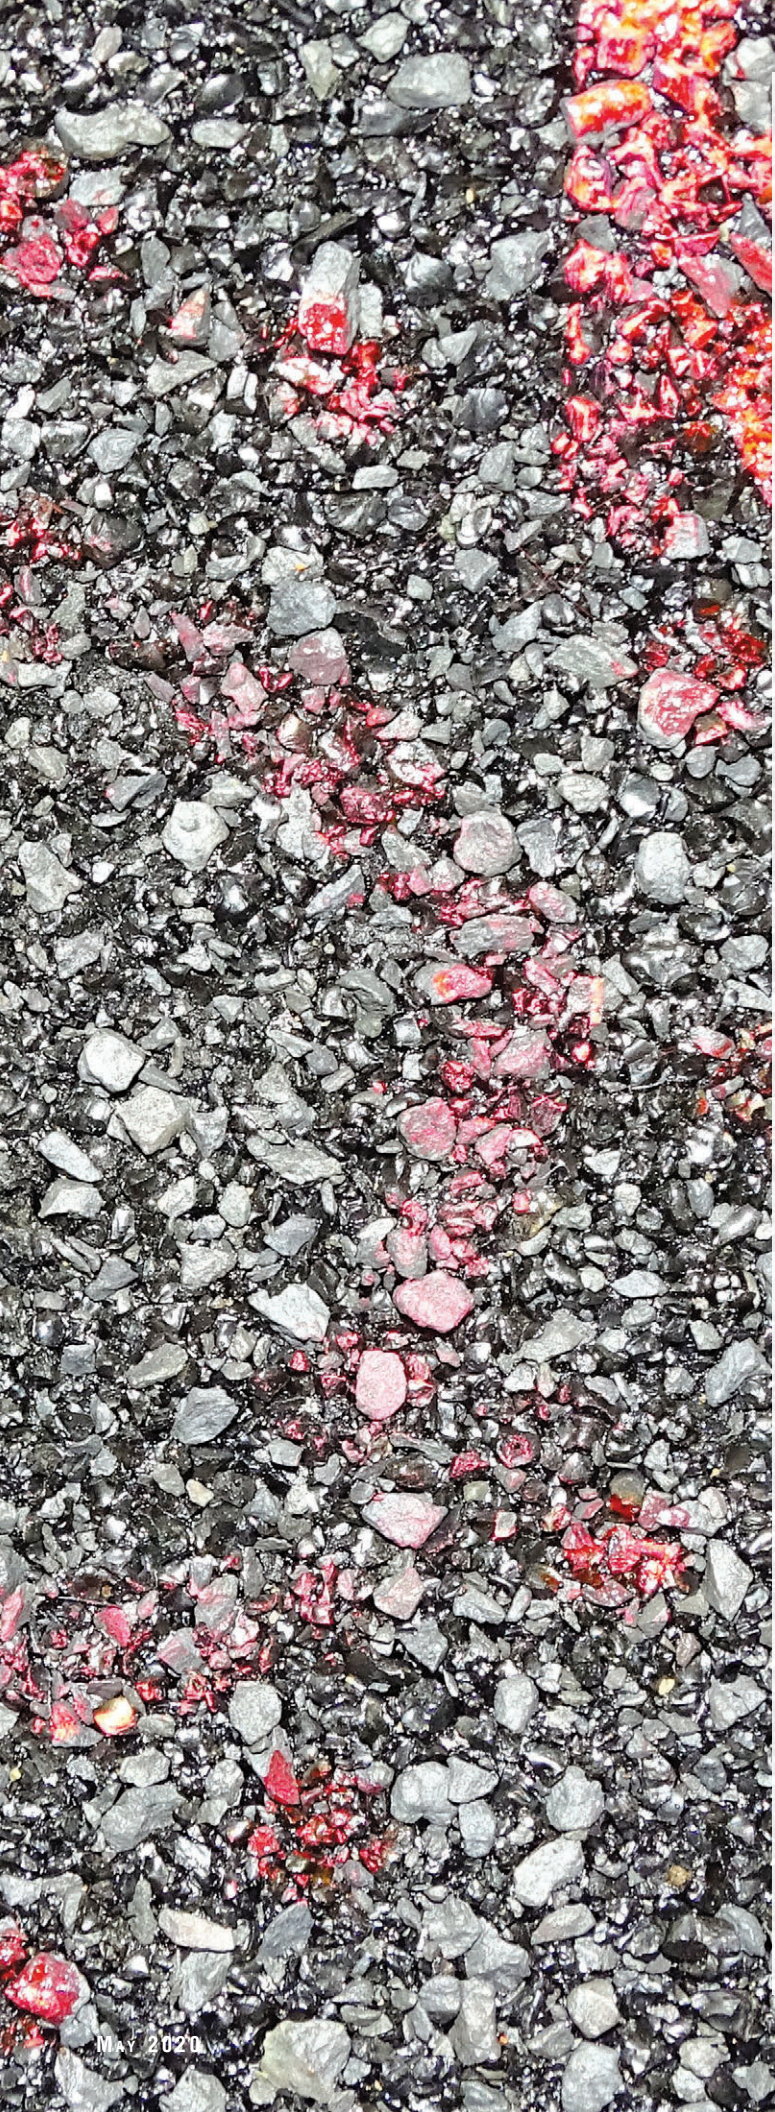
Figure 12 – Fracture visible on bottom of shingle at impact shown in Figure 11.

Figure 11 – ANSI FM-4473 Class 2 double impact on a Class 3 shingle.

Figures 11 through 14 depict the Class 3 shingle after a set of Class 2 double impacts per the ANSI FM-4473 standard. Note the granules did not crush, but a clear fracture was detected on the bottom side of the shingle. Desaturation of the shingle revealed a fracture in the reinforcement at the impact location.

Based on the results of this testing, we recommend the UL-2218 and ANSI FM-4473 test standards be modified to include solvent extraction of reinforcements when testing asphalt shingles to absolutely determine whether the products have been damaged during testing. This step would prevent asphalt shingles from appearing more hail-impact-resistant than they actually are.
