1981 48 Delta/LeClerq Combination Fishing
"FV: Mattea Marie"

Report of Marine Survey

Report of Condition/Valuation

"FV: Mattea Marie"

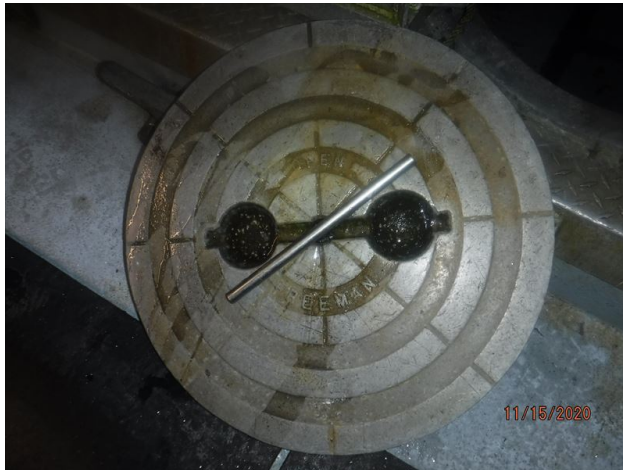
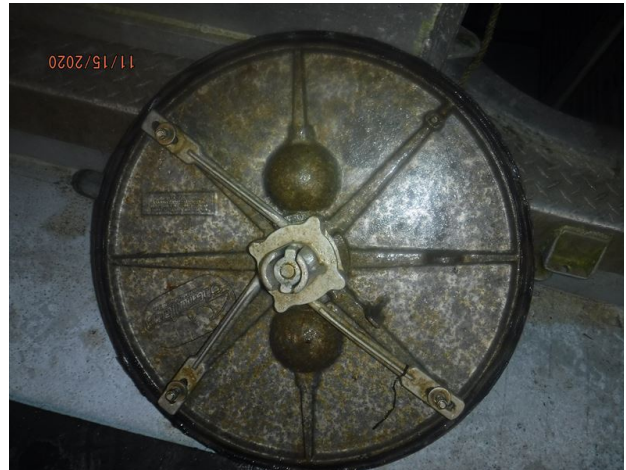
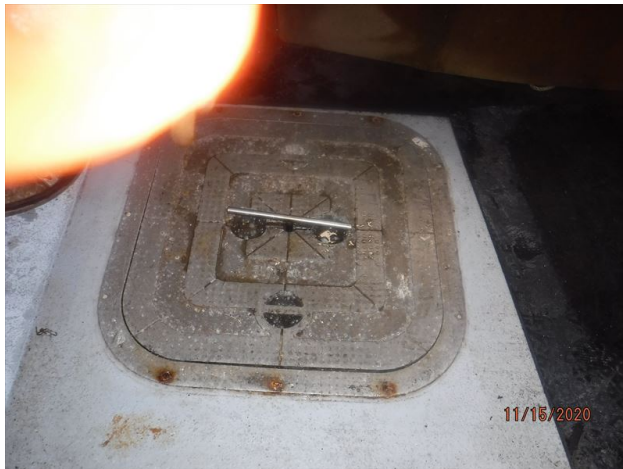
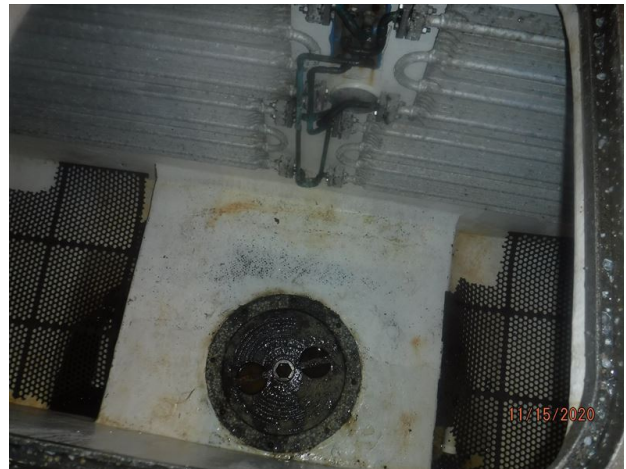
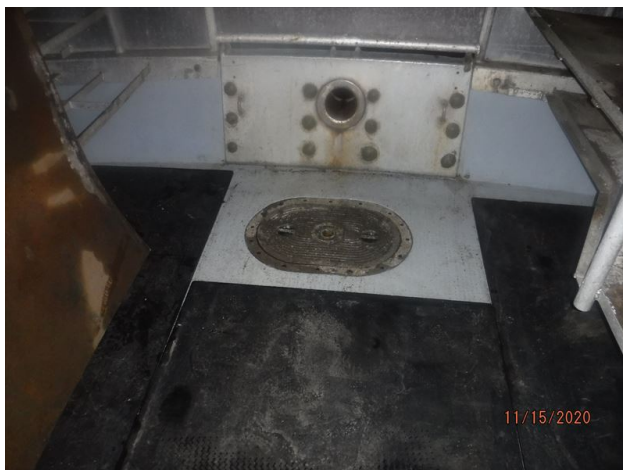
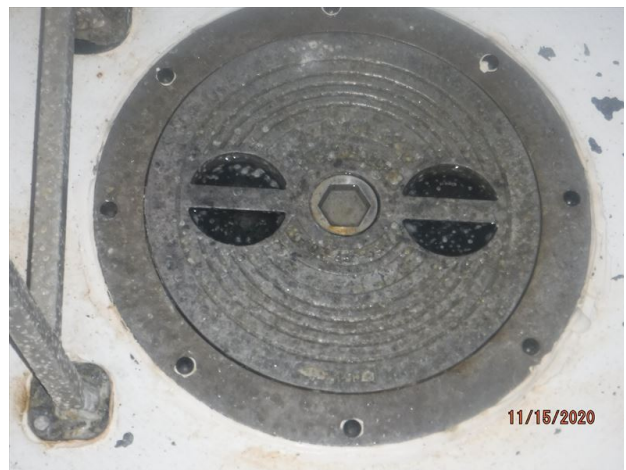
On the foredeck is a flush aluminum escape hatch hose test for signs of leakage, replace gaskets and/or tighten adjustment bolts as needed

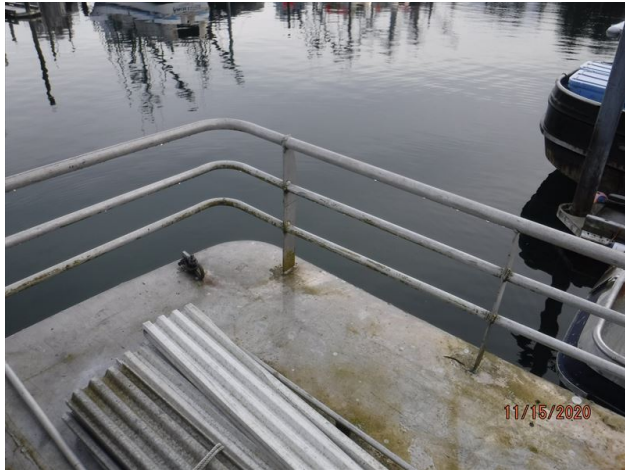
HAND RAILS/GRAB RAILS

Hand rails were located at convenient locations of the vessel. Ladder treads and handholds have been seized for additional grip and traction as needed

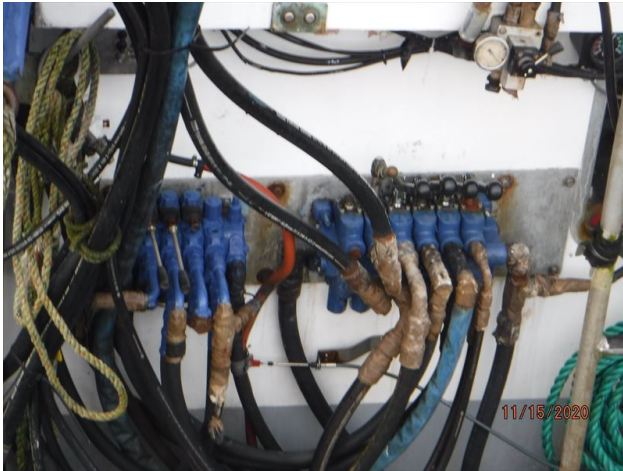
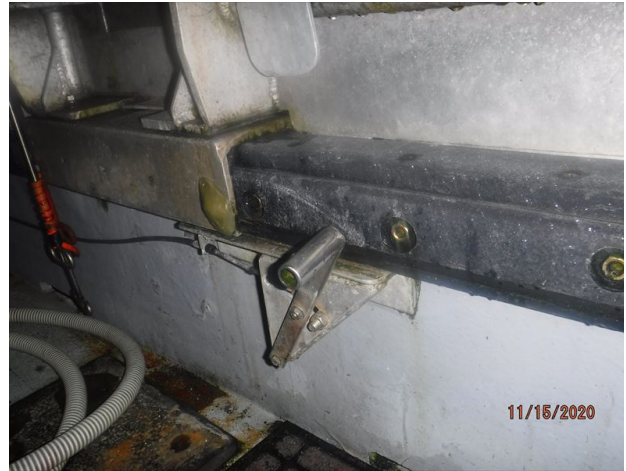
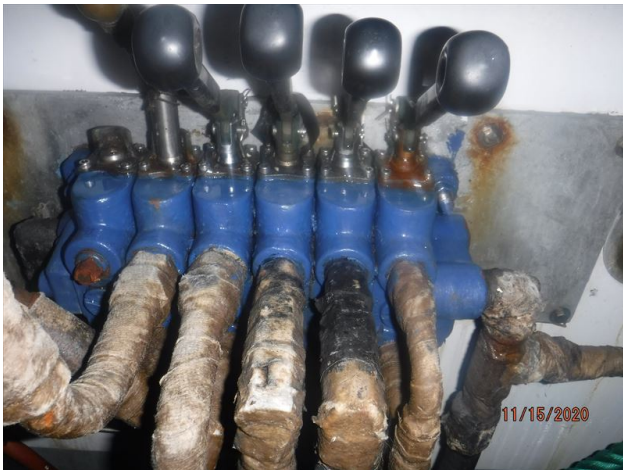
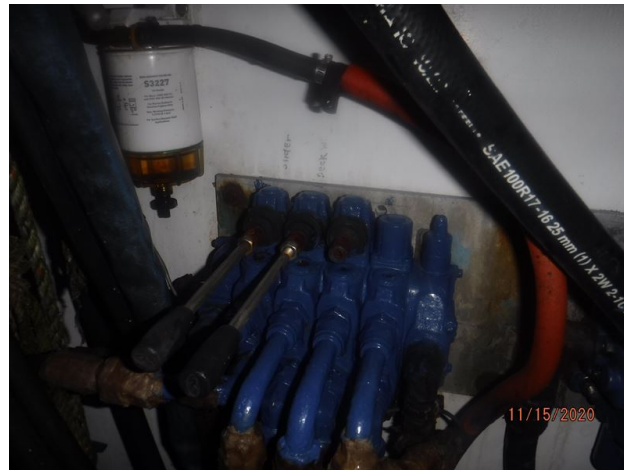
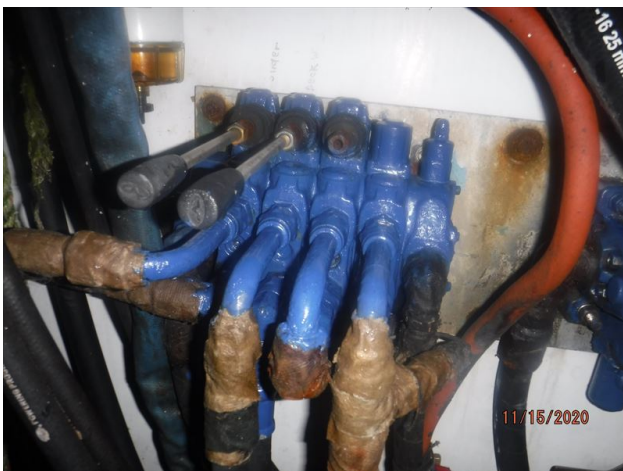
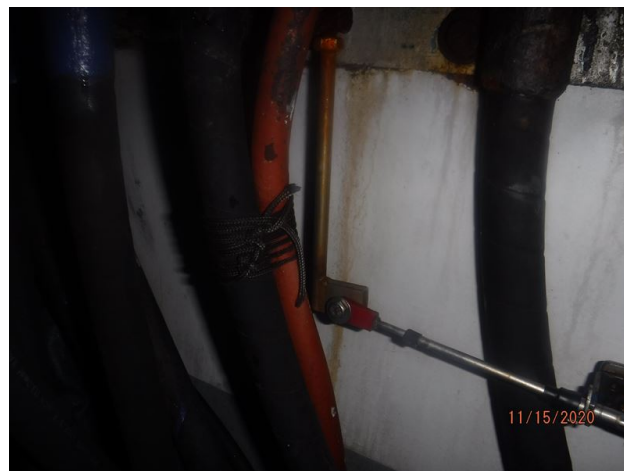
HYDRAULIC VALVES

There are two hydraulic banks on deck. A small side bank and a big bank. The small side is a Valvol 4 spool bank that runs the longline machinery. It can be run by either the cessna or the Commercial Shearing pump. The big bank is a 5 spool Gresen valve that runs all of the seining winches. It can only power up with the Commercial shearing pump. One of the small side levers is remotely activated via a stainless steel knee kick handle and morse cable mounted at the rail.

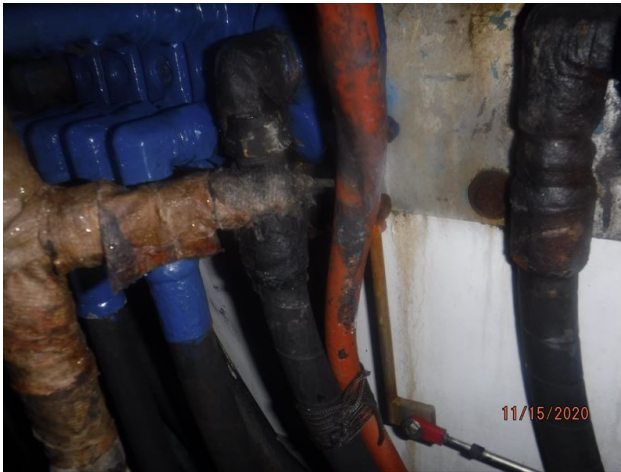
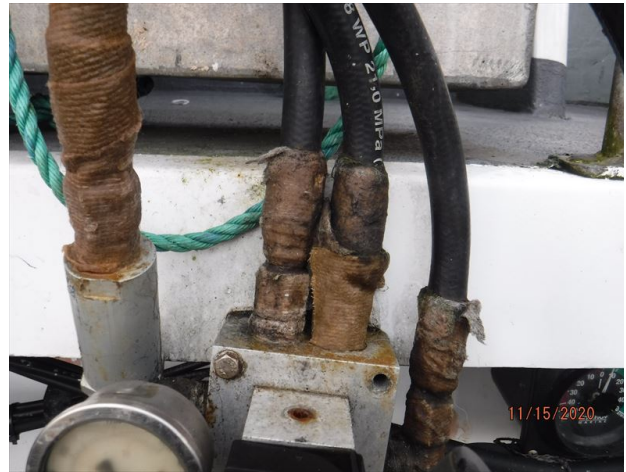
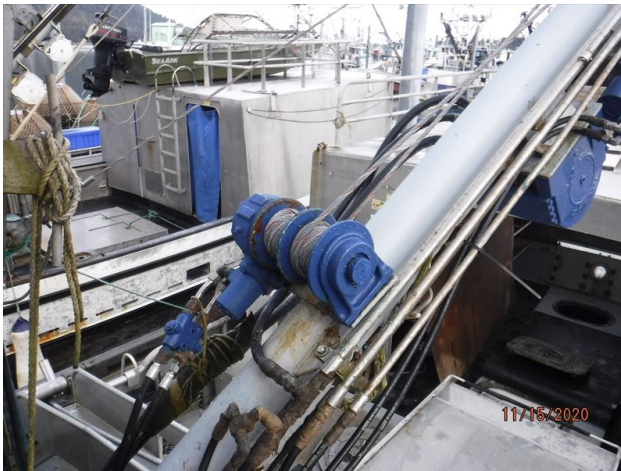
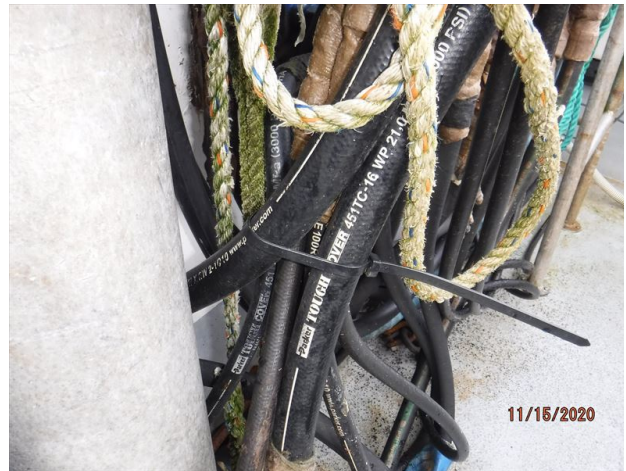
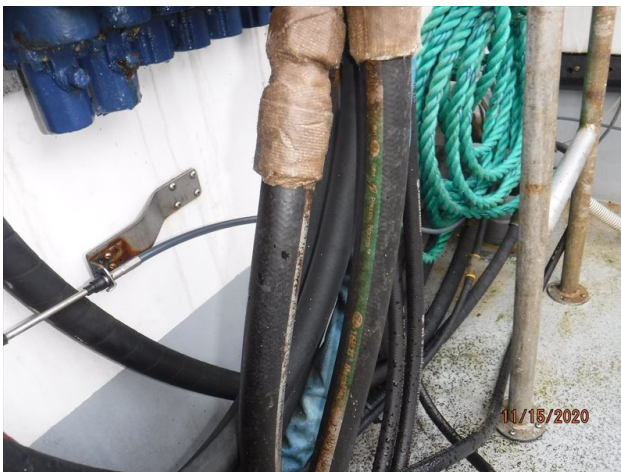
HYDRAULIC LINES/FITTINGS

The small bank is supplied with 1/2" Parker lines, the Gresen bank is supplied with 1" Parker Tough cover and 3/4" to the winches. Stainless steel pipe and tubing along the main boom. All of the hose ends and fittings are wrapped in Denzo. There is chaffing gear where needed.

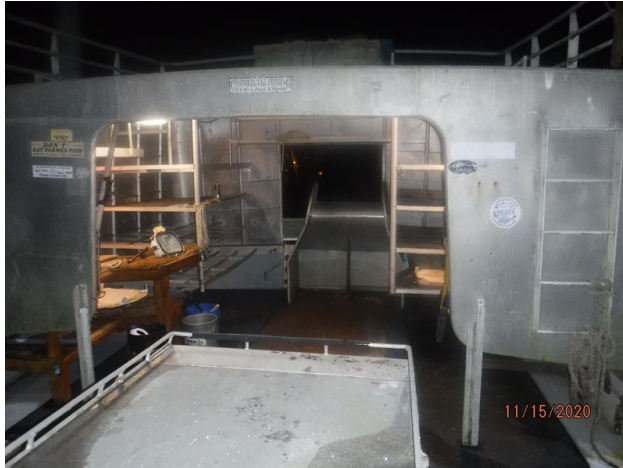
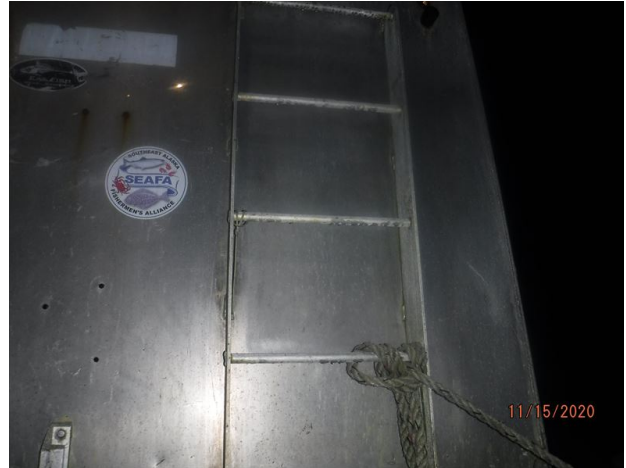
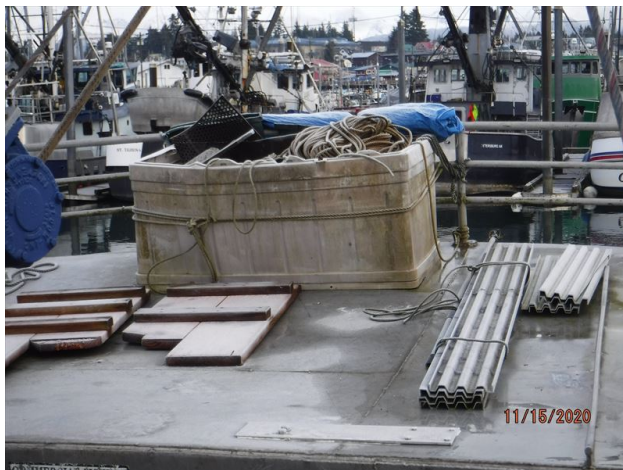
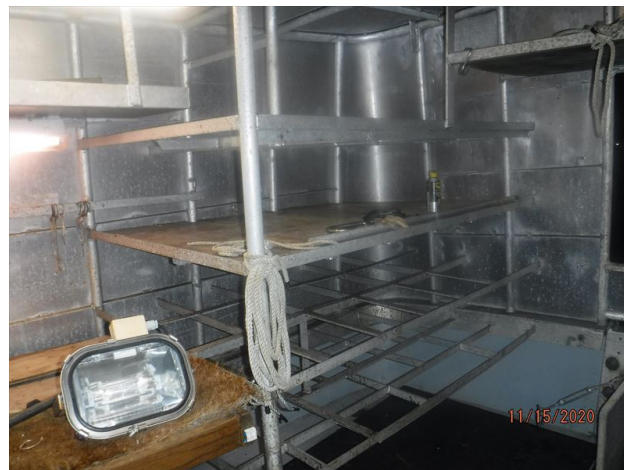
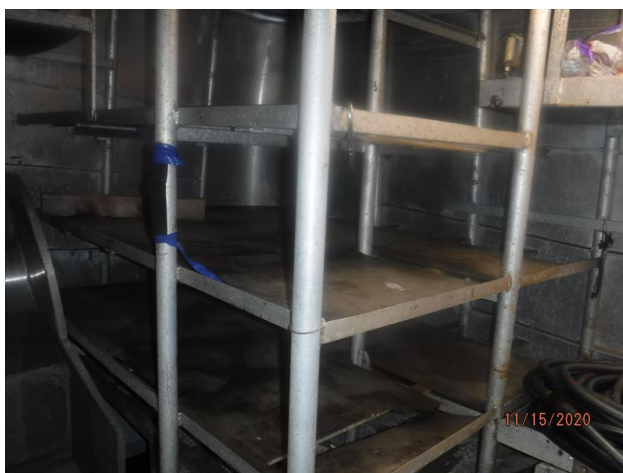
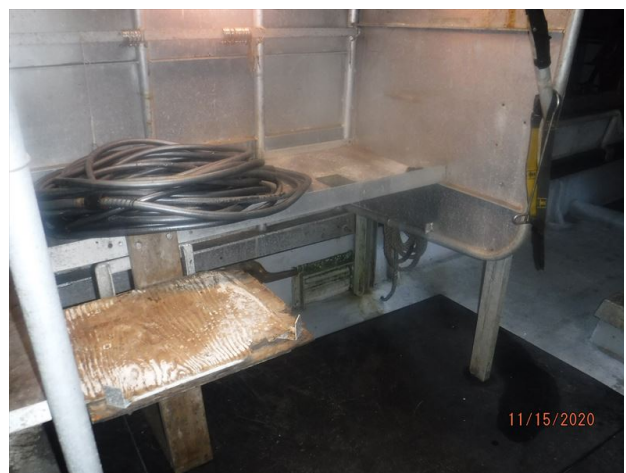
BAIT SHED

Aluminum tent open fore and aft with storage and safety railing above. Accommodates baiting stations for two crew, one each port and starboard. Port and starboard tub racks 13" high and 3 deep Port side, 2 deep starboard side. Wired with 110 vdc light fixtures. Stern opening and deck accommodates a double setting shoot.

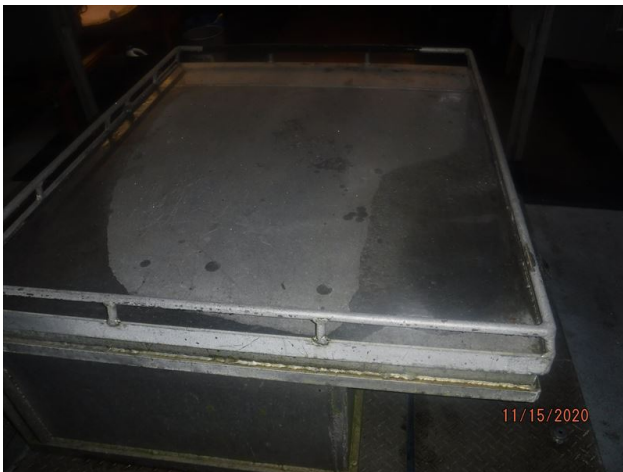
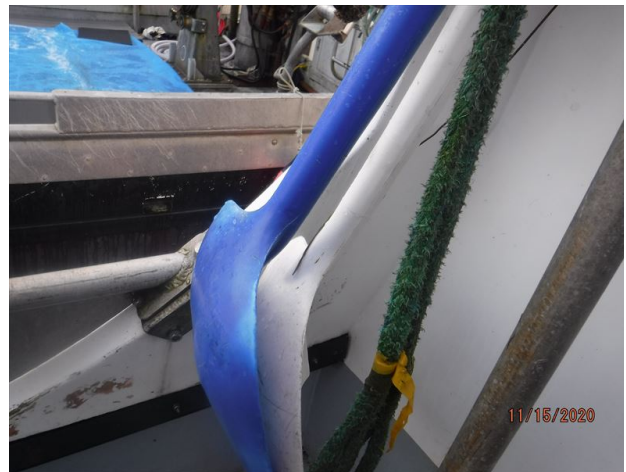
PROCESSING TABLE

The processing table is 4.9 x 4. It is mounted on the hatch cover giving the aft edge of the table a working height of 32". Ice shovels

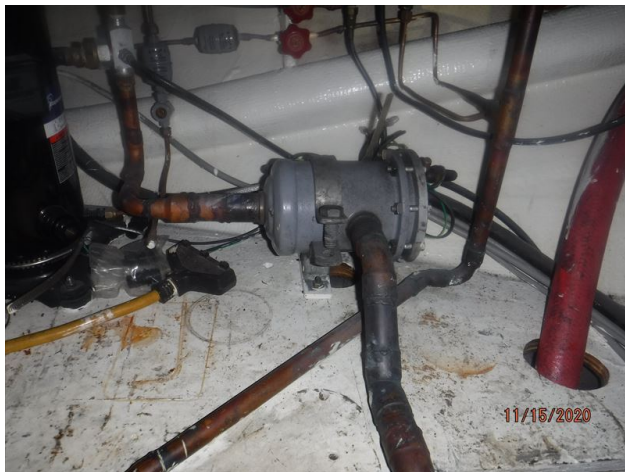
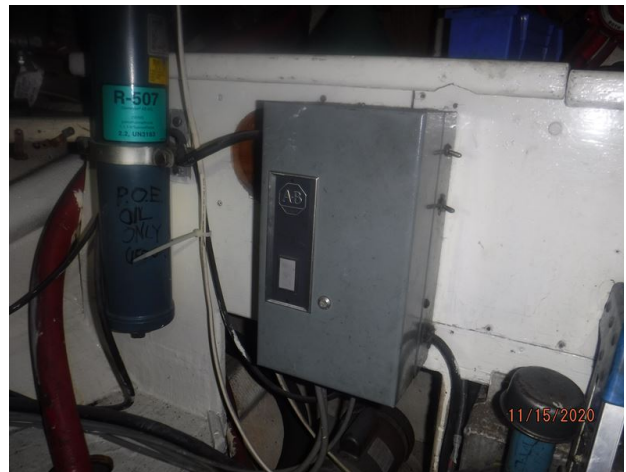
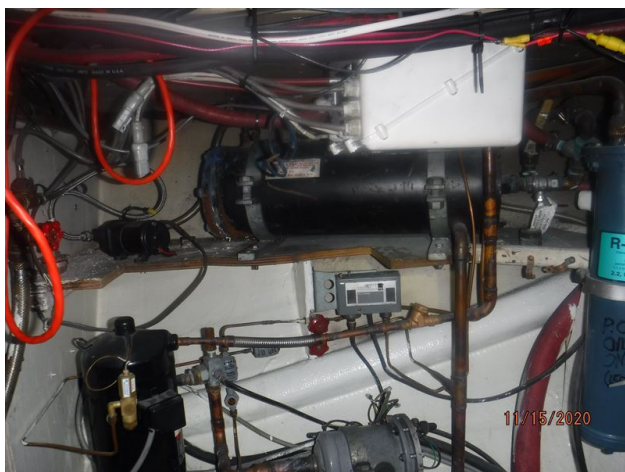
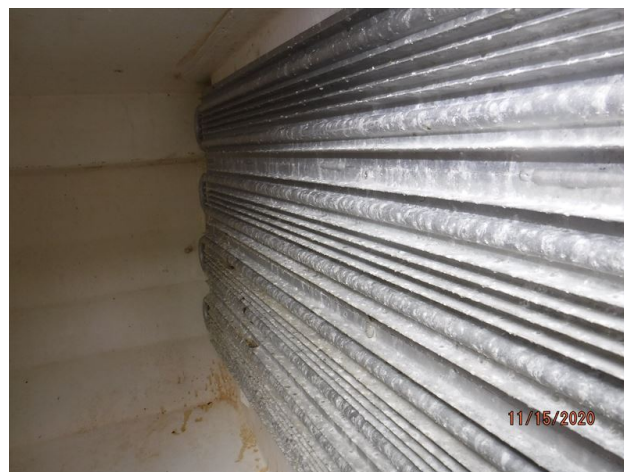
PRODUCT REFRIGERATION (ICE, RSW, PLATES, BLAST)

There are freezer coils/plates in the bait hold by Custom Fleet Refrigeration.

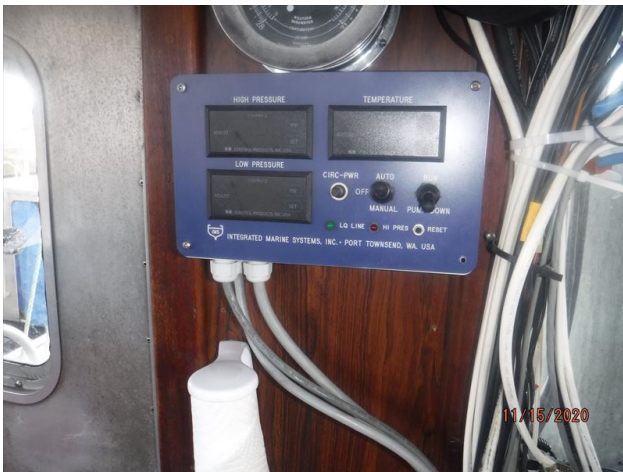
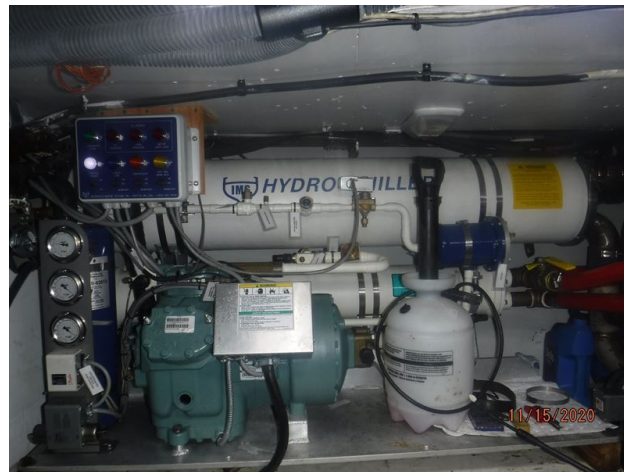
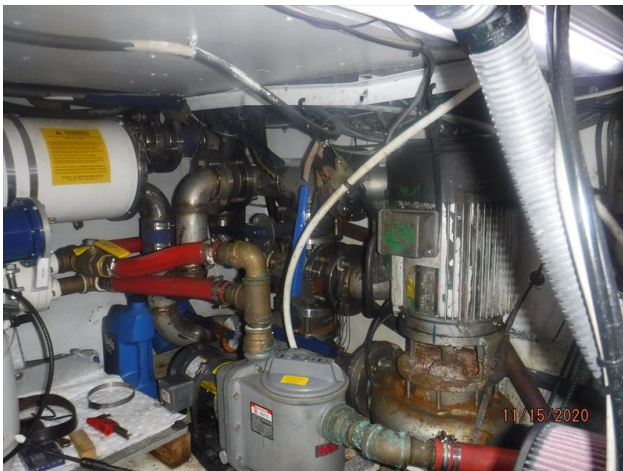
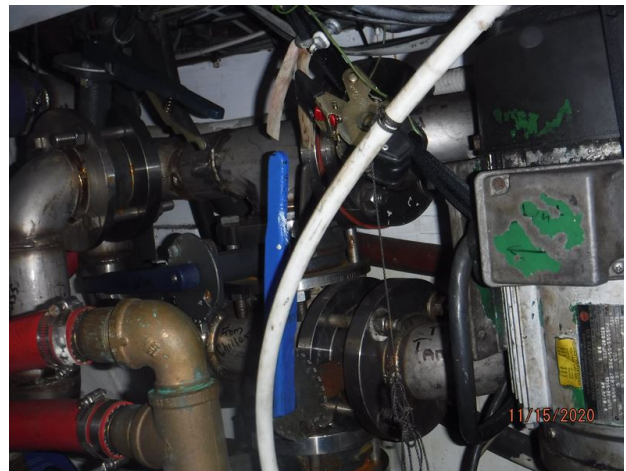
The main hold is plumbed for RSW. THE RSW system is an IMS (Integrated Marine Systems) 18 ton, reportedly new in 2014. Remote control box at the helm

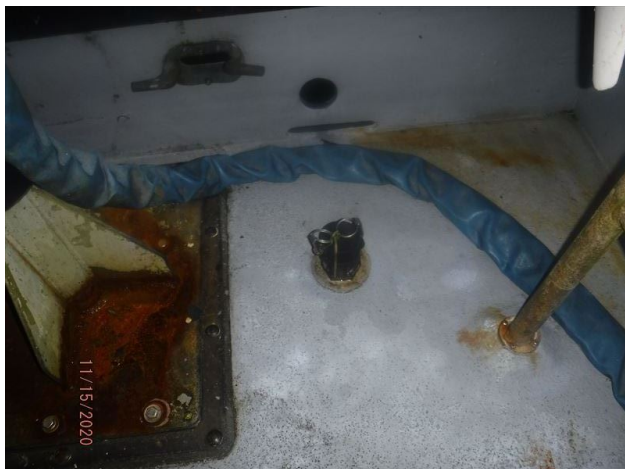
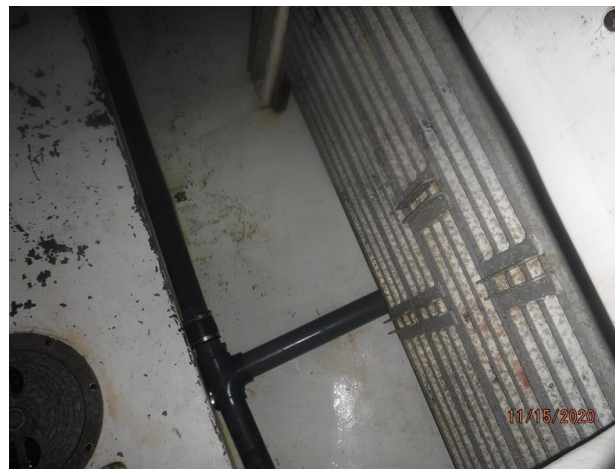
FISH HOLDS AND HATCH COVERS

Two (2) A tanked insulated RSW main hold with 40k capacity, and an aft bait hold insulated with coil refrigeration, sumped. 10,000 lbs capacity. The main hold is also plumbed with an additional deep water circulation inlet for pumping deep water onto certain species of live crab and shrimp

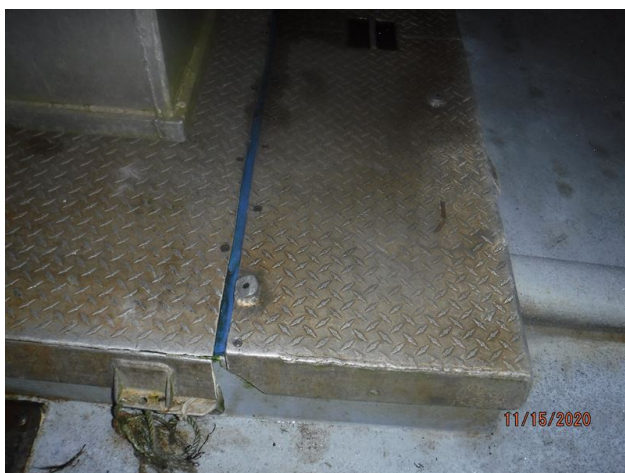
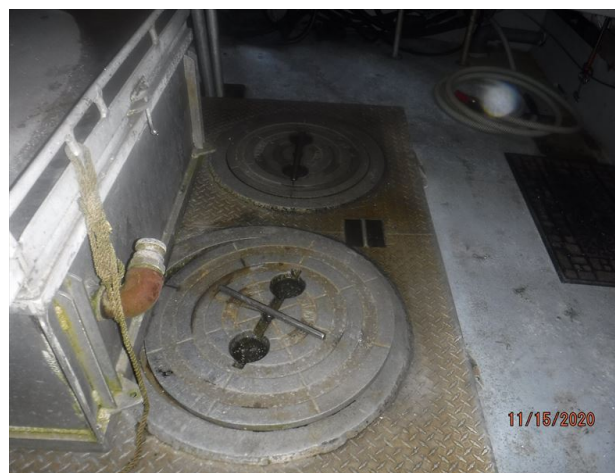
HATCH COVERS

Aluminum cover with mounted processing table. Two round Freeman access hole flush hatches inset on the starboard side of the main hatch. The port side of the hatch is hinged

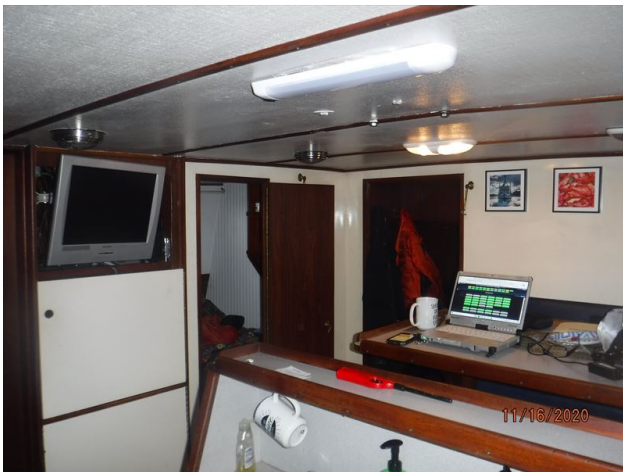
GALLEY ARRANGEMENT

The Galley was located starboard side aft in the cabin. Entrance is via a double Dutch aluminum and dogged door. The galley sole is a step below the work deck. The entrance step is a diamond plate aluminum storage box. There is a double sink and counter forward. A pantry with TV above to port. A refrigerator/work station and an oil burning oven are aft in the galley. The stove cook top is integral to the oven.

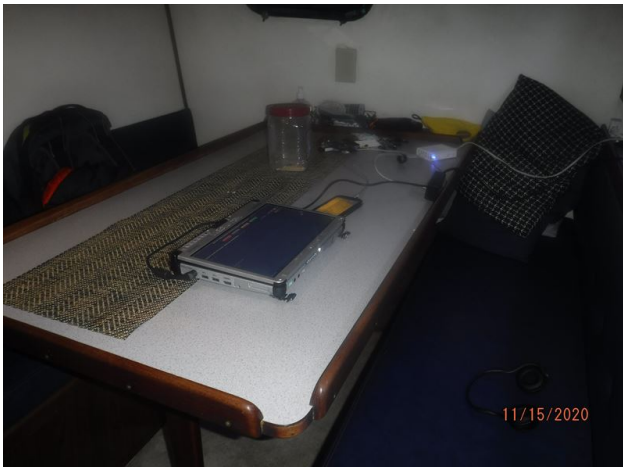
ACCOMMODATION ARRANGEMENT

In the focsle step down and are found 4 stacked v bunks with shelves and adequate storage lockers for each
The master stateroom has a double bunk with book shelves forward and clothing/personal gear shelves aft
In the top house is a day bunk

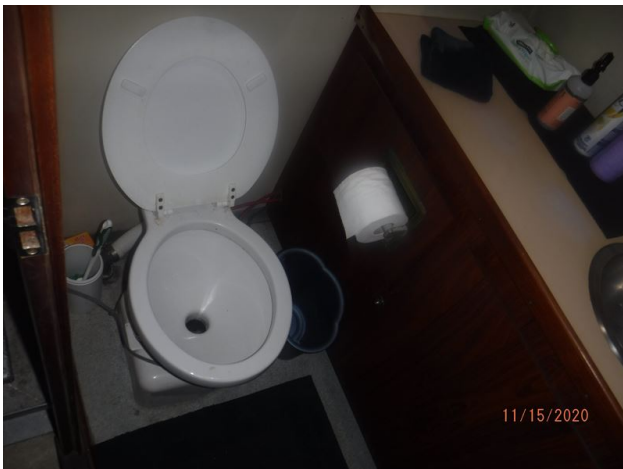
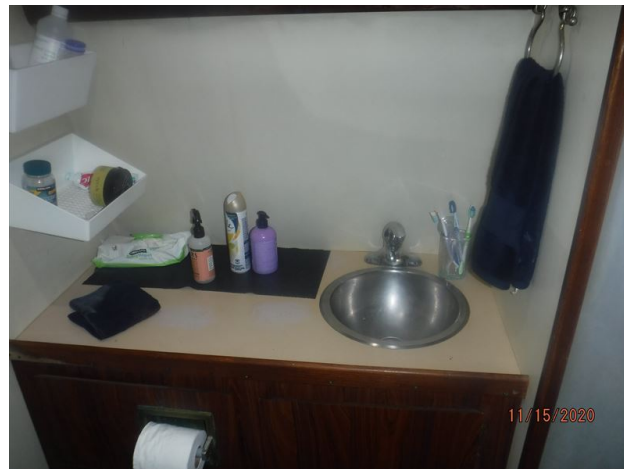
SHOWER ARRANGEMENT

Stall shower in the Head.

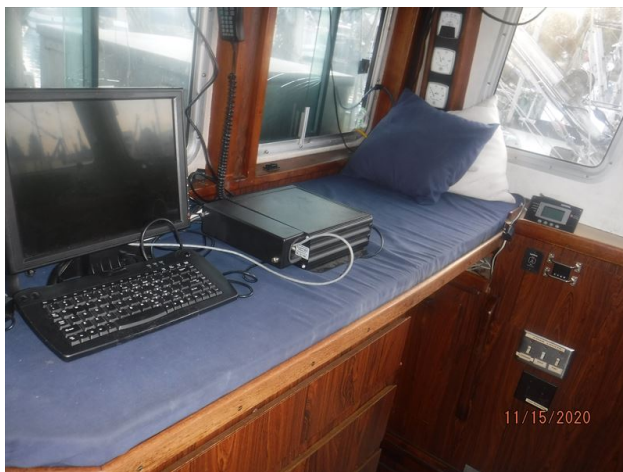
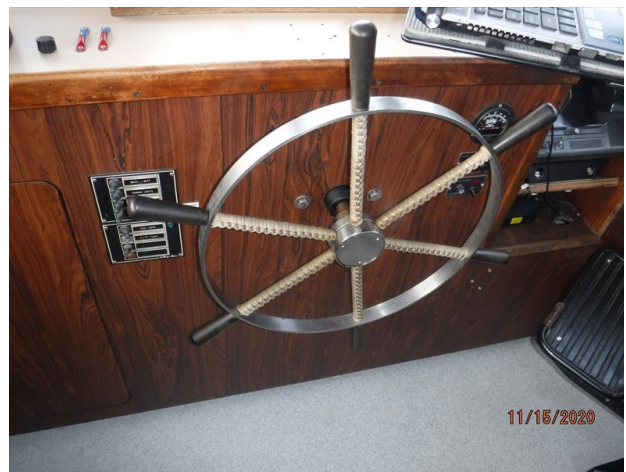
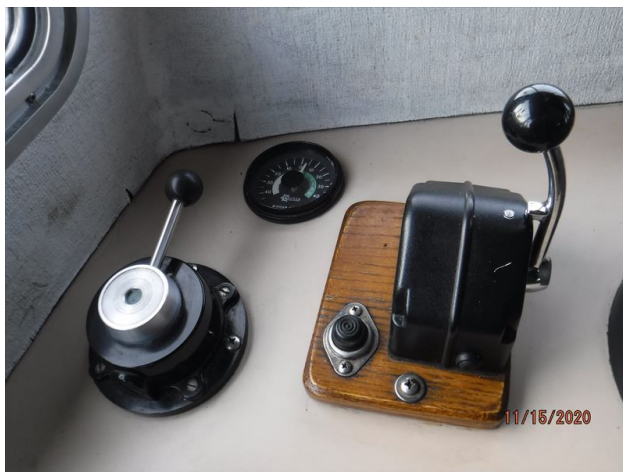
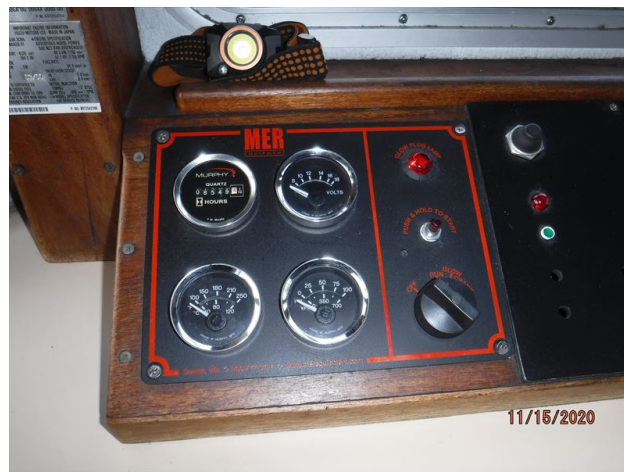
HELM STATION (PILOT HOUSE)

Raised top house with a day bunk, ***** helm chair, full modern electronics, manual and automatic hydraulic steering, electronic engine controls, engine monitors (digital and analog) for both the genset and the main, refrigeration monitor and control panel, all alarm systems, 110volt and 12 volt breaker panels.

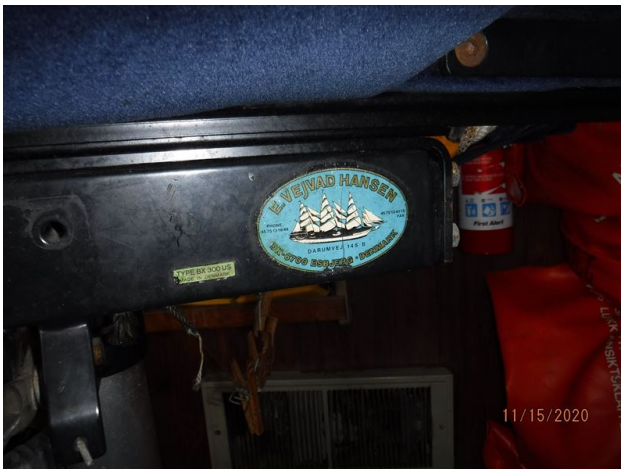
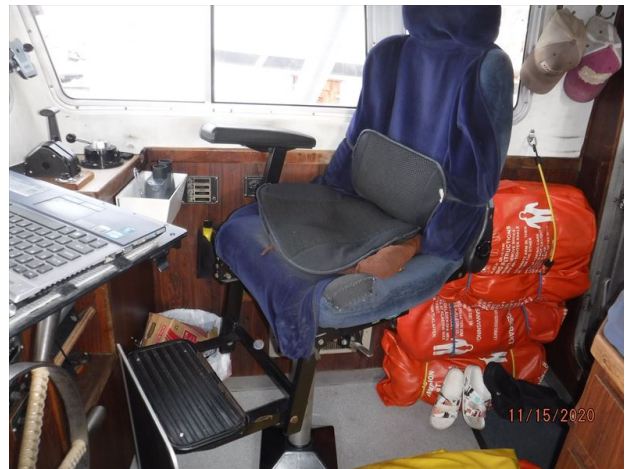
INTERIOR CABINETRY & TRIM

The interior Satin finished Mahogany cabinetry and trim appeared serviceable.

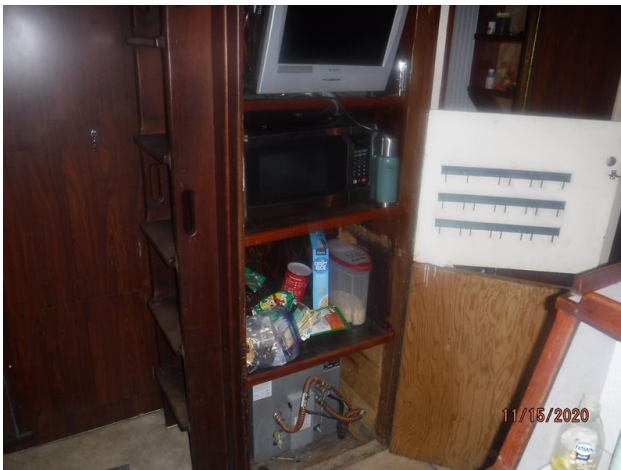
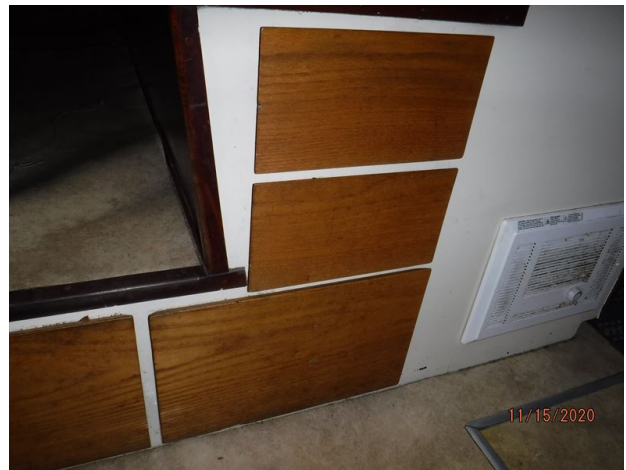
INTERIOR STORAGE

The cabinets, lockers, drawers and shelving appeared serviceable, where sighted. There is a pantry to port. The settee has storage drawers on the face. In the galley there is ample storage for pots and pans, dishes /cups appliance and staples

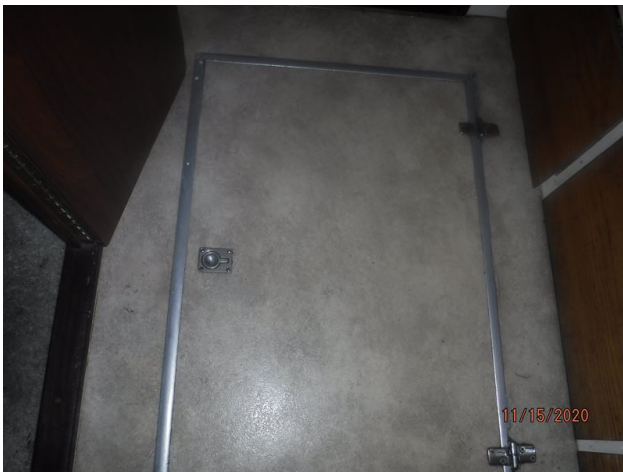
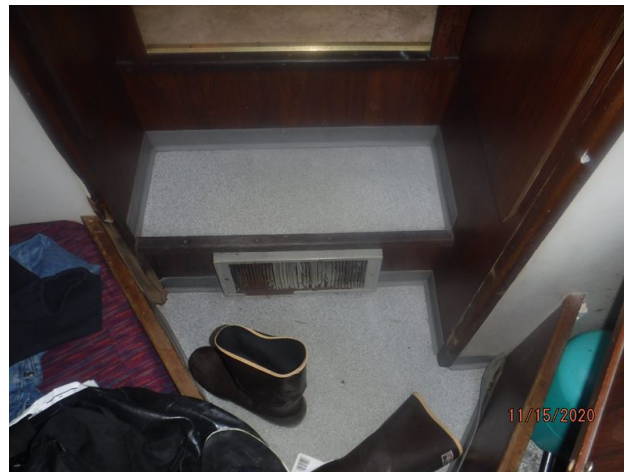
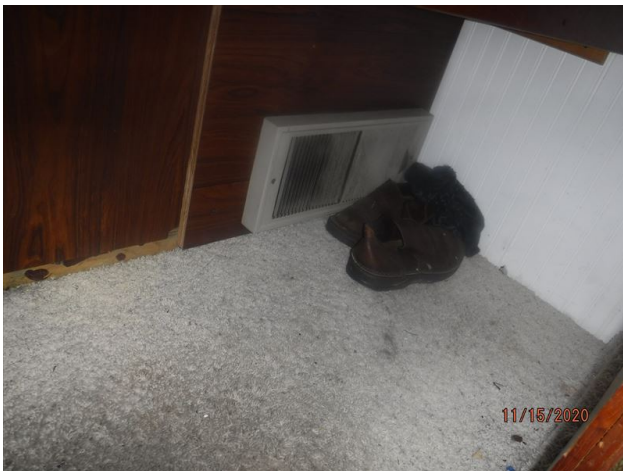
FLOORING

Linoleum, in the cabin and focsle, carpet in the master stateroom

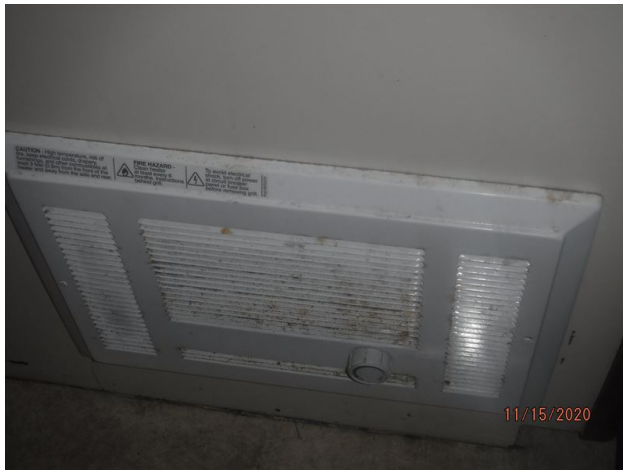
CABIN HEATING SYSTEM

Dickinson oil stove 110 vac units through out. All demonstrated

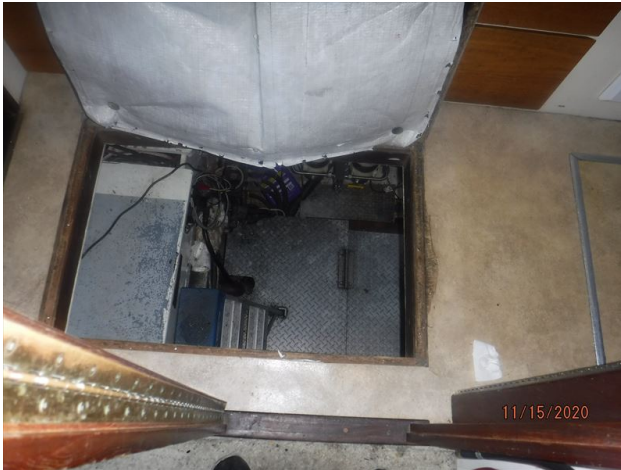
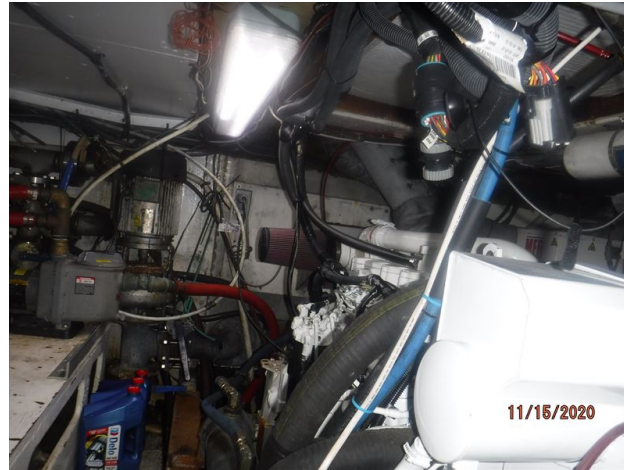
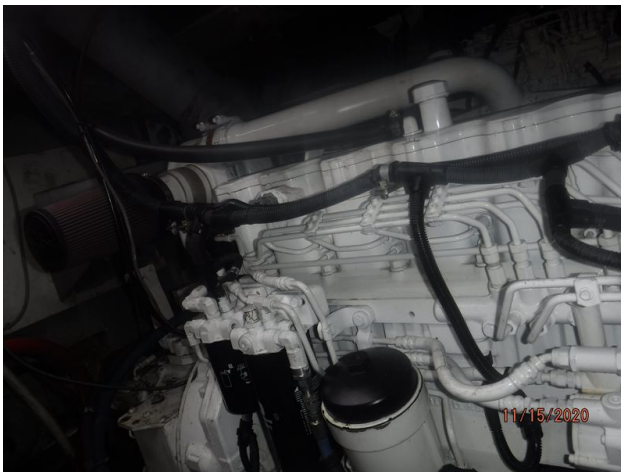
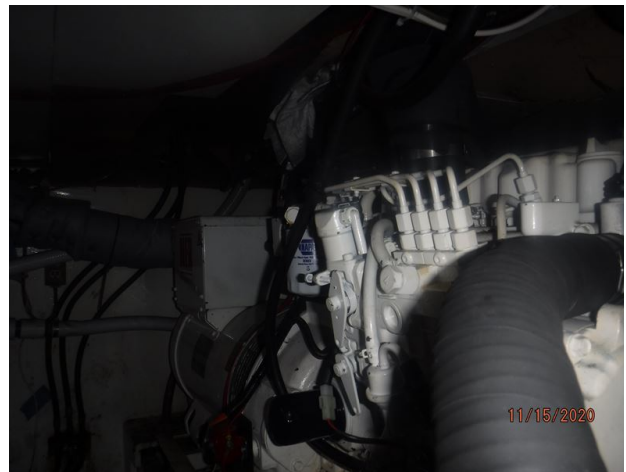
ENGINE MODEL

John Deere 6081 Marine Power Turbo after cooled

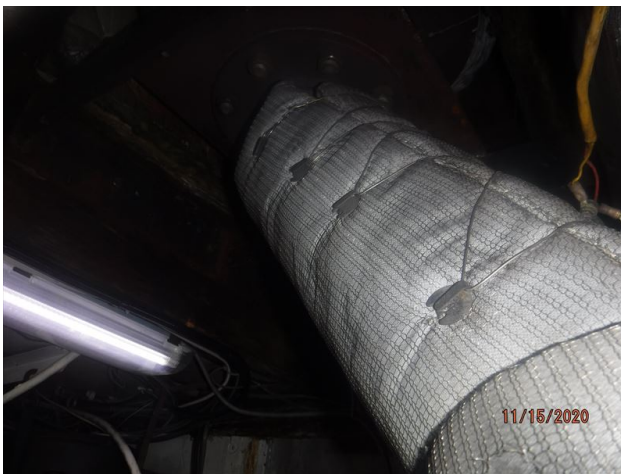
ENGINE EXHAUST SYSTEM

Steel exhaust to the muffler, insulated in blankets

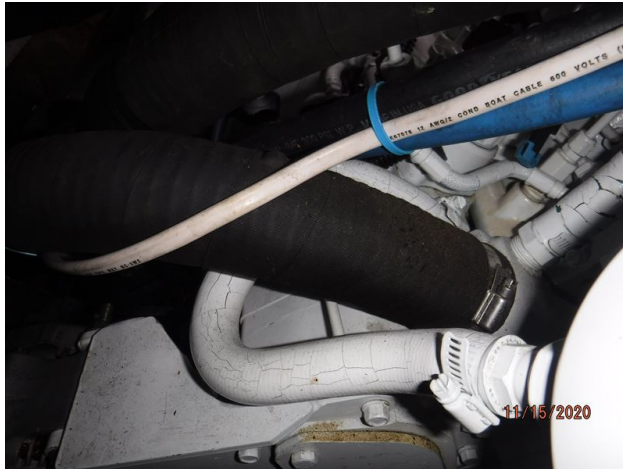
FINDING B-1

The cooling hoses were blistered, worn

Inspect all hoses and replace the hoses with appropriate type, as necessary.

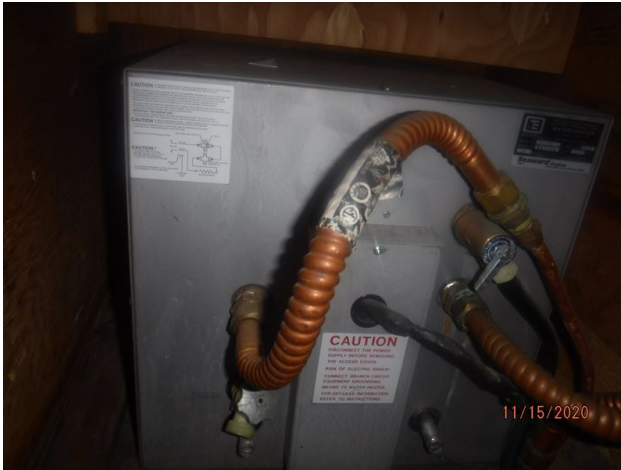
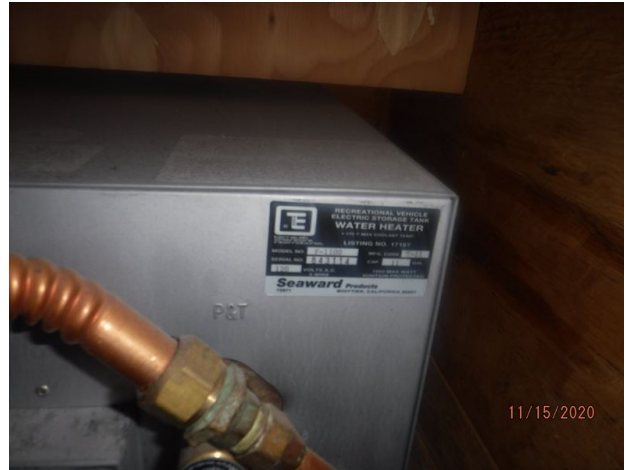
WATER HEATER

Seaward Products (Stainless Steel). In the galley pantry

Marine Grade 120 volt.

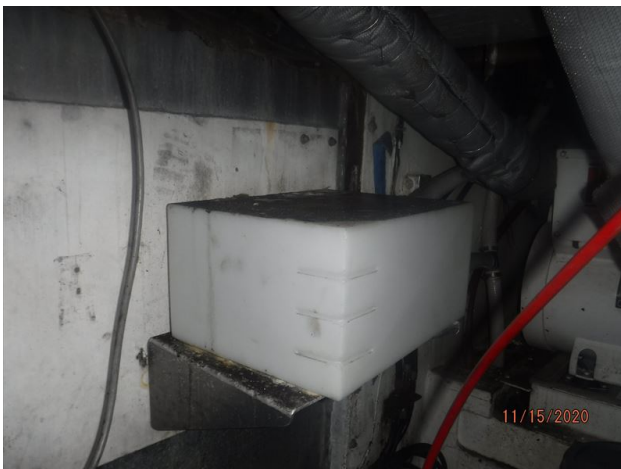
BLACKWATER TANKAGE

Polyethylene Blackwater (sewage) holding tank.

FINDING C-3

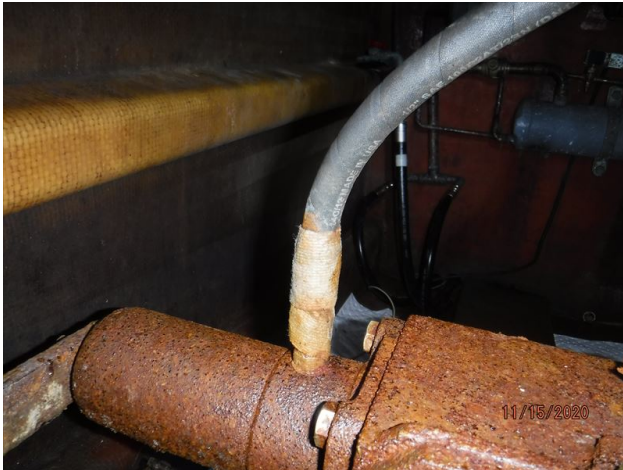
STEERING SYSTEM ACTUATORS

T-ram the steering ram appeared to be well secured.

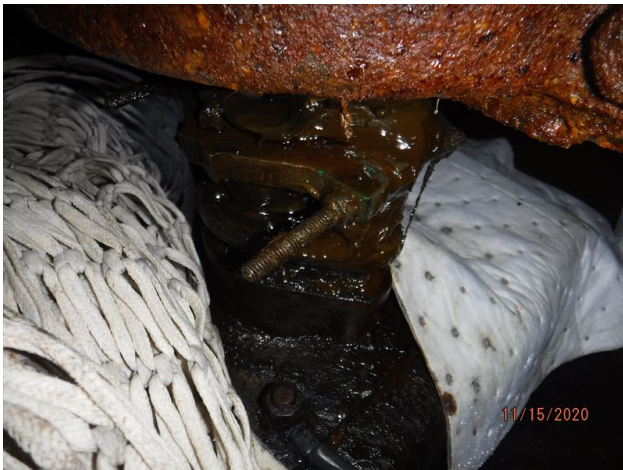
RUDDER LOG PACKING GLANDS

Bronze hex nut type packing glands appeared serviceable. Monitor frequently.

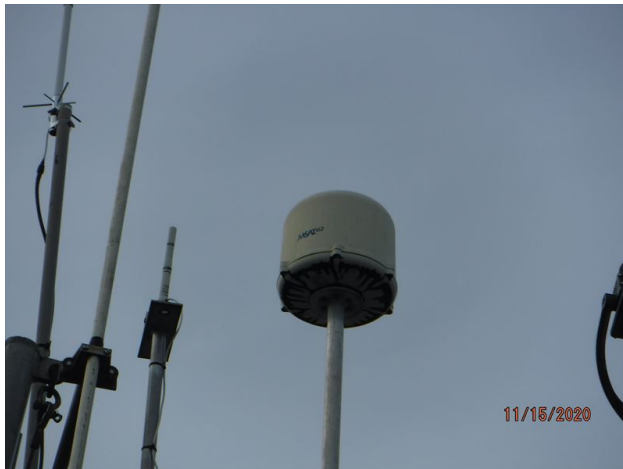
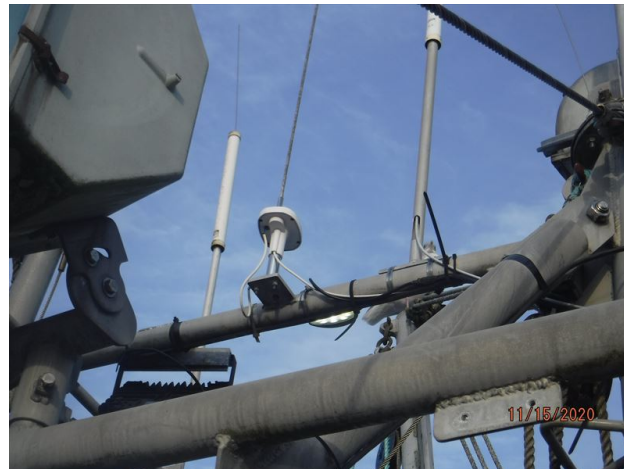
ANTENNAS

The antennas appeared to be well mounted, where sighted (observed from deck level).

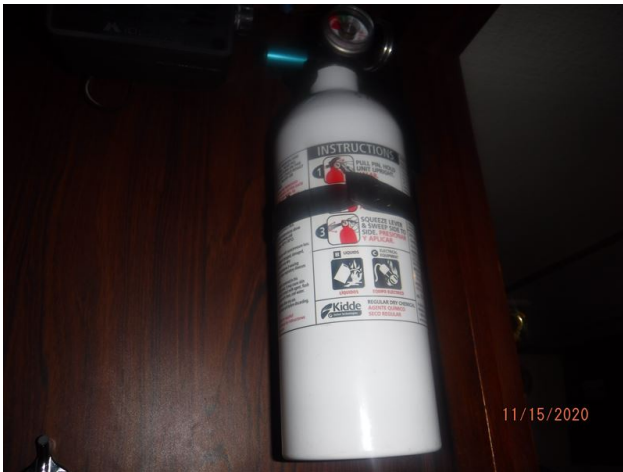
FIRE EXTINGUISHERS (46 CFR 25)

Four (4) Type ABC-I 2.5 lb. Dry Chemical.

FINDING C-4

Check www.fishsafewest.com for the Bullitan. " On November 2, 2017, Kidde issued a voluntary recall, REF (A), of two styles of disposable fire extinguishers that identified 142 models of Kidde fire extinguishers with plastic handles or push button indicators manufactured between January 1, 1973 and September 22, 2017; these extinguishers can become clogged or require excessive force to discharge and can fail to activate during a fire emergency. In addition, the nozzle can detach with enough force to pose an impact hazard.

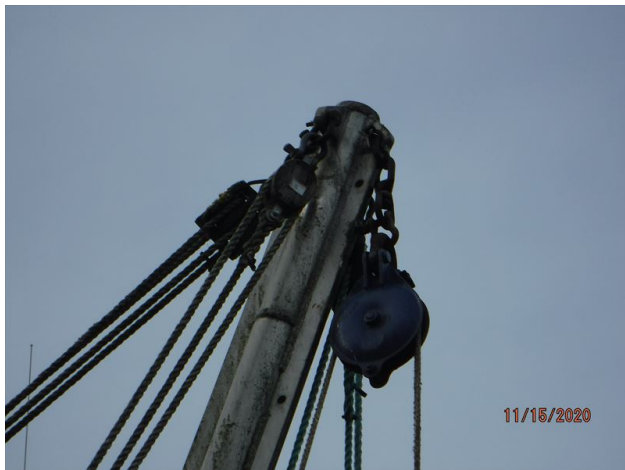
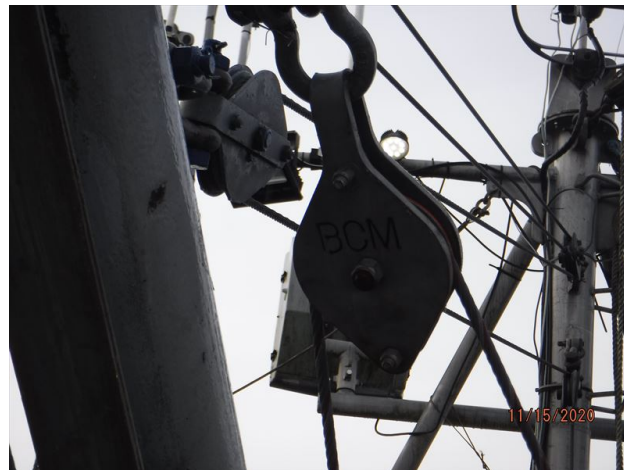
SWIVEL BLOCKS

Heavy duty steel, and wood. Some of the wooden blocks appear to be nearing the end of serviceable life, weathered.

Replace the blocks

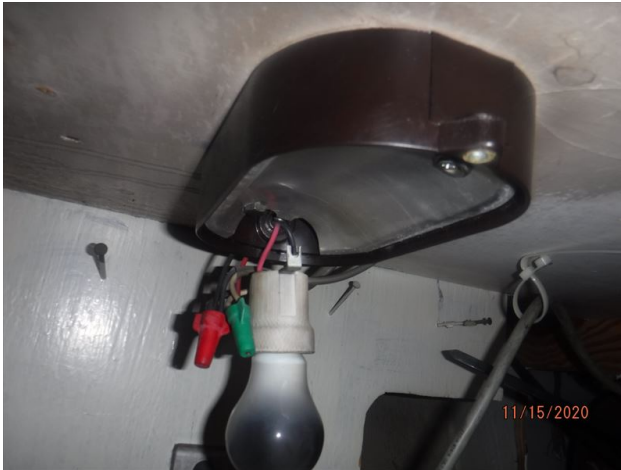
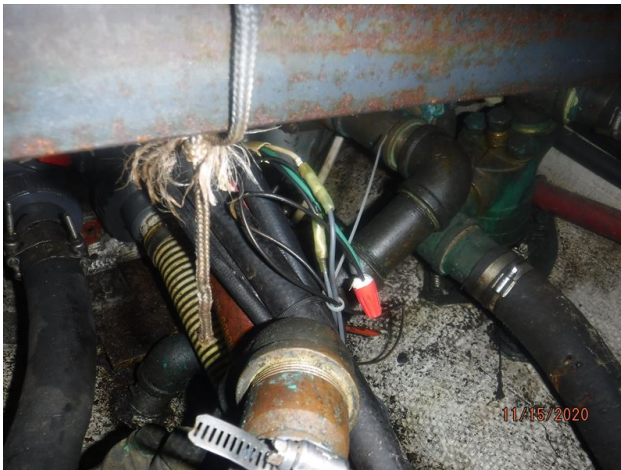
DC ELECTRICAL/WIRING COMMENTS (ABYC E-11)

Appeared to be well supported and secured, where sighted some exceptions were observed (see Findings Appendix).

Replace wire nut connections with Marine Grade insulated butt connections (wire nuts are approved for solid household type wiring only).

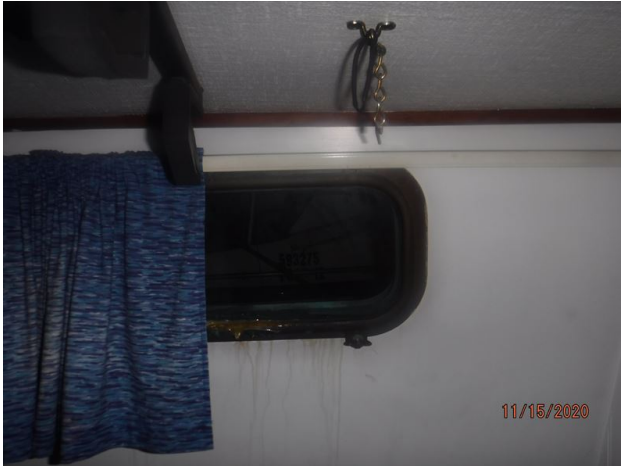
Master stateroom port light is exhibiting signs of possible leakage

Investigate further, and service, repair or replace as necessary.
