Inspection Report

100 Main Drive
Sedona AZ 86336

"Almost Home" Inspection Services LLC

Date: 11/30/2020	Time: 09:00 AM	Report ID: Example Report
Property: 100 Main Drive Sedona AZ 86336	Customer:	Real Estate Professional:

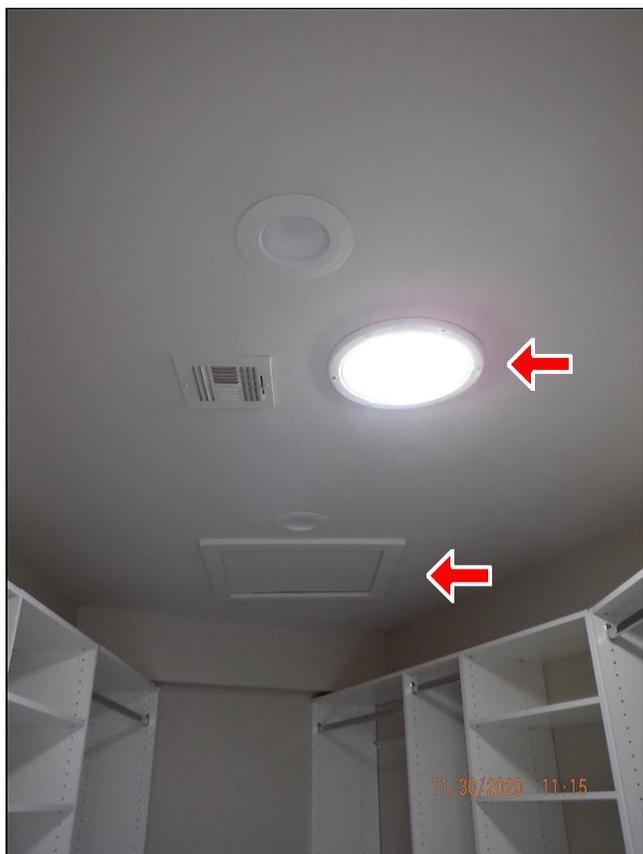
A. Item 1(Picture)

A. (1) The guest bedroom closet has a ceiling attic access door and a skylight.

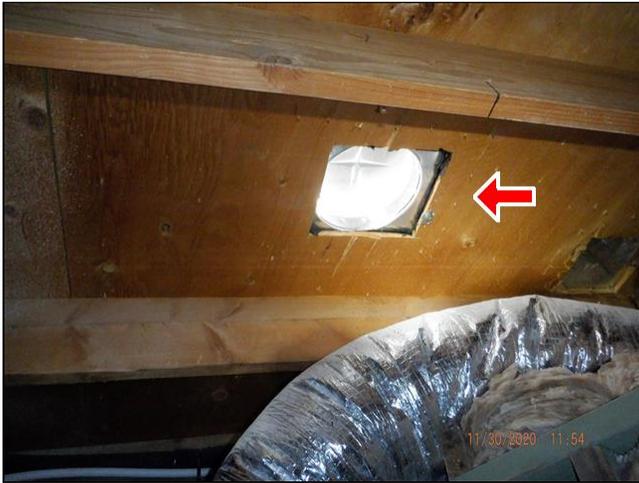
E. Item 1(Picture)

E. The attic had roof and soffit vents installed.

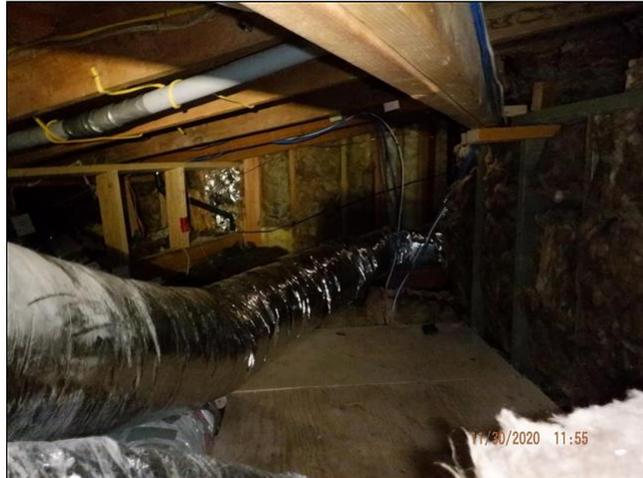
I. Item 2(Picture)

I. The attic floor insulation depth averaged approximately 8 to 10 inches. The Inspector always recommends the consideration of installing additional insulation.

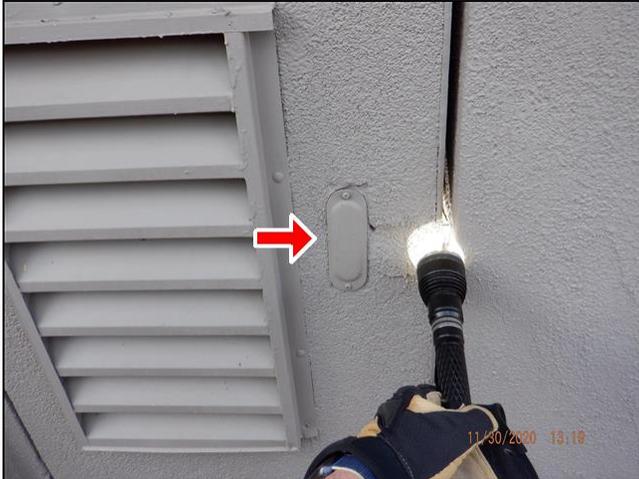
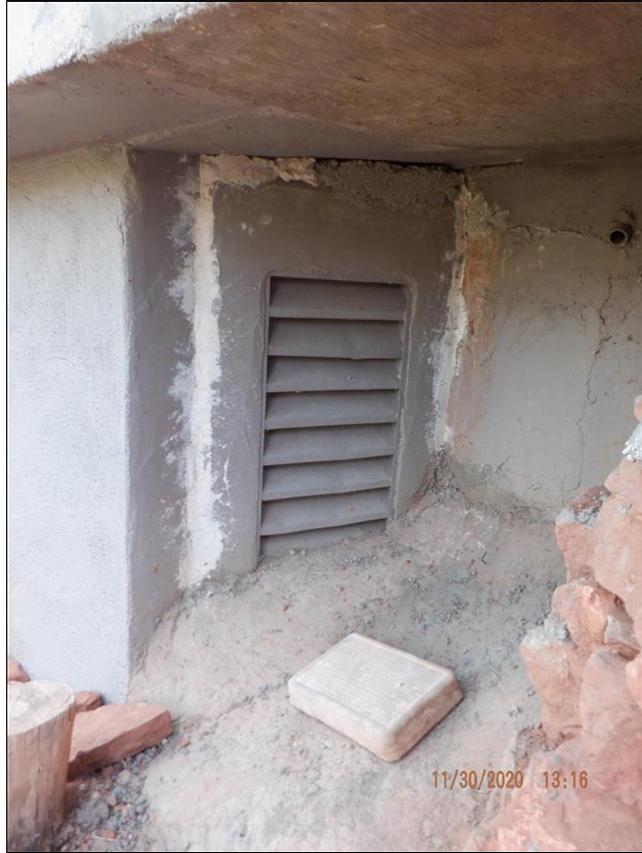
F. There is a crawlspace under the back of the main house. This door probably provides access, but the latch bolt was not operable. The Seller should demonstrate it's operation to the Buyer. The Inspector could not inspect this crawlspace.

F. Item 2(Picture) crawlspace vent

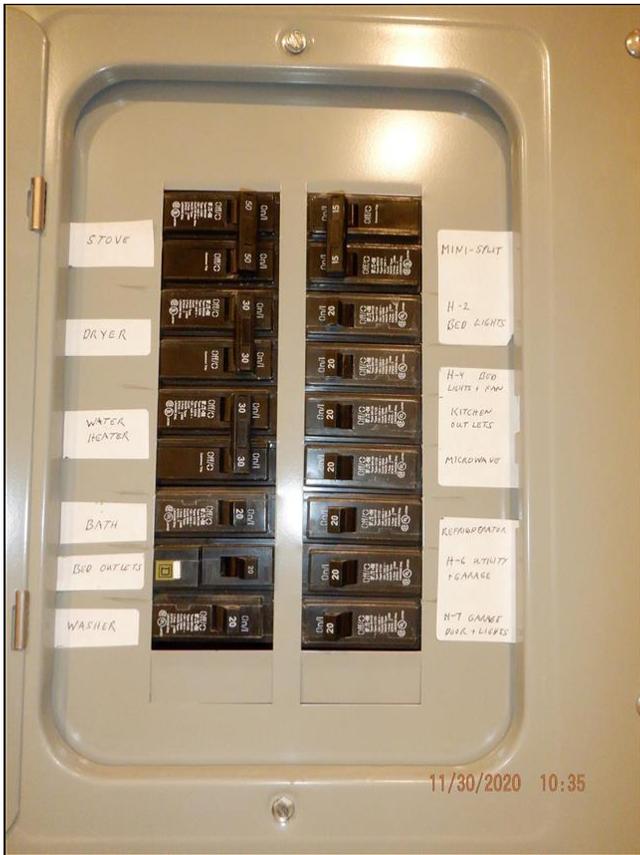
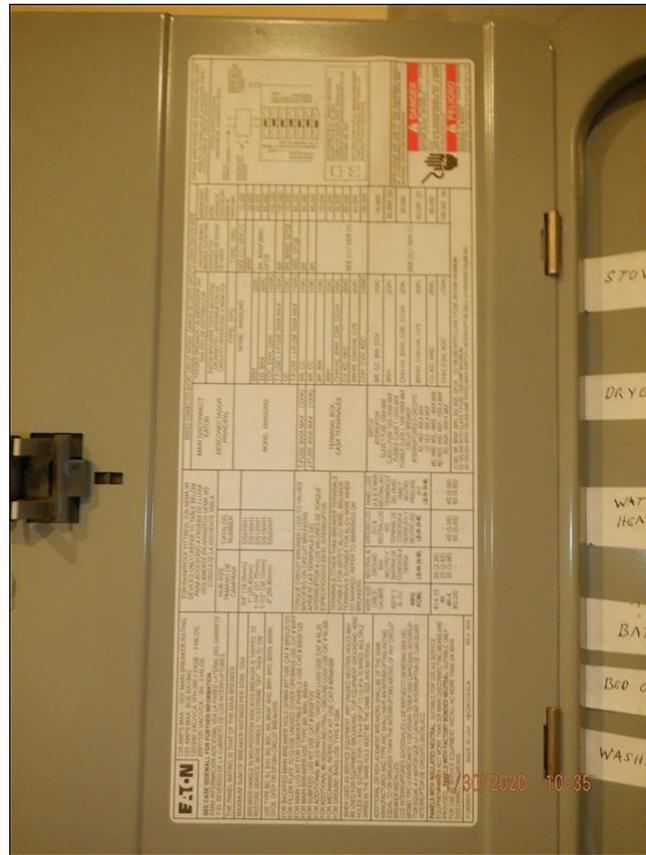
R. (1) This sub-panel in the home's garage hallway is new and appears to be well marked.

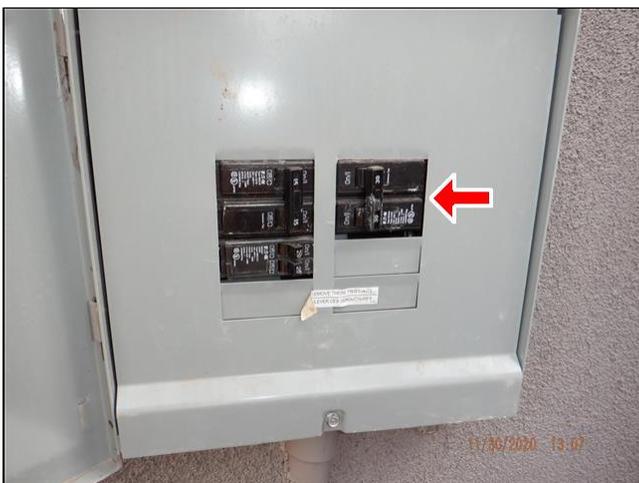
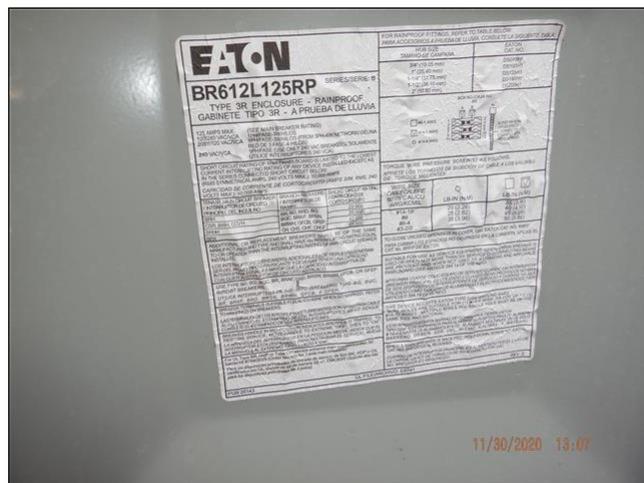
⚠️ (3) This small sub-panel services the guest house. The circuits need to be labeled for safety. A competent electrician can address this item. The 30 amp 240 volt circuit breaker was off at the time of the inspection. This circuit may service the electrical water heater that is located under the guest house. The Inspector could not turn on this circuit, to check it, due to liability concerns.

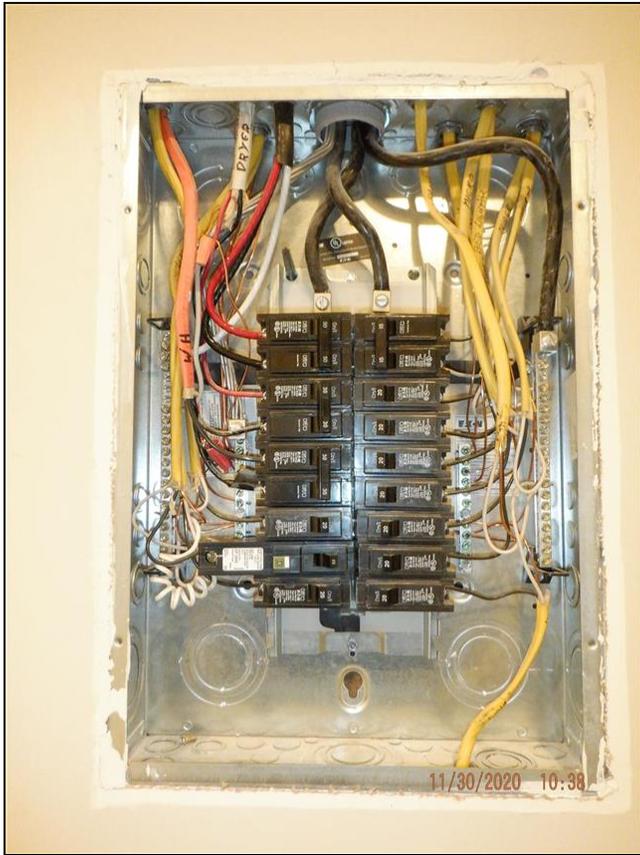
S. Item 1(Picture)

S. (1) This sub-panel in the garage hallway appears to be wired correctly. Kill power to this panel at the main panel on the east exterior wall of the home.

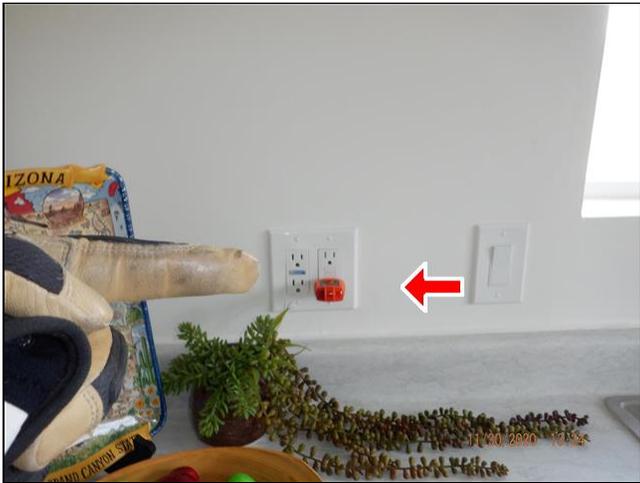
V. Item 1(Picture)

V. This GFCI receptacle in the basement suite was the protection/reset for a adjacent exterior receptacle.

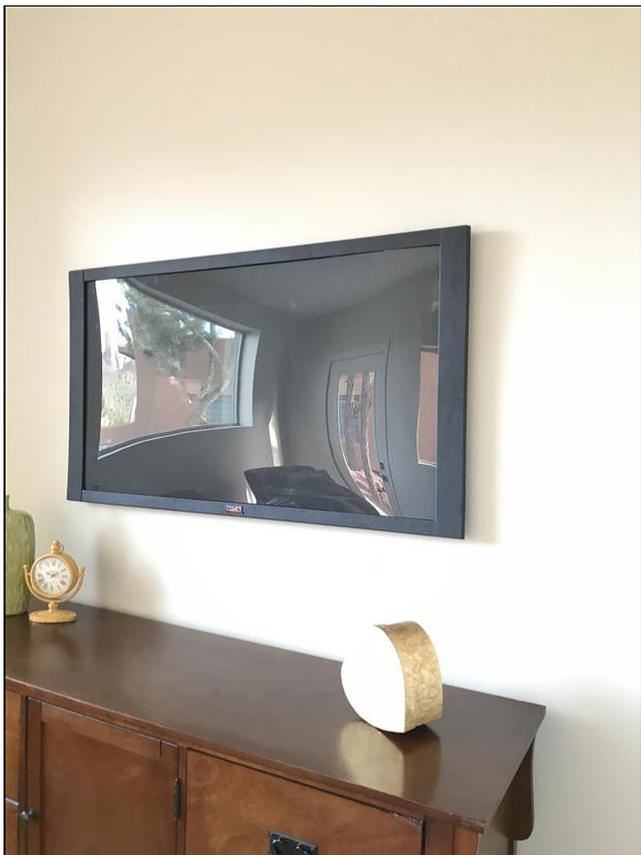
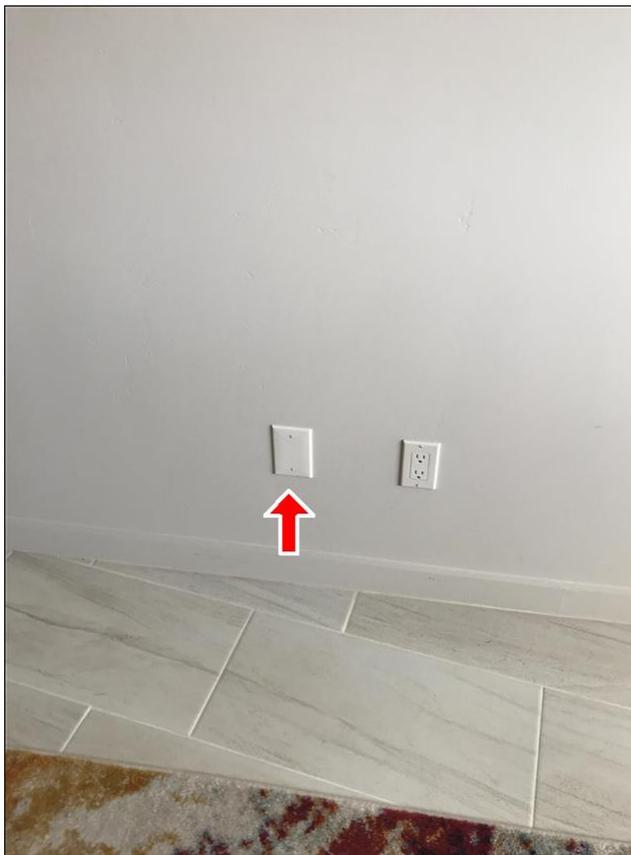
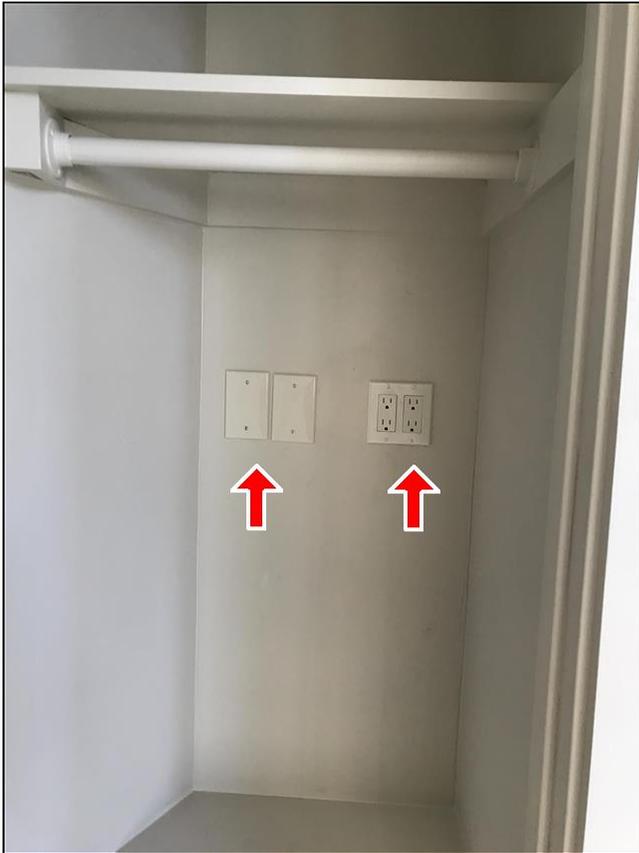
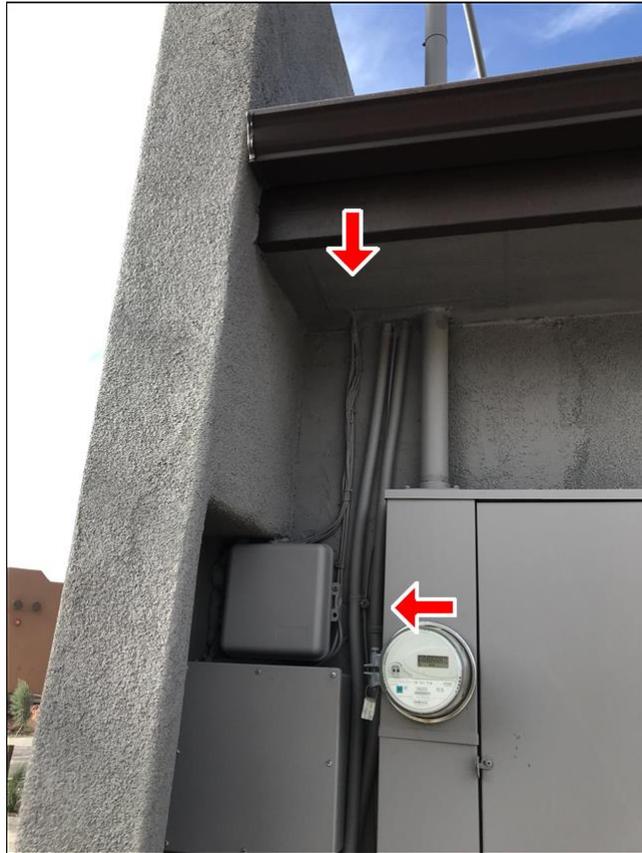
II. Low voltage systems are not part of a general home inspection. The Inspector did note that there were boxes for future low voltage or cable located in multiple locations in the bedrooms. Flush wall mounted TV's were installed in several locations, but any electrical connections were hidden behind the mounting trim. The Buyer should have the Seller demonstrate the extent and operation of the low voltage systems in the home.

II. Item 3(Picture) electrical trim/utilities in closet off living room

II. Item 4(Picture) low voltage box/wiring at service panel

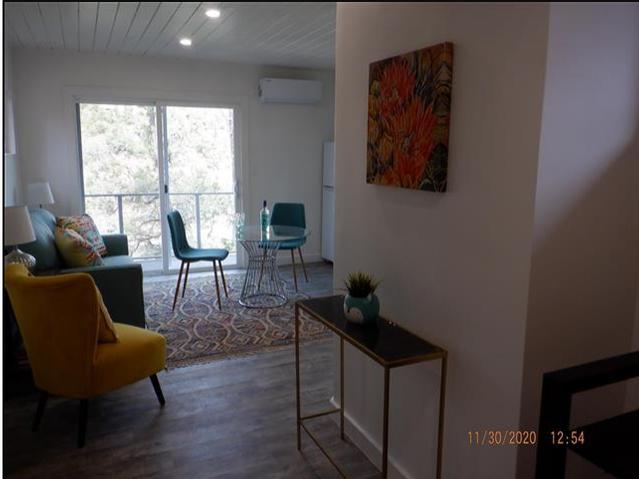
Q. Item 1(Picture)

Q. The Inspector and Buyer detected some odor in the guesthouse interior air space. The Seller should be asked about it's origin. The cold temperatures during the inspection may have partially masked this odor.

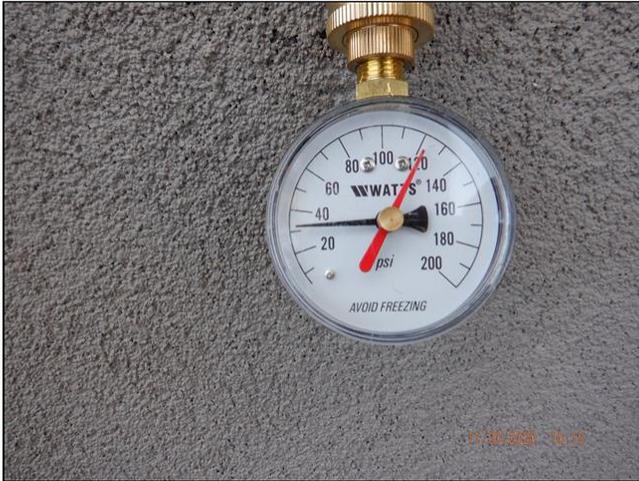
C. Item 1(Picture)

C. (1) The home's water pressure was 32 psi at the time of the inspection which is a bit low. It appears that Sedona tends to have lower water pressure than other municipalities. The Buyer should check out the water flow for him/herself. The flow from the faucets appeared to be low but acceptable.

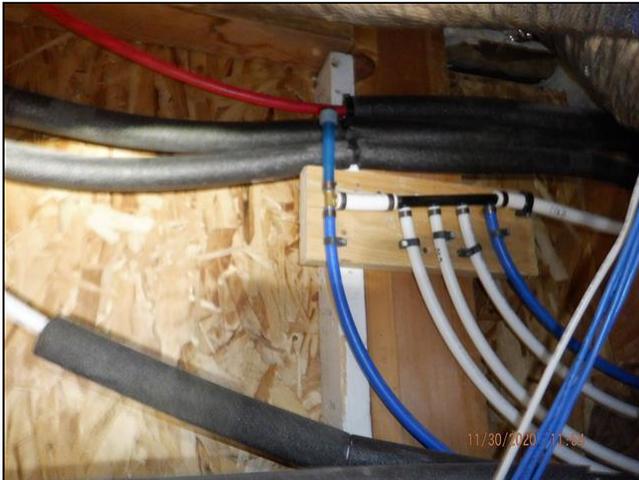
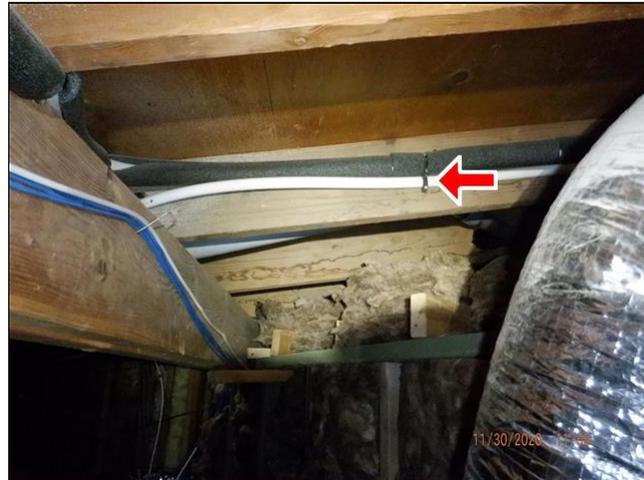
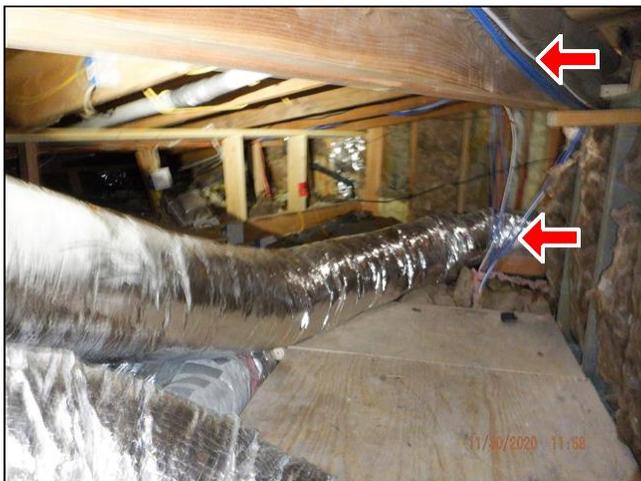
(2) The home appeared to be replumbed with plastic piping.

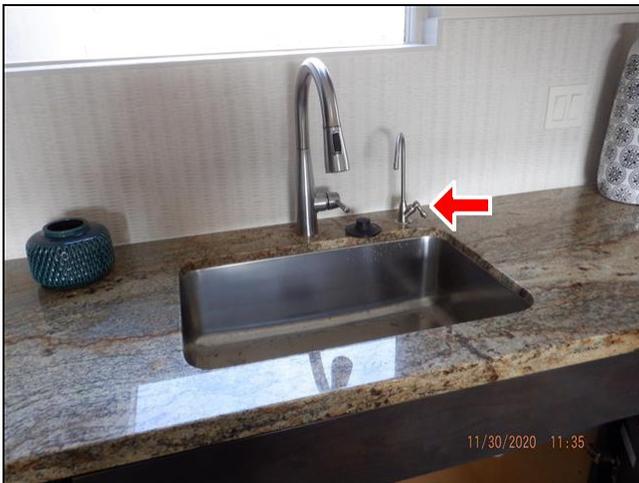
F. Item 1(Picture)

F. The kitchen had a water filtration system that appeared to be operational. Water treatment is not part of a general home inspection.

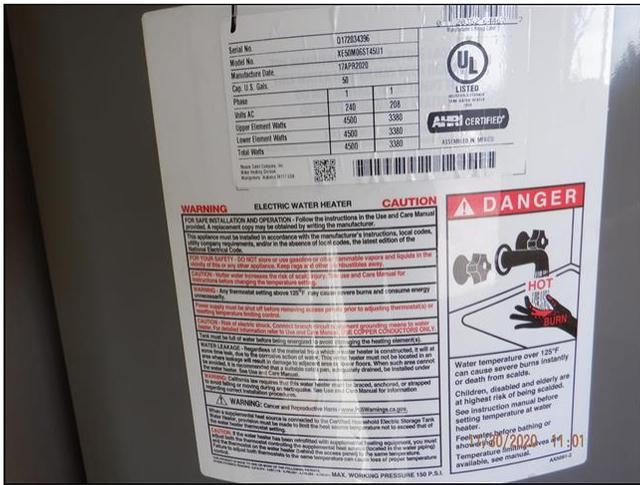
M. Item 1(Picture)

M. (1) The home's 50 gal. electric water heater is located in the garage and was manufactured in 2020.

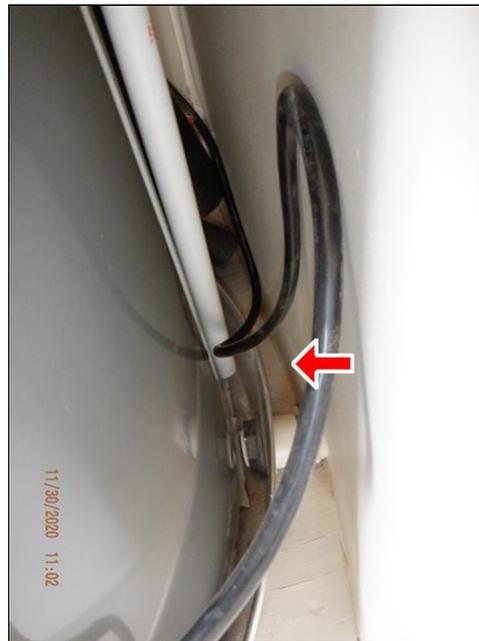
M. Item 3(Picture)

- ⚠ 7 (2) The water heater's T&P valve drain appears to have a pipe that is not connected to the valve. Additionally, the pipe ends behind the heater, up against the drywall. Water discharge would damage this drywall and might scald a nearby person. This pipe should be directed outside, away from finishes. This item can be addressed by a competent handyman or plumber.
- ⚠ 8 (8) The water heater under the guest house does not have a drain pipe servicing the T&P relief valve. A hot water release from this valve could burn someone and damage adjacent electrical items and the crawlspace grade. A competent handyman or plumber can address this item.

⚠️ (2) The water heater's T&P valve drain appears to have a pipe that is not connected to the valve. Additionally, the pipe ends behind the heater, up against the drywall. Water discharge would damage this drywall and might scald a nearby person. This pipe should be directed outside, away from finishes. This item can be addressed by a competent handyman or plumber.

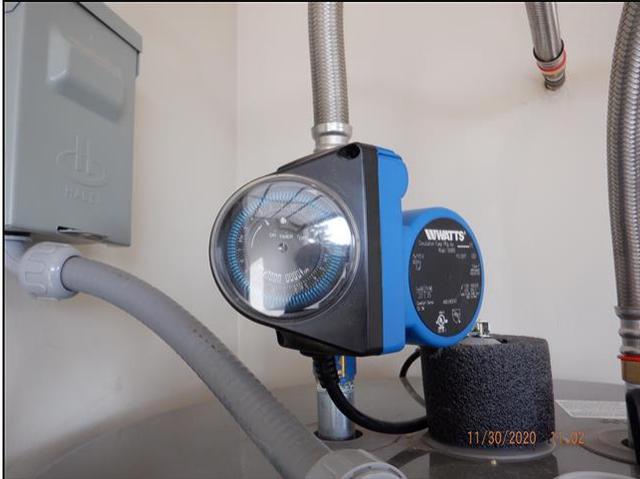
M. Item 4(Picture)

(3) The water distribution system had a recirculation pump at the home's water heater location. The Buyer should review the water distribution system with the seller.

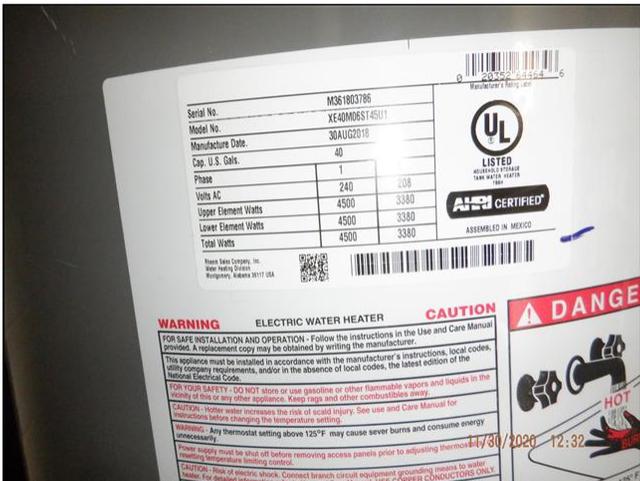
M. Item 5(Picture)

(4) The 40 gal electric water heater in the main house basement suite was manufactured in 2018.

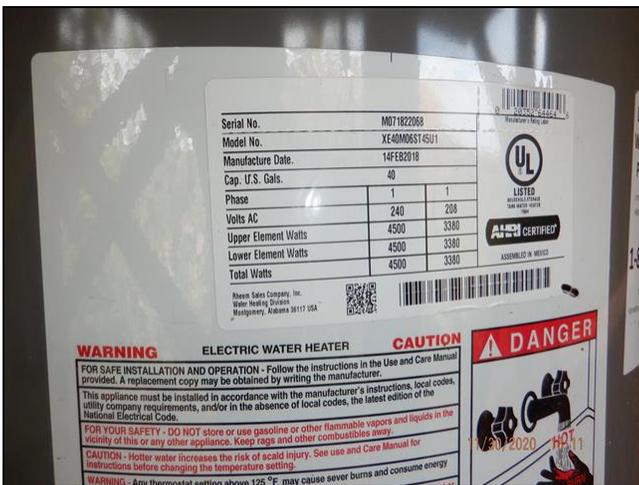
M. Item 7(Picture)

(6) The 40 gal electric water heater under the guest house was manufactured in 2018.

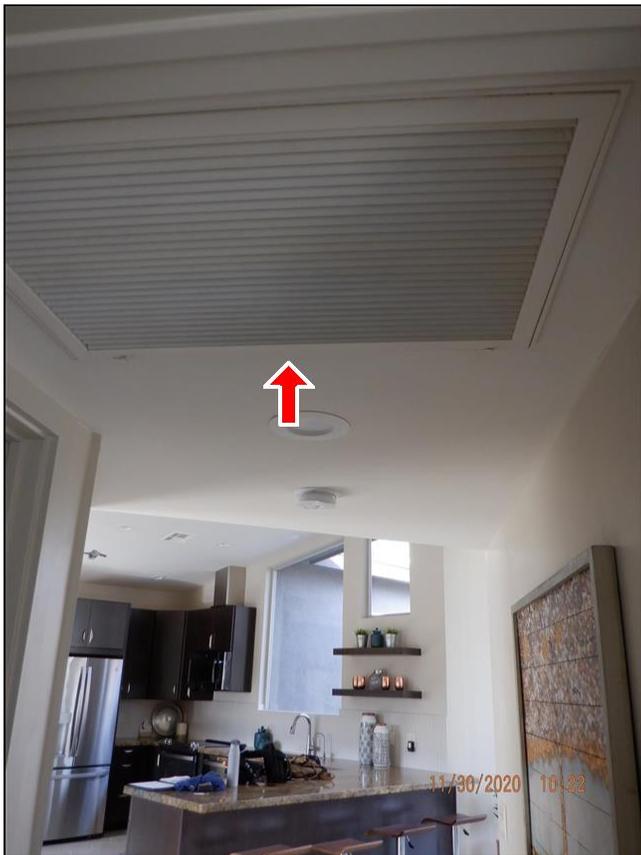
C. Item 1(Picture)

C. (1) The air filter for the forced air system is located behind this return air register in the hallway. The filter should be checked frequently, especially before heating and A/C seasons. A dirty filter can lead to system shut down, system overheating, ice ups and higher wear and tear on the blower system.

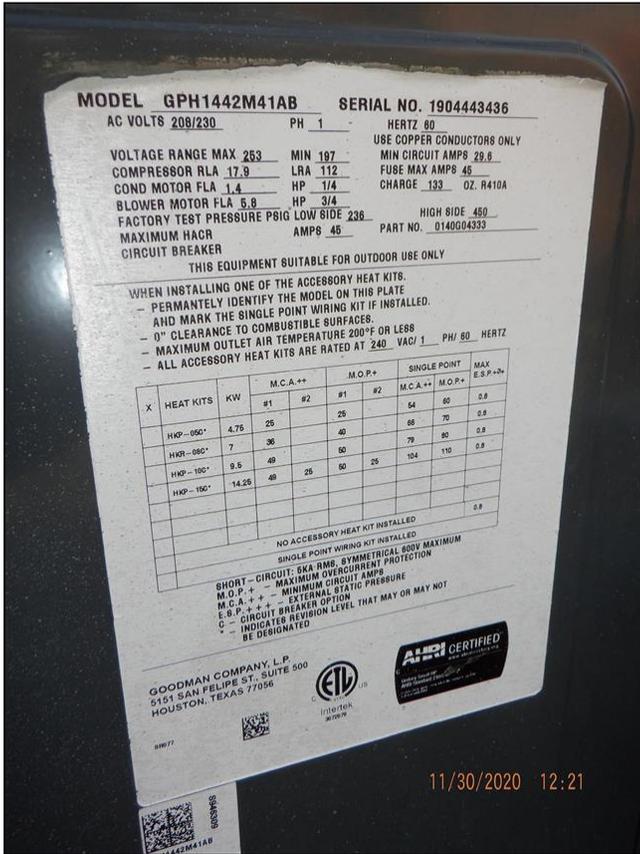
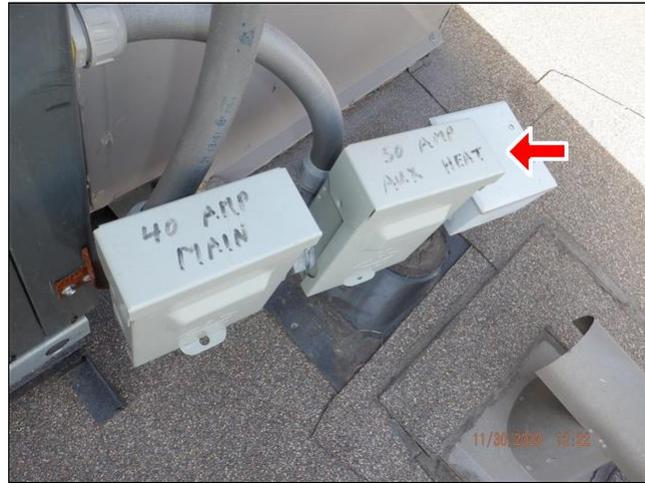
(2) This main house roof top heat pump unit was manufactured in 2019. It provides heating and cooling to the main part of the house. An auxiliary electric heating section was added for operation in cold weather, when the heat pump section no longer works well.

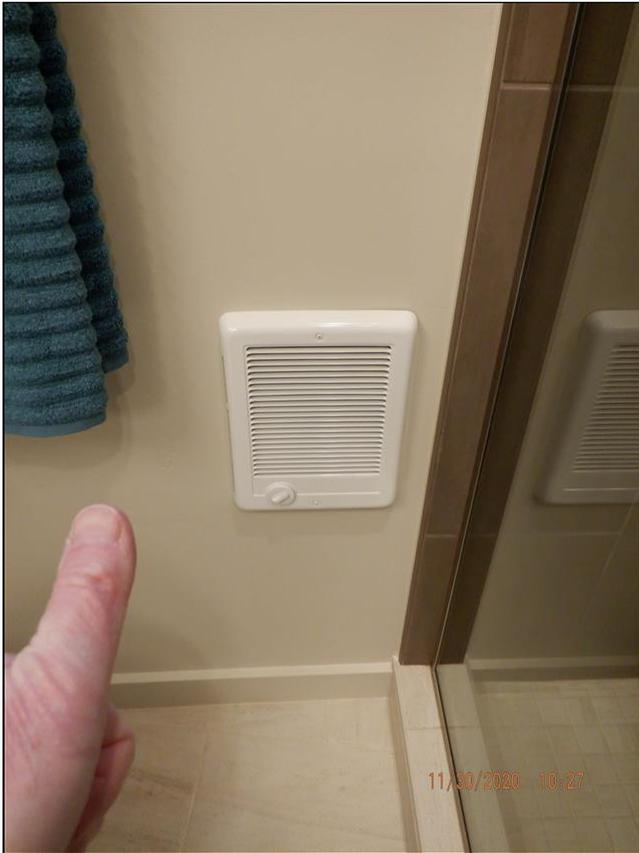
J. Item 1(Picture)

J. The electric wall heater in the guest bath was operational.

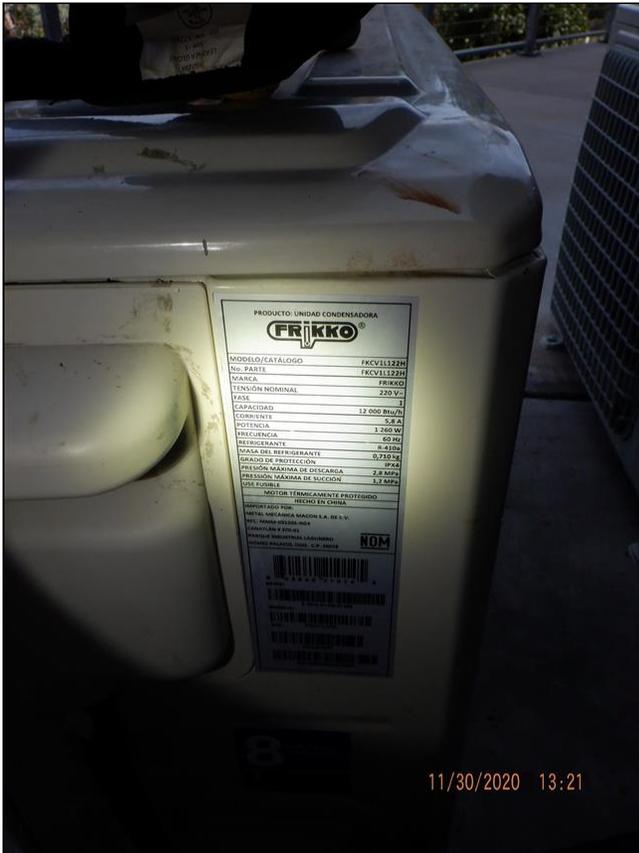
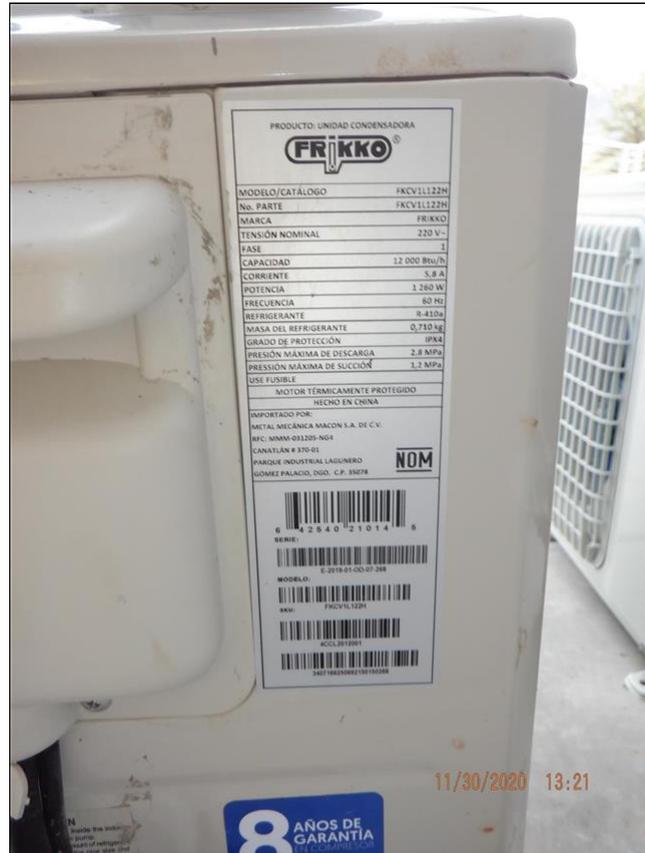
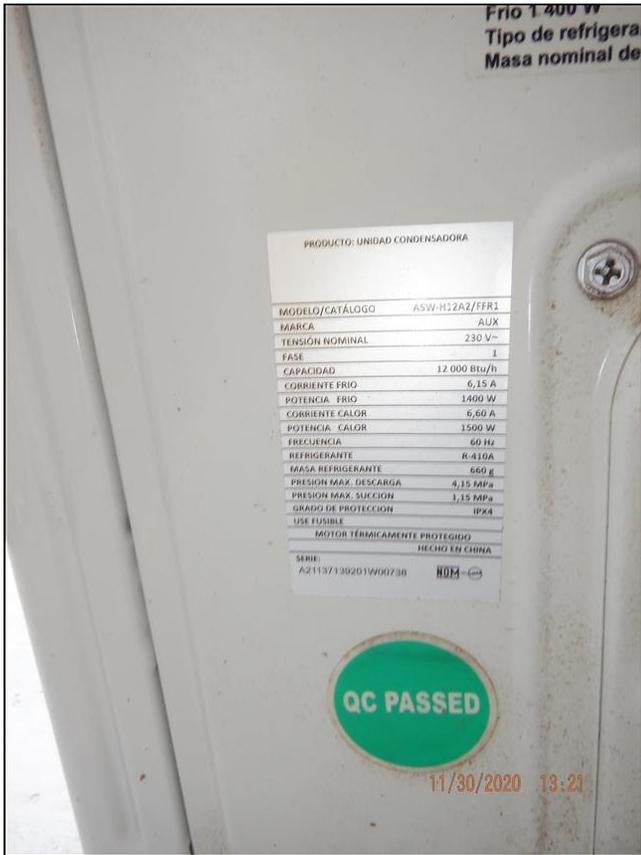
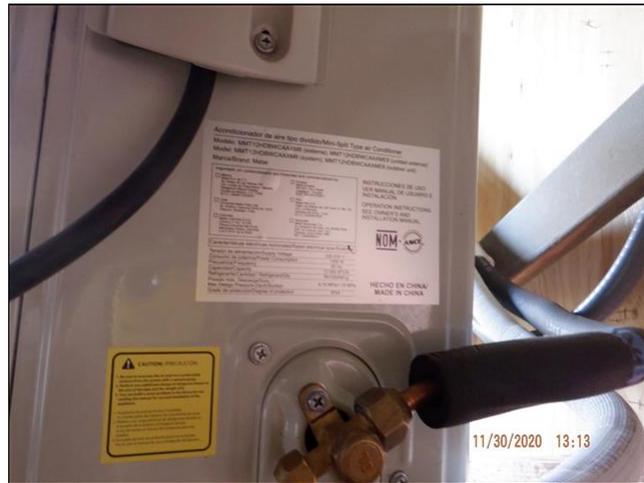
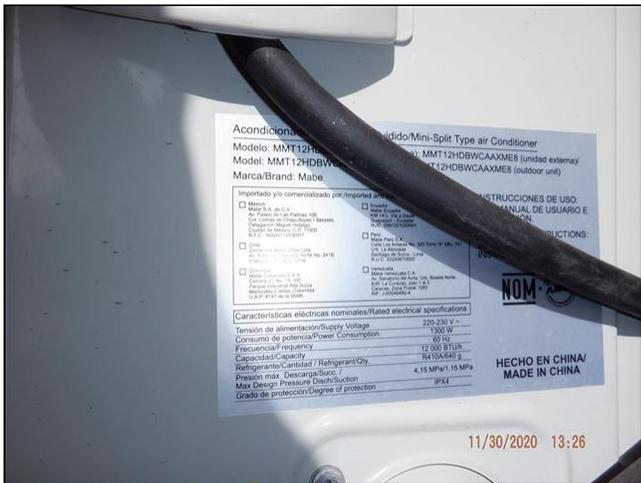
A. (1) The Inspector was not able to obtain the manufacture dates of the mini split compressor units because they were labeled in spanish and the website did not have this information.

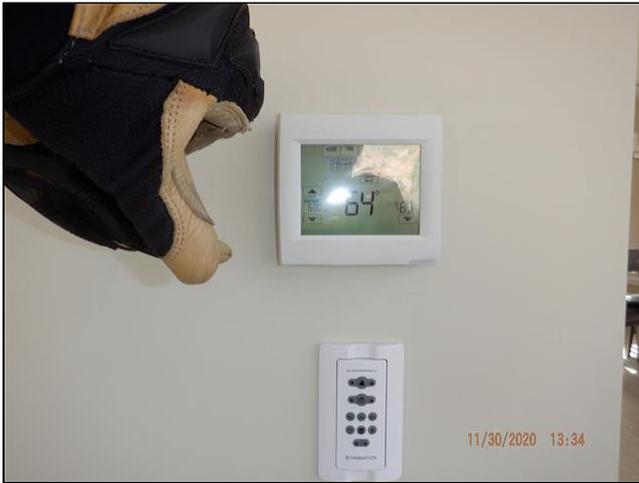
A. Item 6(Picture)

(2) The Inspector verified that all the heating units (rooftop unit and mini-splits) were operational and all the mini split units turned out cold air. Probably because of an equipment protection system, the rooftop unit would not start it's cold air production, possibly due to cold temperatures.

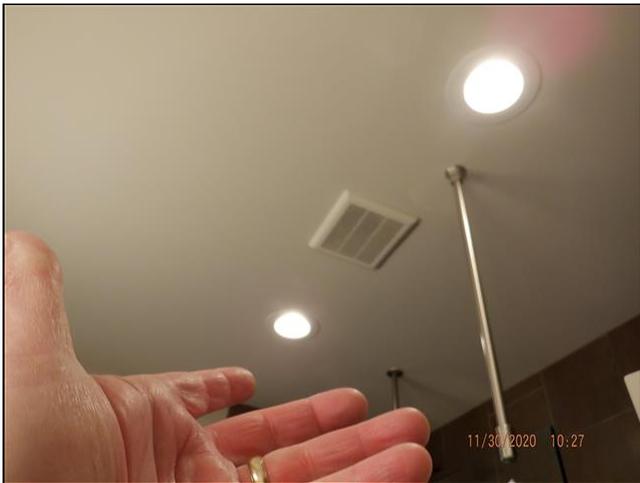
I. Item 1(Picture)

I. All the bathrooms had exhaust fans. Only the master bathroom had forced air registers to supply conditioned air. The guest bathroom in the main house had an electric heater while the other bathrooms had a exhaust fans which provided a draw of conditioned air from the adjacent rooms.

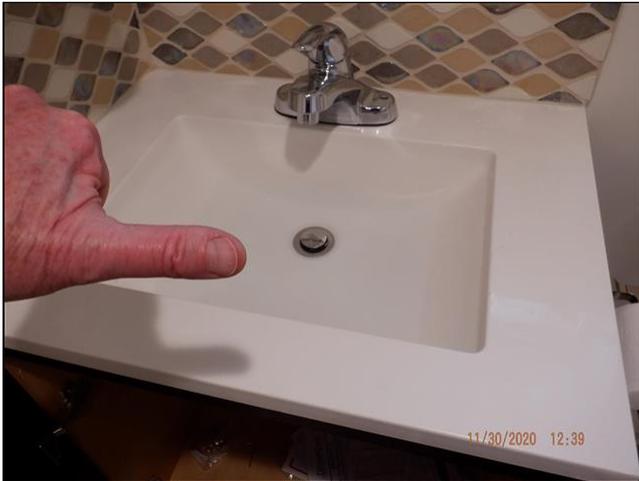
T. Item 1(Picture)

T. The bathroom vanity drain in the basement suite is a bit slow. It may be due to system design.

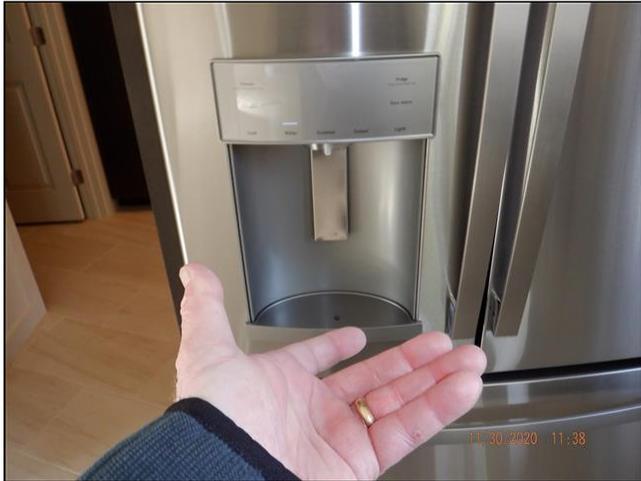
V. Item 1(Picture)

V. Kitchen appliances are generally not part of a general home inspection. The Inspector suggests testing the refrigerator cold water and ice dispenser for operational. The interior temperatures were good.

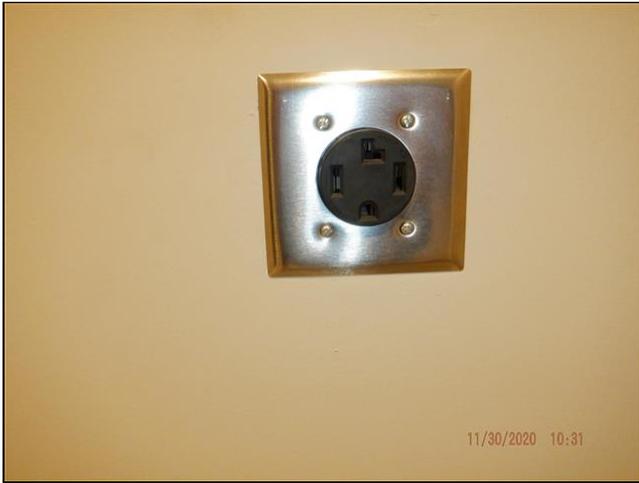
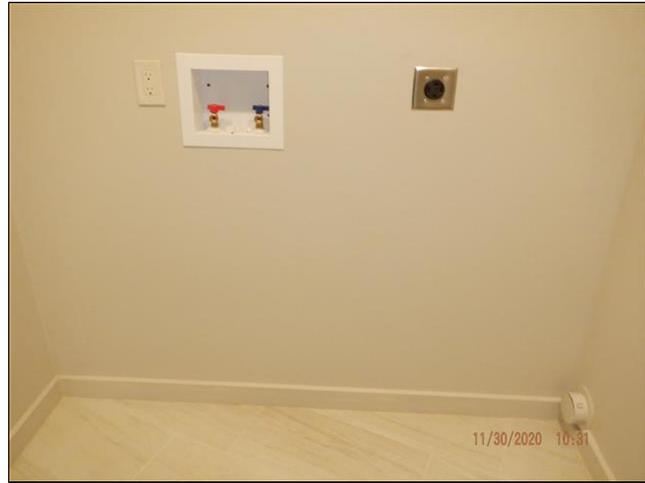
G. Item 1(Picture)

G. The laundry area had a 4 prong 240 volt outlet for a clothes dryer. No gas utility is incorporated into the home.
