MKhomeinspections
PO BOX 11492
Olympia, Wa 98508-1149
360-338-8171

Property Condition Report

1234 Older Home Dr

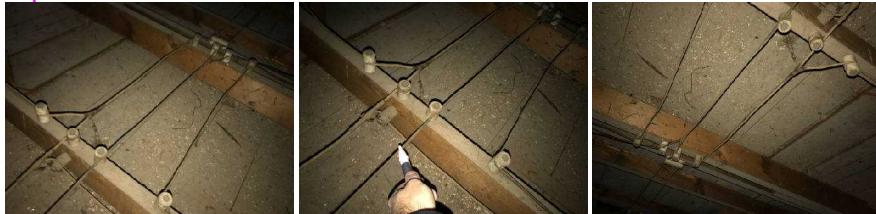
- Knob and tube wiring is designed to dissipate heat to the surrounding air. When covered by thermal insulation (a common condition in attics), wiring is often no longer able to dissipate heated adequately and becomes a potential fire hazard. The Inspector recommends evaluation of all knob and tube wiring by a qualified electrical contractor with whom you should consult concerning the possibility of wiring replacement.

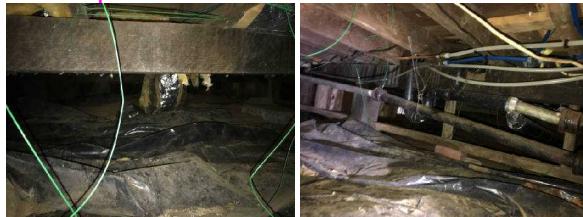
5. Moisture Location: Was dry at time of inspection
6. Acceptable Ventilation: Vents
7. Marginal, Defective Insulation: Fiberglass - Evidence of Rodents or Mice have been found. This can pose a Safety concern Rodents such as Mice and Rats can spread harmful diseases. Not to mention can destroy insulation and get into your heating ducts which can be costly to remedy. It is important to seal off any entry points where they may be able to enter the house. It is recommend that you contact a pest control company to further evaluate and eliminate pest activity. I noticed a few areas in the crawl space where insulation has been damaged by pests. This can lead to increased heat loss. I recommend a qualified persons replace any damaged insulation and to clean any and all damaged insulation out of the crawl space.

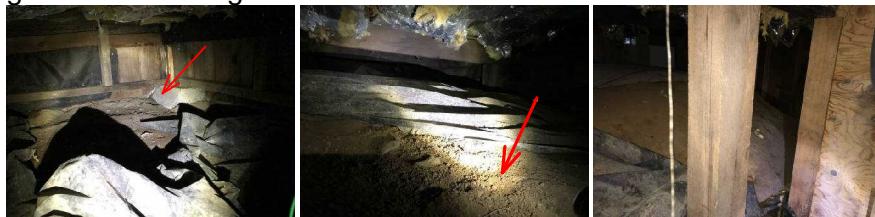
8. Marginal, Defective Vapor Barrier: Under entire home - Found several areas in the crawl space where bare ground was showing. This can allow for excess amounts of moisture to be introduced into the crawl space. This is a conducive condition for WDO wood destroying organisms and fungal growth. Recommend a qualified persons remove all wood scraps and debris from under the house and to redistribute the vapor barrier so it overlaps at the seam and no bare ground is showing.

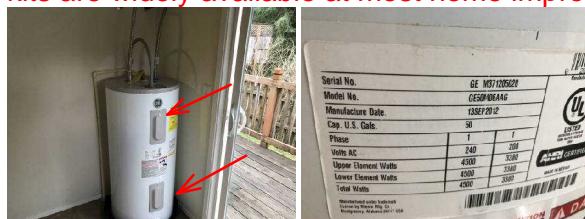
8. Defective, Safety Issue Water Heater Operation: Functional at time of inspection - Securing water heaters is mandatory in the state of Washington when buying or selling a home. It is also Washington state law the water heaters be secured with state architect approved restraining devices. Water heaters must be secured with two straps-one near the top and another near the base. They must be firmly anchored to studs or masonry. Bracing kits are widely available at most home improvement stores.

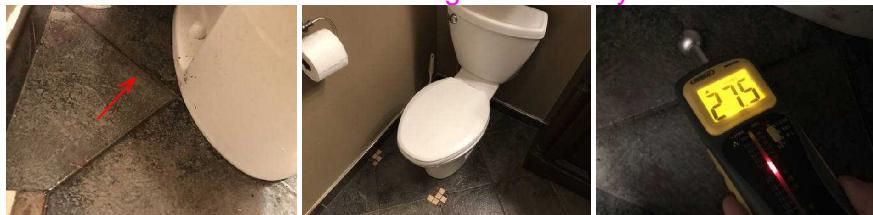
10. Defective Toilets: 1 1/2 Gallon Tank - Moisture present at toilet base. Recommend replacing wax ring. In this bathroom, The inspector recommends re-attached by a qualified contractor. In this bathroom, Moisture meter readings indicated moisture levels in the floor around the base of the toilet. This condition is typically due to failure of the wax gasket that seals the toilet to the floor. The inspector recommends that this gasket be replaced be preformed by a qualified plumbing contractor to avoid subfloor damage from decay.

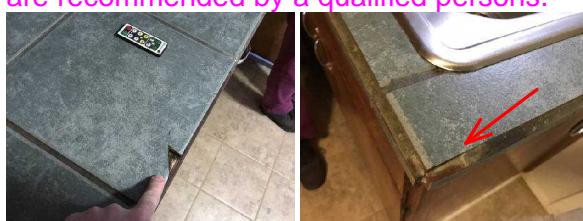
10. Acceptable, Marginal Plumbing/Fixtures: PVC
11. Marginal, Defective Counter Tops: tile - I noticed some broken and chipped tiles in the counter top. Repairs are recommended by a qualified persons.

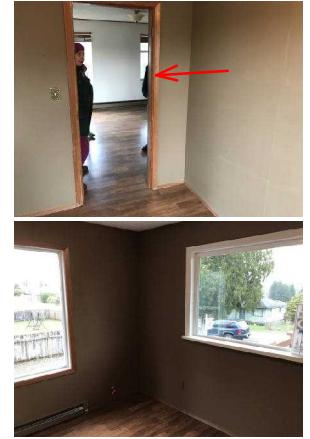
22. Defective Doors: none - **The bedroom door was missing and a qualified contractor is recommended to make all repairs and installations necessary.**

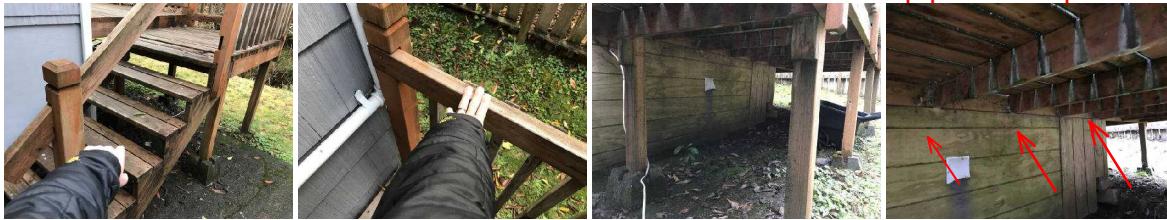
The deck ledger board was attached to the home with nails only. While no failure was seen at the time of the inspection and this was standard practice for many years, the modern standard fastener schedule for attachment of the deck to the home structure is one 1 1/2-inch lag screw installed every two feet, staggered up and down.

All mildew should be cleaned and removed from the back deck to help prevent slips and falls.

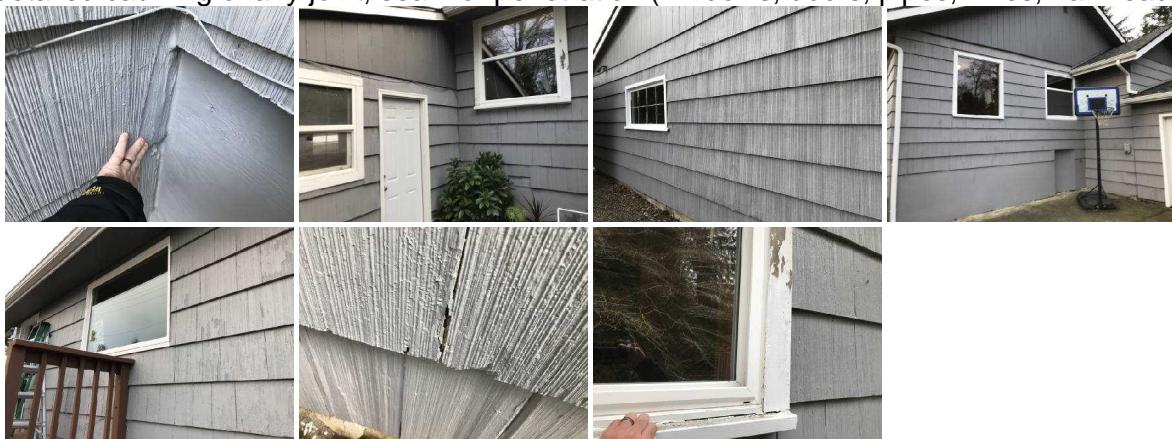
that are in contact with the ground also tend to rot out over time. Future repairs can be expected. Caulking is needed: I recommend that exterior of structure be (re)caulked as needed to prevent moisture intrusion and that this practice be preformed yearly as part of an annual maintenance program. Proper maintenance involves detailed caulking of any joint, seam or penetration (windows, doors, pipes, wires, nail heads etc.) of the siding.

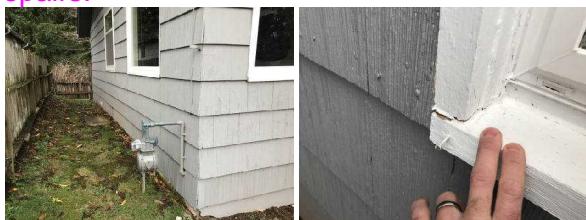
11. Trim: Wood - Noted at the back of the house peeling paint around some of the window trim and this should be repainted and caulked to prevent wood damages. A qualified person is recommended to make these repairs.

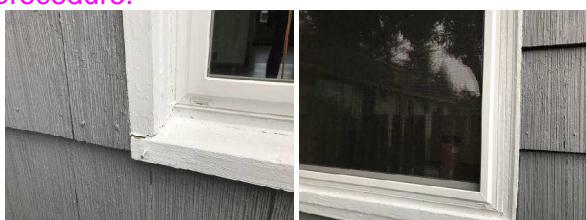
12. Patio Door: Vinyl sliding - I recommend caulking around the back sliding glass door.
13. Windows: Vinyl slider wood casement - Some of the windows appear to be updated some appear to be possibly the original. The older single pane windows should be updated in the future. This will help with energy savings.
All exterior seams should be (re)caulked as needed to prevent moisture intrusion. Particular attention should be given to penetrations (doors, windows, light fixtures, pipes, wires etc.) I recommend using a high quality, paintable exterior caulk. This should be done on an annual basis as part of a general home maintenance procedure.

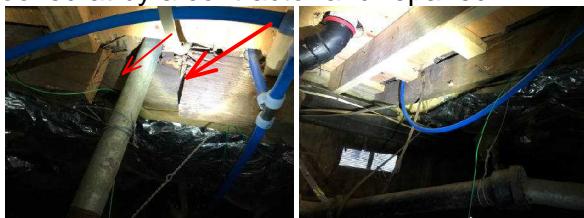
32. Joists/Trusses: 2x8 - Joists have been modified and will require evaluation. It appears under the bathroom area Joist have been modified cut or added on to and where one of the Joist is sister onto it should be further looked at by a contractor and repaired.

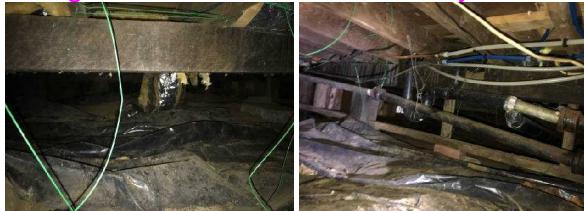
40. Main Crawl Space Insulation: Fiberglass - **Evidence of Rodents or Mice have been found. This can pose a Safety concern Rodents such as Mice and Rats can spread harmful diseases. Not to mention can destroy insulation and get into your heating ducts which can be costly to remedy. It is important to seal off any entry points where they may be able to enter the house. It is recommend that you contact a pest control company to further evaluate and eliminate pest activity. I noticed a few areas in the crawl space where insulation has been damaged by pests. This can lead to increased heat loss. I recommend a qualified persons replace any damaged insulation and to clean any and all damaged insulation out of the crawl space.**

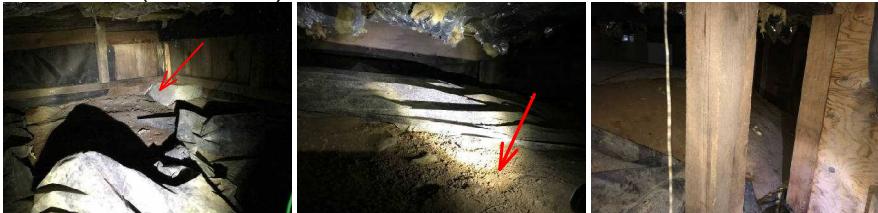
41. Main Crawl Space Vapor Barrier: Under entire home - Found several areas in the crawl space where bare ground was showing. This can allow for excess amounts of moisture to be introduced into the crawl space. This is a conducive condition for WDO wood destroying organisms and fungal growth. Recommend a qualified persons remove all wood scraps and debris from under the house and to redistribute the vapor barrier so it overlaps at the seam and no bare ground is showing.

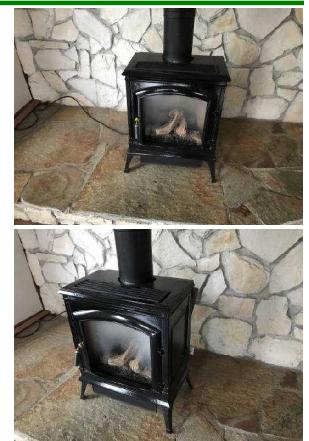
43. Living Room Fireplace Freestanding Stove: Decorative - Inspector recommends an outlet be installed to plug-in for the blower motor on the fireplace extension cords are a temporary fix and an outlet should be installed in the appropriate location for this blower motor.

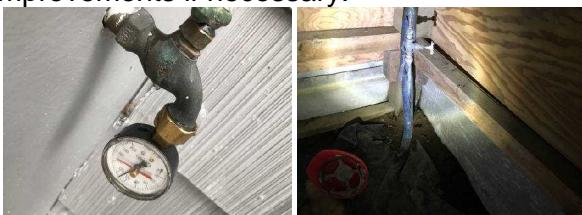
45. Service Line: Copper - Excessive pressure noted at 110psi. at the exterior hose bib. The main line coming into the house also appears to be 1/2 line and appears to be the original. I believe 1 or 3/4 service lines are what are standard. A Pressure reducer valve might be required at the main to run to reduce pressure to a more normal level of between 40 and 80 psi. A qualified plumbing contractor would be necessary to make these improvements if necessary.

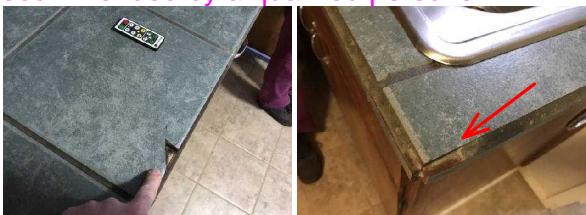
52. 1st Floor Kitchen Counter Tops: tile - I noticed some broken and chipped tiles in the counter top. Repairs are recommended by a qualified persons.

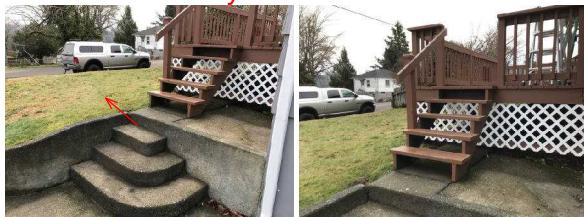
3. Steps/Stoops: Concrete - The front stairs were missing grab bars handrails on the lower set of stairs. The upper step towards the front porch had an open handrail on one side and no barrier on the other side. This could lead to potential falls on slips qualified contractor is recommended to evaluate and install handrails in this location for safety.

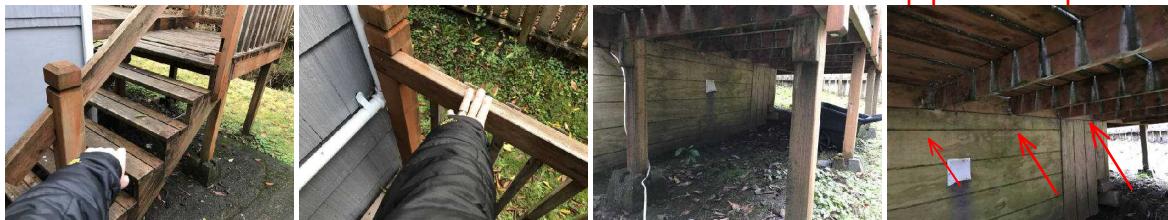
4. Deck: Stained wood - When inspecting the deck i noticed the handrails were wobbly and the stairs had an open handrail. This is a fall hazard for children. I also noticed the back shed had a deck around it and the handrails were missing from that deck. Handrail need to be install around that deck or blocked off to prevent any falls. That is concerning and is a big drop off. A qualified contractor is recommended to install handrails at that location. The front deck had a few boards that were starting to rot out and should also be replace at that time. Ledger- nails only- QC

The deck ledger board was attached to the home with nails only. While no failure was seen at the time of the inspection and this was standard practice for many years, the modern standard fastener schedule for attachment of the deck to the home structure is one 1/2-inch lag screw installed every two feet, staggered up and down.

All mildew should be cleaned and removed from the back deck to help prevent slips and falls.

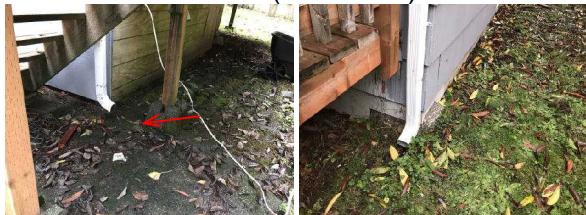
5. Exterior Surface Drain: Surface drain - Evidence of poor drainage at the down spouts. the down spouts are discharging next the foundation which can lead to foundation settling issues along with introducing moisture into the crawl space. I recommend adding extensions to help divert water away from the foundation.

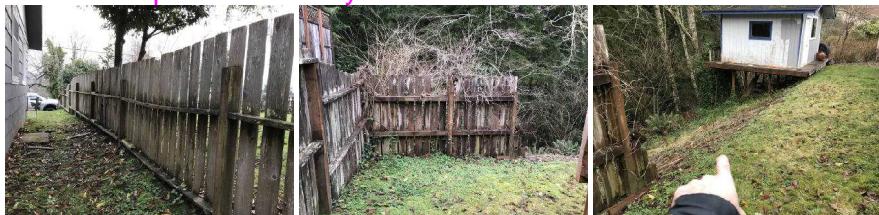
6. Fences: Wood - I noticed a few of the fence boards were damaged and should be repaired missing sections along the backside of the fence and the steep embankment could pose a fall safety issue and recommend that a barrier be put back in this location to prevent any falls. A qualified contractor is recommended to evaluate and make all repairs necessary.

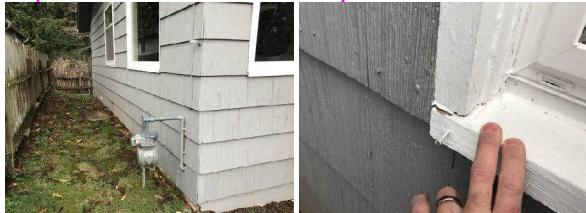
7. Trim: Wood - Noted at the back of the house peeling paint around some of the window trim and this should be repainted and caulked to prevent wood damages. A qualified persons is recommended to make these repairs.

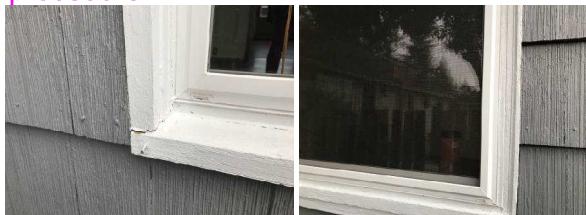
8. Windows: Vinyl slider wood casement - Some of the windows appear to be updated some appear to be possibly the original. The older single pane windows should be updated in the future. This will help with energy savings.

All exterior seams should be (re)caulked as needed to prevent moisture intrusion. Particular attention should be given to penetrations (doors ,windows, light fixtures pipes, wires etc.) I recommend using a high quality, paintable exterior caulk. This should be done on an annual basis as part of a general home maintenance procedure.

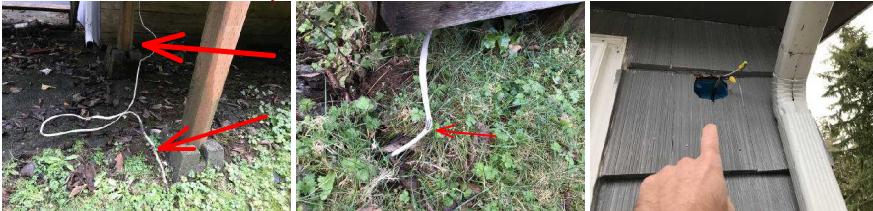
11. Exterior Electric Outlets: 110 VAC - When inspecting the backside of the house i noticed an exposed electrical wiring it appears it is going to the back shop but was not in a proper weatherproof conduit and was broken in several places this poses a major safety electrocution risk and recommend a qualified electrical contractor evaluate and route the electrical into a conduit. This wiring was severely damaged in multiple places and will need to be replaced also.

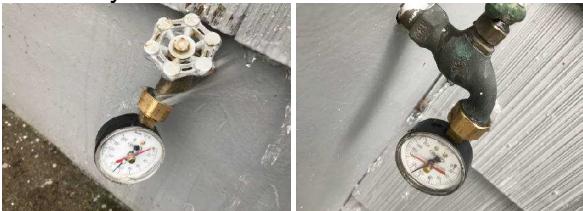
12. Hose Bibs: Gate - This is an older home and recommend that anti siphon frost free hose bibs be installed to help prevent back flow.. The exterior hose bib was noted at 110psi. This is on the higher side for water pressure. Higher water pressure can put extra strain on the plumbing fittings and fixtures. Normal water pressure is around 40-70psi. A pressure reducer valve might be necessary at the main to help reduce pressure down to normal level. A plumbing contractor would be recommended to consult and possibly add if deemed necessary.

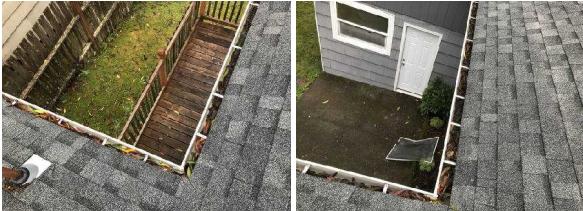
13. Gutters: Aluminum - Debris had accumulated in one or more gutters. This is a conducive condition for wood destroying insects since gutters may overflow and cause water to come in contact with the building exterior or make water accumulate around the foundation. Gutters should be cleaned now and as necessary in the future.

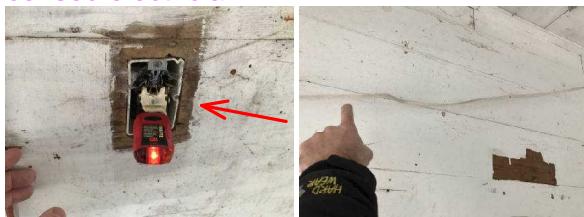
15. Attached Garage Electrical: 110 VAC - The exposed electrical wiring should be properly attached is loose in a few areas recommend a qualified persons attach the wiring so it is not loose. I also noticed a broken damaged outlet that should be replaced along with the wiring repairs. Open or missing grounds were noticed at all three plug outlet this poses a safety issue this gives the fall sense that the outlet is grounded when it is not properly grounded. The evaluation and all repairs is recommended from a licensed electrician

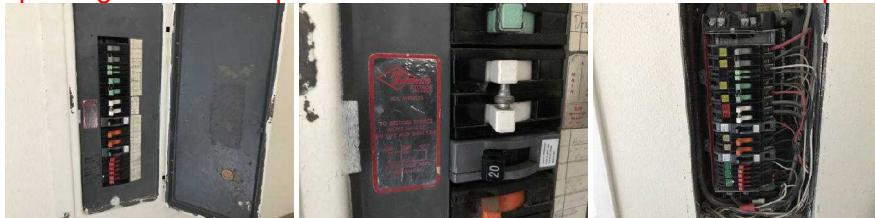
18. Recessed in wall Electric Panel Manufacturer: Zinsco - Zinsco

The service panel brand was Zinsco. Zinsco panels are reputed to have a high rate of circuit breaker failure which can result in a fire or shock/electrocution. The Inspector recommends that before the expiration of your Inspection Objection Deadline, you consult with a qualified electrical contractor concerning the necessity for replacing this service panel. Information about defective Zinsco panels is widely available on the internet.

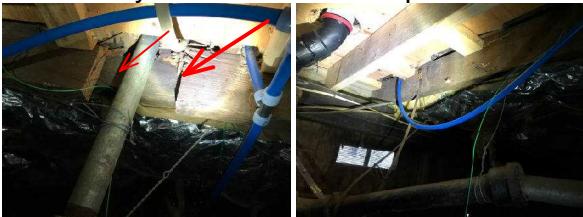
21. Joists/Trusses: 2x8 - Joists have been modified and will require evaluation. It appears under the bathroom area Joist have been modified cut or added on to and where one of the Joist is sister onto it should be further looked at by a contractor and repaired.

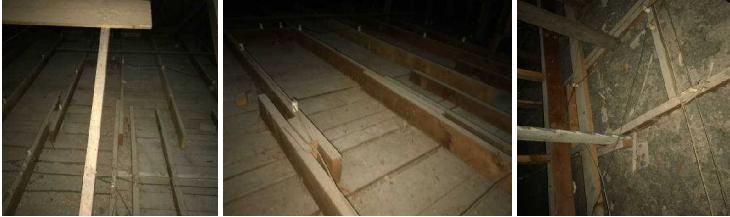
23. Main Attic Insulation: Fiberglass - Large areas of missing insulation over the bedrooms and living room areas of the attic space. the other locations were maybe 2 inches of insulation. Inadequate insulation levels- QC Thermal insulation installed to limit heat gain and loss in the living space did not appear to meet widely-accepted modern standards. To reduce energy consumption and heating/cooling costs, the inspector recommends that additional thermal insulation be added to meet modern standards. A qualified insulation contractor should be able to advise you capably.

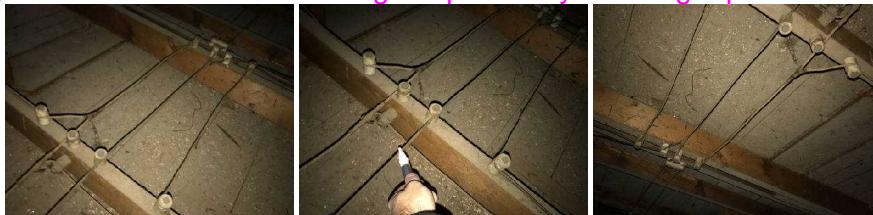
Energized knob and tube wiring visible in the attic was commonly installed prior to 1950. It is ungrounded, and considered unsafe by today's standards. Problems with knob and tube wiring are as follows:

- Limited wire gauge in conjunction with the use of modern appliances may result in wire overheating; a potential fire hazard.
- With repeated overheating/cooling cycles, insulation encapsulating the wire conductors can become brittle, deteriorated and cracked, resulting in energized electrical conductors becoming exposed to touch: a shock/electrocution and fire hazard.
- Knob and tube wiring is designed to dissipate heat to the surrounding air.

When covered by thermal insulation (a common condition in attics), wiring is often no longer able to dissipate heated adequately and becomes a potential fire hazard.

The Inspector recommends evaluation of all knob and tube wiring by a qualified electrical contractor with whom you should consult concerning the possibility of wiring replacement.

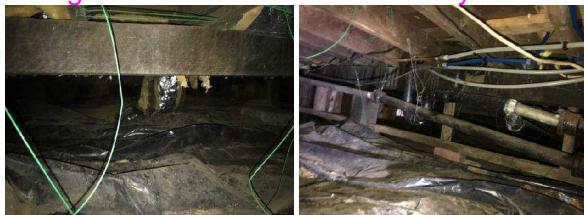
27. Main Crawl Space Insulation: Fiberglass - Evidence of Rodents or Mice have been found. This can pose a Safety concern Rodents such as Mice and Rats can spread harmful diseases. Not to mention can destroy insulation and get into your heating ducts which can be costly to remedy. It is important to seal off any entry points where they may be able to enter the house. It is recommend that you contact a pest control company to further evaluate and eliminate pest activity. I noticed a few areas in the crawl space where insulation has been damaged by pests. This can lead to increased heat loss. I recommend a qualified persons replace any damaged insulation and to clean any and all damaged insulation out of the crawl space.

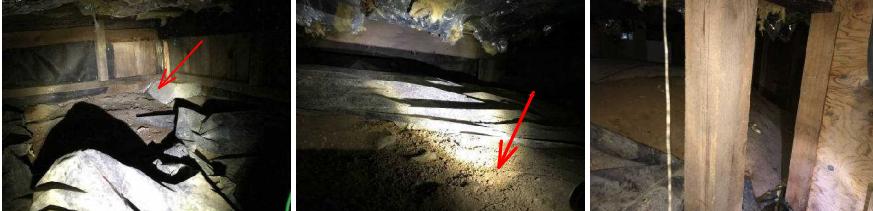
28. Main Crawl Space Vapor Barrier: Under entire home - Found several areas in the crawl space where bare ground was showing. This can allow for excess amounts of moisture to be introduced into the crawl space. This is a conducive condition for WDO wood destroying organisms and fungal growth. Recommend a qualified persons remove all wood scraps and debris from under the house and to redistribute the vapor barrier so it overlaps at the seam and no bare ground is showing.

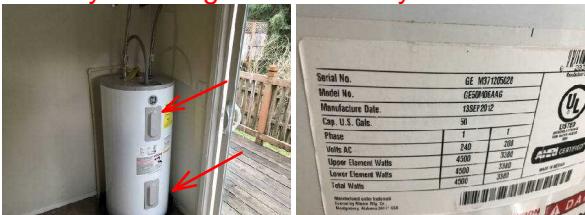
33. Utility Room Water Heater Water Heater Operation: Functional at time of inspection - Securing water heaters is mandatory in the state of Washington when buying or selling a home. It is also Washington state law the water heaters be secured with state architect approved restraining devices. Water heaters must be secured with two straps-one near the top and another near the base. They must be firmly anchored to studs or masonry. Bracing kits are widely available at most home improvement stores.

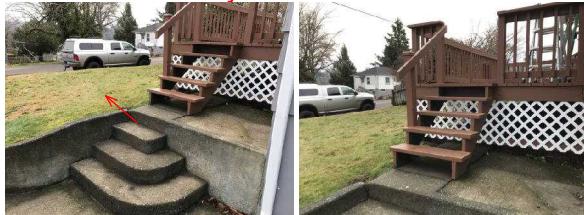
1. Steps/Stoops: Concrete - The front stairs were missing grab bars handrails on the lower set of stairs. The upper step towards the front porch had an open handrail on one side and no barrier on the other side. This could lead to potential falls or slips. A qualified contractor is recommended to evaluate and install handrails in this location for safety.

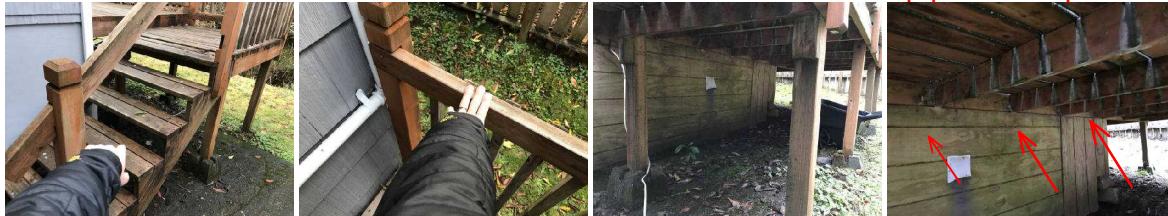
2. Deck: Stained wood - When inspecting the deck I noticed the handrails were wobbly and the stairs had an open handrail. This is a fall hazard for children. I also noticed the back shed had a deck around it and the handrails were missing from that deck. Handrails need to be installed around that deck or blocked off to prevent any falls. That is concerning and is a big drop off. A qualified contractor is recommended to install handrails at that location. The front deck had a few boards that were starting to rot out and should also be replaced at that time. Ledger- nails only- QC

The deck ledger board was attached to the home with nails only. While no failure was seen at the time of the inspection and this was standard practice for many years, the modern standard fastener schedule for attachment of the deck to the home structure is one 1/2-inch lag screw installed every two feet, staggered up and down.

All mildew should be cleaned and removed from the back deck to help prevent slips and falls.

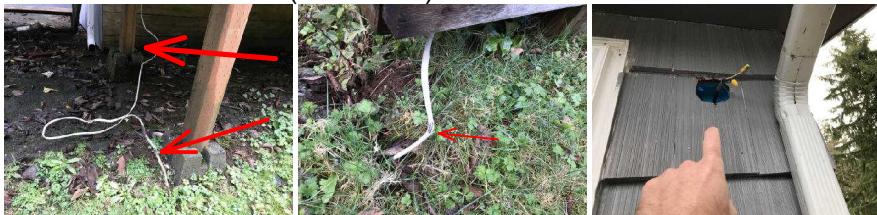
4. Exterior Electric Outlets: 110 VAC - When inspecting the backside of the house I noticed an exposed electrical wiring. It appears it is going to the back shop but was not in a proper weatherproof conduit and was broken in several places. This poses a major safety electrocution risk and recommend a qualified electrical contractor evaluate and route the electrical into a conduit. This wiring was severely damaged in multiple places and will need to be replaced also.

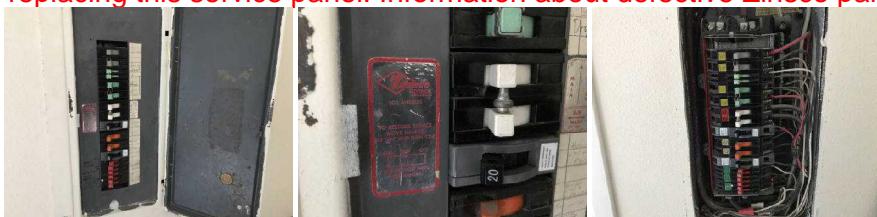
8. Recessed in wall Electric Panel Manufacturer: Zinsco - Zinsco

The service panel brand was Zinsco. Zinsco panels are reputed to have a high rate of circuit breaker failure which can result in a fire or shock/electrocution. The Inspector recommends that before the expiration of your Inspection Objection Deadline, you consult with a qualified electrical contractor concerning the necessity for replacing this service panel. Information about defective Zinsco panels is widely available on the internet.

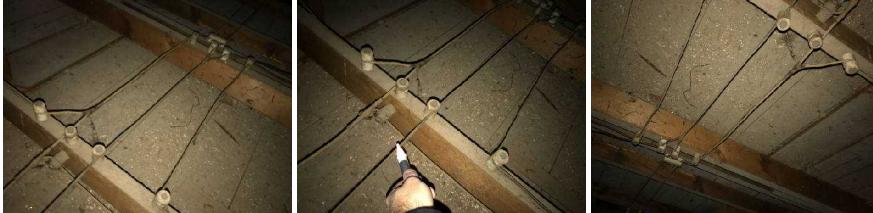
Energized knob and tube wiring visible in the attic was commonly installed prior to 1950. It is ungrounded, and considered unsafe by today's standards. Problems with knob and tube wiring are as follows:

- Limited wire gauge in conjunction with the use of modern appliances may result in wire overheating; a potential fire hazard.
- With repeated overheating/cooling cycles, insulation encapsulating the wire conductors can become brittle, deteriorated and cracked, resulting in energized electrical conductors becoming exposed to touch: a shock/electrocution and fire hazard.
- Knob and tube wiring is designed to dissipate heat to the surrounding air.

When covered by thermal insulation (a common condition in attics), wiring is often no longer able to dissipate heated adequately and becomes a potential fire hazard.

The Inspector recommends evaluation of all knob and tube wiring by a qualified electrical contractor with whom you should consult concerning the possibility of wiring replacement.

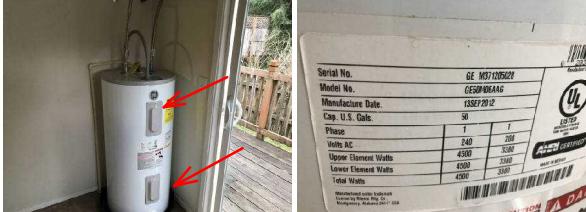
12. Utility Room Water Heater Water Heater Operation: Functional at time of inspection - Securing water heaters is mandatory in the state of Washington when buying or selling a home. It is also Washington state law the water heaters be secured with state architect approved restraining devises. Water heaters must be secured with two straps-one near the top and another near the base. They must be firmly anchored to studs or masonry. Bracing kits are widely available at most home improvement stores.
