**Adaptive Reuse Feasibility Study**  
**November 2019**

**BLACK BEAR INN (24SAxxx )  
THOMPSON FALLS, MONTANA  
ADAPTIVE REUSE FEASIBILITY STUDY**

Black Bear Inn  
101 Fulton Street  
Thompson Falls, MT 59873

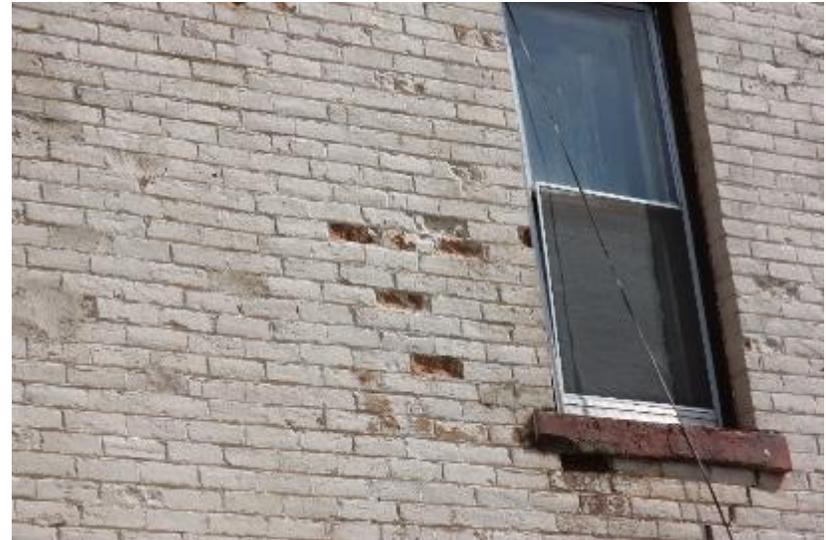
Figure 19: Black Bear Inn. The lug windowsills are of poured-in-place concrete.

1. Chimney: Repoint the mortar joints.
2. Repoint the joints in the stepped cracks above windows.
3. Prepare and fill skyward joints in the concrete windowsills.

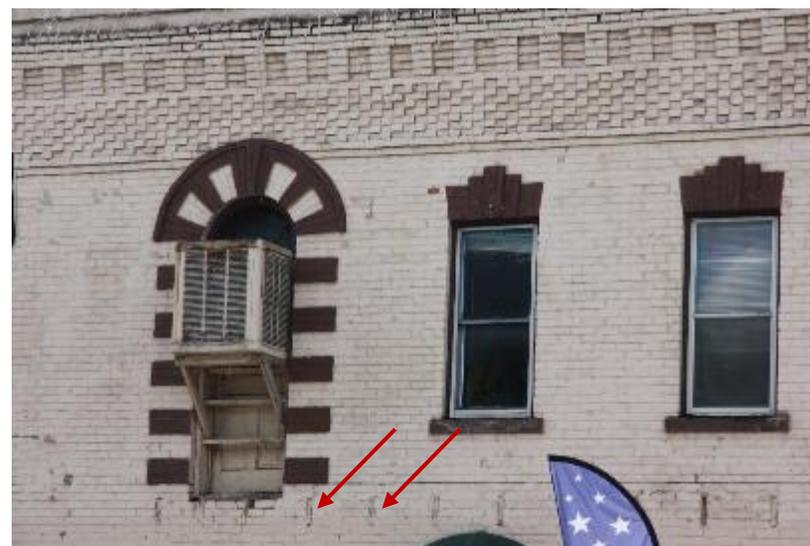
Figure 21: Black Bear Inn. The second floor opening to the original balcony (location evident by the joist pockets at arrow tips), with brick quoins accentuated by the alternating paint coloration.

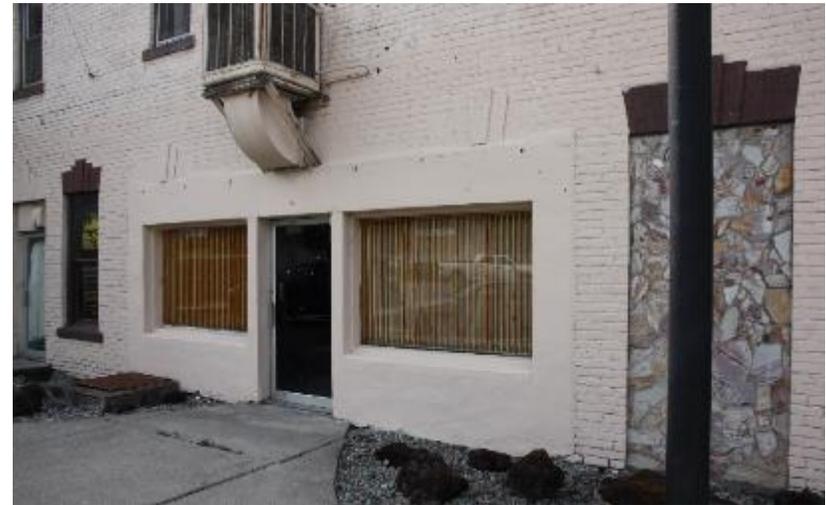
Figure 25: The first floor opening into the erstwhile dining room was updated with concrete c.1938. The center entry - to the right - has been infilled with stone.

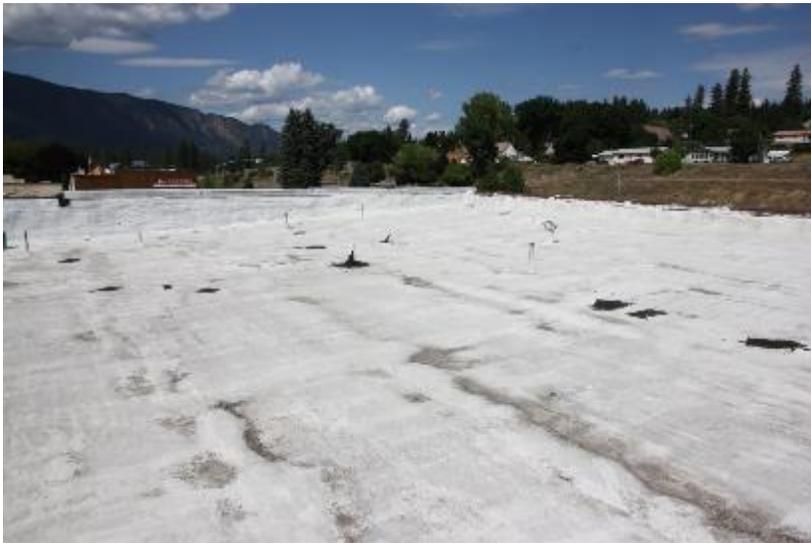
Figure 36: Black Bear Inn. Looking to the northwest across the slightly-sloped membrane roof.

The roofing membrane is in poor condition, with swollen areas that contain water. Cracking at the membrane seams and holes in the the parapet flashing are allowing further water into the system. Plaster at the upper walls and ceilings of the upper story is water-damaged from these penetrations in the roofing system.

1. Replace the roofing down to the sheathing.
2. Replace the hung gutter with a 5"-wide gutter. Reinstall the two existing downspouts.
3. Replace the sheet metal of the front coping, lapping over the roofing membrane. Resecure coping units at the joints. Coordinate this work with replacement of the parging (with sheet metal flashing) over the brick below the front edge of the coping.
4. Provide sheet metal coping over southernmost end of west parapet wall. oof Penetrations

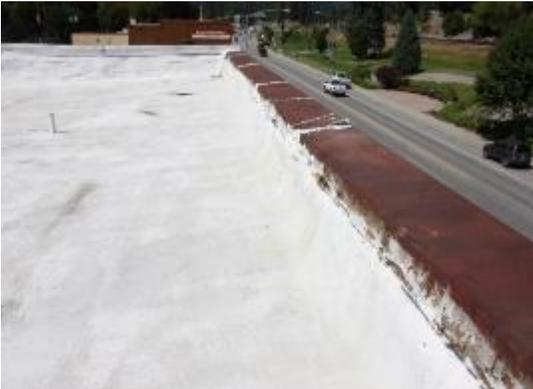
The sheet metal coping of the front parapet is rusting and in poor condition, holes have formed, and the joints between coping units (approximately two feet long) are loosening. The sealant used to cover these joints is dried and cracked with aging. The sheet metal coping of the side parapets is generally in fair condition and not

Figure40: Black Bear Inn. Looking west along the back face of the front parapet wall.

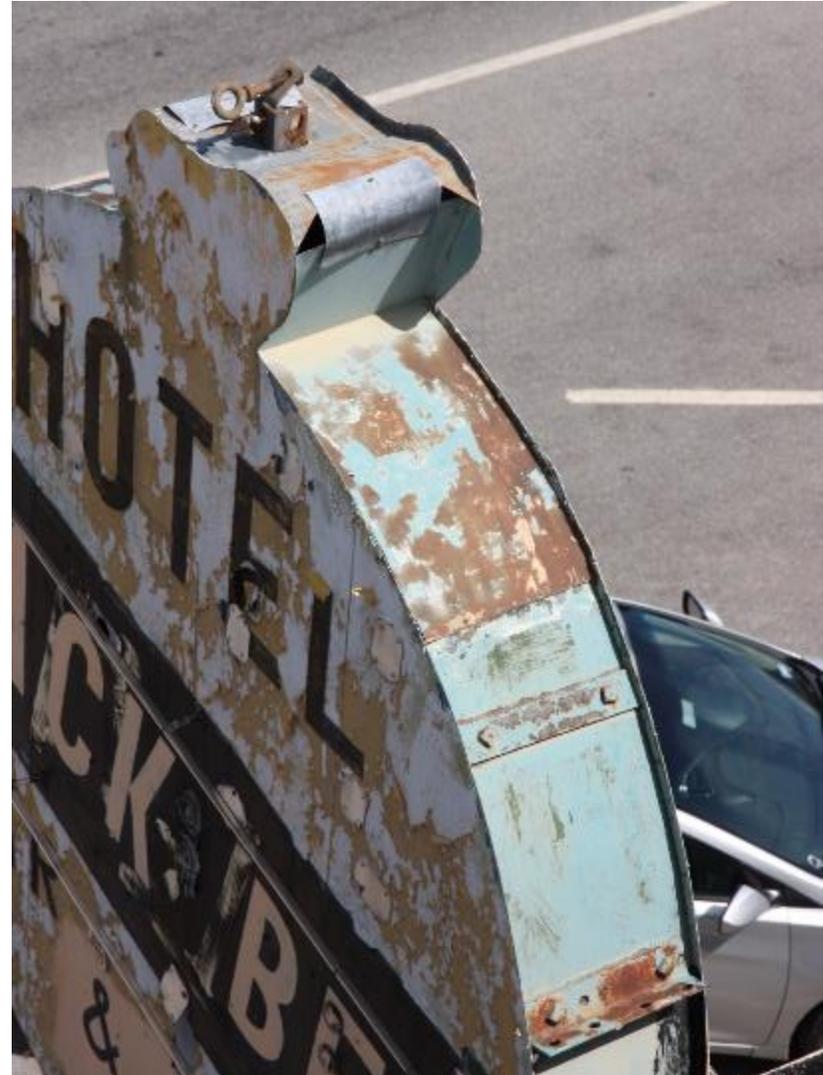
The painted sign is in good condition; the paint is well adhered. The projecting sign is in fair to poor condition. The metal has surface rust, several large holes have been patched with sheet metal, and the face

Figure 56: Black Bear Inn. The c.1930s projecting sign announcing the Black Bear Hotel.

of the sign is pockmarked with numerous sheet metal patches. The latter presumably were installed to cover holes caused by rust.

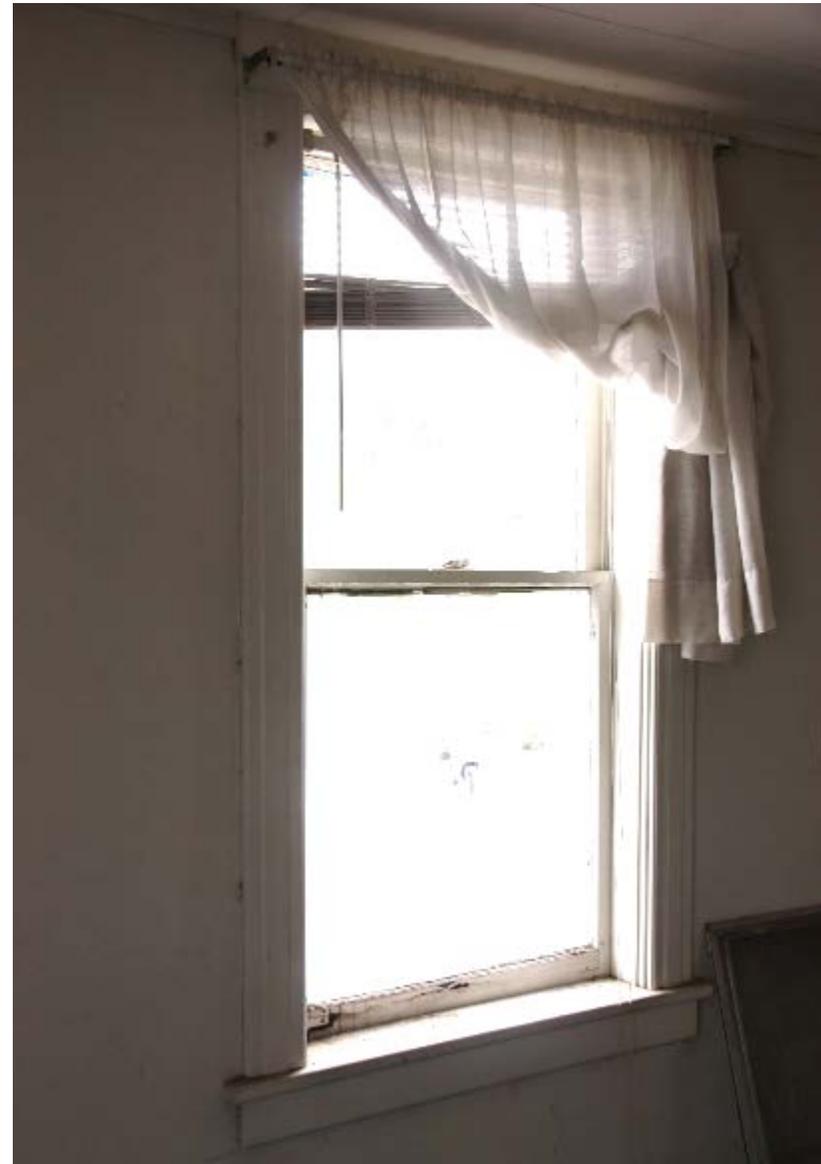
A representative sampling of the windows operate smoothly, yet the sash are in fair to poor condition. The bottom rails of several of the windows have rotted and split, prompting prior installation of steel angles to fix the rail to the stiles. Some bottom rail joints need to be reglued. Some of the glass panes are cracked, some of the pulls and locks are missing, and some of the pulley cords are cut.

*Figure 58: Black Bear Inn. The northwest window in Room 11 is representative of the typical window in the building. Room 11 is at the northwest corner of the 2<sup>nd</sup> floor.*

1. Reglue lower rail and stile joints, removing metal angles in the process.
2. Scrape wood sash and trim and prepare for paint. This should be coordinated with, and occur after, testing for lead.
3. Replace glazing putty and reset glass with proper glazing points as required.
4. Repaint sash and putty.
5. Patch cracks in concrete sills.
6. Replace missing hardware, replace missing sash cords. Render windows operable.
7. Provide sheet metal weatherstripping at the meeting rails, jambs, sill, and head. This will reduce air infiltration.
8. Provide exterior storm sash; repair aluminum storms as desired.

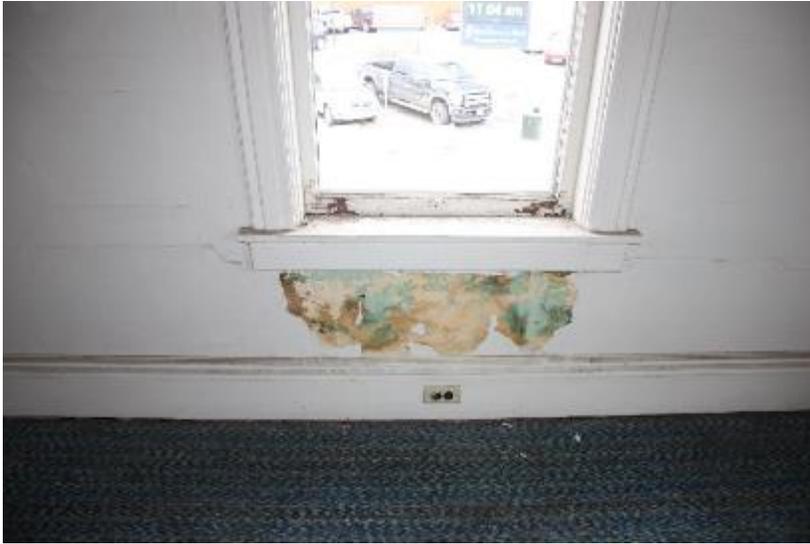
*Figure 59: Black Bear Inn. Lower portion of northwest window in Room 11.*

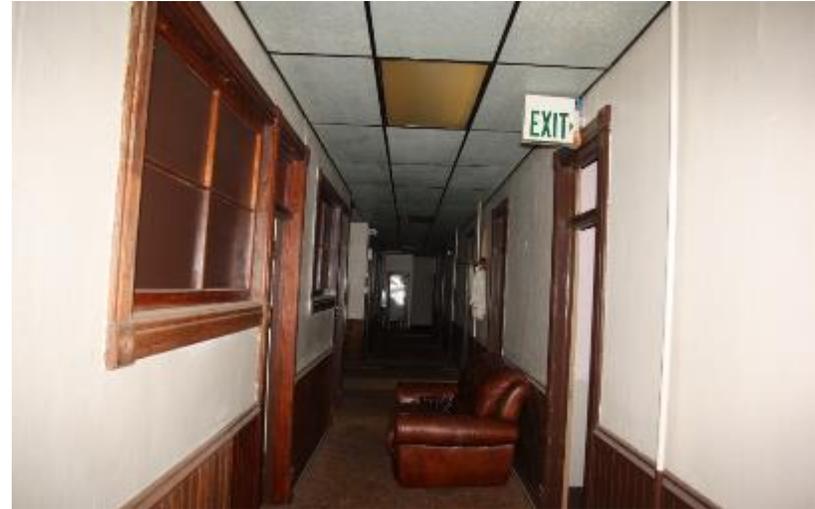
Figure 61: Black Bear Inn. Looking east down main corridor.

Severe: Remove and discard the suspended ceilings. Remove deteriorated and delaminated plaster. Repair remaining plaster.

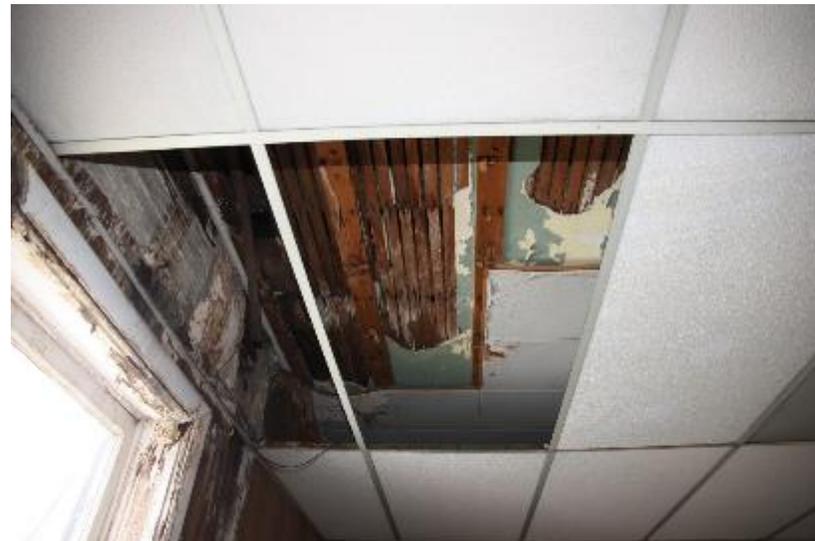
Figure 62: Black Bear Inn. Original plaster ceiling exposed above the fiberboard ceiling and suspended ceiling below.

The Owner has indicated the intent of exposing the original plaster ceiling.

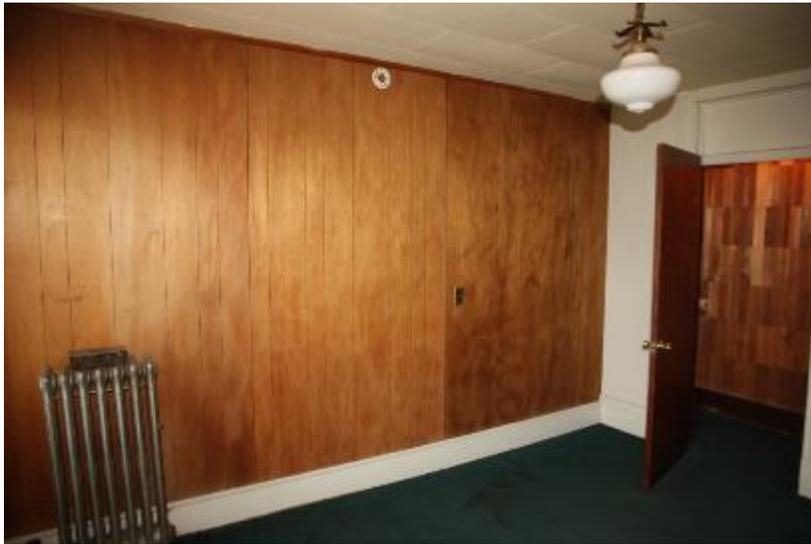
Figure 63: Black Bear Inn. Wood veneer paneling in second floor Room 10.

Most of the wall plaster is in good condition, as is the wood veneer paneling. Some of the exterior walls have been damaged by penetrating moisture – typically near the roof/ceiling.

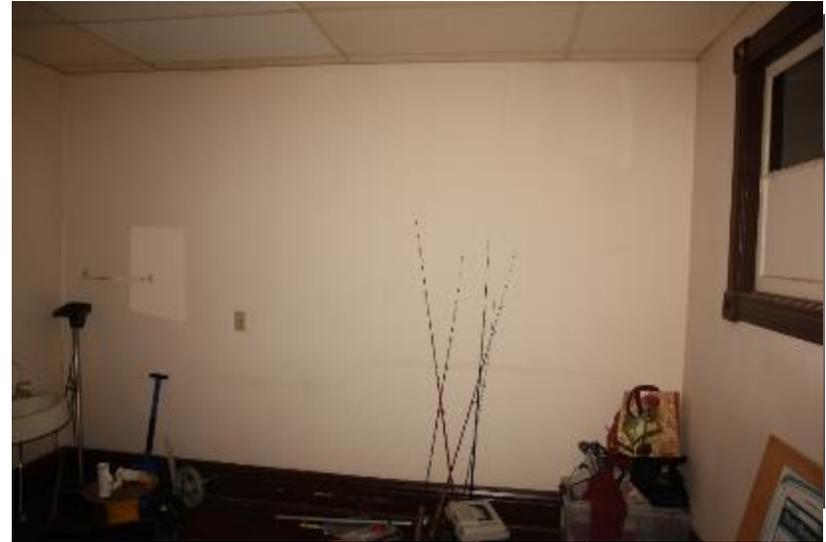
Figure 64: Black Bear Inn. The plaster walls are typically in good condition.

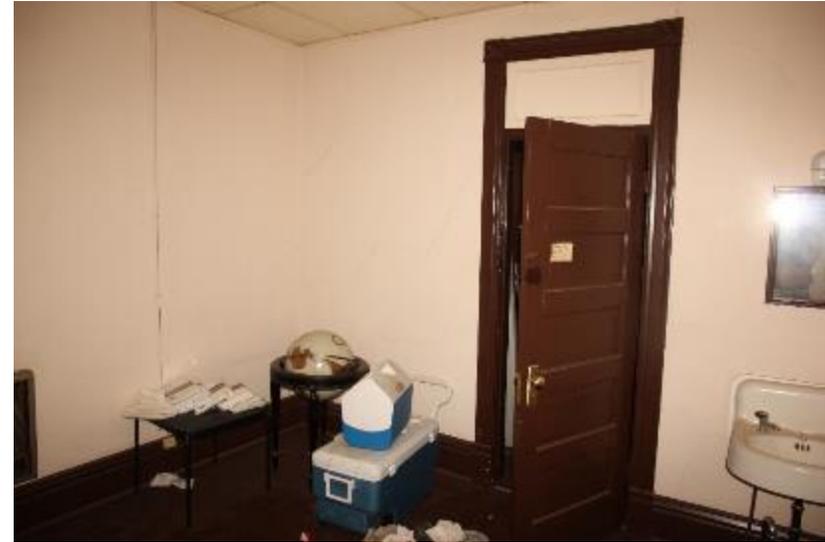
Figure 66: Black Bear Inn. Typical five panel door and painted transom.

Low: Provide missing hardware. Lubricate hardware. Install doors where needed.

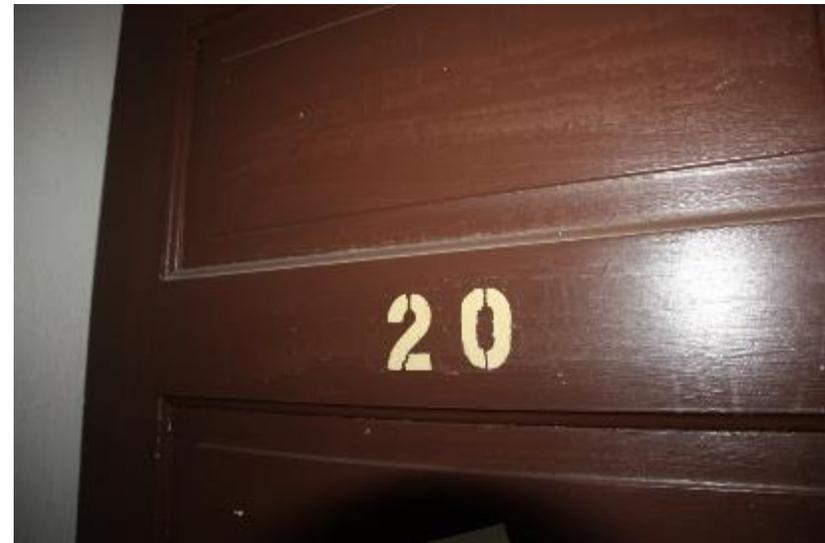
Figure 67: Black Bear Inn. Most of the hallside of the doors are identified by stenciled numbers.

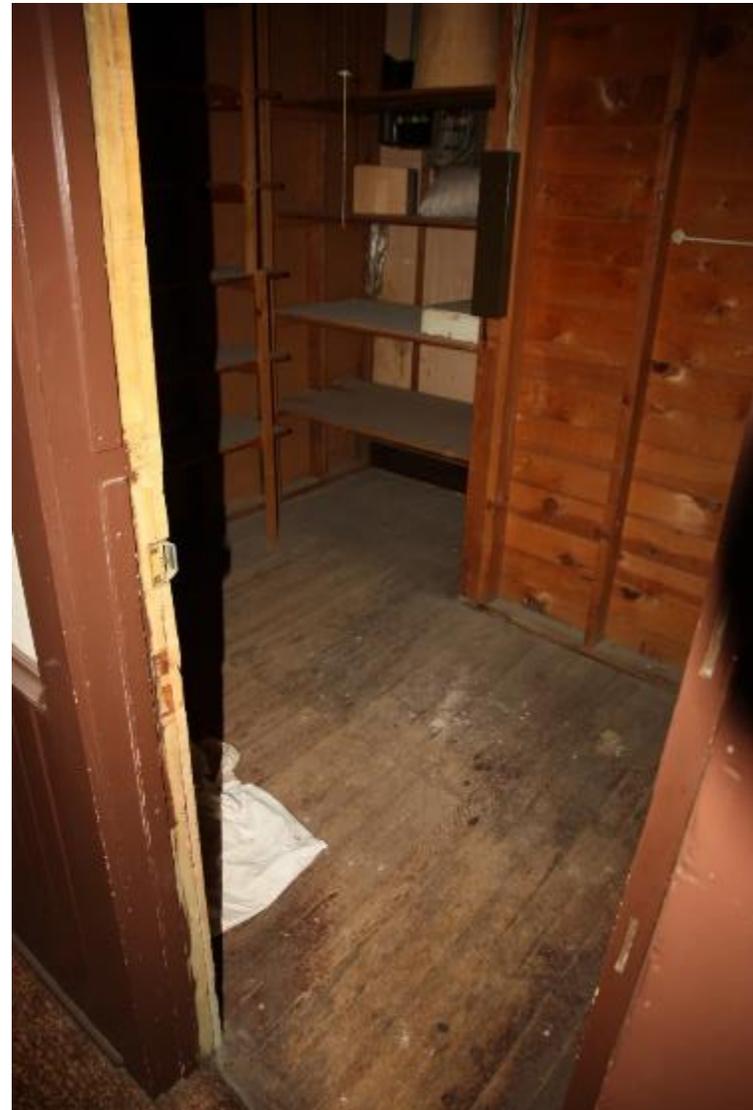
Figure 68: Black Bear Inn. The wood tongue-and-groove flooring in the second floor closet is indicative of the flooring throughout the second floor.

Moderate: Remove all the carpeting. Salvage, repair, and clean the resilient flooring. Repair/patch wood flooring that has been sawcut. Refinish the wood flooring.

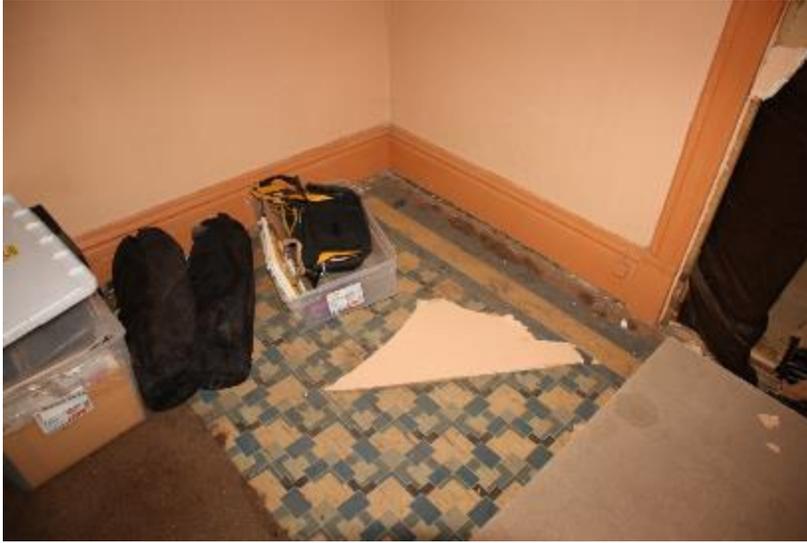
*Figure 69: Black Bear Inn. Some rooms have sheet linoleum flooring underneath the carpeting.*

**Material Note:** The resilient flooring and adhesive have not been tested for asbestos. If any of the flooring or adhesive is scheduled for removal, it should be tested first and proper precautions taken during removal.

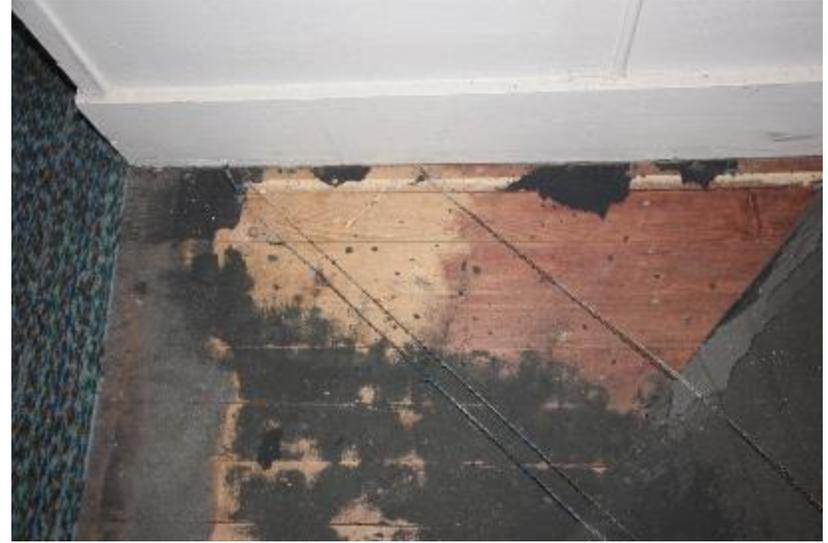
*Figure 70: Black Bear Inn. Original wood flooring visible where the carpet has been pulled up in Room 11.*
