# 3D-Sq. Home Inspection Service

## Property Inspection Report

Property address: **12345 Your Road**  
**Your Town, MO 11111-2222**

Inspection date: **Tuesday, January 30, 2018**

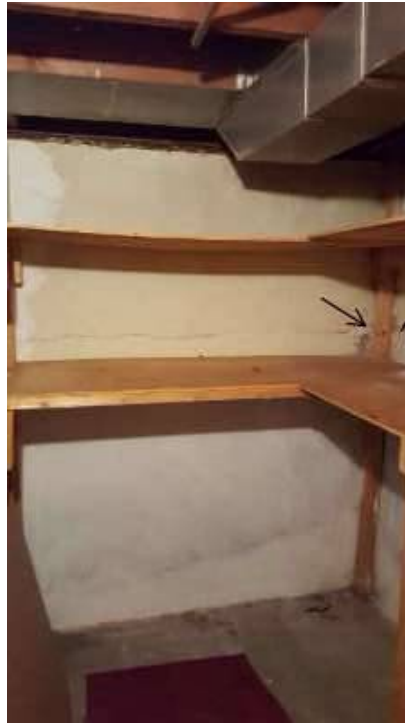
Photo 5-2

Moderate cracks (1/8 inch - 3/4 inch) and/or leaning were found in the foundation. This may be a structural concern or an indication that settlement is ongoing. The client should consider hiring qualified contractors and/or engineers as necessary for further evaluation. Such contractors may include:

At a minimum, recommend sealing cracks to prevent water infiltration. Numerous products exist to seal such cracks including hydraulic cement, resilient caulks and epoxy sealants.

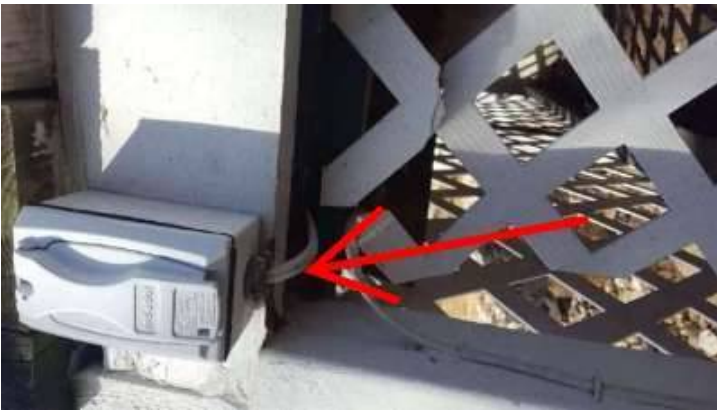
**Photo 12-1**  
All exterior outlets non GFCI. Some have exposed wiring.
