Peace of Mind Automotive Inspection Report.

Site conducted	Unanswered
Customer name	Luis LMJ auto motor sales
Date / Time	Jan 21st
Payment method	Invoice
Inspection cost	199
Vehicle Year / Make / Model / Color	2007 ford f150 KR

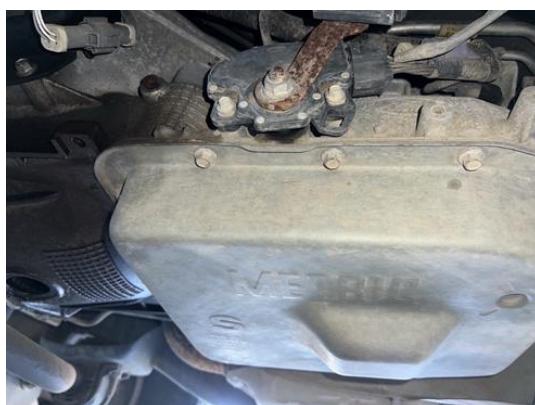
Photo 162

Oil seepage noticed from the oil pan gasket area, future replacement of the oil pan gasket is to be expected

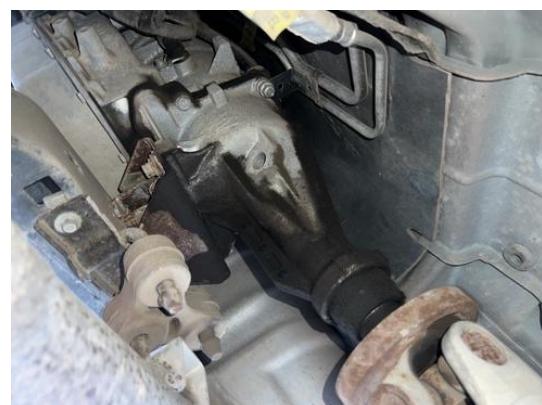
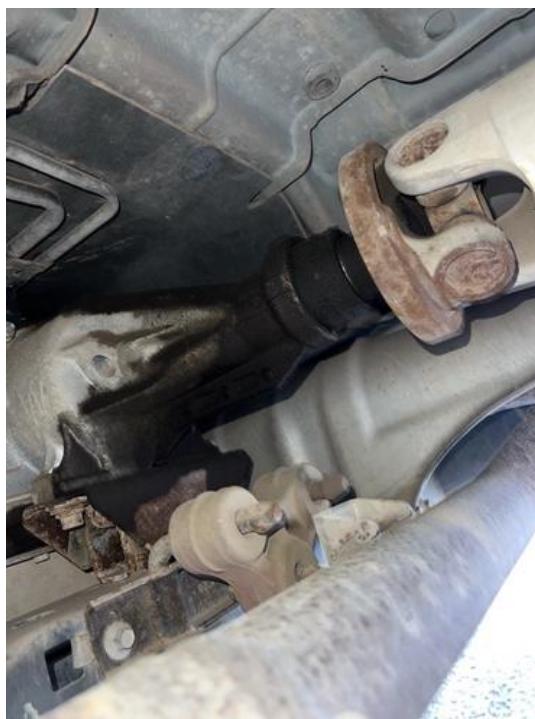
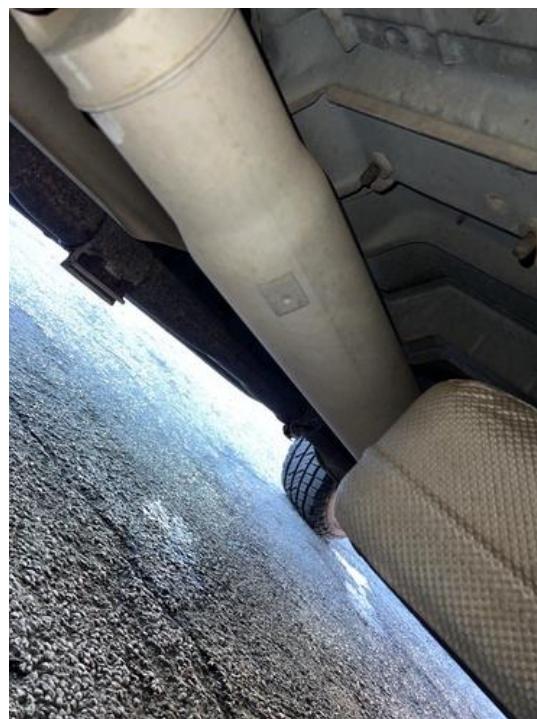
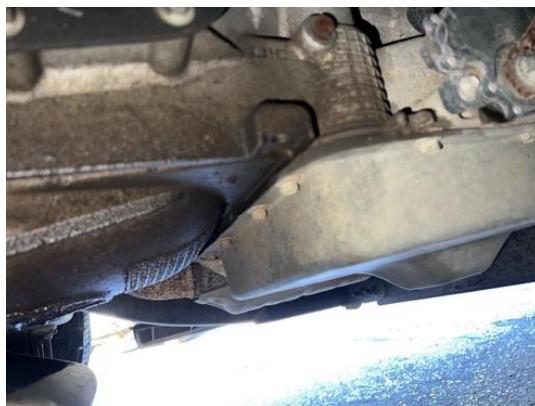
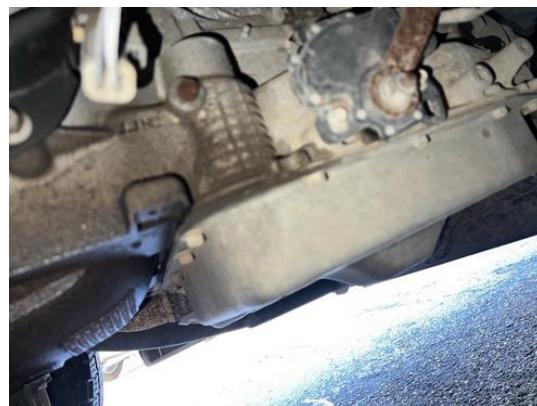
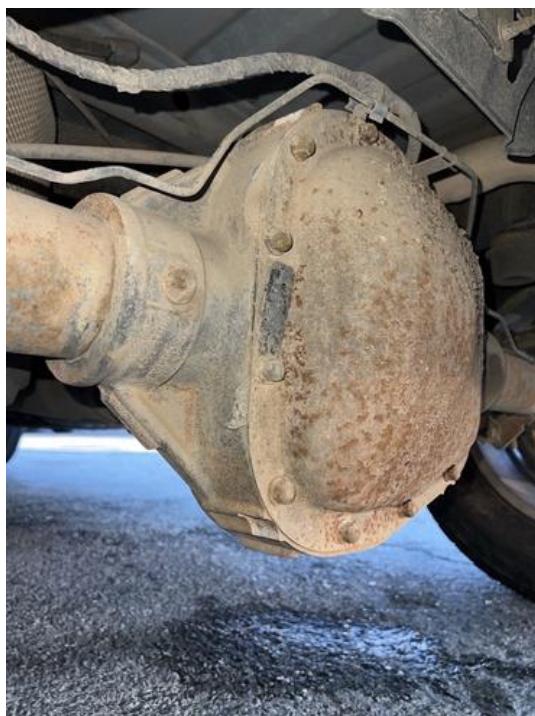
No transmission fluid leak out from the transmission casing or the transmission pan area. Drive shaft and seal is free of any fluid leaks. The rear differential is free of any fluid leak out. Shift transitions out on the road are correct across the board.
