## Peace of Mind Automotive Inspection Report.

<b>Site conducted</b>	Unanswered
<b>Customer name</b>	Luis LMJ auto motor sales
<b>Date / Time</b>	Jan 21st
<b>Payment method</b>	Invoice
<b>Inspection cost</b>	199
<b>Vehicle Year / Make / Model / Color</b>	2010 ford f150
<b>VIN</b>	86712 last 5

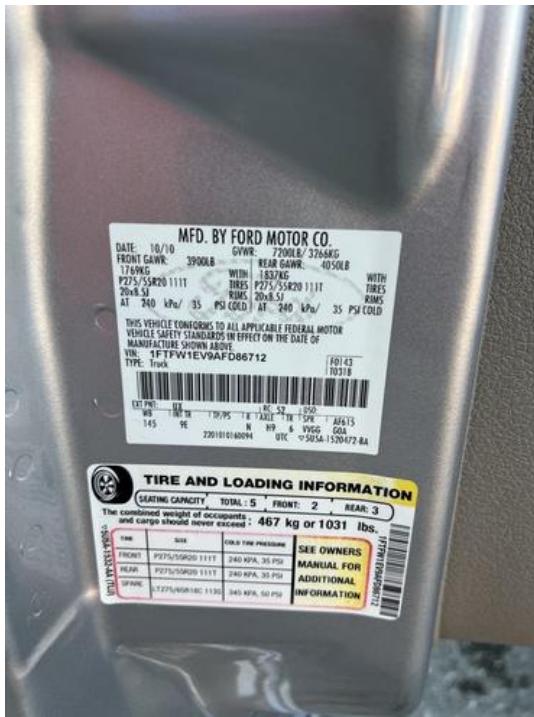
Photo 1

<b>license plate</b>	Dealer
<b>Mileage</b>	100307
<b>Color</b>	Silver

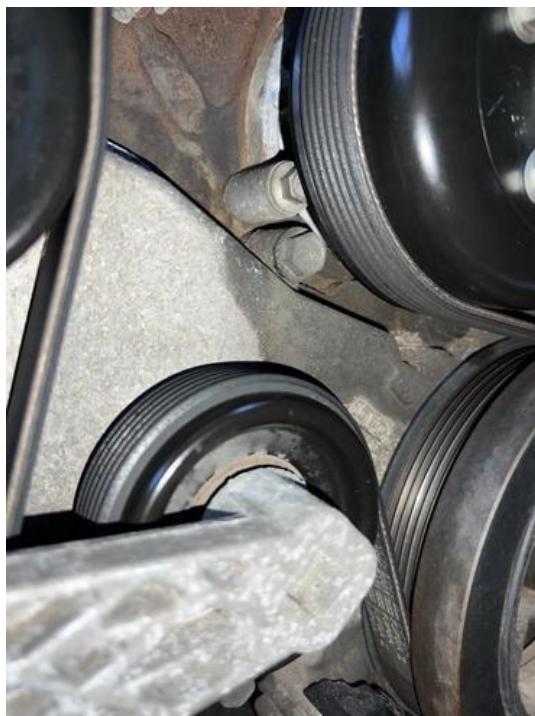
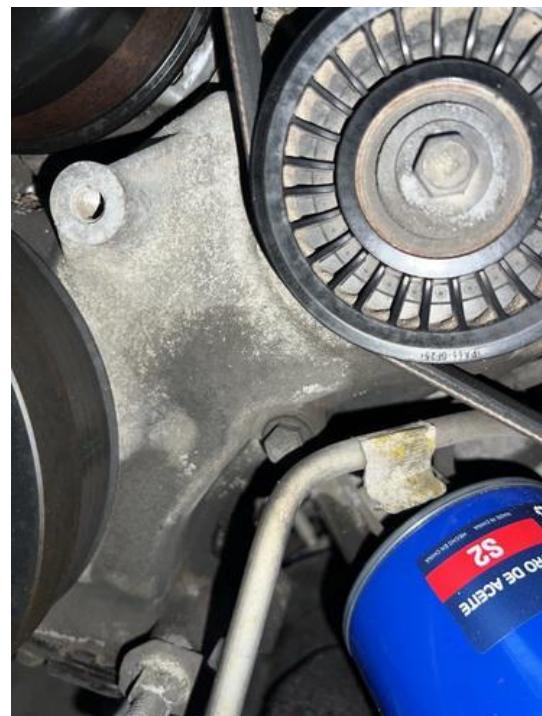
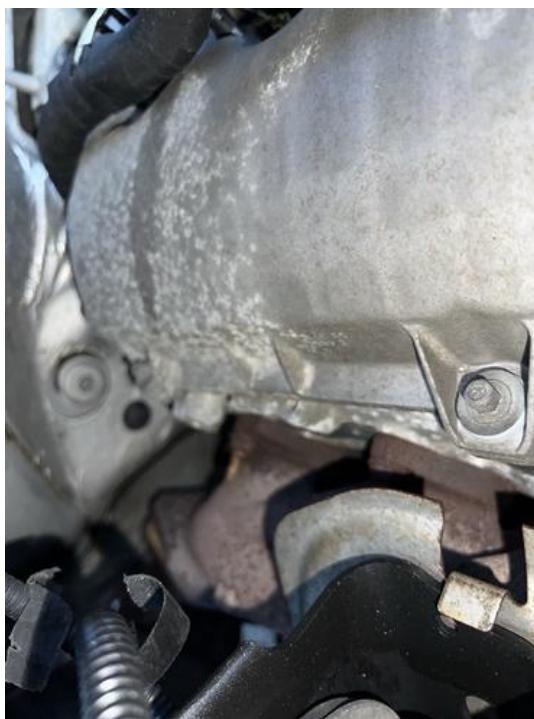
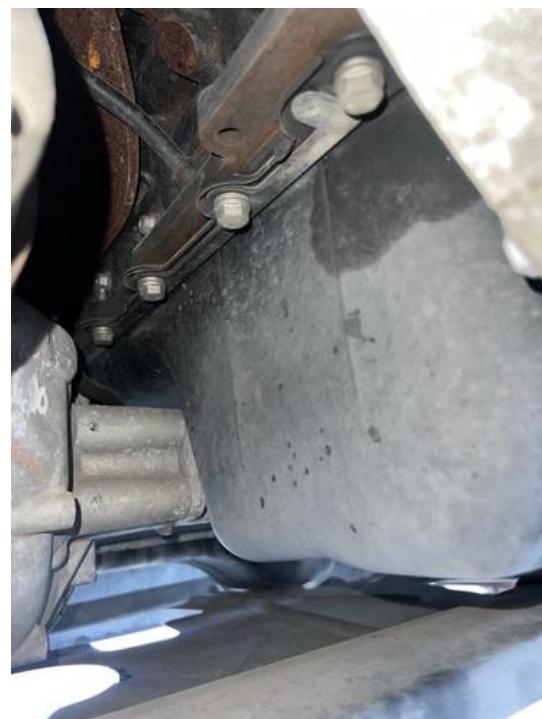
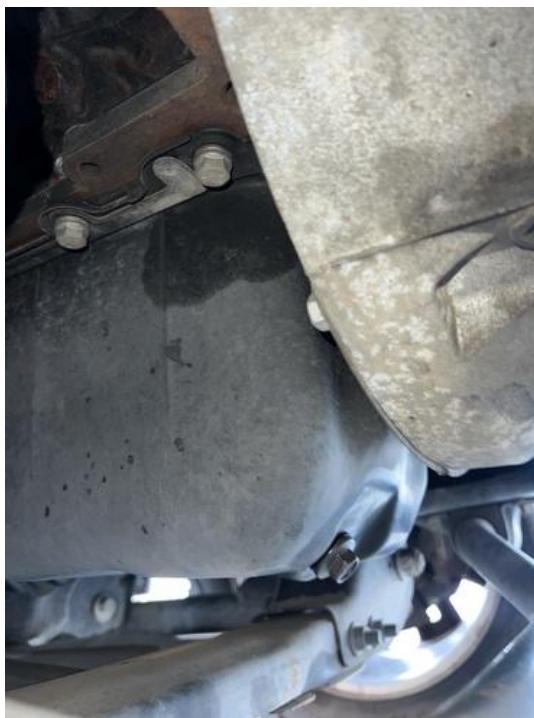
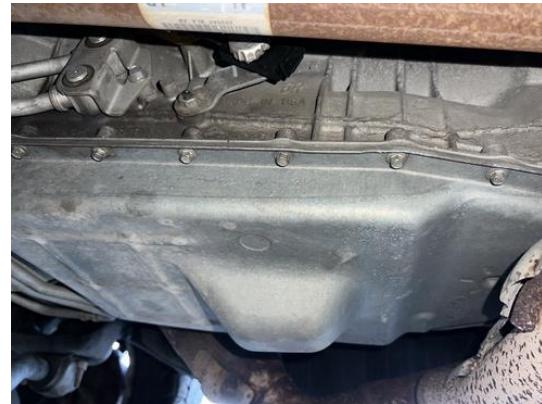
Engine clean internally, no gunk or sludge presents. Proper signs of maintenance present. Block test passed, no internal combustion leak out. Coolant mixture correct and cooling system functionality is healthy. All external engine accessories in good working. No leaks or seepage from anywhere on the engine. External drive belts in decent condition. Currently no concern in mechanical issues present in relation to the engine or related accessories.

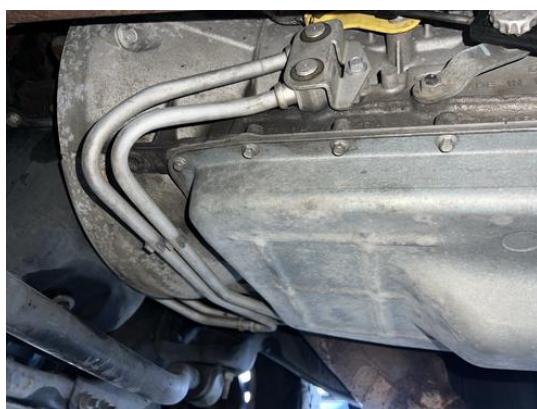
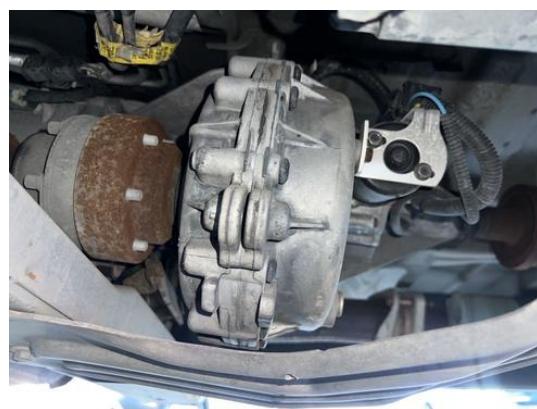
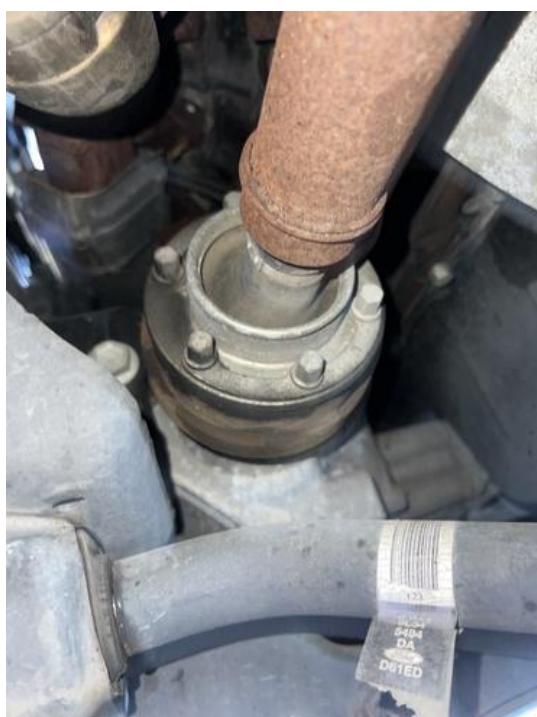
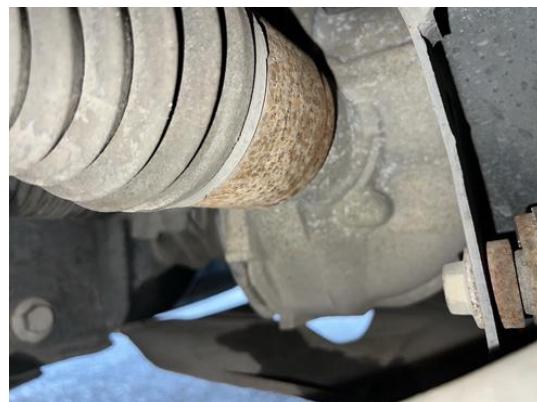
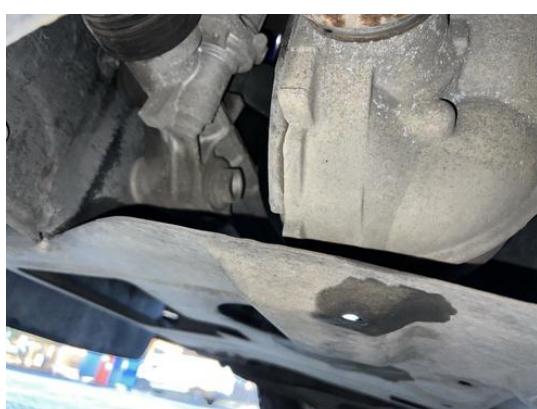
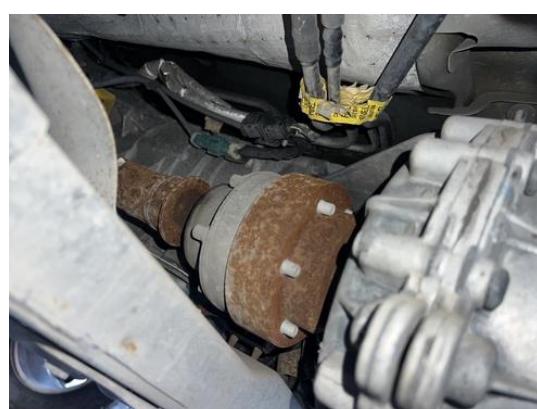
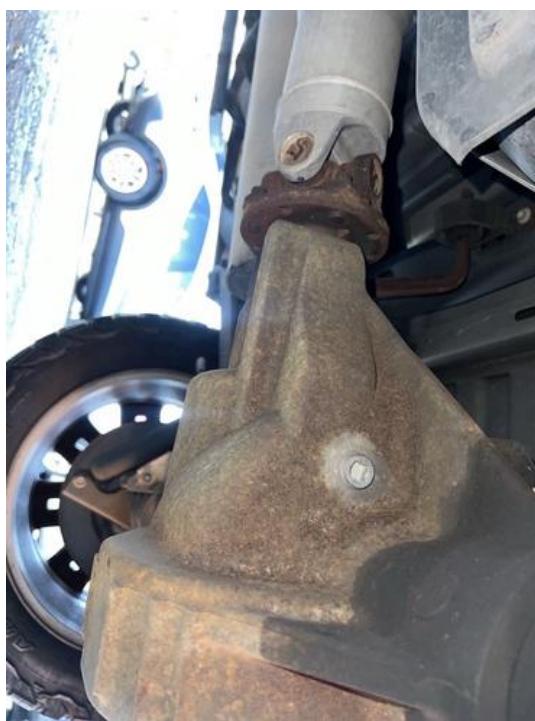
No transmission fluid leak out from the transmission casing or the transmission pan area. Drive shaft and seal is free of any fluid leaks. The rear differential is free of any fluid leak out. Shift transitions out on the road are correct across the board.

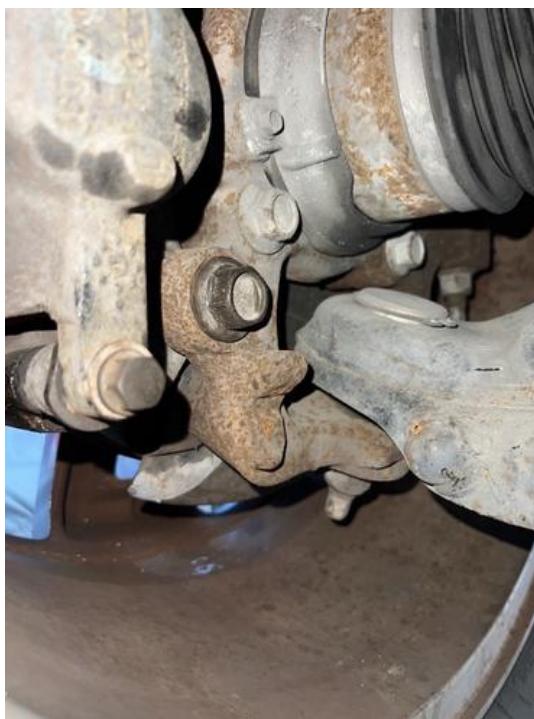
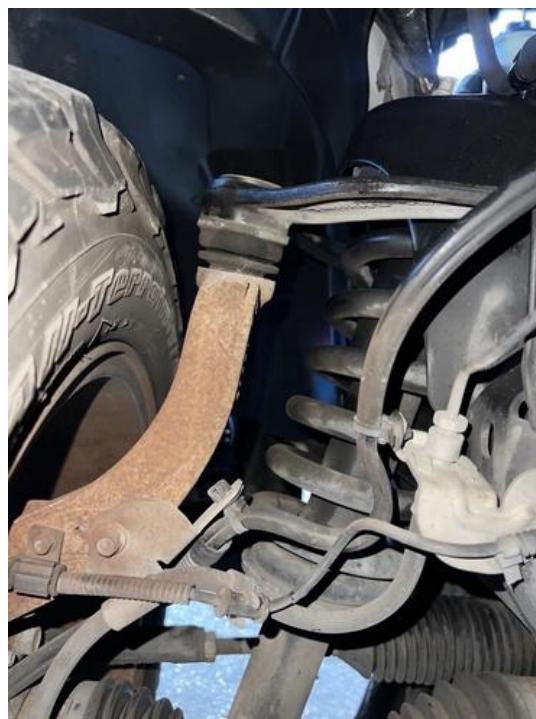
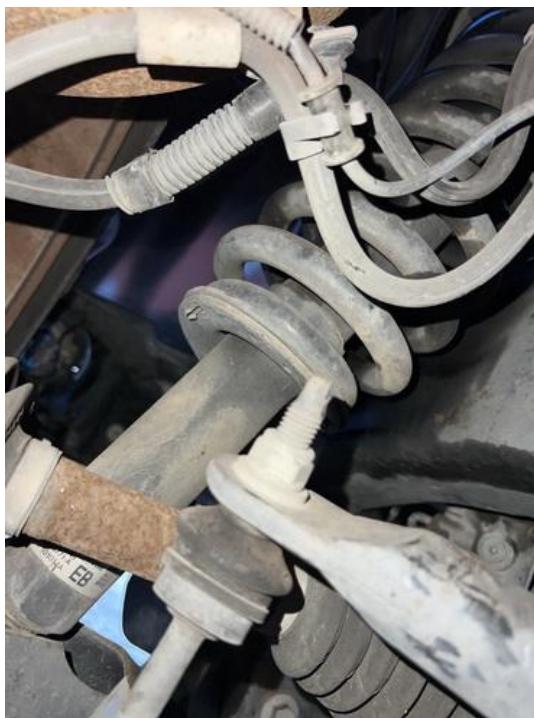
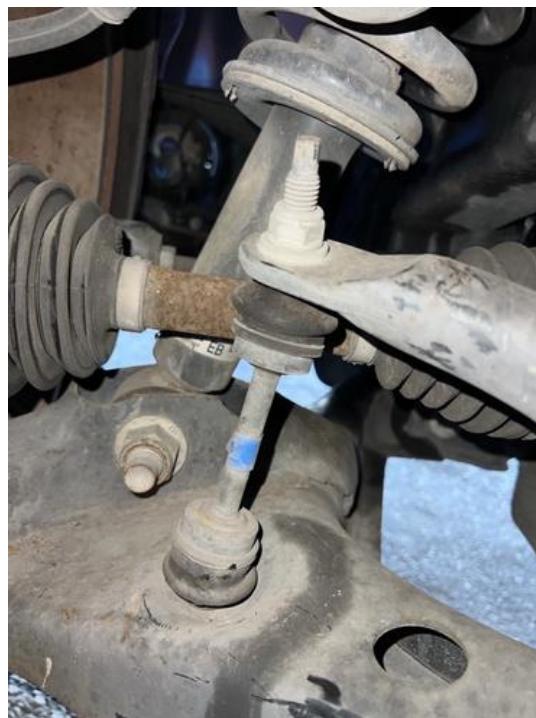
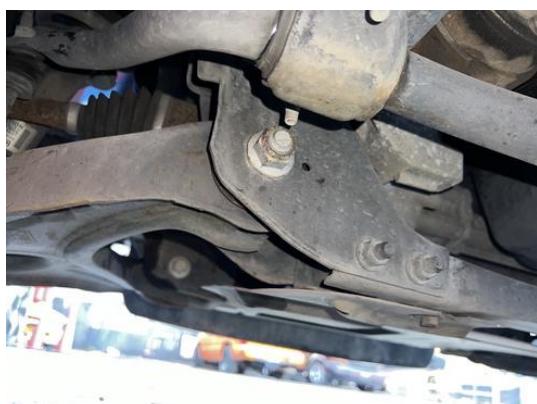
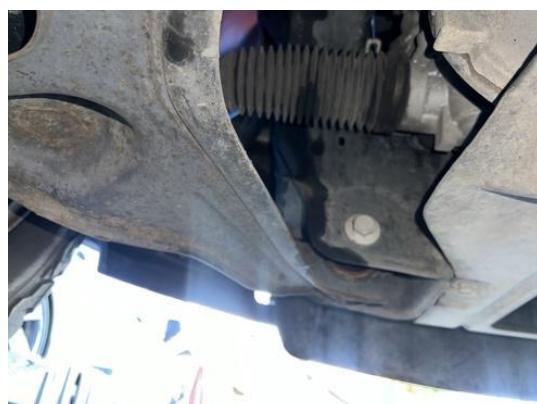
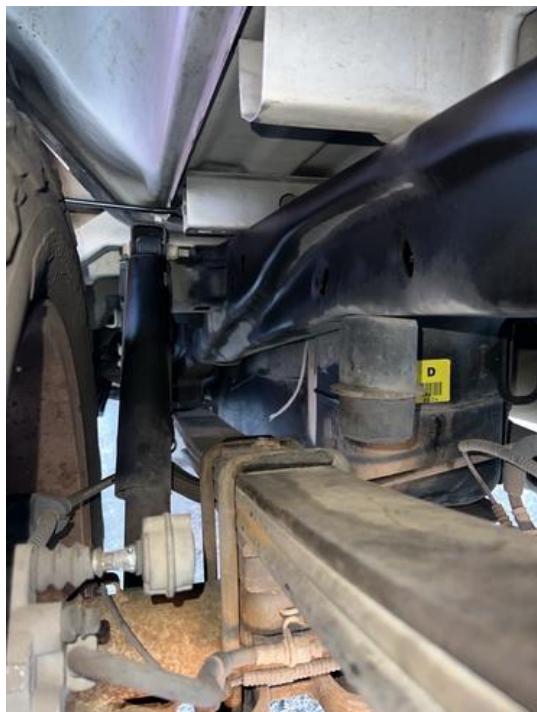
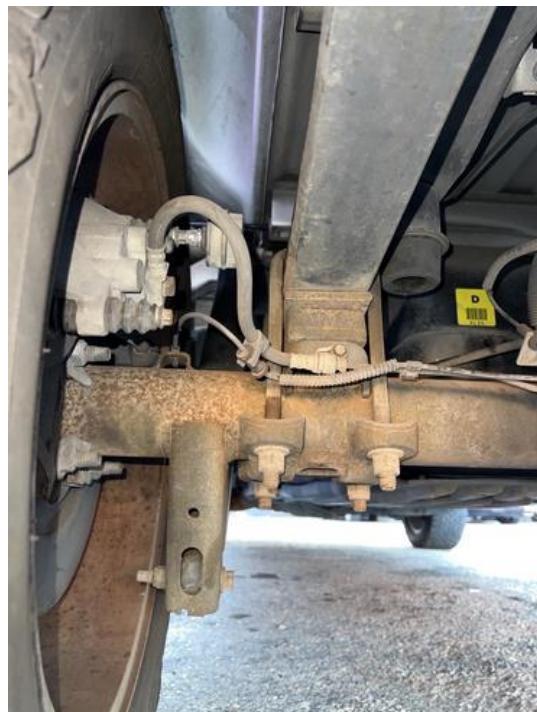
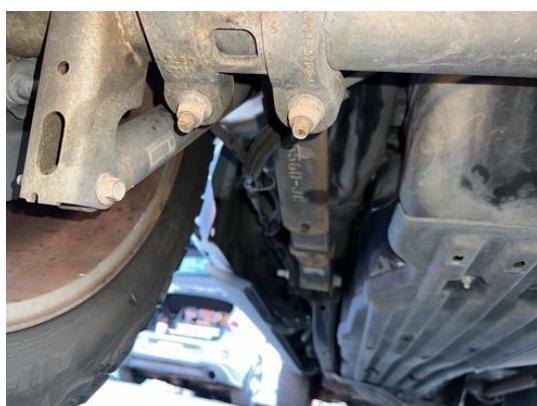
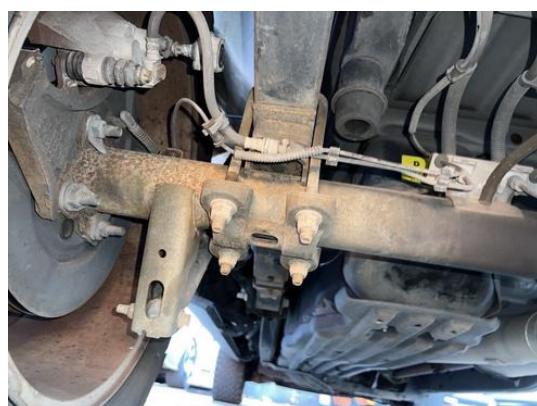
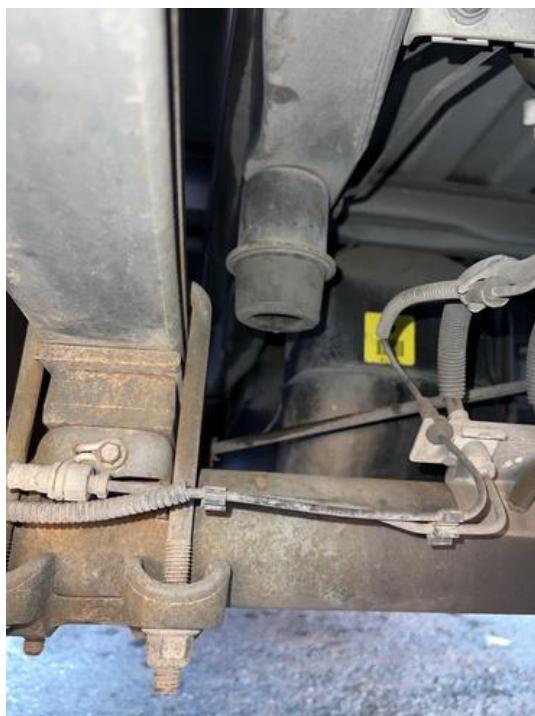
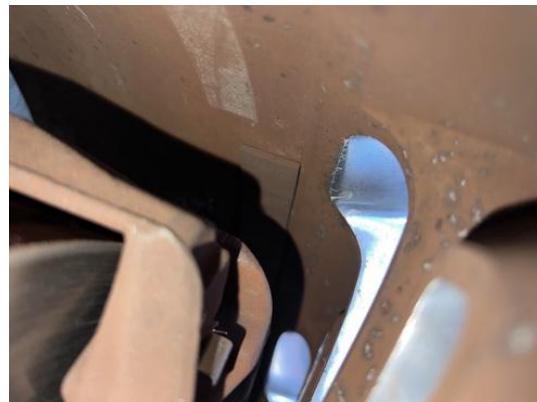
Normal fatigue notice to the suspension components. All of the suspension components seem to be original. None of the suspension components are blown out and due form the replacement. The No excessive surface rust on the exposed metal. No abnormal noise or feedback from the suspension while out on the road. All of the rubber in relation to the mounts, joints and bushings has decent texture.
