# Peace of Mind Automotive Inspection Report.

Score	4 / 4 (100%)	Flagged items	1	Actions	0
<b>Site conducted</b>					Unanswered
<b>Customer name</b>					Luis LMJ auto motor sales
<b>Date / Time</b>					Jan 21st
<b>Payment method</b>					Invoice
<b>Inspection cost</b>					199
<b>Vehicle Year / Make / Model / Color</b>					2010 ford f150 kR
<b>VIN</b>					11144 last 5

<b>license plate</b>					Dealer
<b>Mileage</b>					117679
<b>Color</b>					Maroon

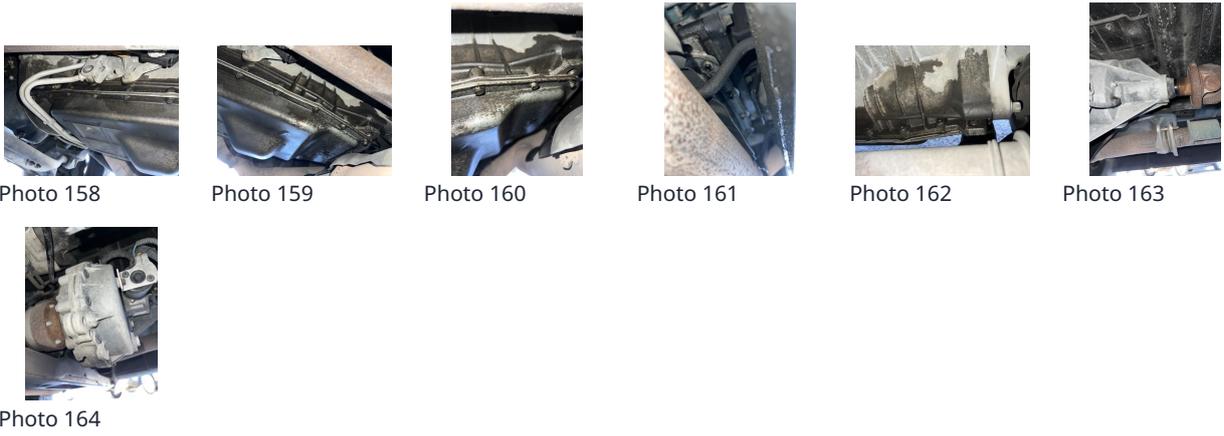
<b>Transmission fluid level</b>	Healthy
<b>Transmission fluid condition</b>	Healthy
<b>Transmission fluid leaks</b>	Present

Small amount of transmission fluid leak out notice from the transmission pan gasket area, future replacement of the transmission pan gasket will be expected

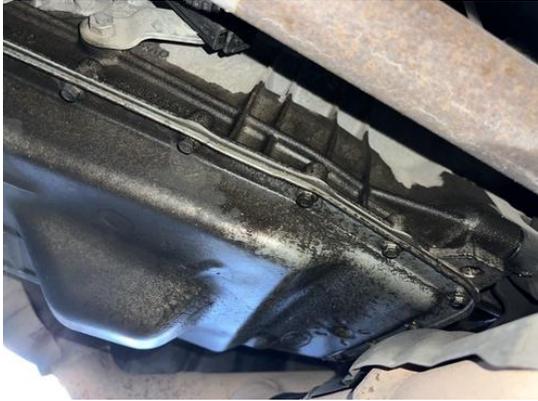
Photo 158

Small amount of transmission fluid leak out notice from the transmission pan gasket area, future replacement of the transmission pan gasket will be expected

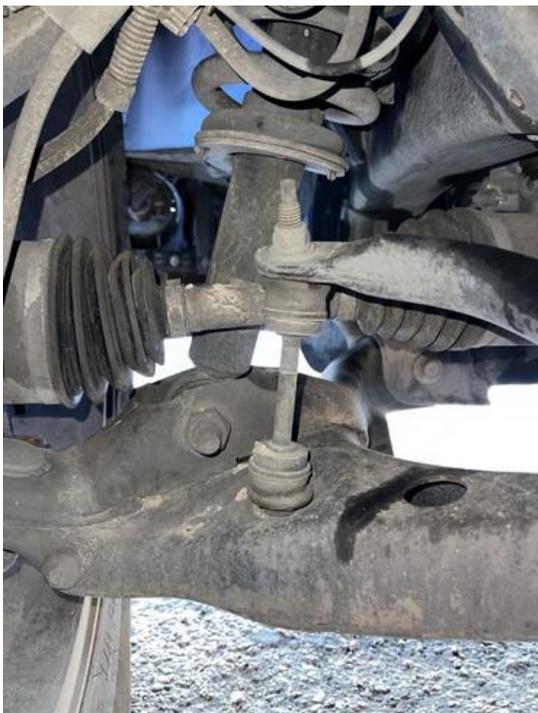
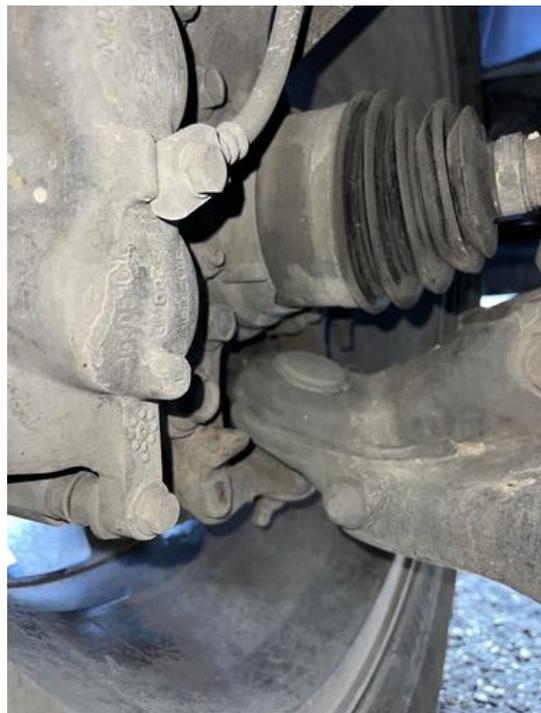
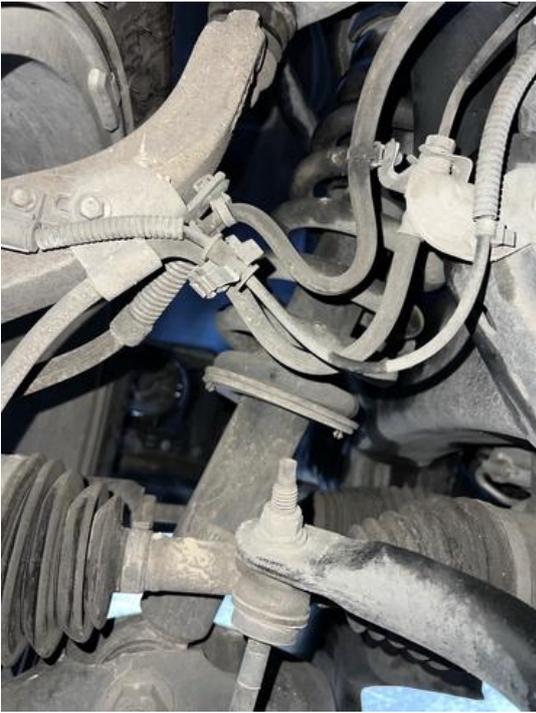
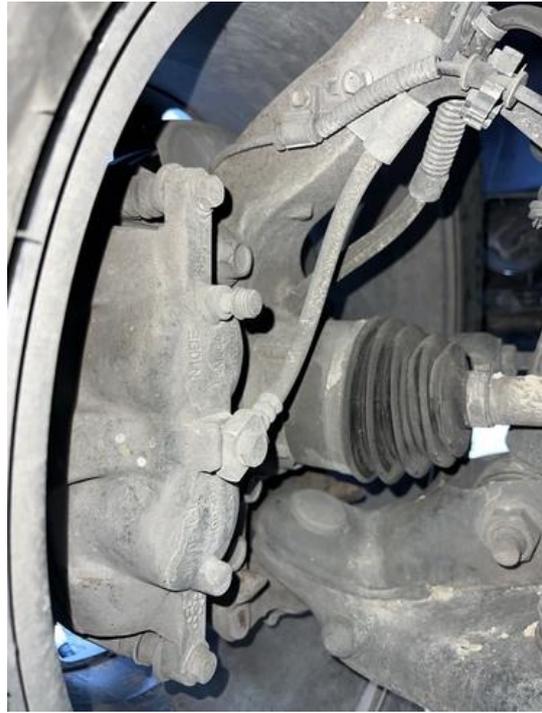
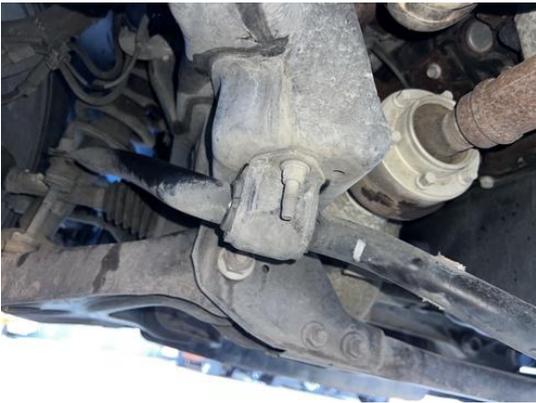
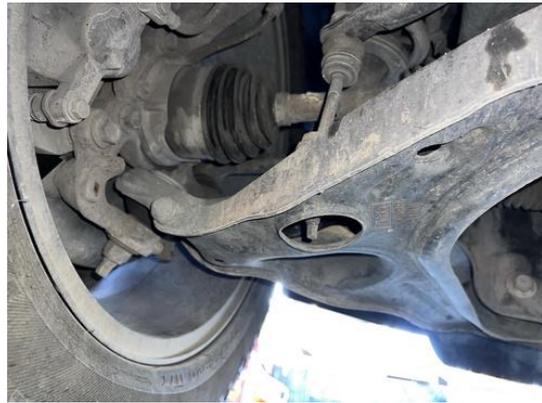
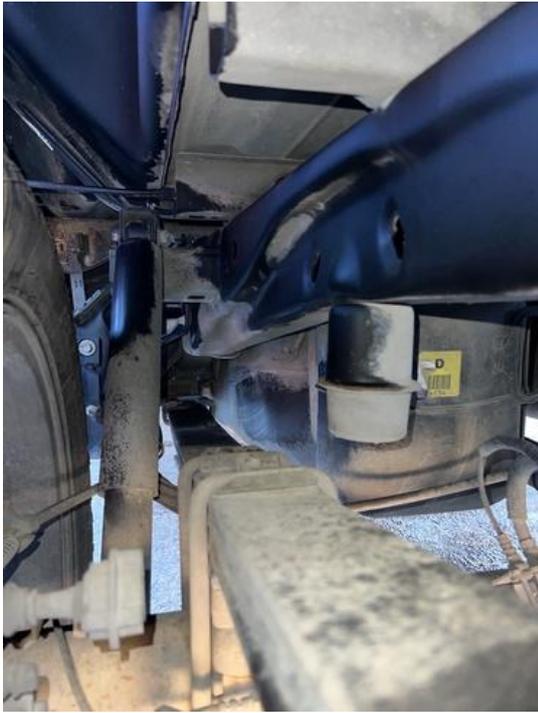
Normal fatigue notice to the suspension components. All of the suspension components seem to be original. None of the suspension components are blown out and due form the replacement. The No excessive surface rust on the exposed metal. No abnormal noise or feedback from the suspension while out on the road. All of the rubber in relation to the mounts, joints and bushings has decent texture.
