# Peace of Mind Automotive Inspection Report.

Score	4 / 4 (100%)	Flagged items	0	Actions	0
<b>Site conducted</b>					Unanswered
<b>Customer name</b>					Luis LMJ auto motor sales
<b>Date / Time</b>					May 18th
<b>Payment method</b>					Invoice
<b>Inspection cost</b>					Fleet
<b>Vehicle Year / Make / Model / Color</b>					2011 ford f150 limited
<b>VIN</b>					83091 last 5

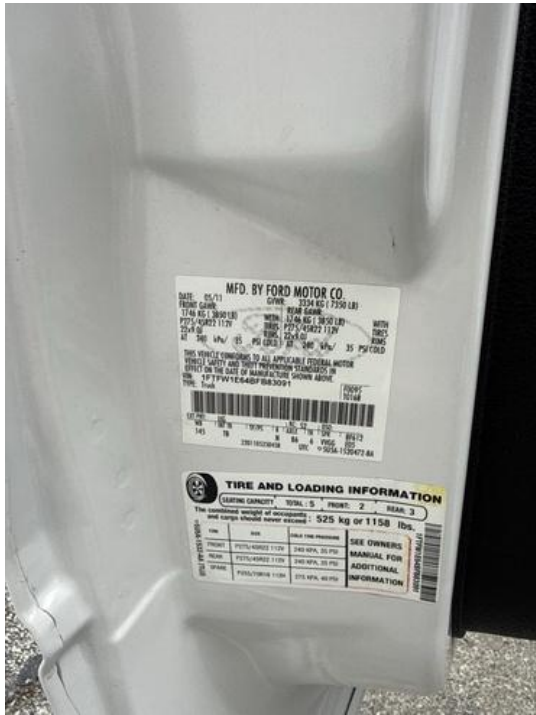
Photo 1					
<b>license plate</b>					Dealer
<b>Mileage</b>					131060
<b>Color</b>					White

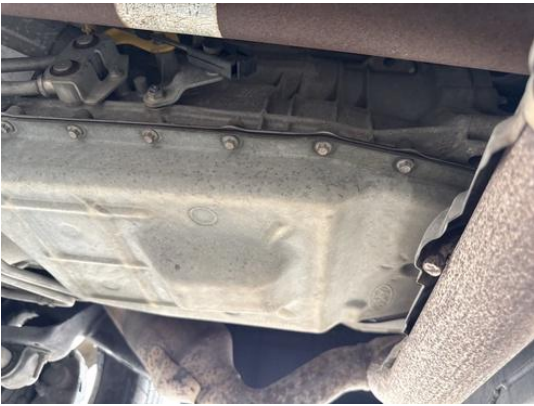
Photo 194

No transmission fluid leaks from the transmission casing or the transmission pan area. The tail shaft seal is free of any fluid leaks. The driveshaft is in healthy condition. Shift transitions out on the road are correct across the board. No fluid leak out from the rear differential. No fluid leak out from the front differential or the center differential. 4 x 4 system functionality is correct.

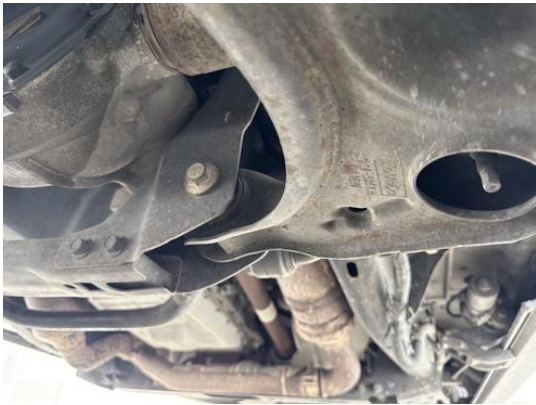
Photo 214

Normal fatigue notice to the suspension components. All of the suspension components seem to be original. None of the suspension components are blown out and due form the replacement. The No excessive surface rust on the exposed metal. No abnormal noise or feedback from the suspension while out on the road. All of the rubber in relation to the mounts, joints and bushings has decent texture.

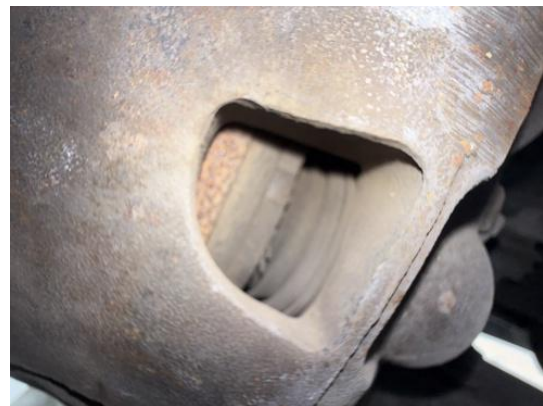
Photo 231

Braking system condition	
Brake fluid condition	Healthy
Brake fluid level	Healthy
Brake fluid leaks	None
Moisture content in brake fluid	None
Brake lines	Healthy
Brake calipers front	Healthy
Brake calipers rear	Healthy
Brake drums rear	N/A
Brake rotors front	Healthy
Brake rotors rear	Healthy
<b>Front brake pad life remaining</b>	50-75% remaining
<p>Right around 55% brake pad life remaining on the front brake system and right about 60% brake pad life remaining on the rear brake system</p>	
<div style="display: flex; justify-content: space-around;"> <div style="text-align: center;">
