Peace of Mind Automotive Inspection Report.

Score	4 / 4 (100%)	Flagged items	1	Actions	0
Site conducted					Unanswered
Customer name					Luis LMJ auto motor sales
Date / Time					Jan 21st
Payment method					Invoice
Inspection cost					199
Vehicle Year / Make / Model / Color					2011 Honda CRZ
VIN					15650 last 5

license plate					Dealer
Mileage					122597
Color					White

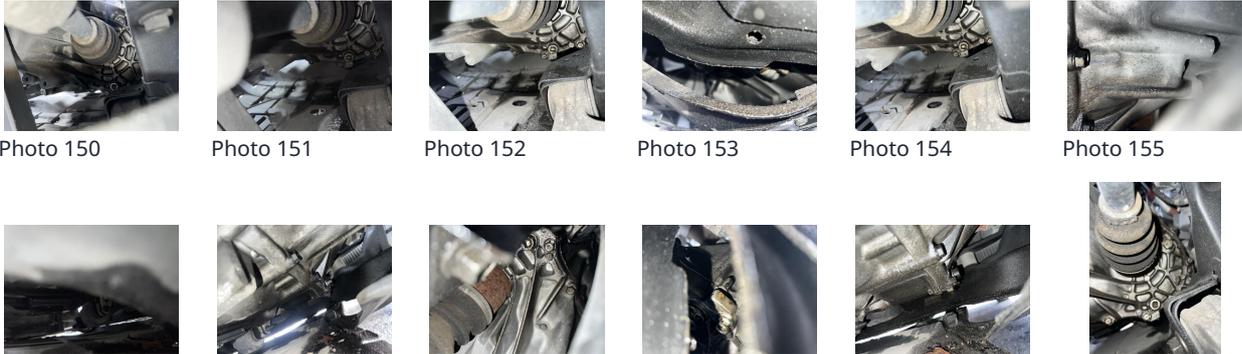
Transmission / Differentials	1 flagged
Transmission fluid level	Healthy
Transmission fluid condition	Healthy
Transmission fluid leaks	Present
<p>There is a small amount of transmission fluid leak out notice from the driver side of the differential, where the CV axle inserts, fluid leak out could potentially be coming from the axle seal itself, or from the different different differential casing.</p>

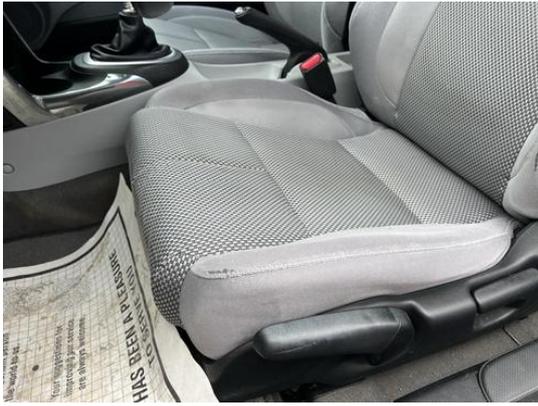
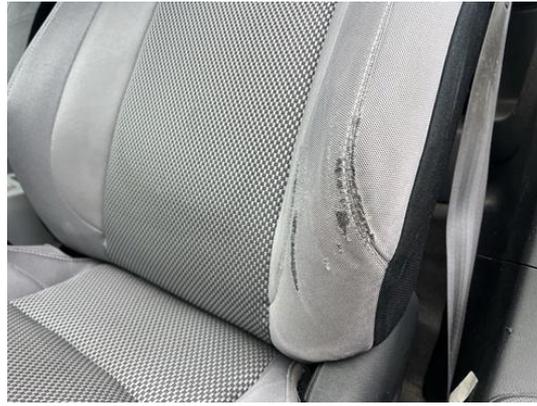
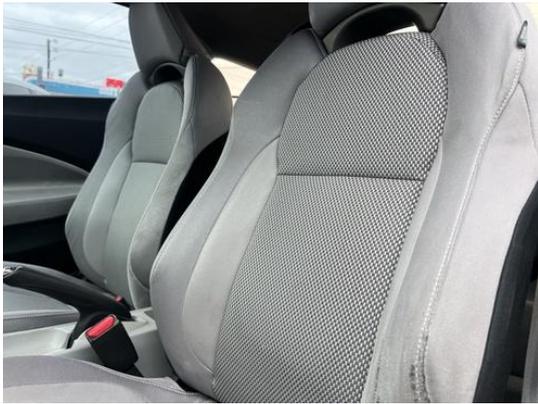
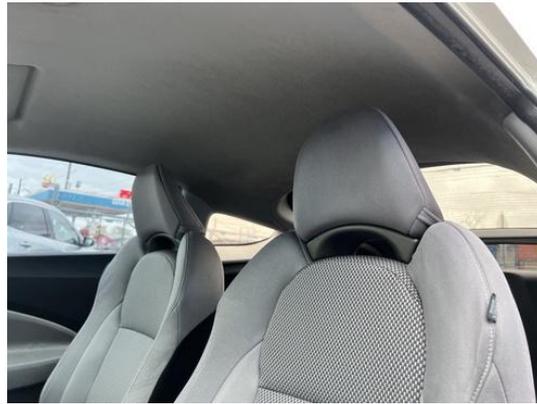
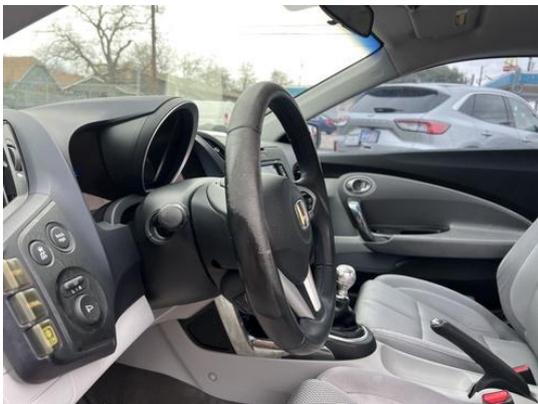
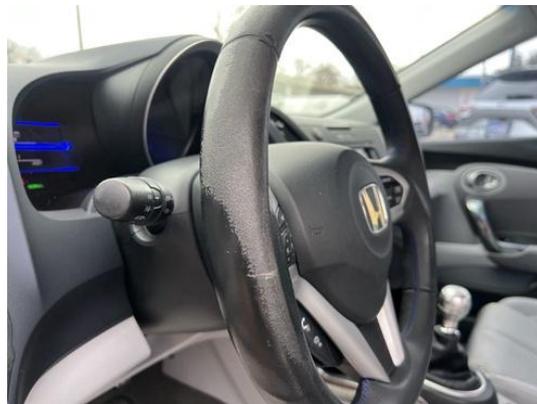
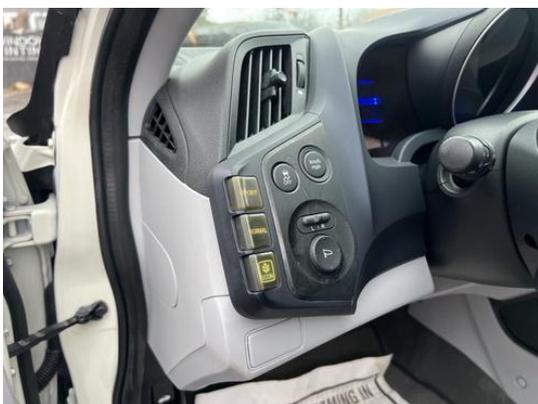
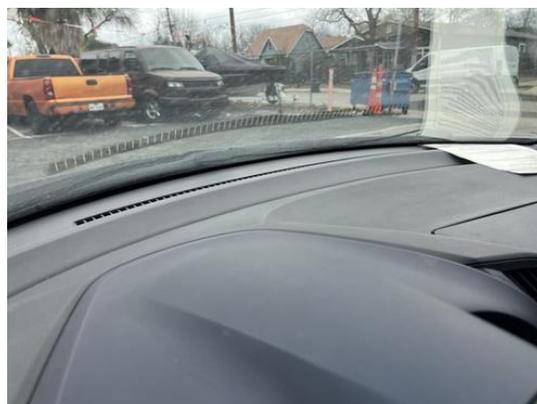
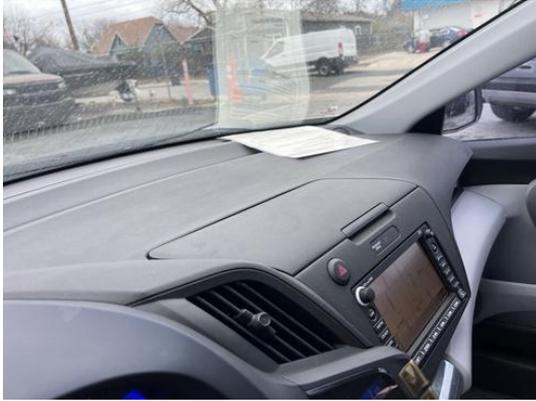
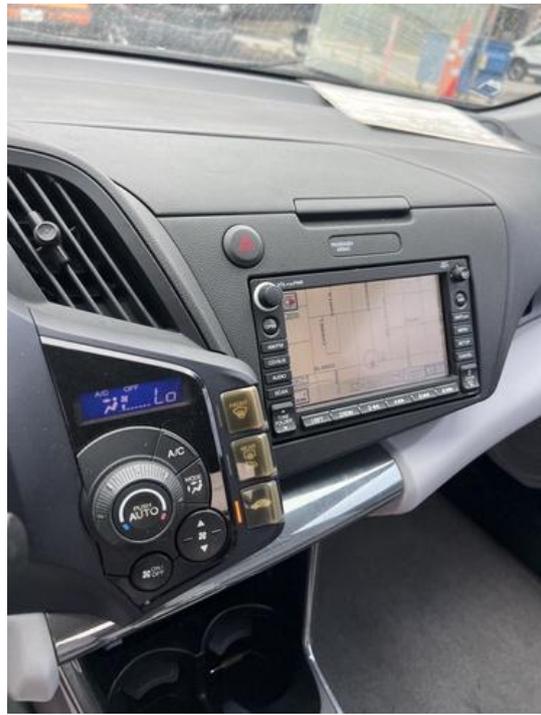
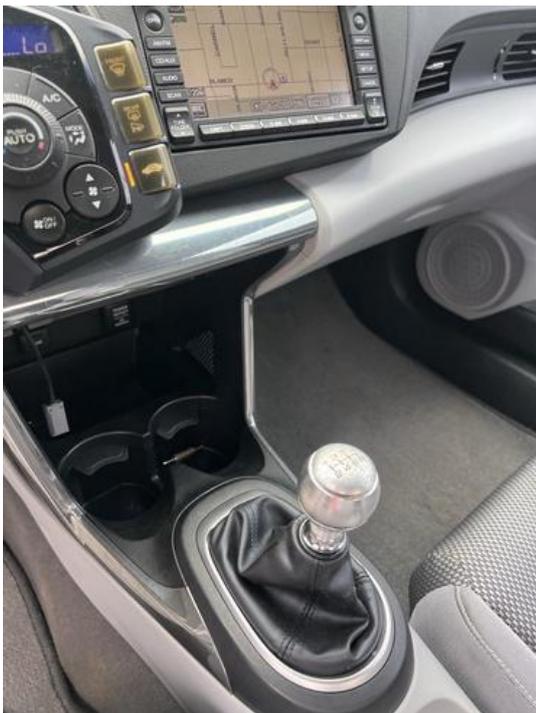
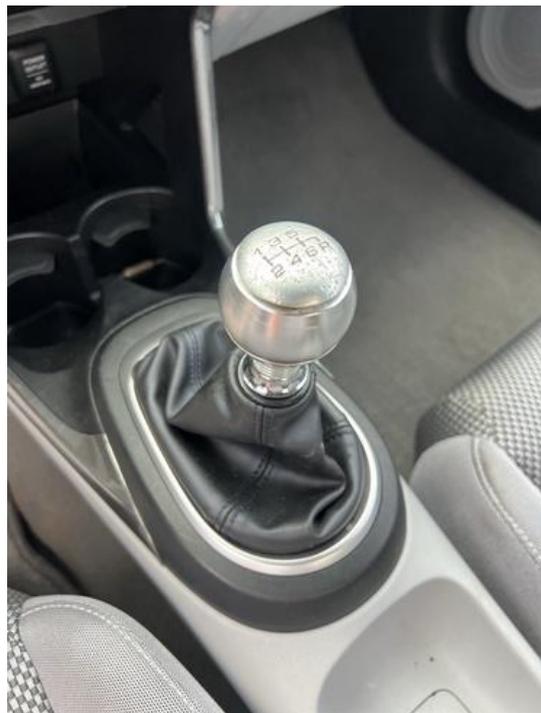
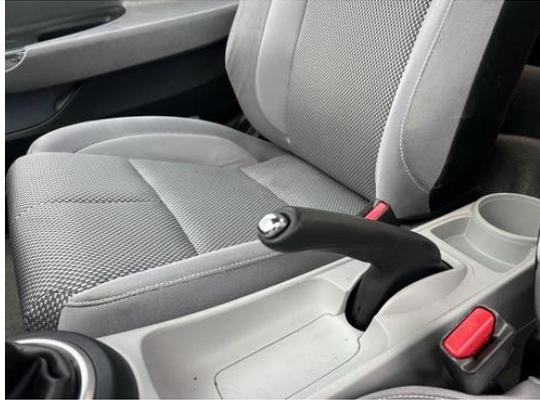
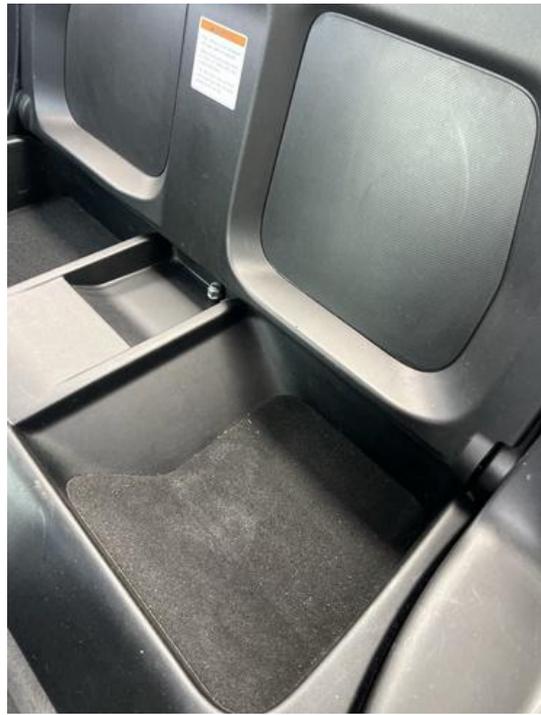
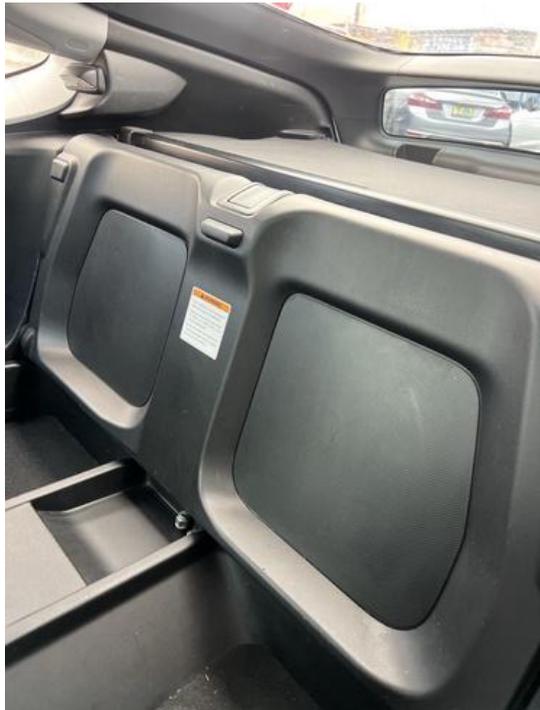
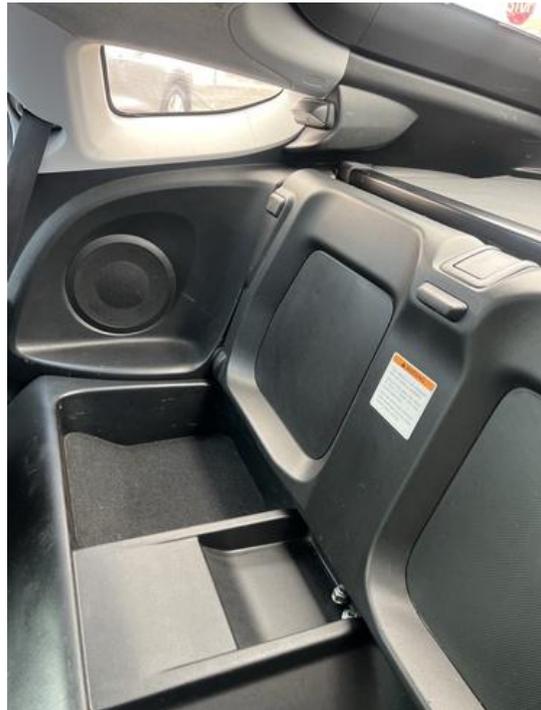
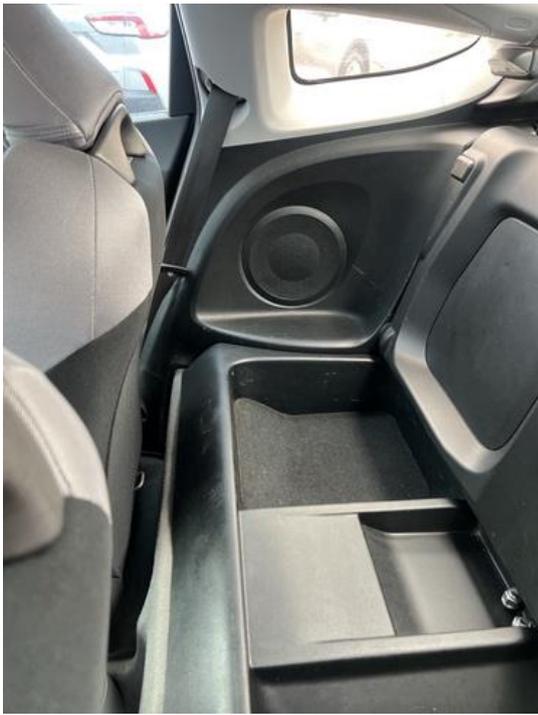
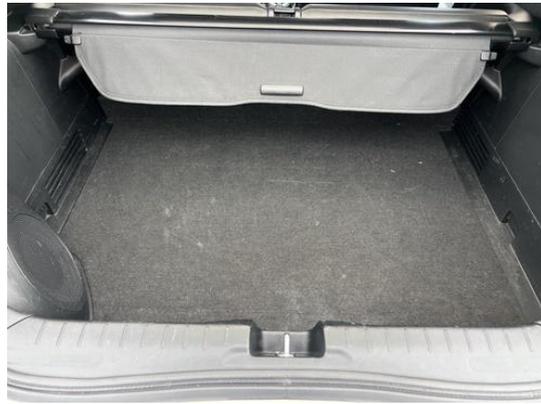
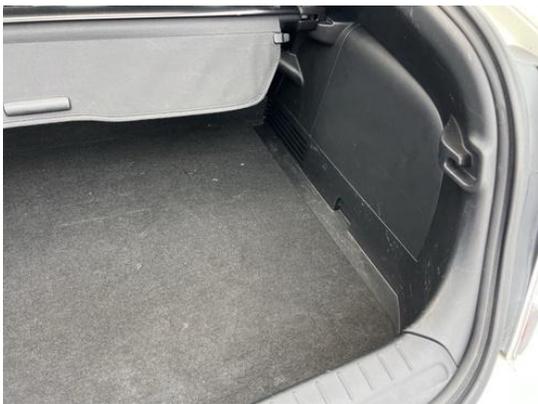
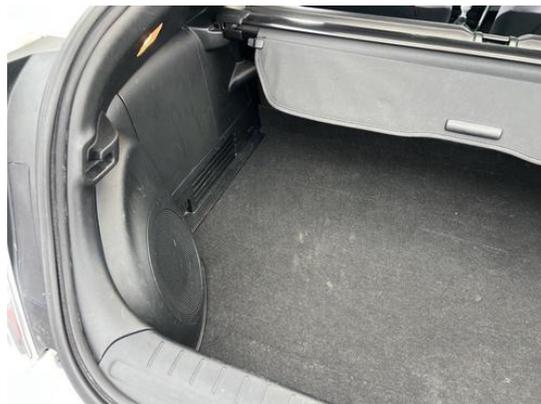
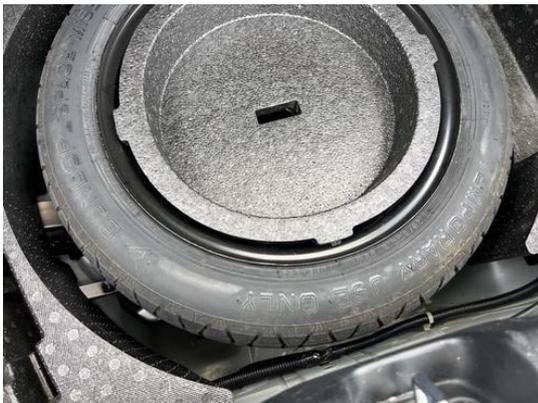
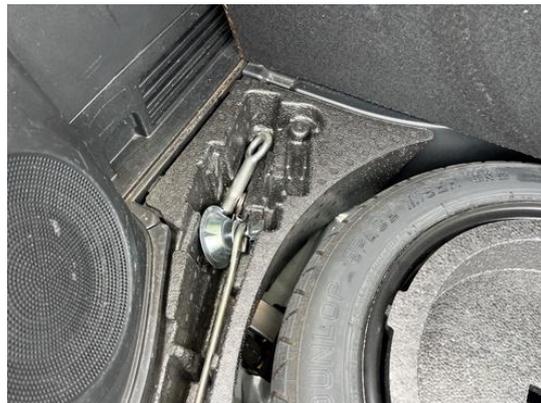
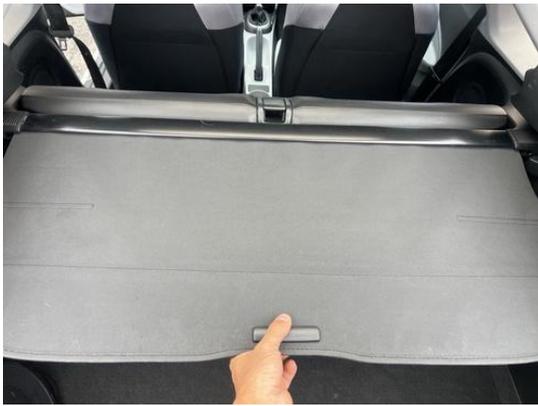
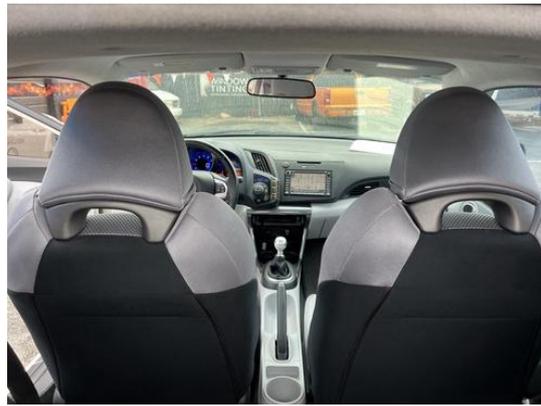
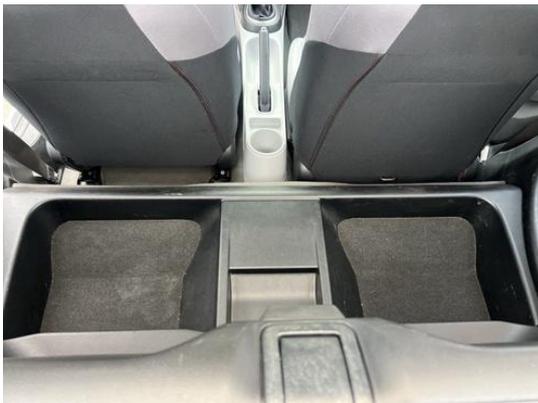
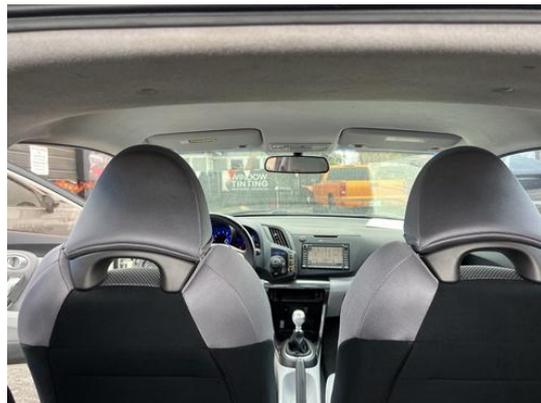
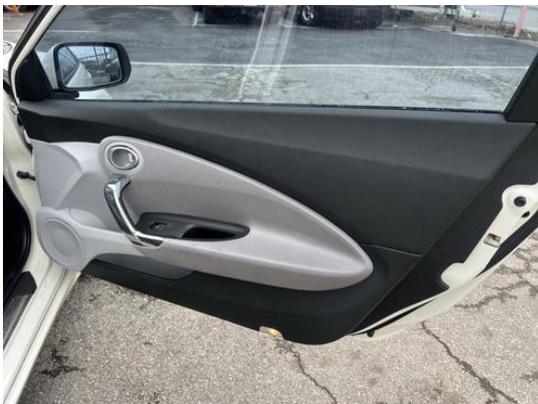
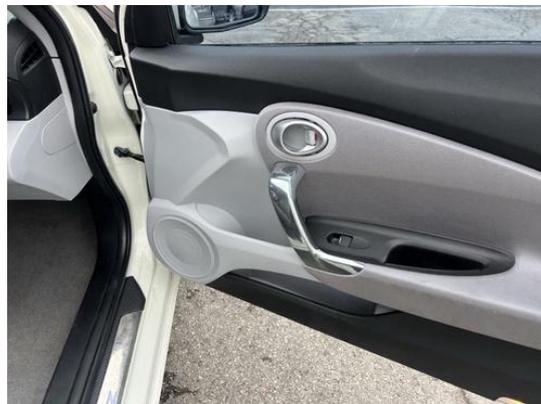
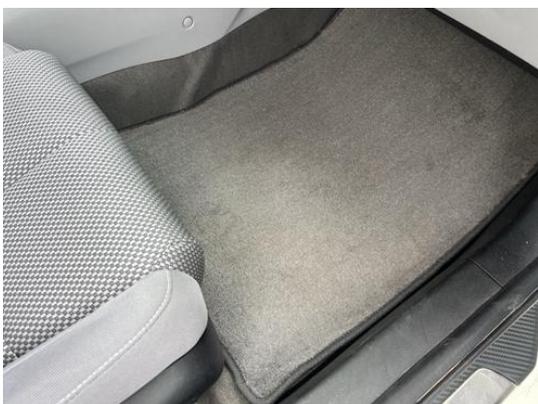
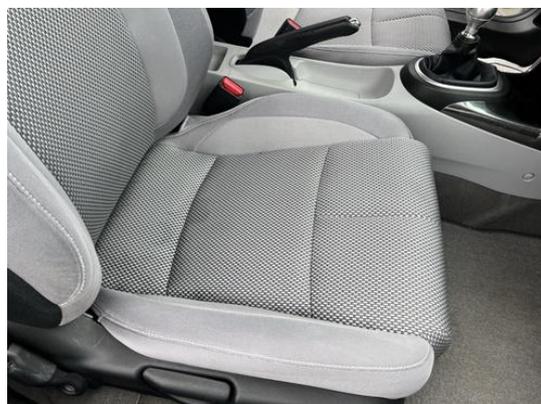
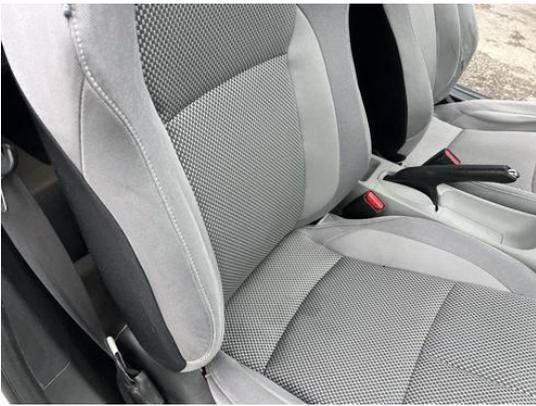
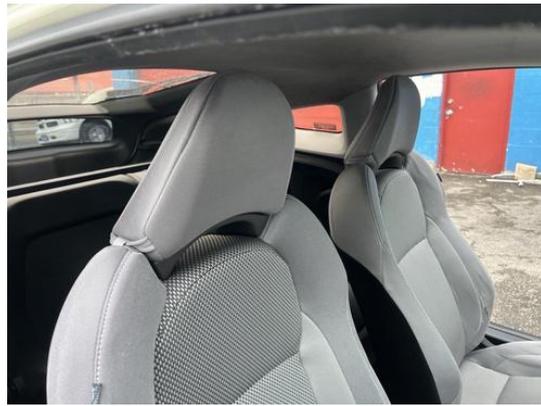
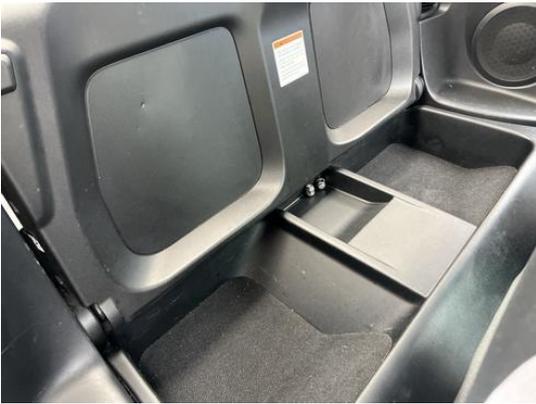
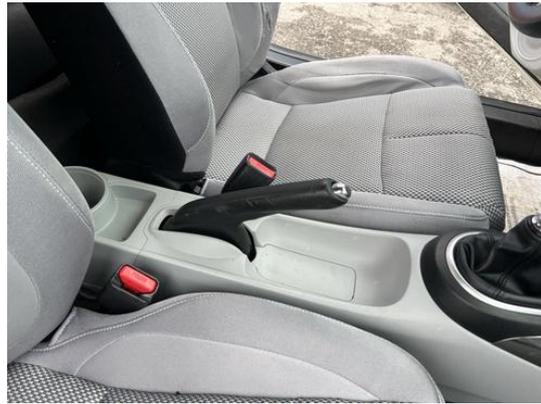
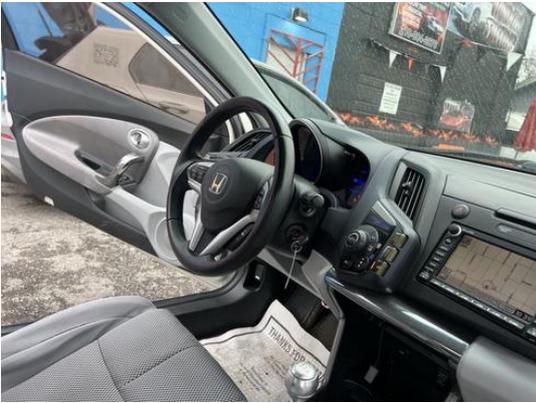
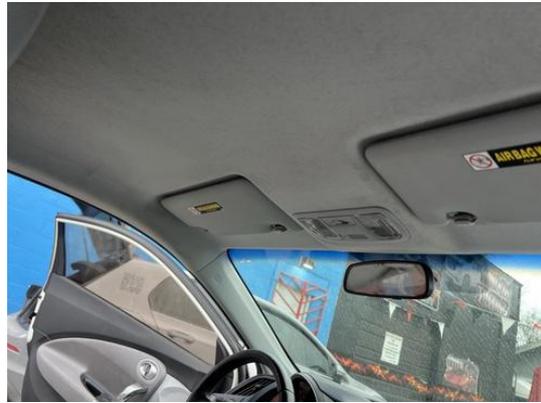
Normal wear to the interior as expected for the age and mileage on the vehicle. No water damage to the carpet or carpet installation. No rust on the bottom side of the dash. No evidence of flood damage present. No evidence of the vehicle being smoked inside. no severely damaged or missing panels. See all interior photos for evidence of current condition.

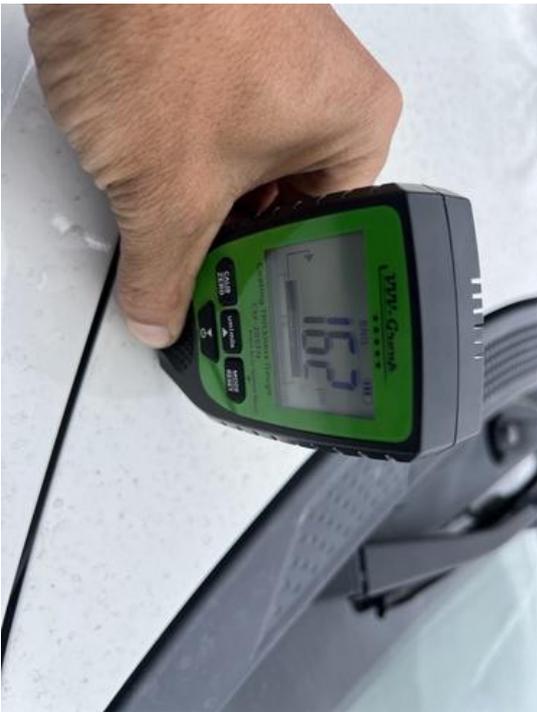
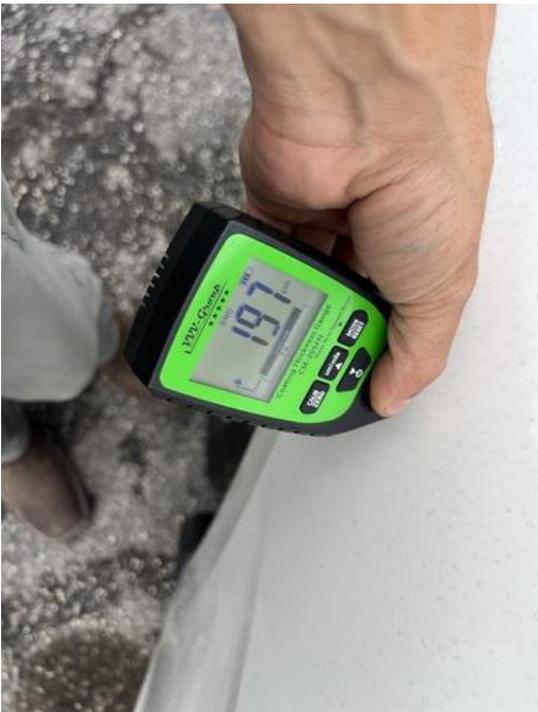
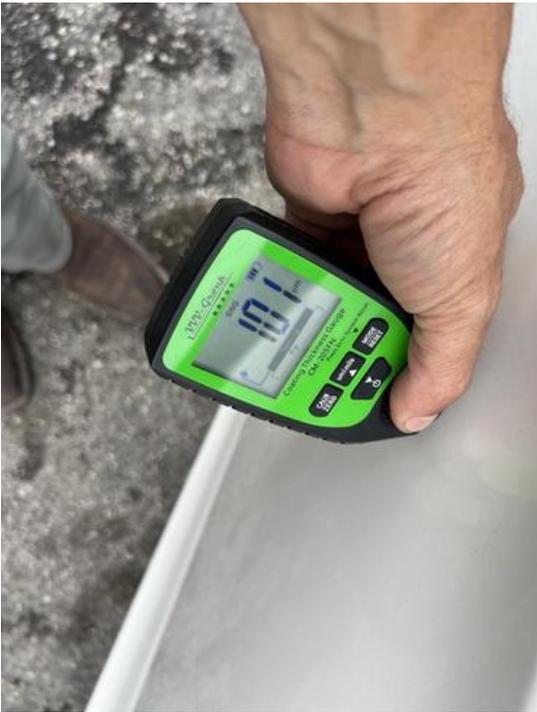
There is some paint and bodywork present on the vehicle, a lot of the exterior metal body panels have been repainted after factory. The roof panel is still showing factory paint depth however, most of the other body panels have been repainted. There is no structural damage nor any structural damage repair work, that's been done. The windshield is original to the vehicle, there is a small chip on the lower section of the windshield. The window tint on the back windows as well as the back hatch glass window is peeling and will become difficult to see out of. What suggest removal of the window window tent. Normal wear to the exterior as expected for the age and mileage on the vehicle, including chips, scrapes, scratches and dings. See all exterior photos for evidence of current condition.

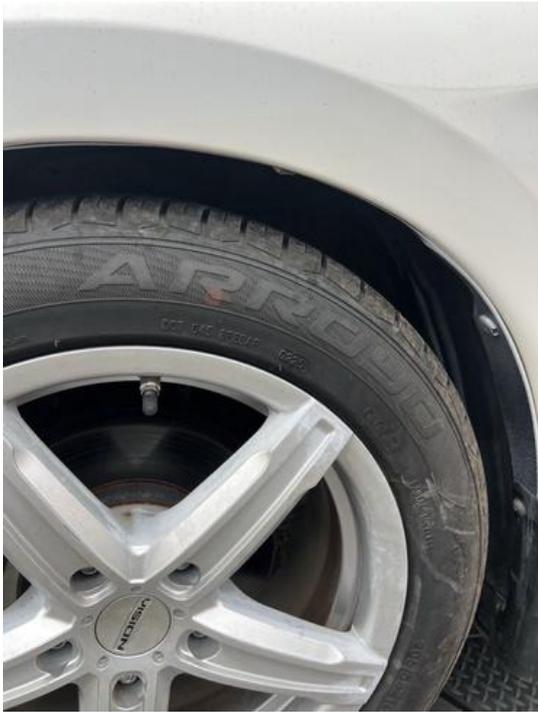
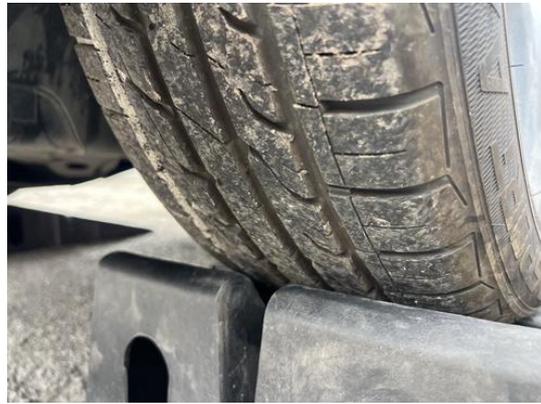
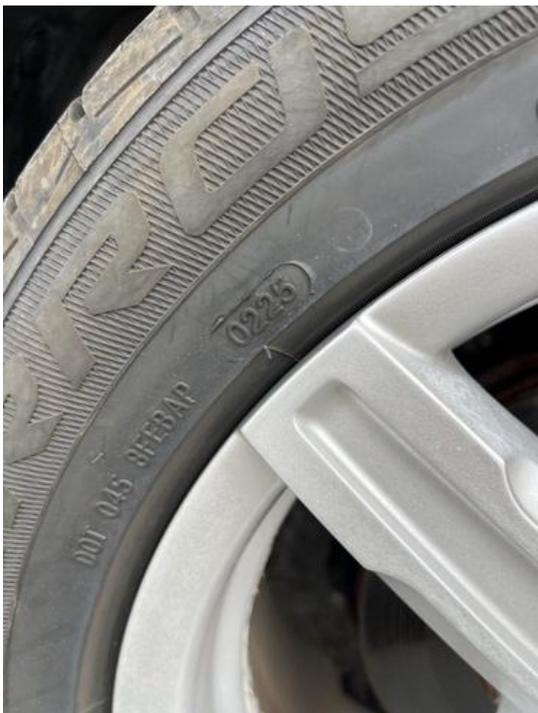
Both front tires have been recently replaced and RA matching set from 2025, front tires have right around 85% tread life remaining

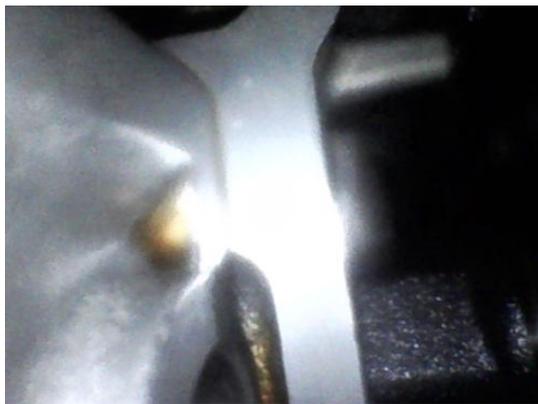
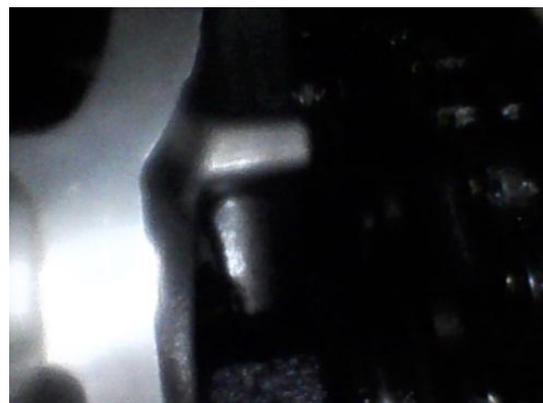
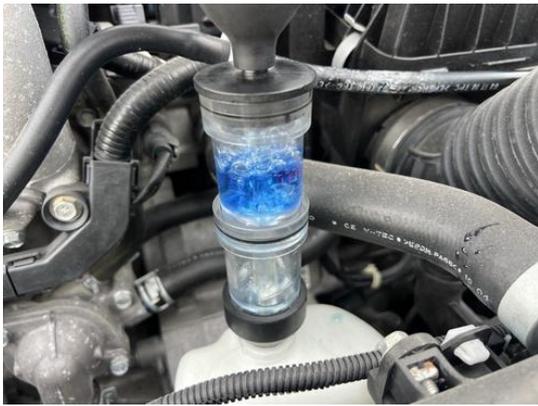
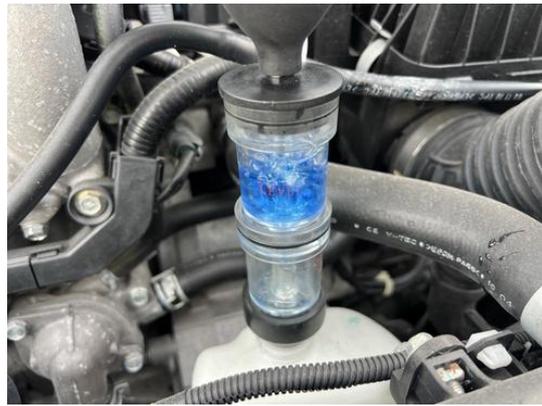
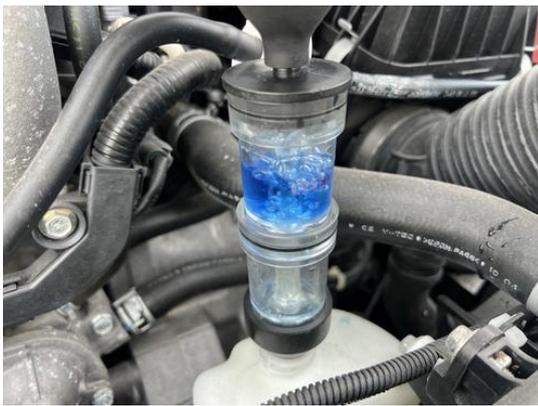
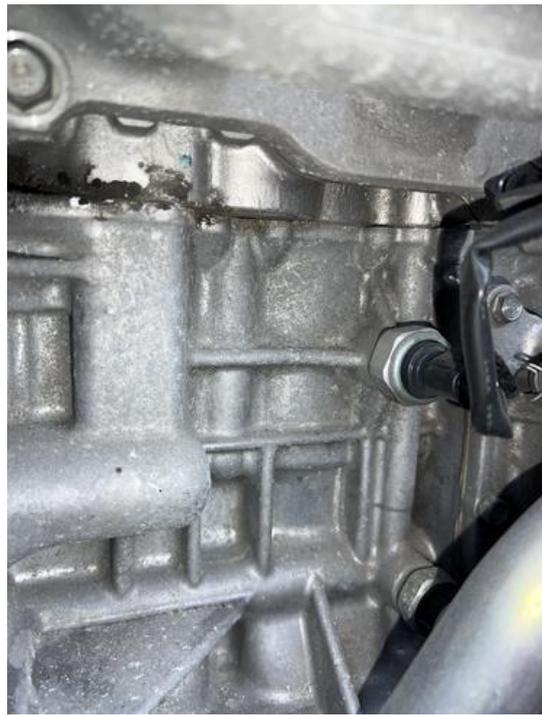
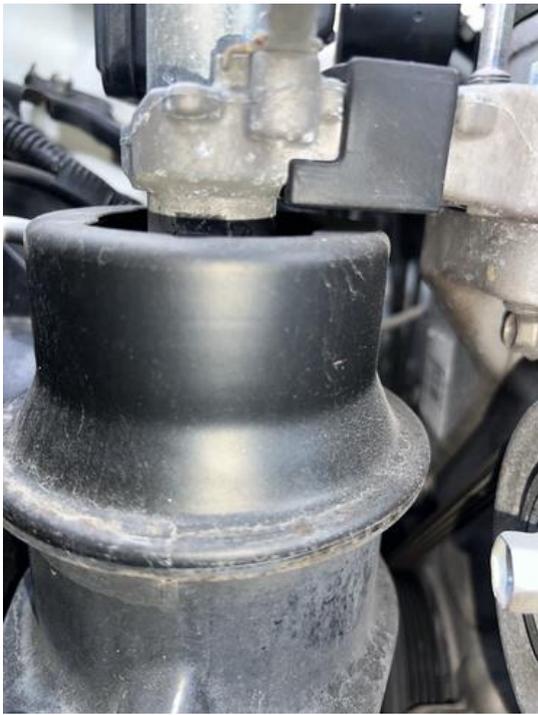
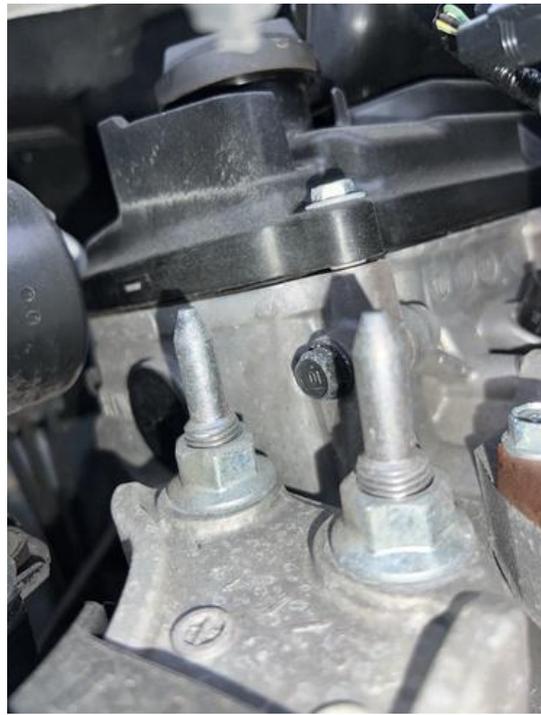
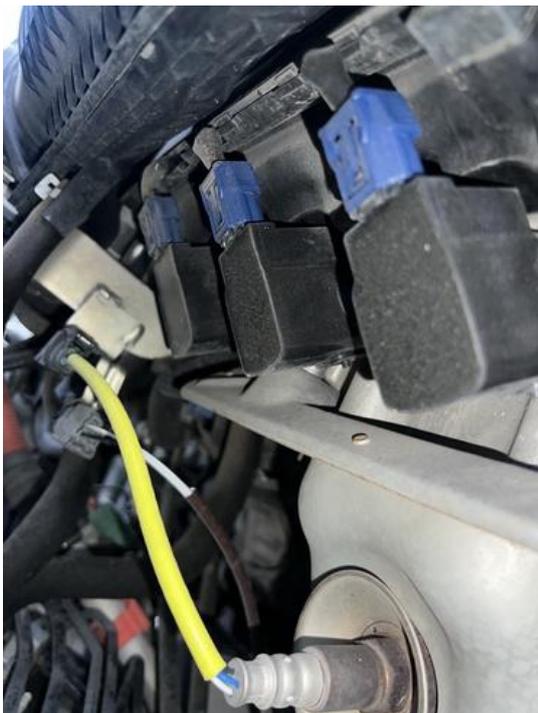
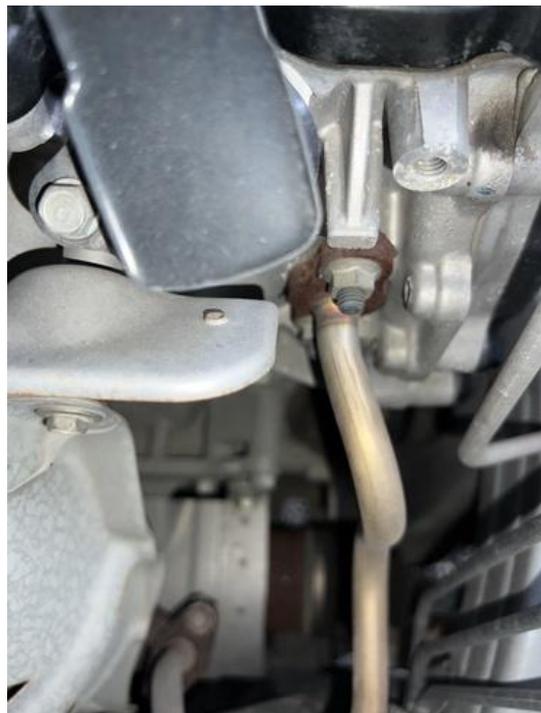
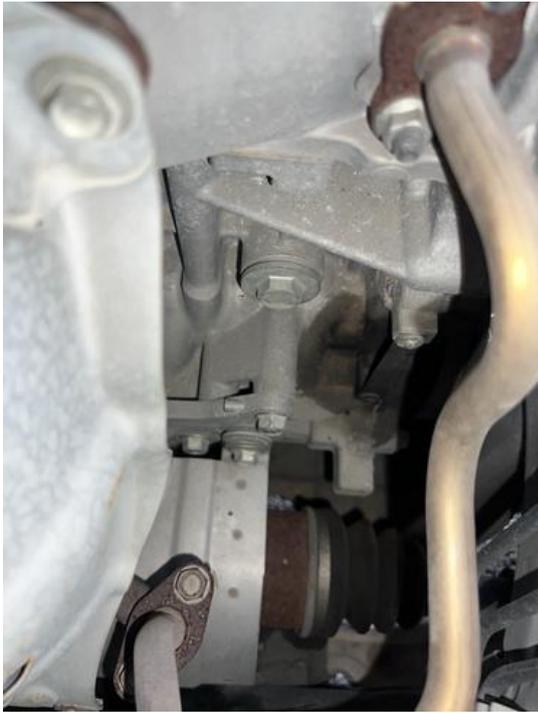
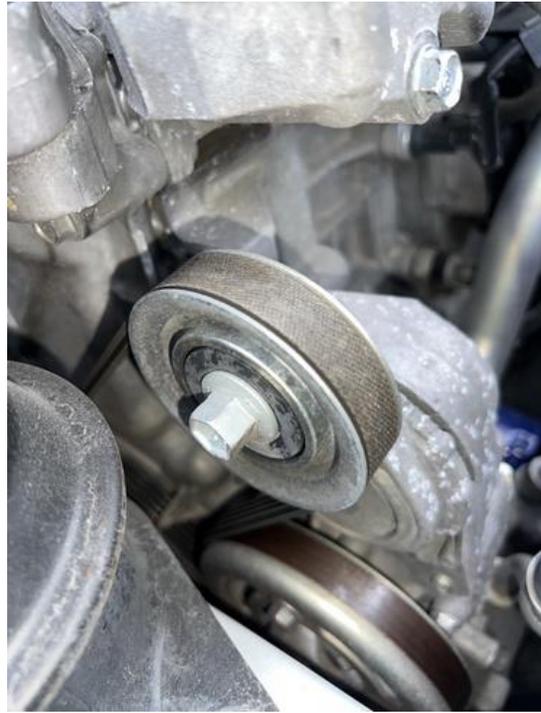
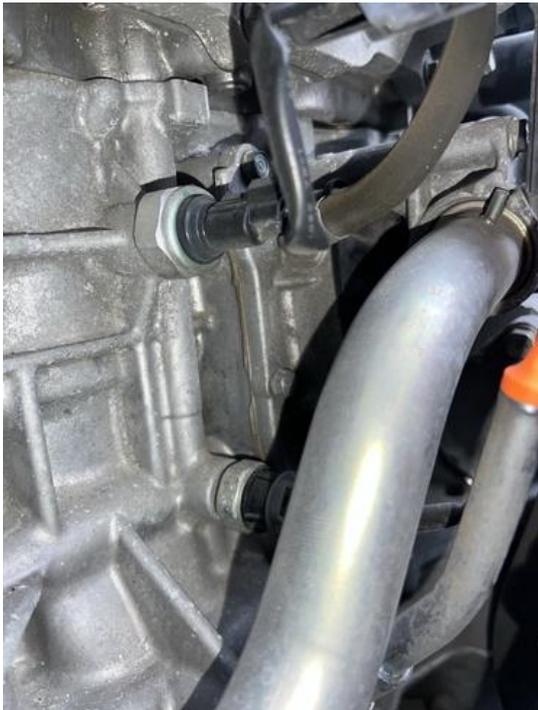
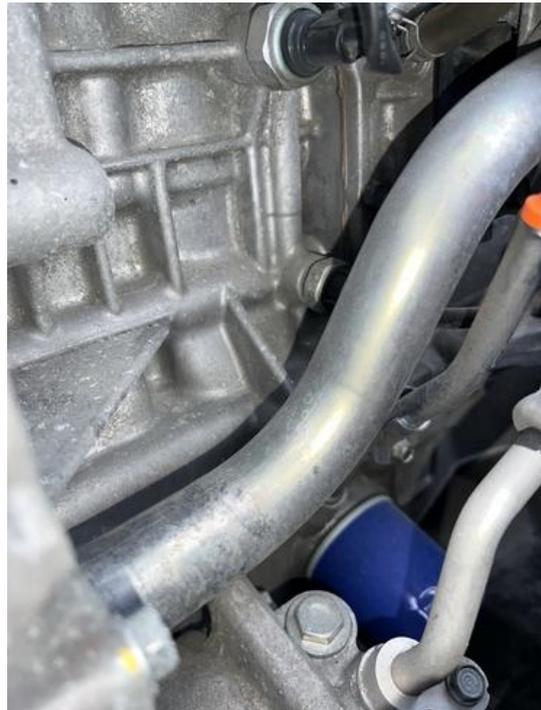
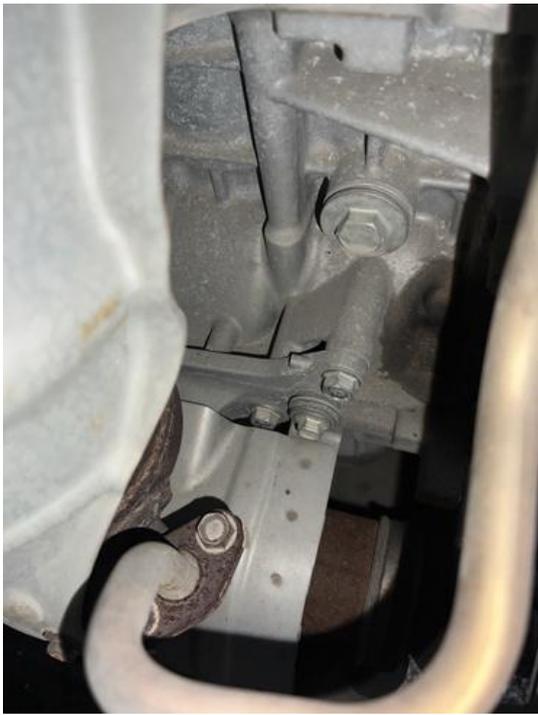
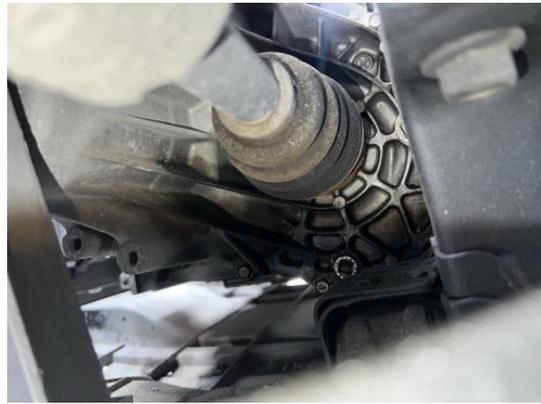
Engine clean internally, no gunk or sludge presents. Proper signs of maintenance present. Block test passed, no internal combustion leak out. Coolant mixture correct and cooling system functionality is healthy. All external engine accessories in good working. No leaks or seepage from anywhere on the engine. External drive belts in decent condition. Currently no concern in mechanical issues present in relation to the engine or related accessories.

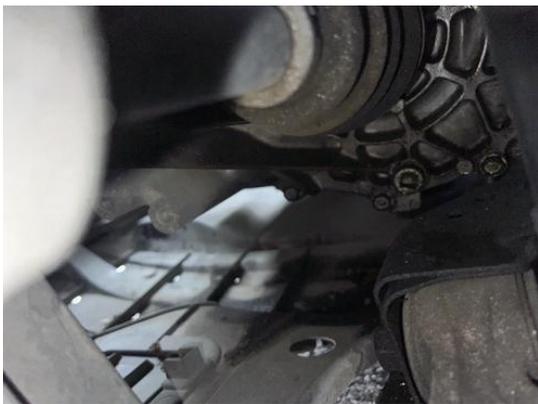
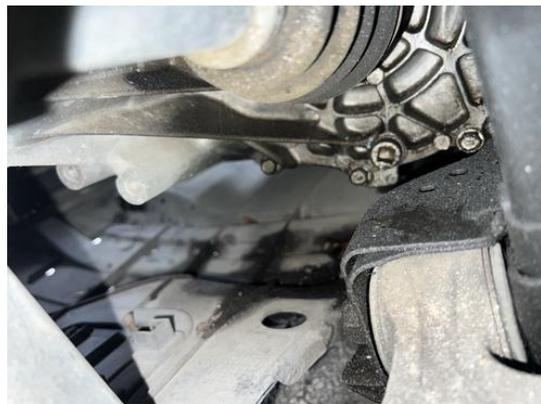
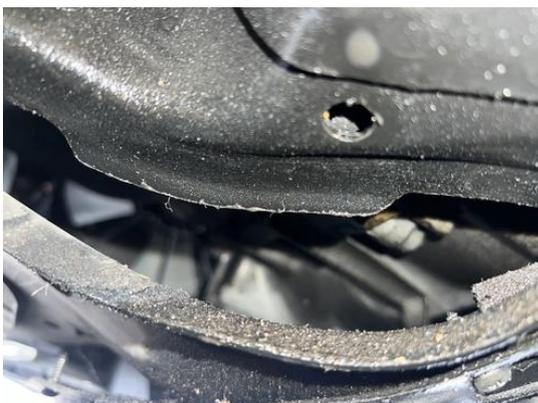
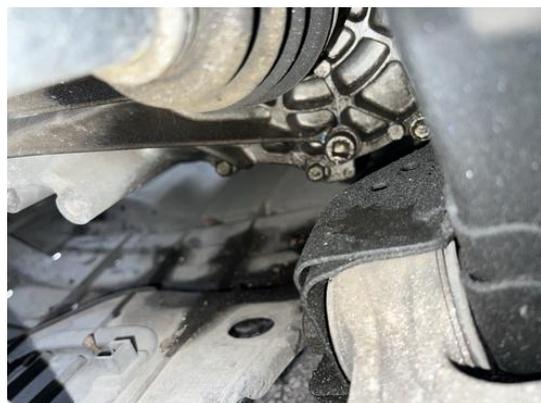
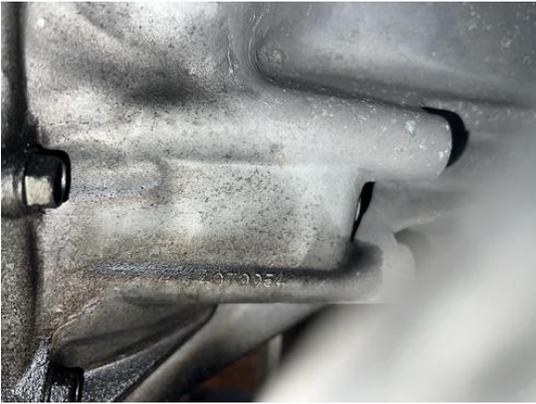
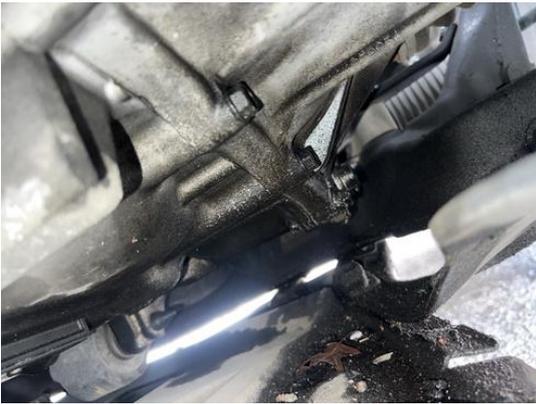
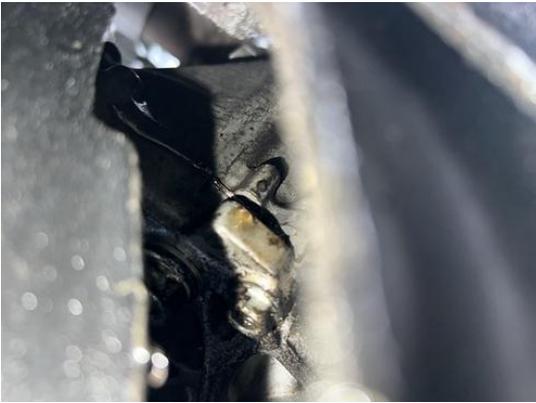
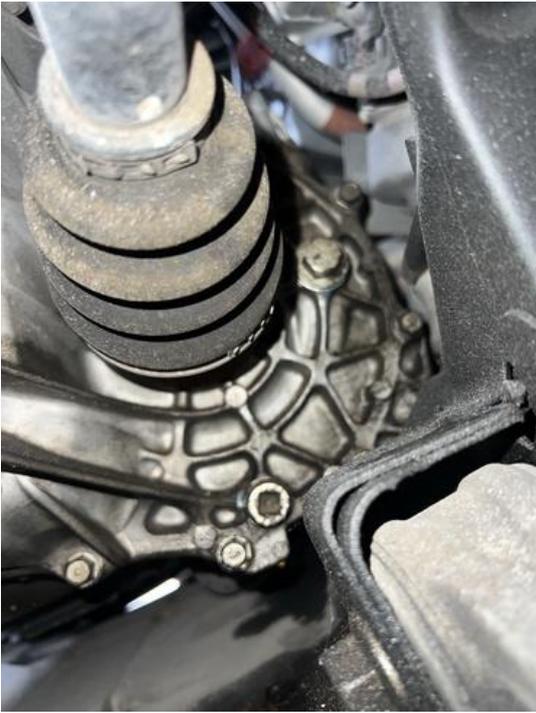
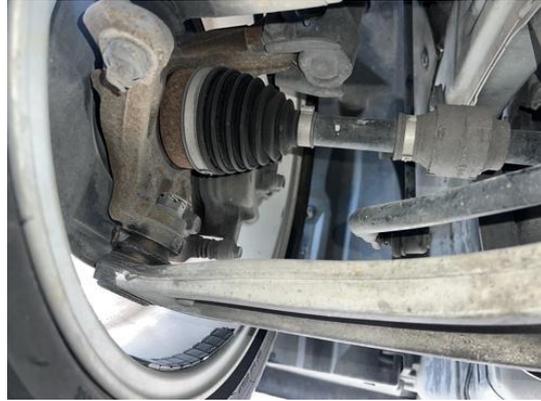
There is a small amount of transmission fluid leak out notice from the driver side of the differential, where the CV axle inserts, fluid leak out could potentially be coming from the axle seal itself, or from the different different differential casing.

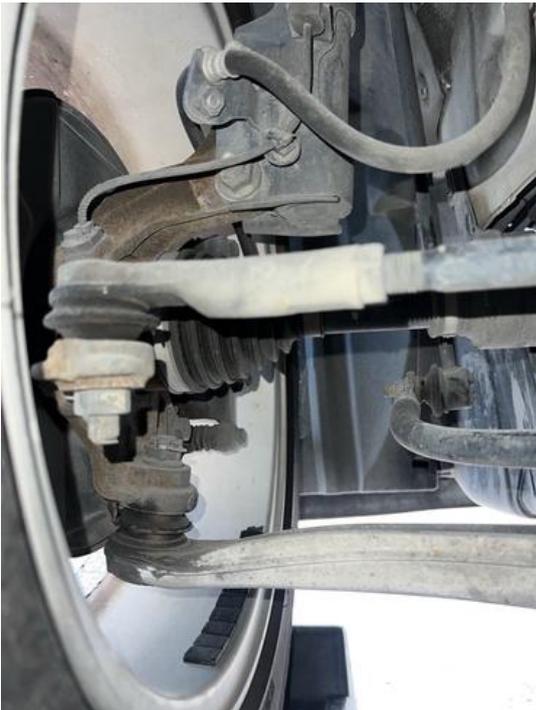
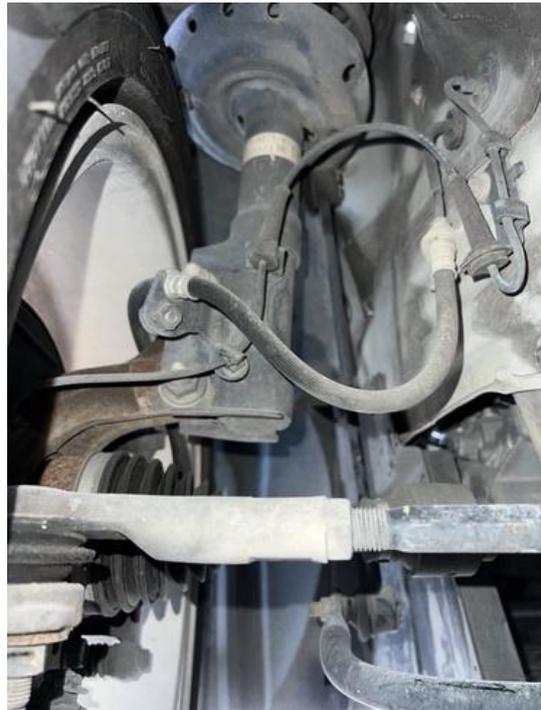
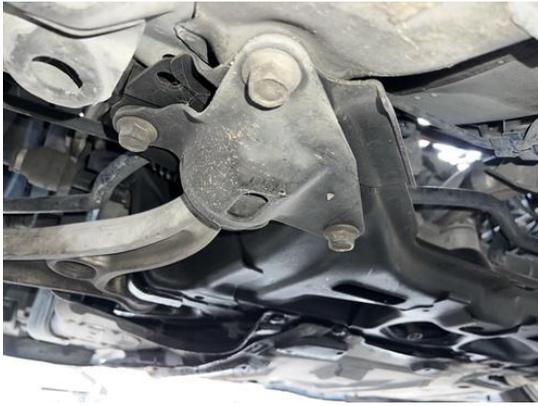
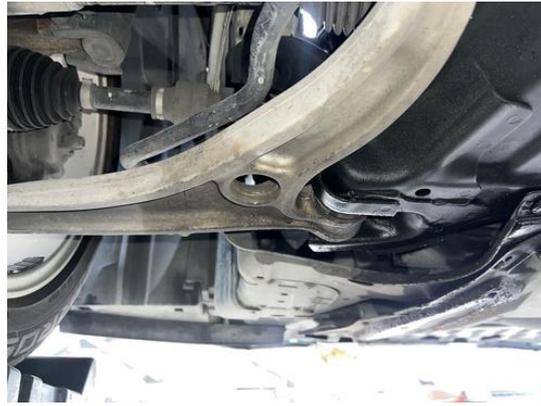
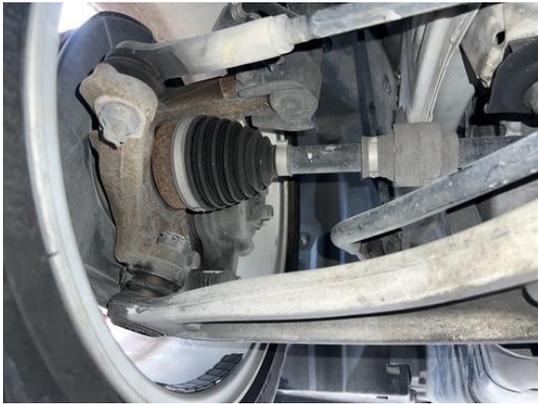
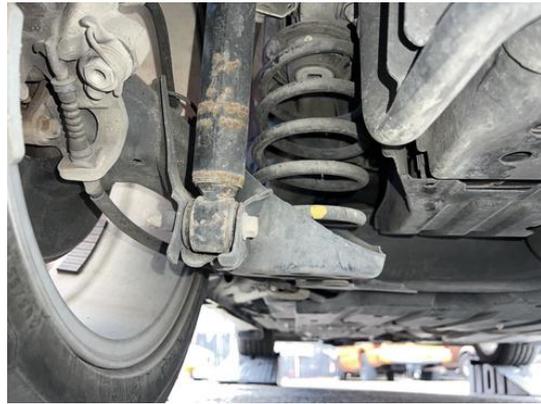
Normal fatigue notice to the suspension components. All of the suspension components seem to be original. None of the suspension components are blown out and due form the replacement. The No excessive surface rust on the exposed metal. No abnormal noise or feedback from the suspension while out on the road. All of the rubber in relation to the mounts, joints and bushings has decent texture.

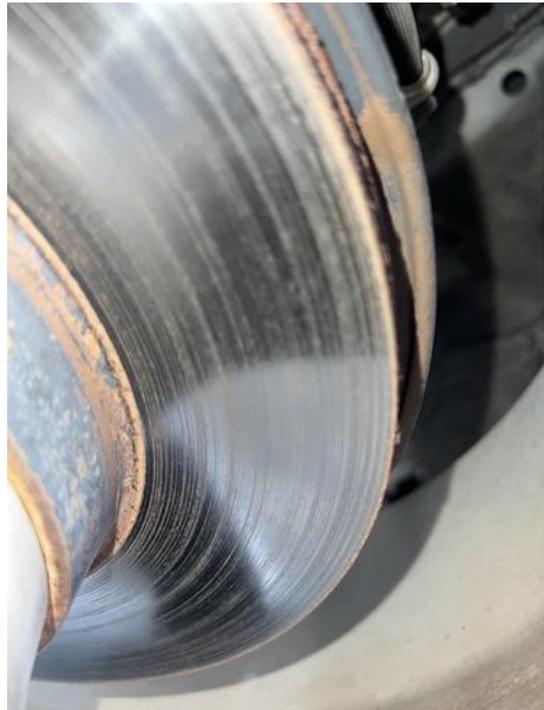
Photo 173

Braking system condition	
Brake fluid condition	Healthy
Brake fluid level	Healthy
Brake fluid leaks	None
Moisture content in brake fluid	None
Brake lines	Healthy
Brake calipers front	Healthy
Brake calipers rear	Healthy
Brake drums rear	N/A
Brake rotors front	Healthy
Brake rotors rear	Healthy
Front brake pad life remaining	50-75% remaining
<p>Right around 65% brake pad life remaining on the front brake system, right around 55% brake pad light remaining on the rear brake system</p> <div style="display: flex; justify-content: space-around;"> <div style="text-align: center;">

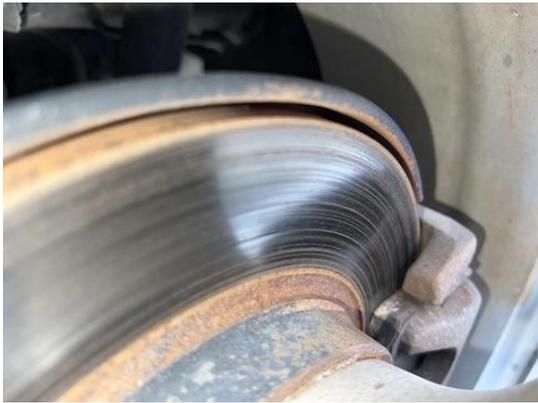
Photo 176

<p>Photo 175</p> </div> </div>	
Rear brake pad life remaining	50-75% remaining
<div style="display: flex; justify-content: space-around;"> <div style="text-align: center;">
