# Peace of Mind Automotive Inspection Report.

Score	4 / 4 (100%)	Flagged items	0	Actions	0
<b>Site conducted</b>					Unanswered
<b>Customer name</b>					Luis LMJ auto motor sales
<b>Date / Time</b>					April 6th
<b>Payment method</b>					Invoice
<b>Inspection cost</b>					Fleet
<b>Vehicle Year / Make / Model / Color</b>					2012 Chevy Camaro
<b>VIN</b>					66757 last 5

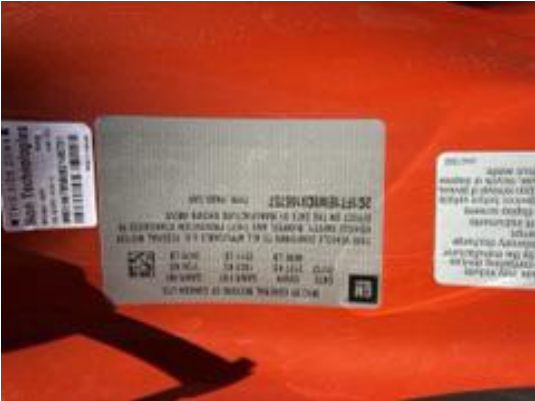
Photo 1					
<b>license plate</b>					Dealer
<b>Mileage</b>					71654
<b>Color</b>					Orange

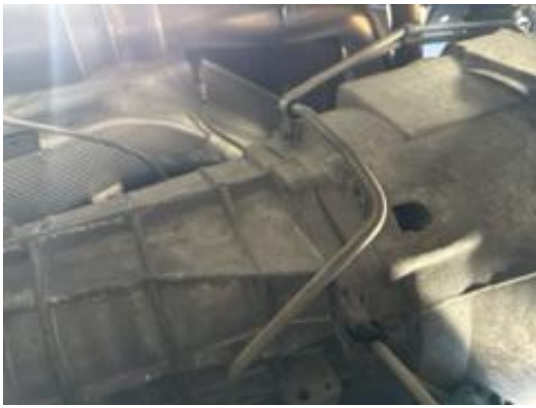
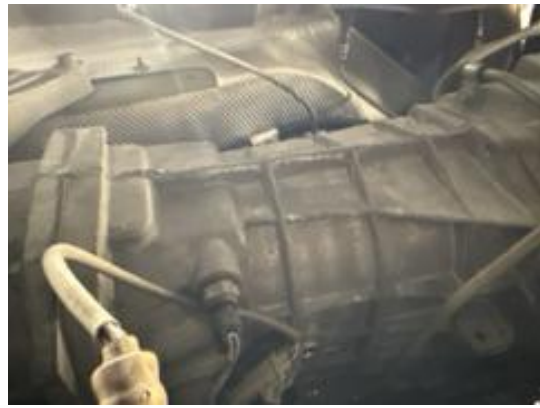
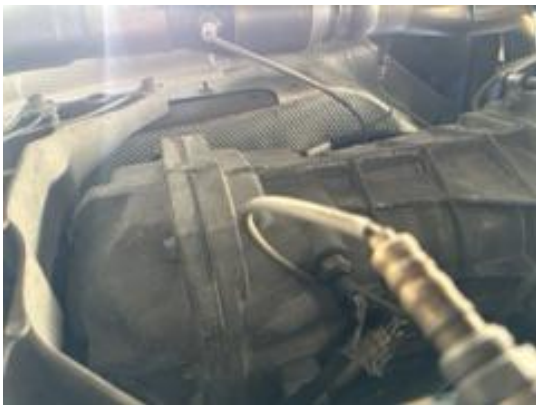
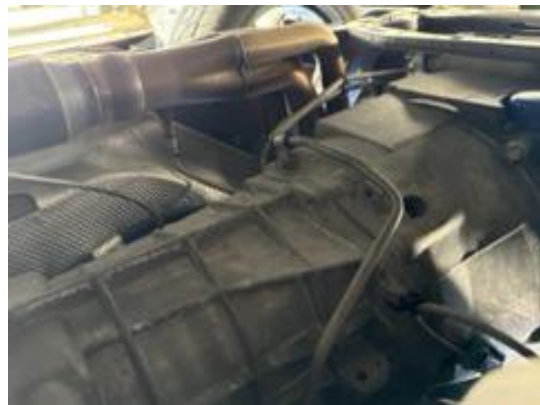
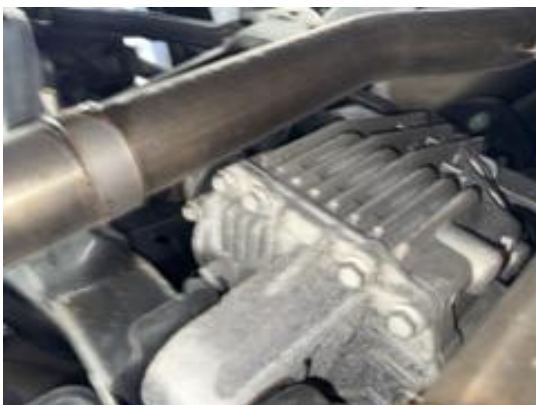
<b>Transmission / Differentials</b>	0 / 0 (0%)
<b>Transmission fluid level</b>	Healthy
<b>Transmission fluid condition</b>	Healthy
<b>Transmission fluid leaks</b>	None
<p>No transmission fluid leaks from the transmission casing or the transmission pan area. The tile shaft seal is free of any fluid leaks. The driveshaft is in healthy condition. Shift transitions out on the road are correct across the board. No fluid leak out from the rear differential.</p>	
<div style="display: flex; justify-content: space-around;"> <div style="text-align: center;">

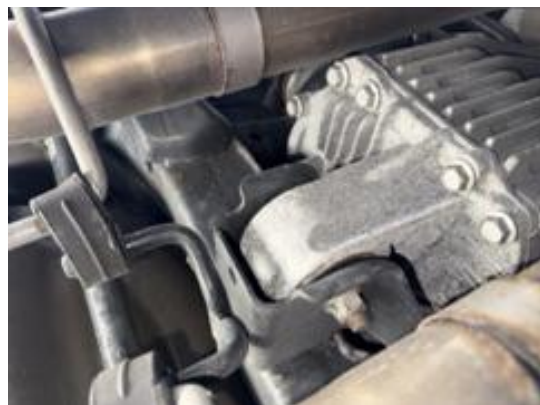
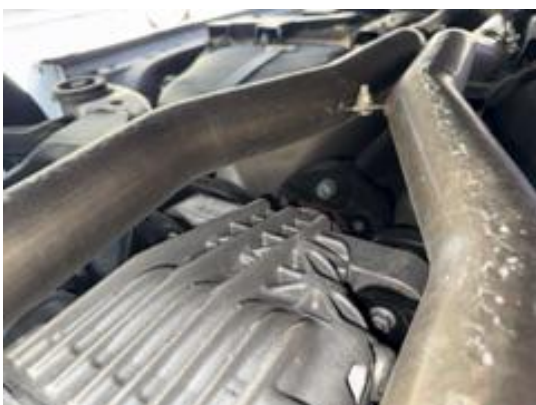
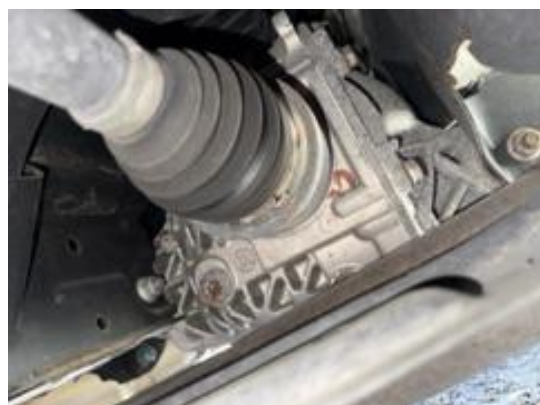
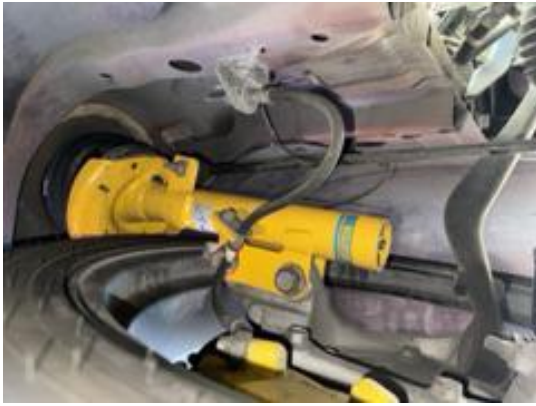
<b>Center differential condition</b>	N/A
<b>Rear differential condition</b>	Healthy
<div style="display: flex; justify-content: space-around;"> <div style="text-align: center;">

<p>Photo 158</p> </div> </div>	
<b>Differential leaks</b>	None
<b>4x4 function / engagement</b>	N/A
<b>Clutch engagement</b>	Healthy
<b>Gear engagement</b>	Healthy
<b>Shift transitions</b>	Healthy
<b>Drive shaft condition</b>	Healthy

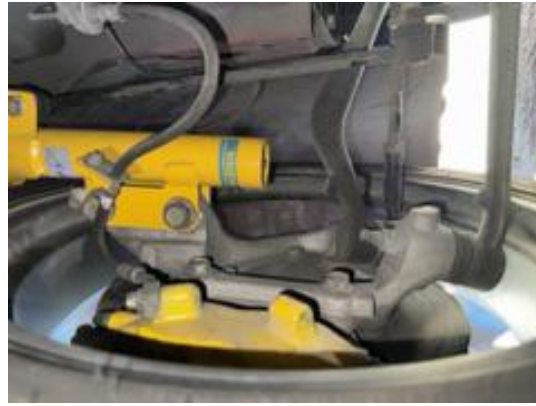
Photo 159

Normal fatigue notice to the suspension components. All of the suspension components seem to be original. None of the suspension components are blown out and due form the replacement. The No excessive surface rust on the exposed metal. No abnormal noise or feedback from the suspension while out on the road. All of the rubber in relation to the mounts, joints and bushings has decent texture.

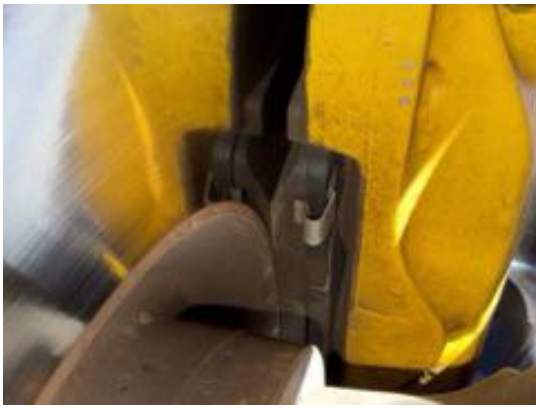
Photo 174

<b>Braking system condition</b>	0 / 0 (0%)
<b>Brake fluid condition</b>	Healthy
<b>Brake fluid level</b>	Healthy
<b>Brake fluid leaks</b>	None
<b>Moisture content in brake fluid</b>	None
<b>Brake lines</b>	Healthy
<b>Brake calipers front</b>	Healthy
<b>Brake calipers rear</b>	Healthy
<b>Brake drums rear</b>	N/A
<b>Brake rotors front</b>	Healthy
<b>Brake rotors rear</b>	Healthy
<b>Front brake pad life remaining</b>	75-100% remaining
<p>Right about 75% brake pad life remaining on the front brake system and right about 80% brake pad life remaining on the rear brake system</p>

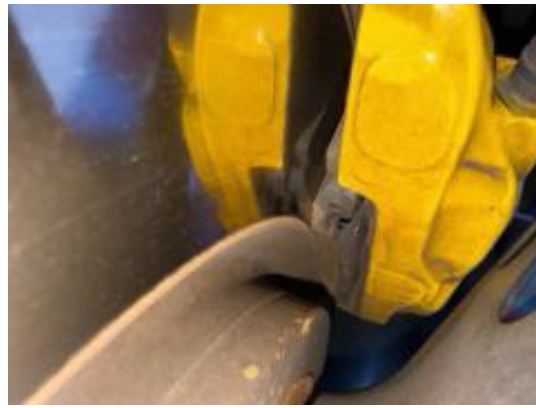
Photo 175

<p>Photo 175</p>
<b>Rear brake pad life remaining</b>	75-100% remaining
