Peace of Mind Automotive Inspection Report.

Site conducted	Unanswered
Customer name	Luis Lmj auto motor sales
Date / Time	Dec 26th
Payment method	Invoice
Inspection cost	Fleet account
Vehicle Year / Make / Model / Color	2012 ford f250 6.7
VIN	61223 last 5

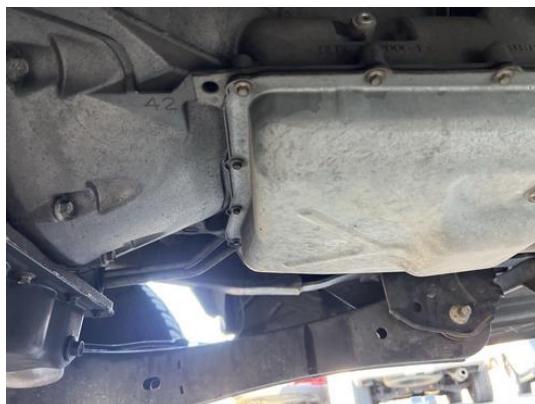
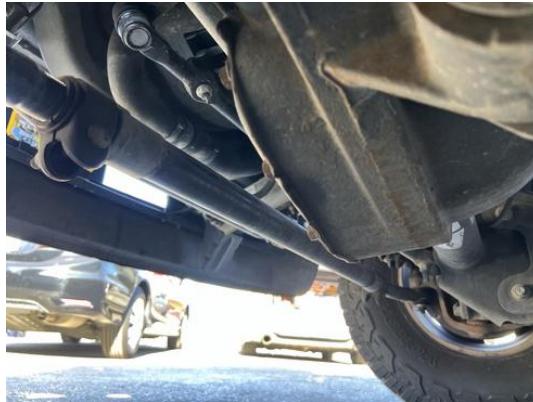
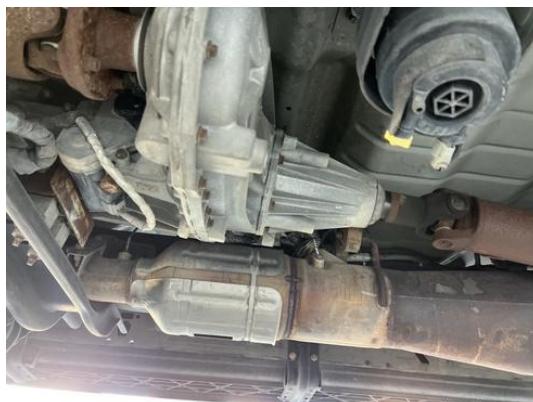
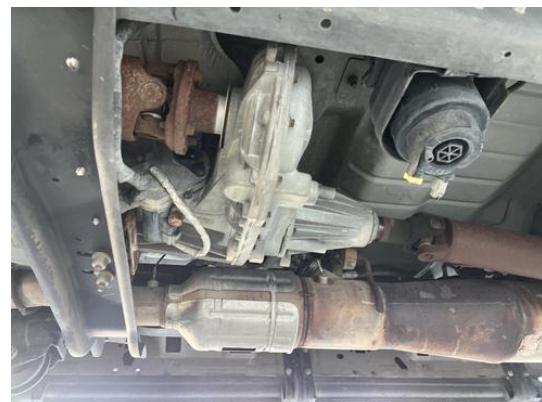
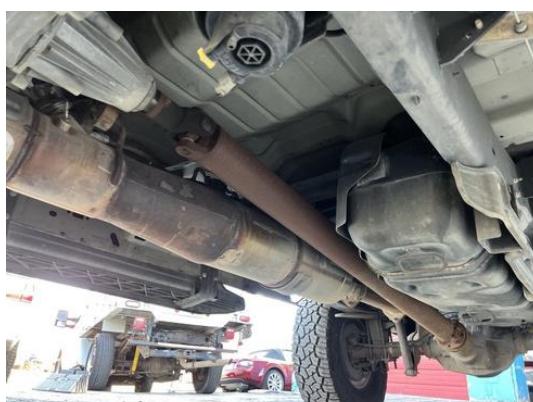
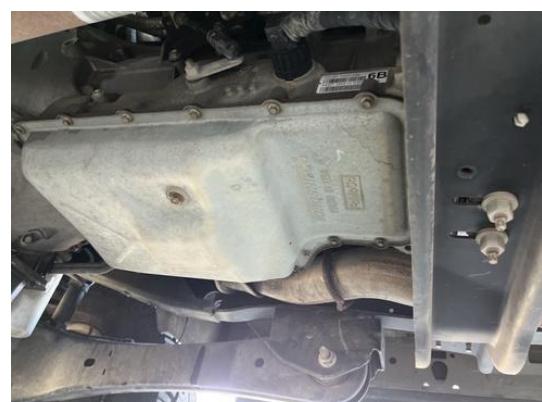
No transmission fluid leak out from the transmission casing or the transmission pan area. Drive shaft and seal is free of any fluid leaks. The rear differential is free of any fluid leak out. Shift transitions out on the road are correct across the board.

No fluid leak out from the front differential or center differential. 4 x 4 system functionality is correct.

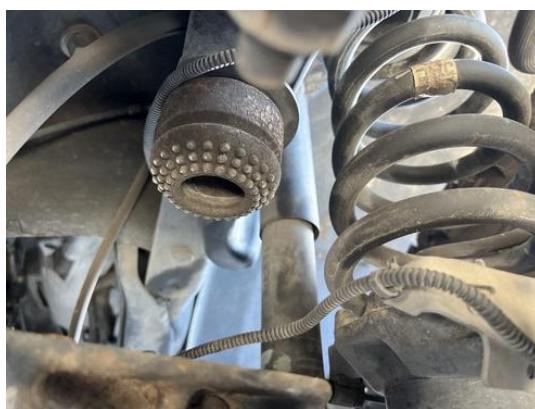
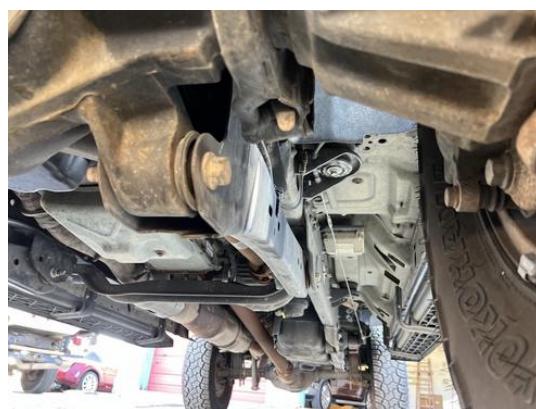
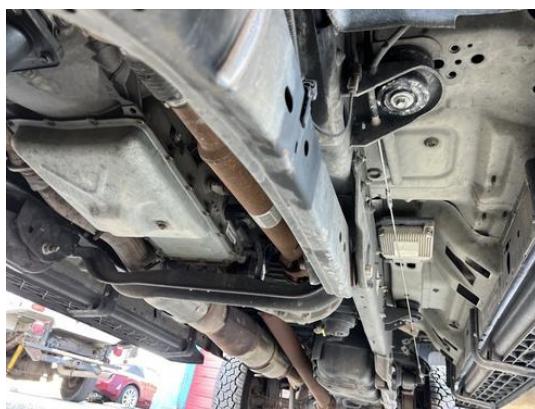
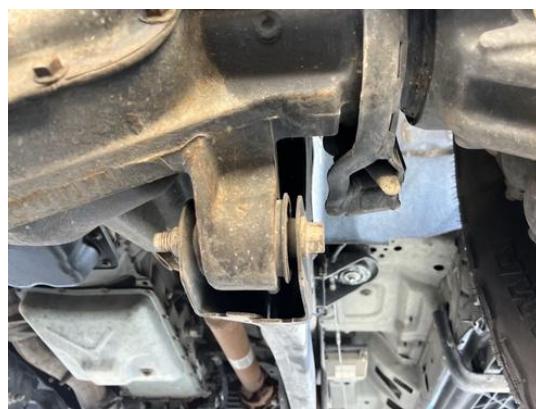
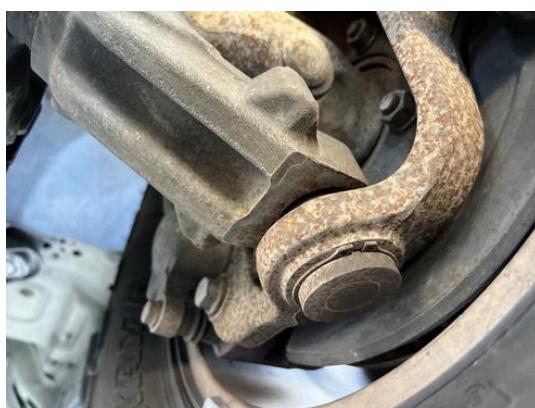
Normal fatigue notice to the suspension components. All of the suspension components seem to be original. None of the suspension components are blown out and due form the replacement. The No excessive surface rust on the exposed metal. No abnormal noise or feedback from the suspension while out on the road. All of the rubber in relation to the mounts, joints and bushings has decent texture.
