Peace of Mind Automotive Inspection Report.

Score	4 / 4 (100%)	Flagged items	0	Actions	0
Site conducted					Unanswered
Customer name					Luis LMJ auto motor sales
Date / Time					April 6th
Payment method					Invoice
Inspection cost					Fleet
Vehicle Year / Make / Model / Color					2012 ford f150 king ranch
VIN					10106 last 5

license plate					Dealer
Mileage					154009
Color					White

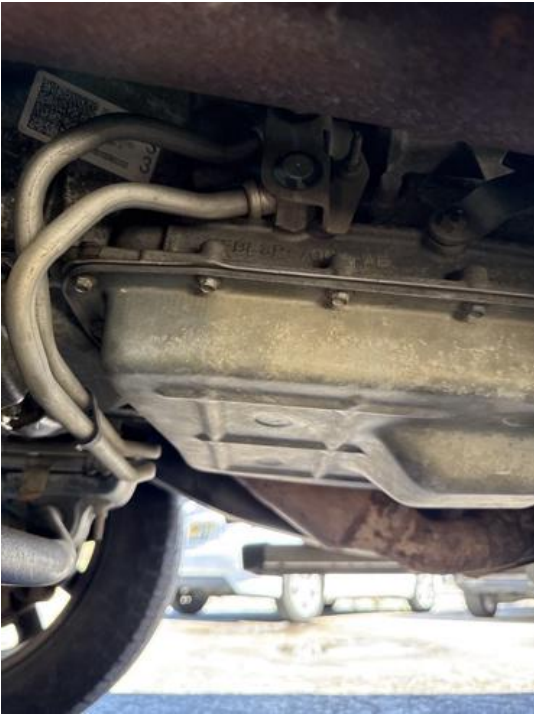
Photo 166

No transmission fluid leaks from the transmission casing or the transmission pan area. Detailed shaft seal is free of any fluid leaks. The driveshaft is in healthy condition. Shift transitions out on the road were correct across the board.

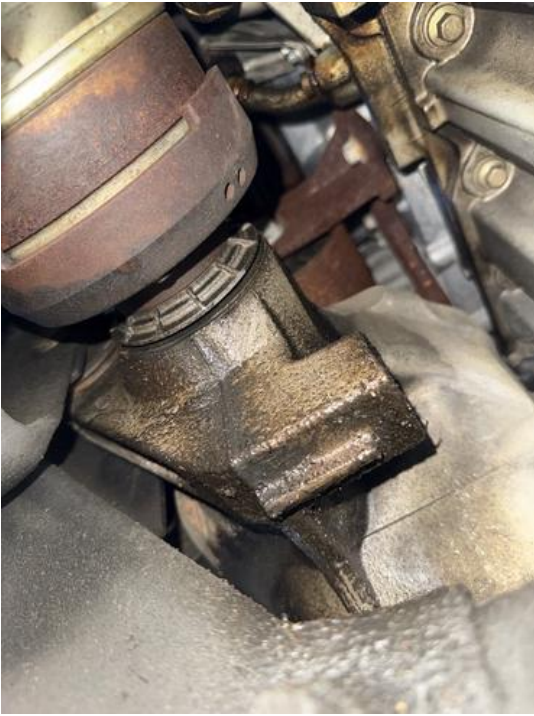
Photo 170

There was some fluid seepage notice from the front differential and front axle area. Seemed as if the input shaft seal on the front differential has started to leak as well as the passenger side axle seal.

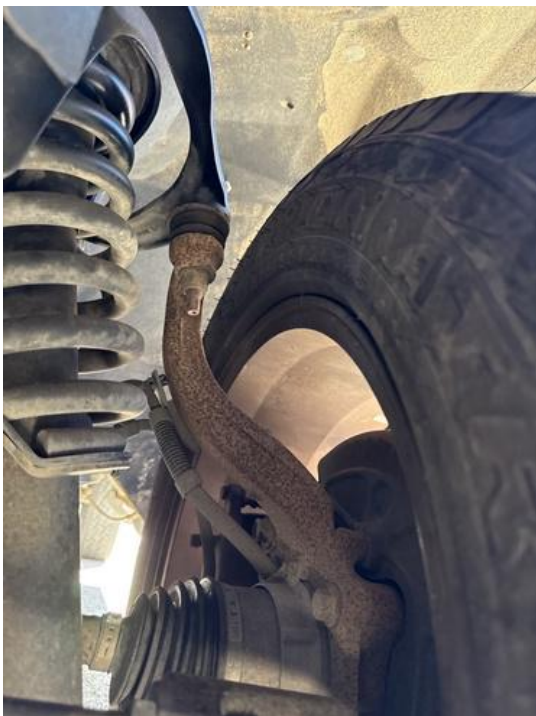
Photo 180

Normal fatigue notice to the suspension components. All of the suspension components seem to be original. None of the suspension components are blown out and due form the replacement. The No excessive surface rust on the exposed metal. No abnormal noise or feedback from the suspension while out on the road. All of the rubber in relation to the mounts, joints and bushings has decent texture.

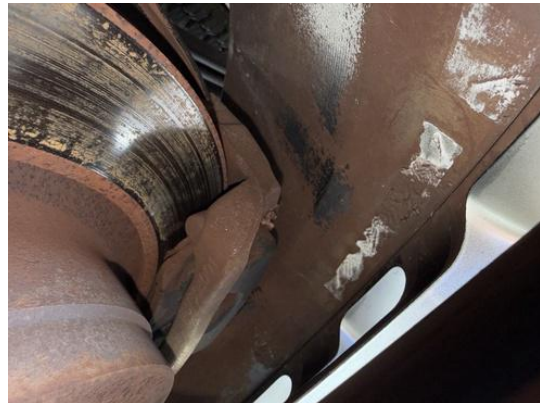
Photo 198 Photo 199	25-50% remaining
Rear brake pad life remaining Right about 70% brake pad life remaining

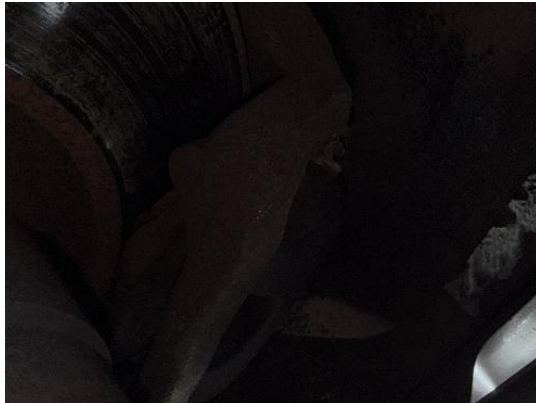
Photo 200 Photo 201	50-75% remaining
E-brake function	Healthy
