## Peace of Mind Automotive Inspection Report.

<b>Site conducted</b>	Unanswered
<b>Customer name</b>	Luis Imj auto motor sales
<b>Date / Time</b>	Dec 26th
<b>Payment method</b>	Invoice
<b>Inspection cost</b>	199
<b>Vehicle Year / Make / Model / Color</b>	2012 Lincoln navigator

<b>VIN</b>	02279 last 5

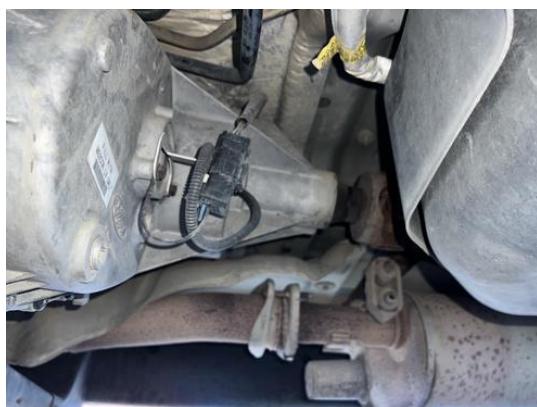
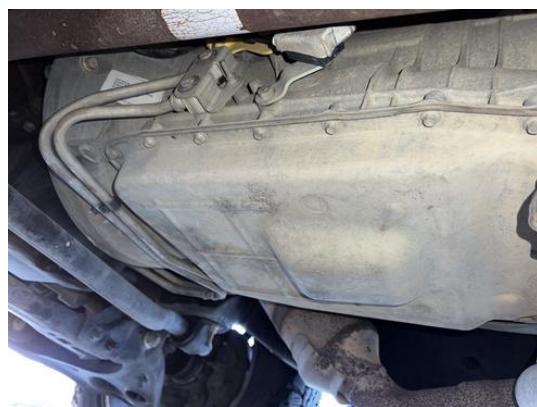
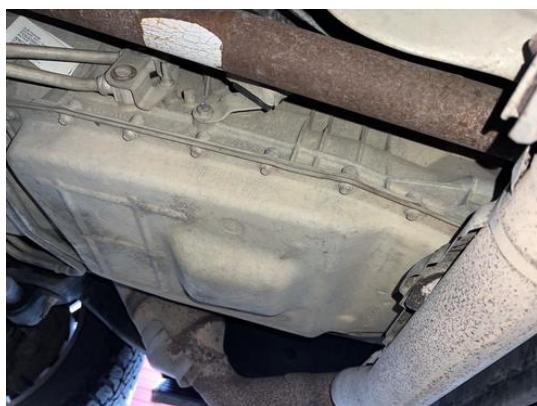
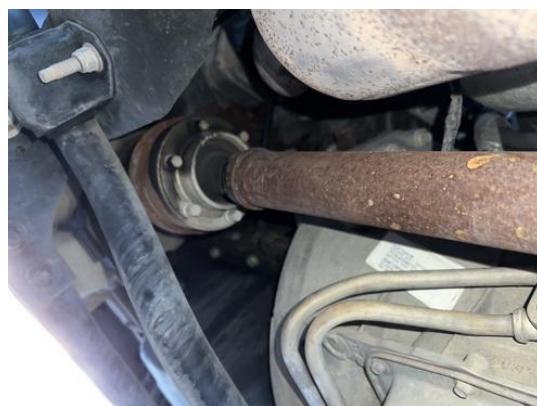
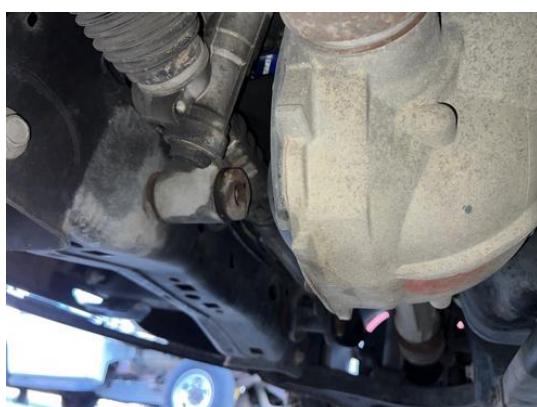
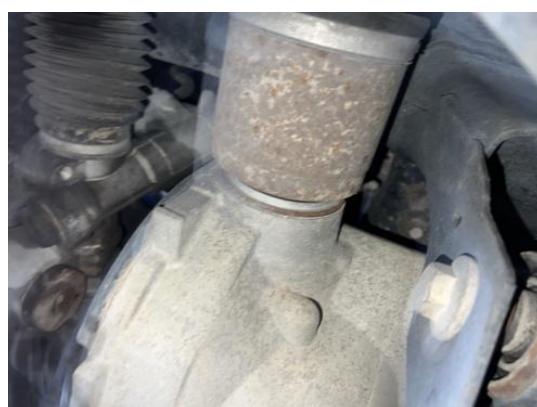
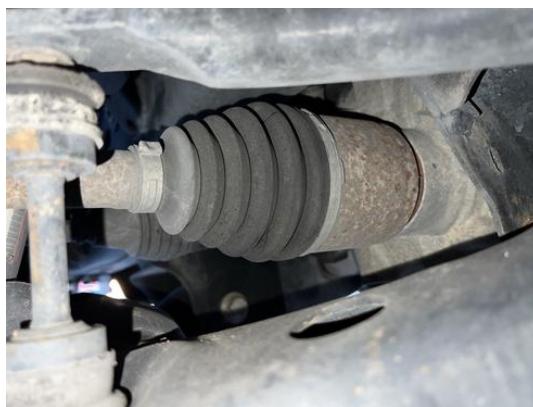
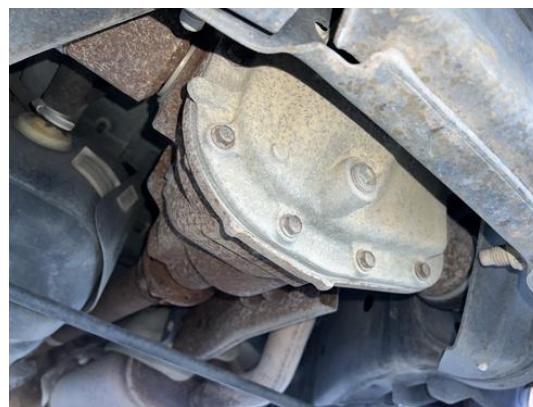
No transmission fluid leak out from the transmission casing or the transmission pan area. Drive shaft and seal is free of any fluid leaks. The rear differential is free of any fluid leak out. Shift transitions out on the road are correct across the board.

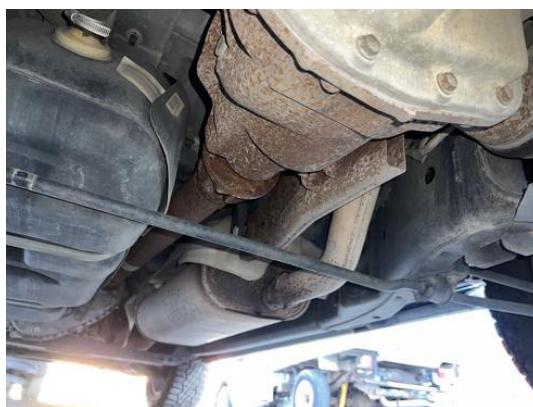
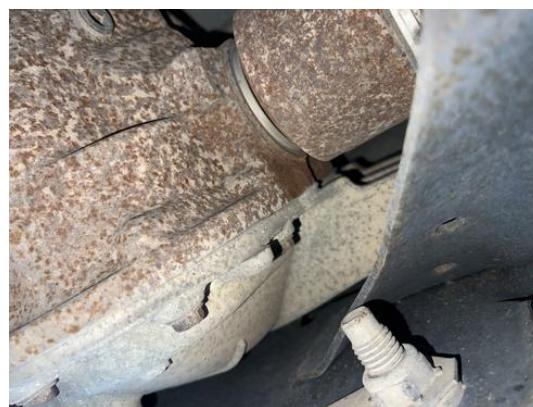
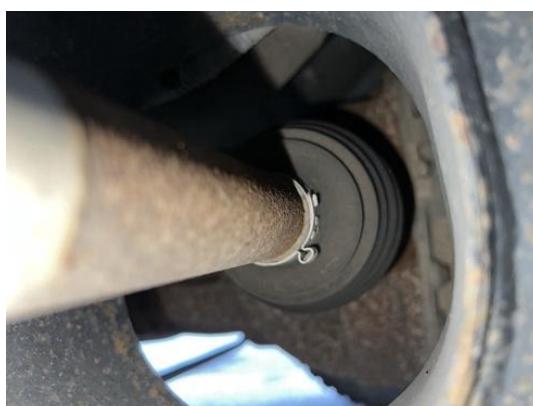
Front differential condition	Healthy
------------------------------	---------

Center differential condition	Healthy
-------------------------------	---------

Rear differential condition	Healthy
-----------------------------	---------

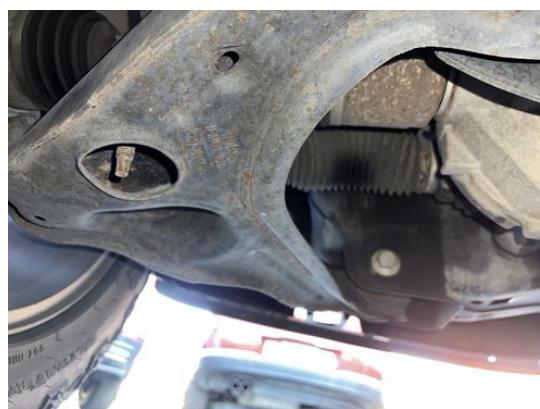
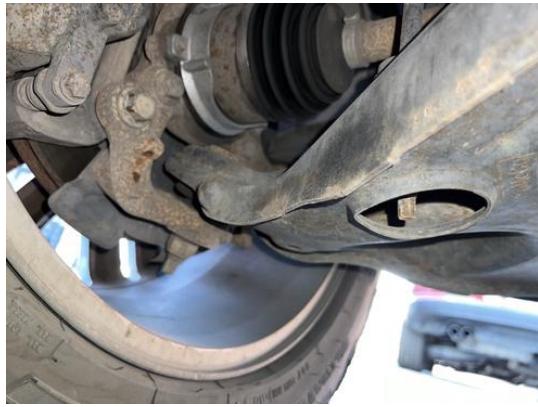
Normal fatigue notice to the suspension components. All of the suspension components seem to be original. None of the suspension components are blown out and due form the replacement. The No excessive surface rust on the exposed metal. No abnormal noise or feedback from the suspension while out on the road. All of the rubber in relation to the mounts, joints and bushings has decent texture.

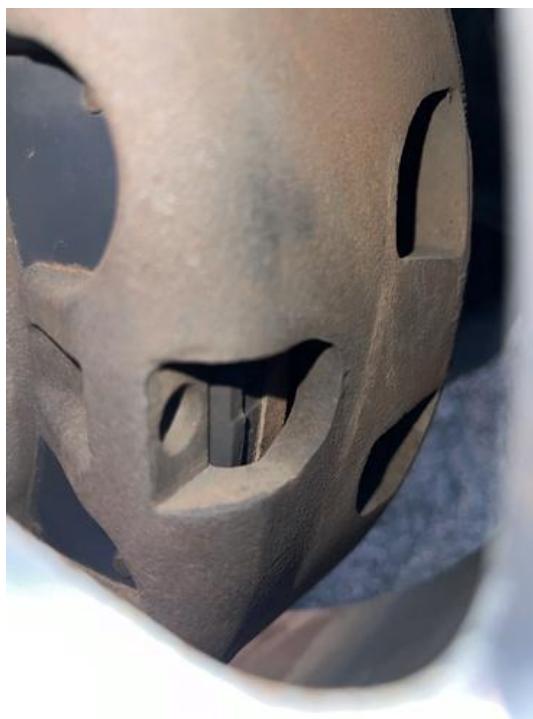
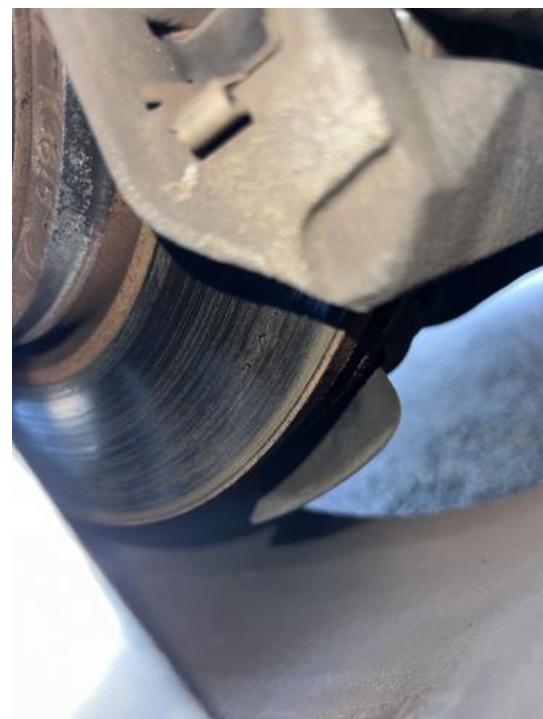
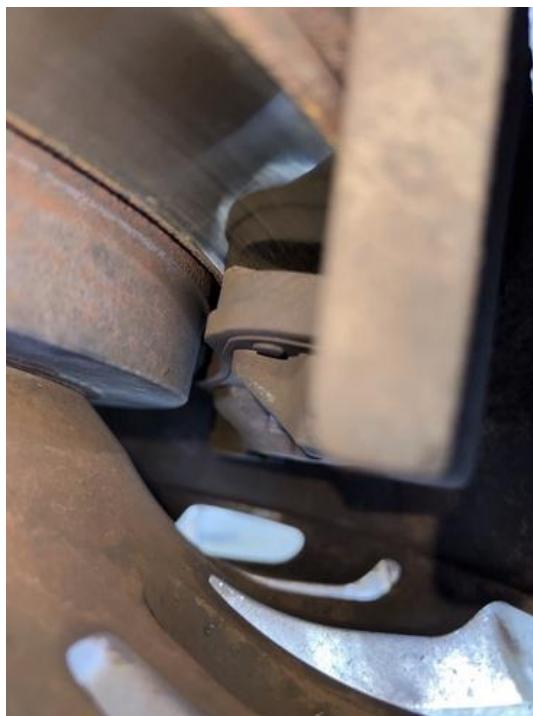
<b>Brake fluid condition</b>	Healthy	
<b>Brake fluid level</b>	Healthy	
<b>Brake fluid leaks</b>	None	
<b>Moisture content in brake fluid</b>	None	
<b>Brake lines</b>	Healthy	
<b>Brake calipers front</b>	Healthy	
<b>Brake calipers rear</b>	Healthy	
<b>Brake drums rear</b>	N/A	
<b>Brake rotors front</b>	Healthy	
<b>Brake rotors rear</b>	Healthy	
<b>Front brake pad life remaining</b>	75-100% remaining

Photo 186	Photo 187	Photo 188
<b>Rear brake pad life remaining</b>	75-100% remaining

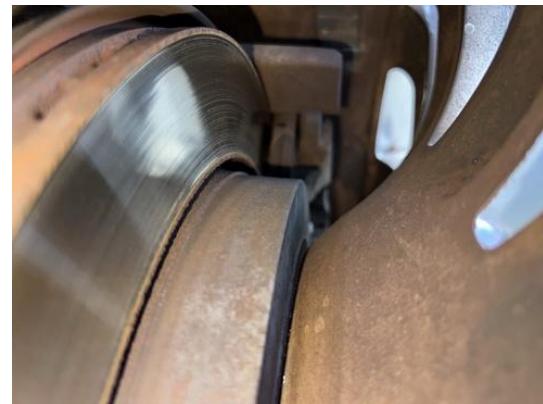
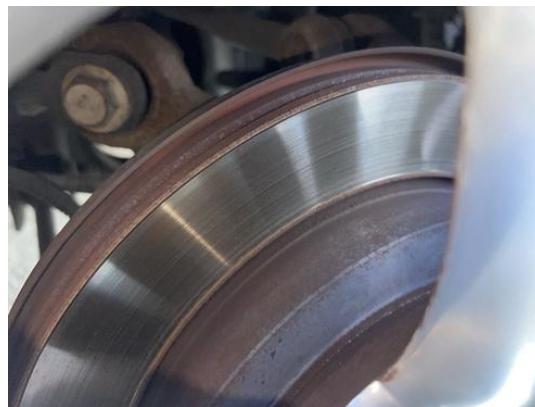
Photo 189	Photo 190	Photo 191
<b>E-brake function</b>	Healthy
