## Peace of Mind Automotive Inspection Report.

| Vehicle Year / Make / Model / Color | | | | 2013 ford f150 | |
| Mileage | | | | 174411 | |

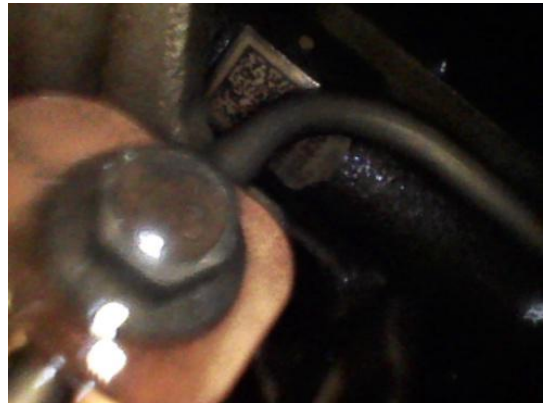
Photo 111

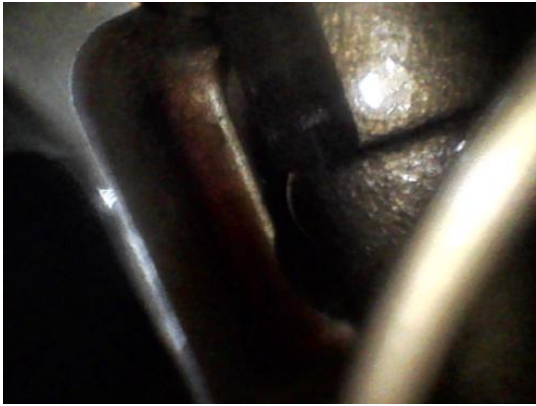
Photo 112

Engine clean internally, no gunk or sludge presents. Proper signs of maintenance present. Block test passed, no internal combustion leak out. Coolant mixture correct and cooling system functionality is healthy. All external engine accessories in good working. No leaks or seepage from anywhere on the engine. External drive belts in decent condition. Currently no concern in mechanical issues present in relation to the engine or related accessories.

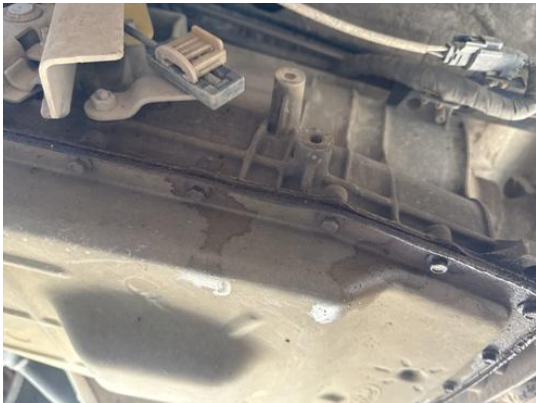
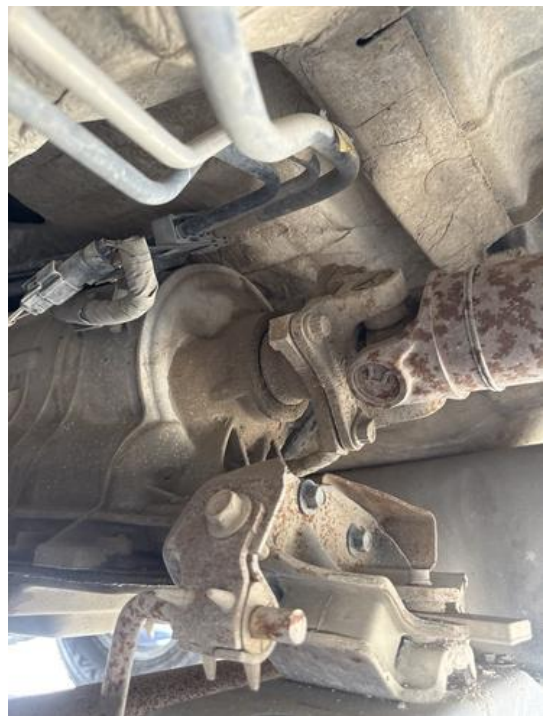
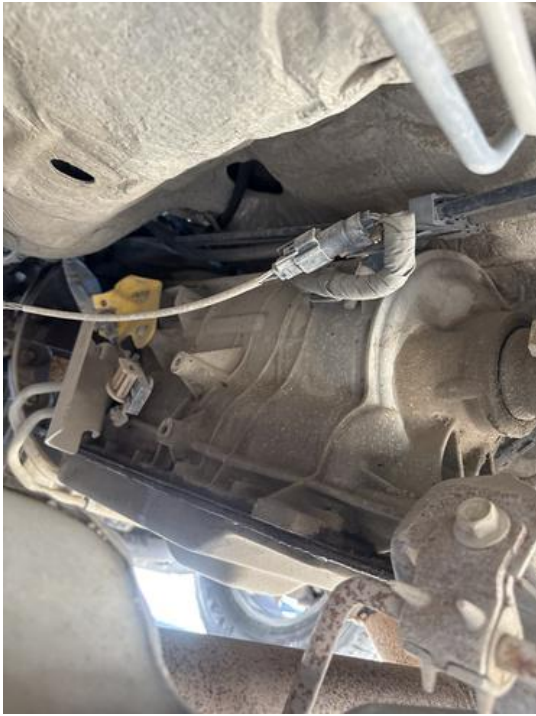
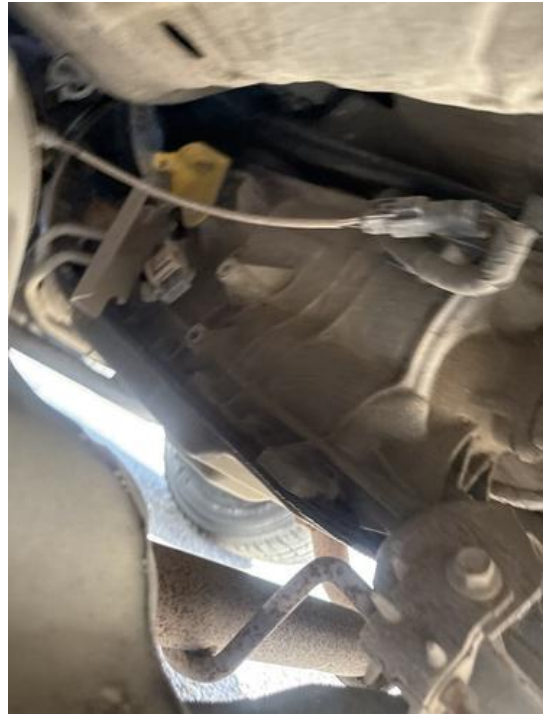
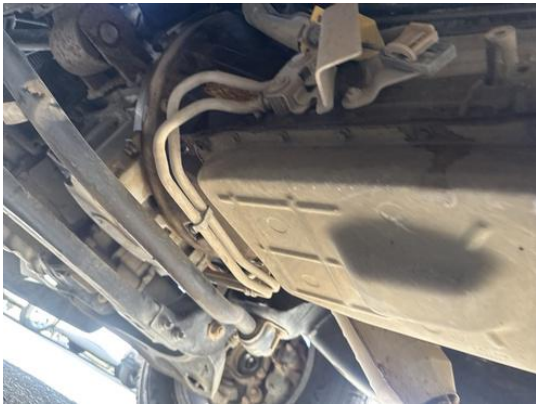
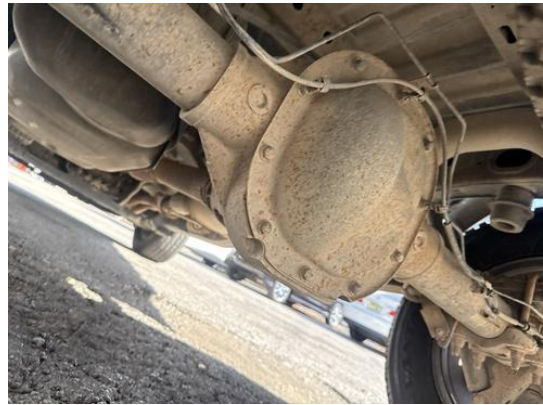
| Transmission / Differentials | |
|---|---|
| Transmission fluid condition | Healthy |
| Transmission fluid leaks | None |
| <p>No transmission fluid leaks from the transmission casing or the transmission pan area. The tail shaft seal is free of any fluid leaks. The driveshaft is in healthy condition. Shift transitions out on the road are correct across the board. No fluid leak out from the rear differential.</p> | |

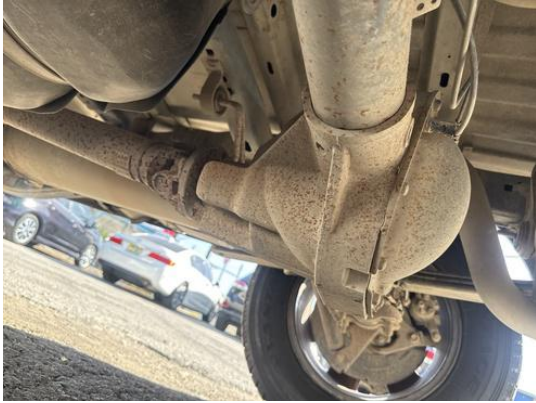
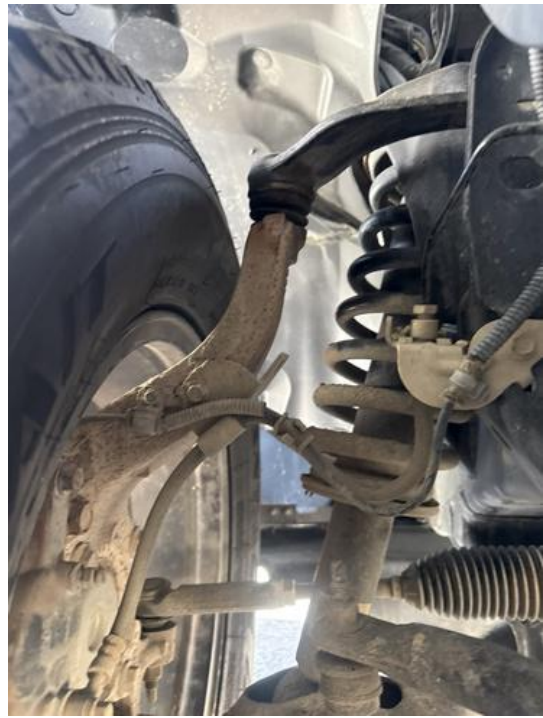
| Transmission / Differentials | |
|---|---|
| Rear differential condition | Healthy |
| Differential leaks | None |

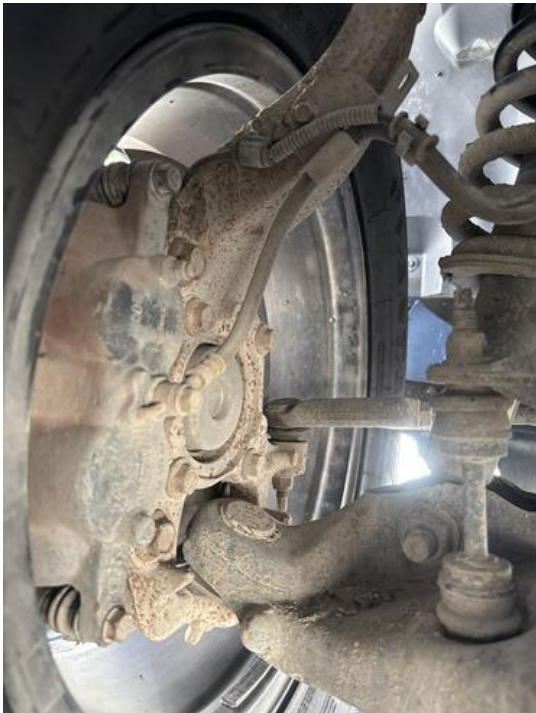
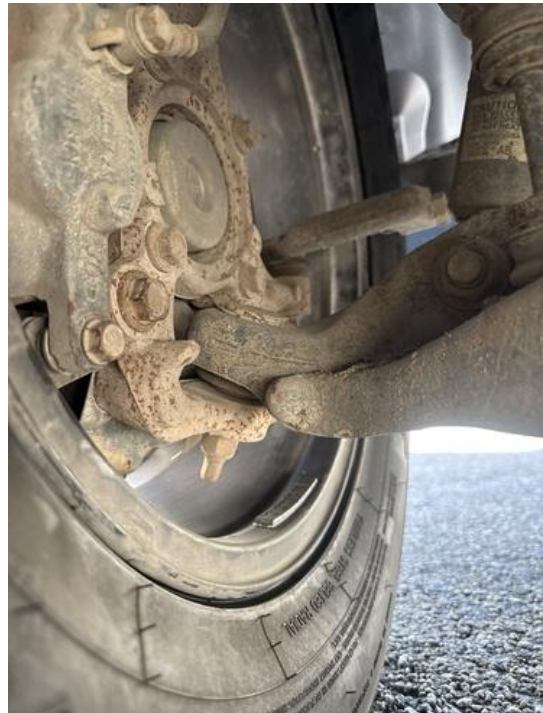
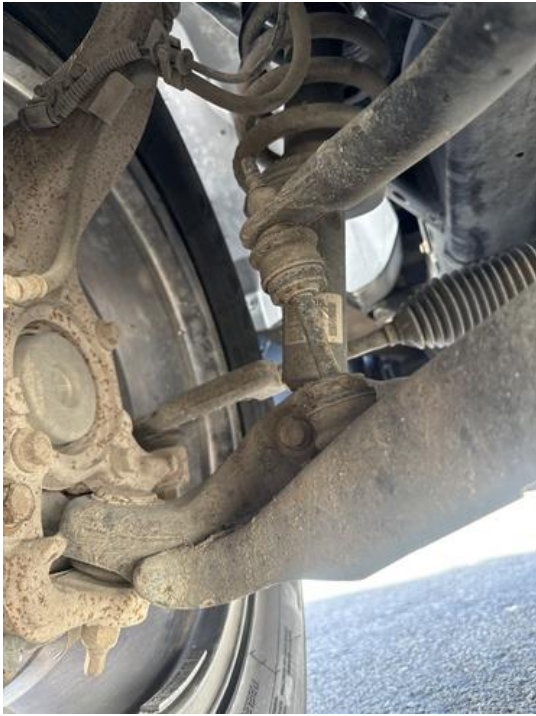
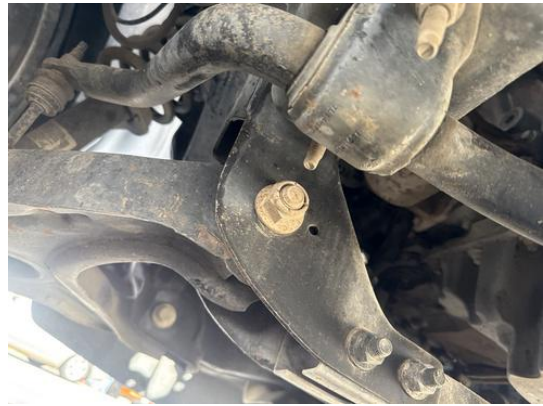
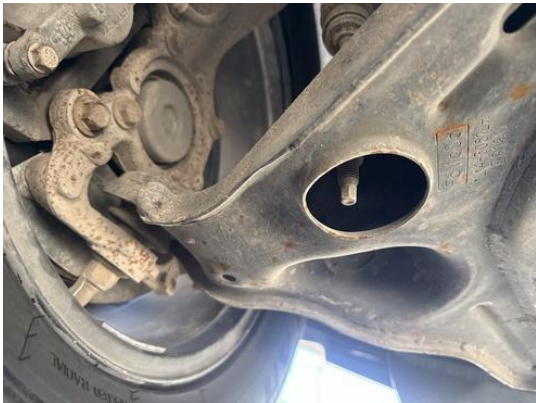
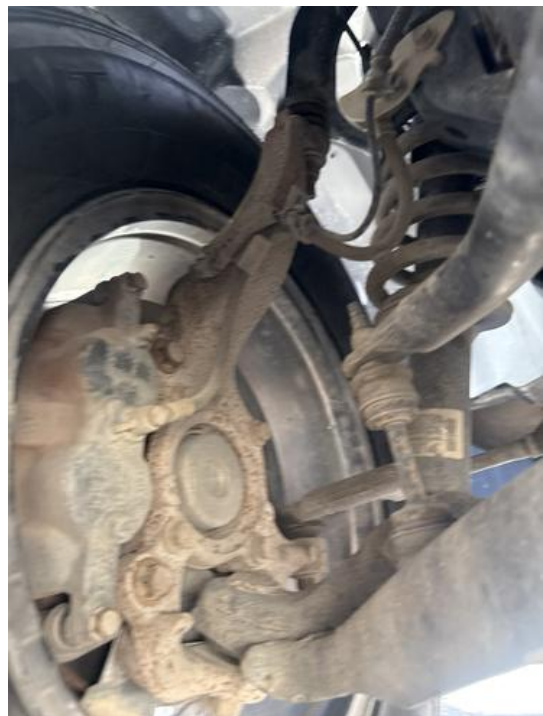
Normal fatigue notice to the suspension components. All of the suspension components seem to be original. None of the suspension components are blown out and due form the replacement. The No excessive surface rust on the exposed metal. No abnormal noise or feedback from the suspension while out on the road. All of the rubber in relation to the mounts, joints and bushings has decent texture.

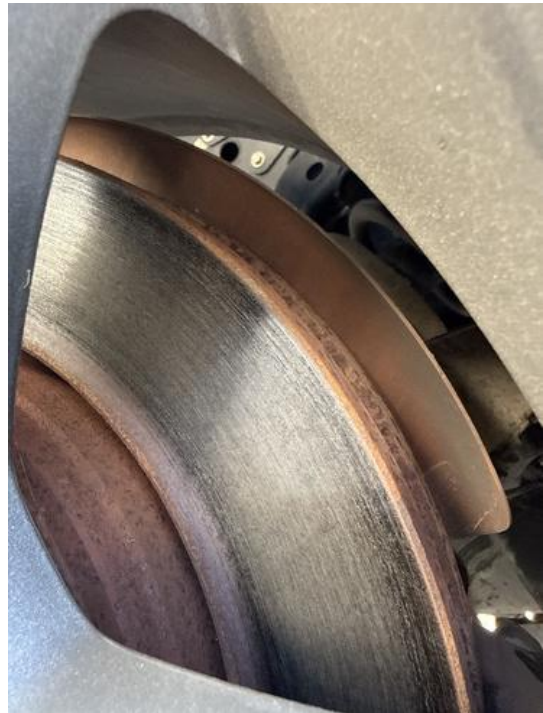
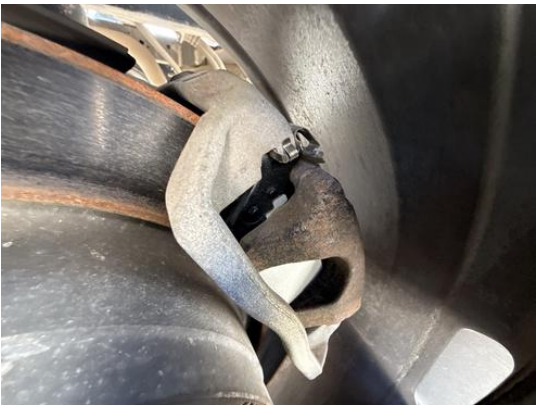
| Braking system condition | |
|---|---|
| Brake fluid condition | Healthy |
| Brake fluid leaks | None |
| Moisture content in brake fluid | None |
