## Peace of Mind Automotive Inspection Report.

| Vehicle Year / Make / Model / Color | | | | 2013 ford f250 | |

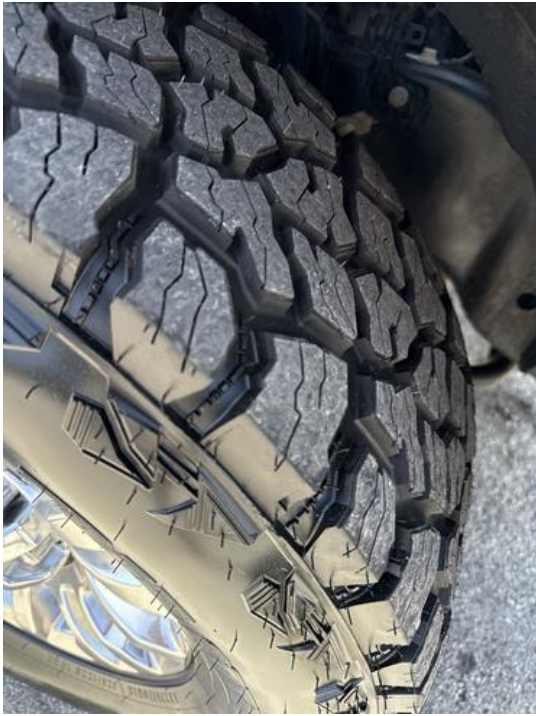
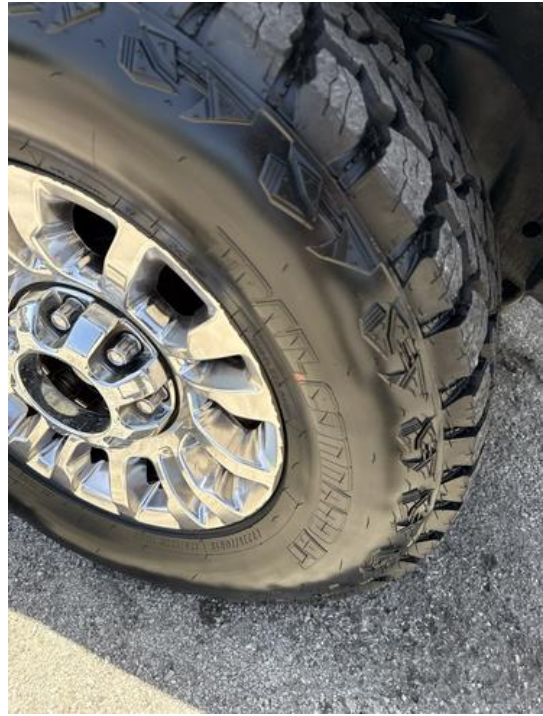
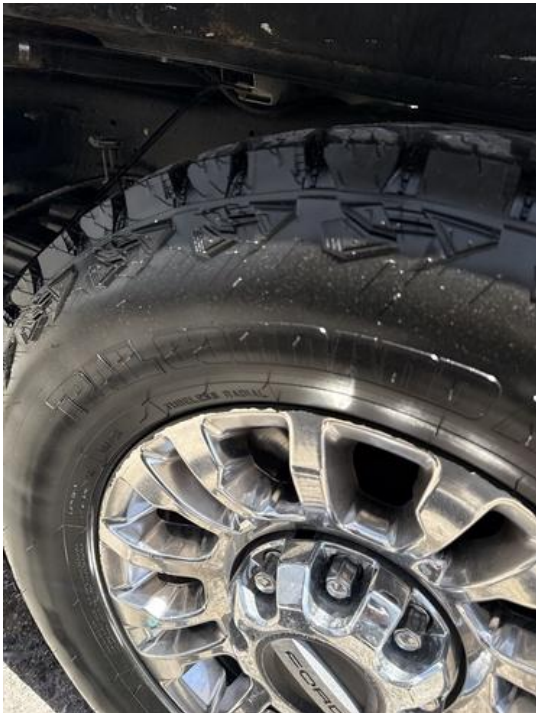
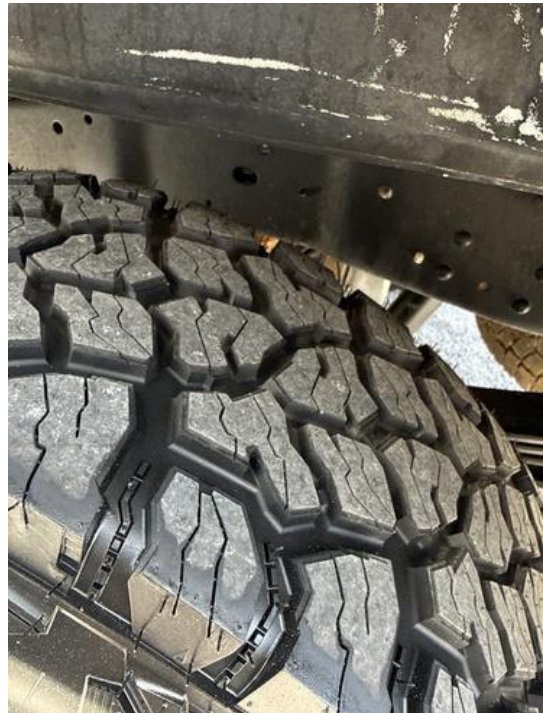
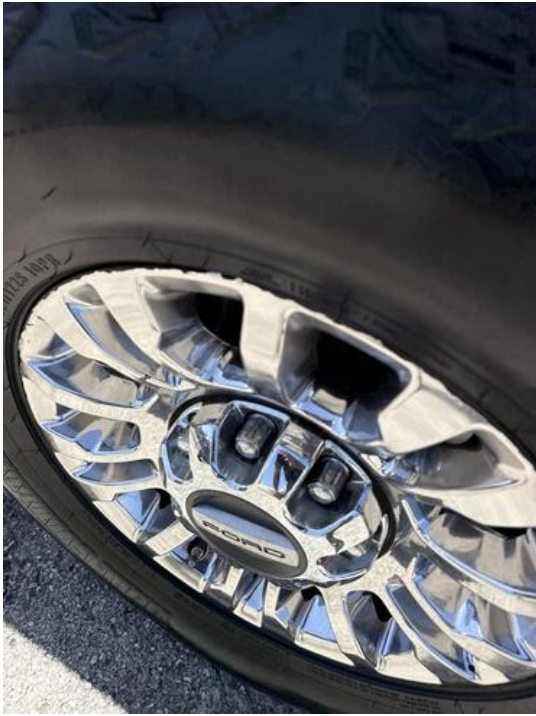
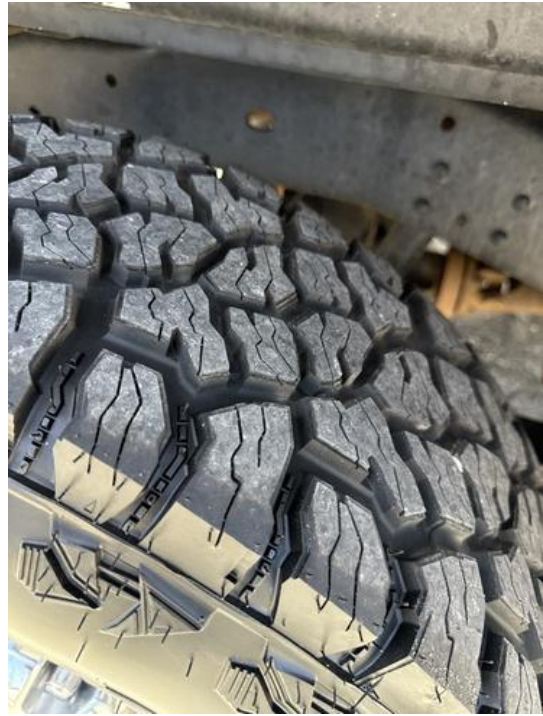
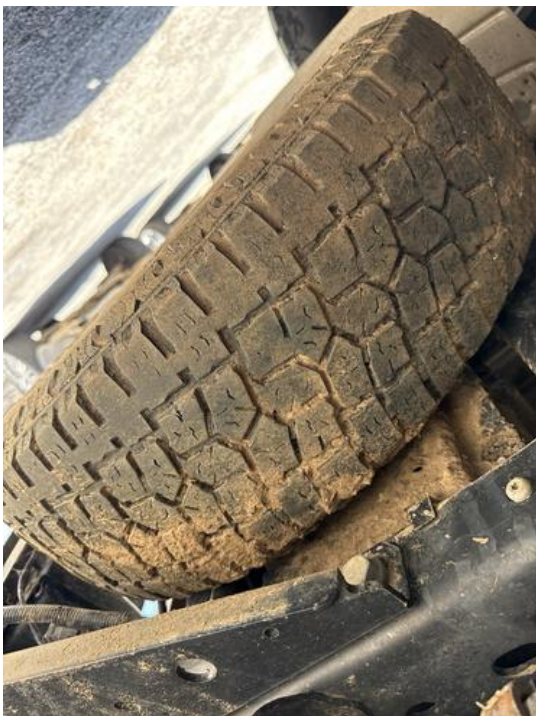
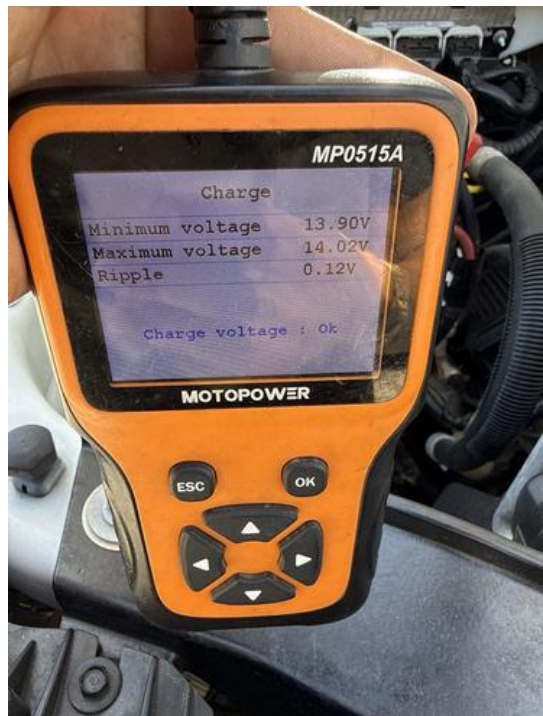
All four tires are matching and have been recently replaced, tires have over 95% tread life remaining

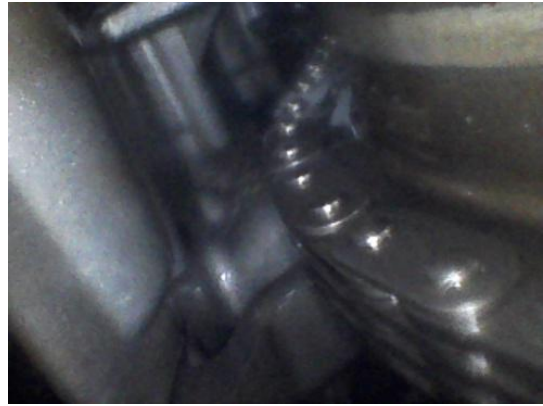
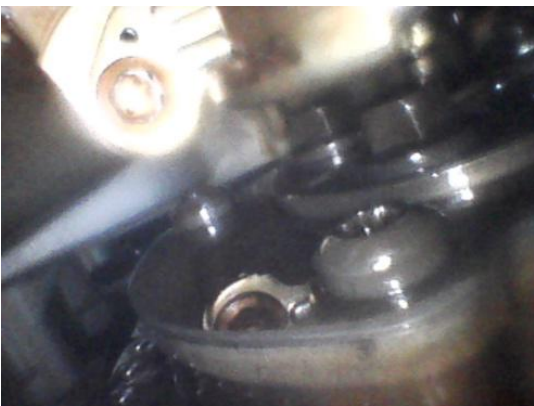
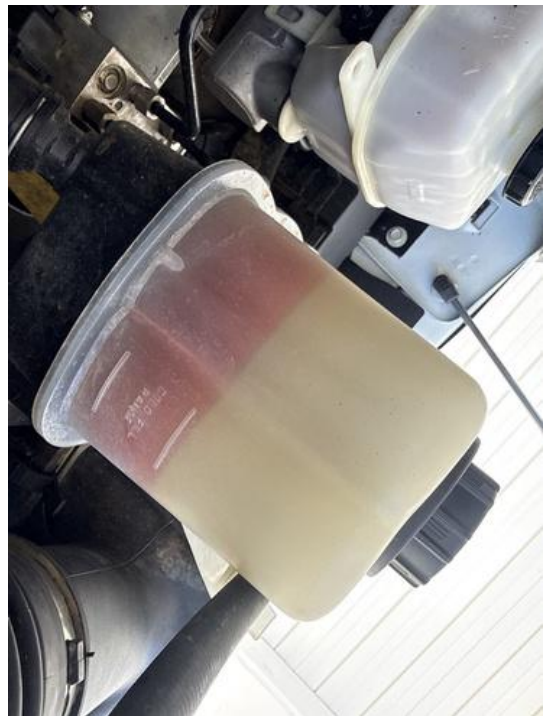
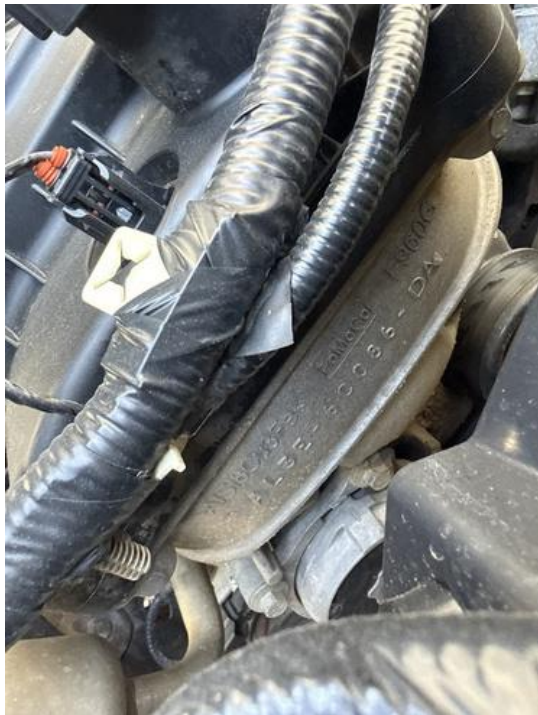
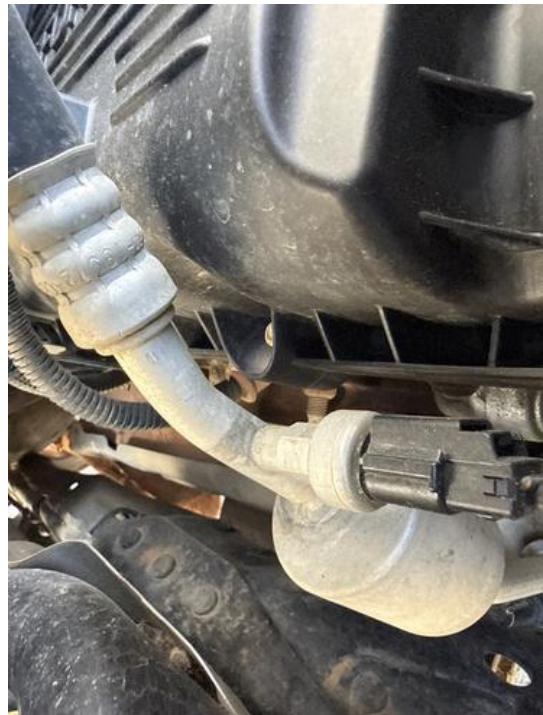
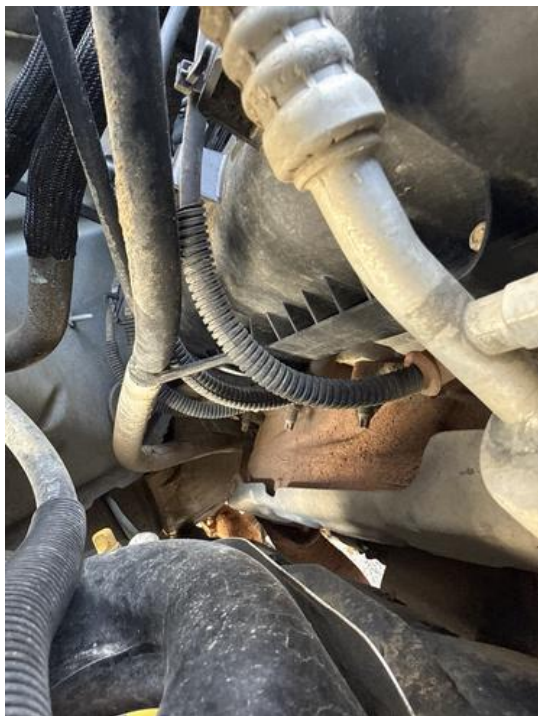
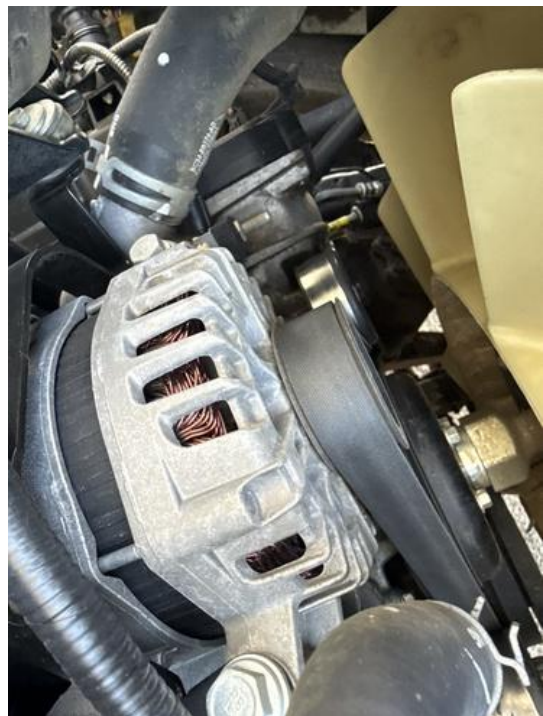
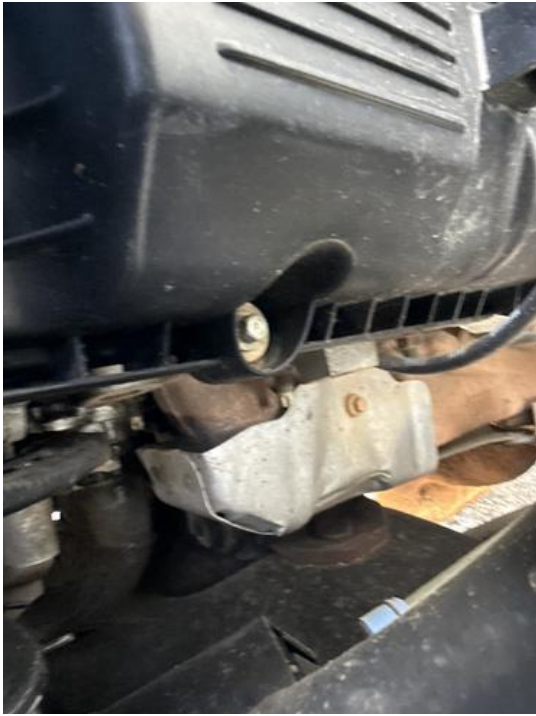
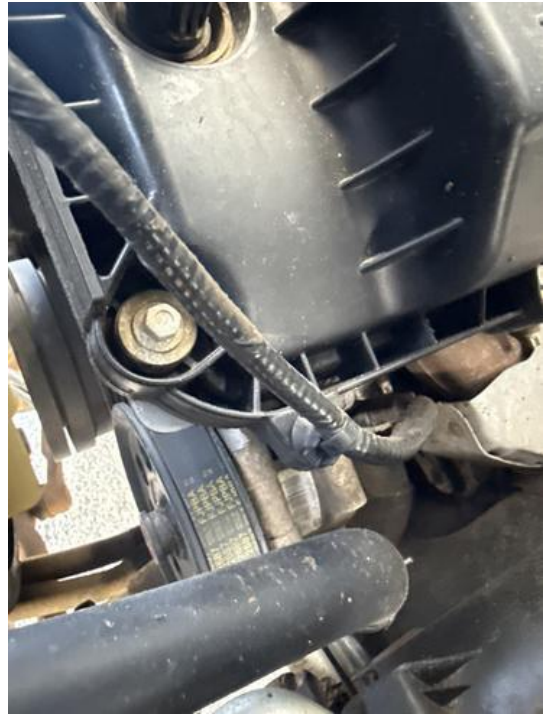
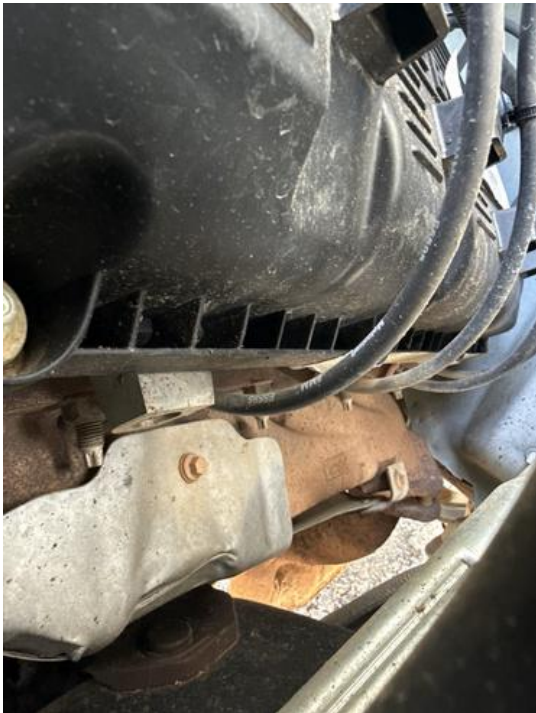
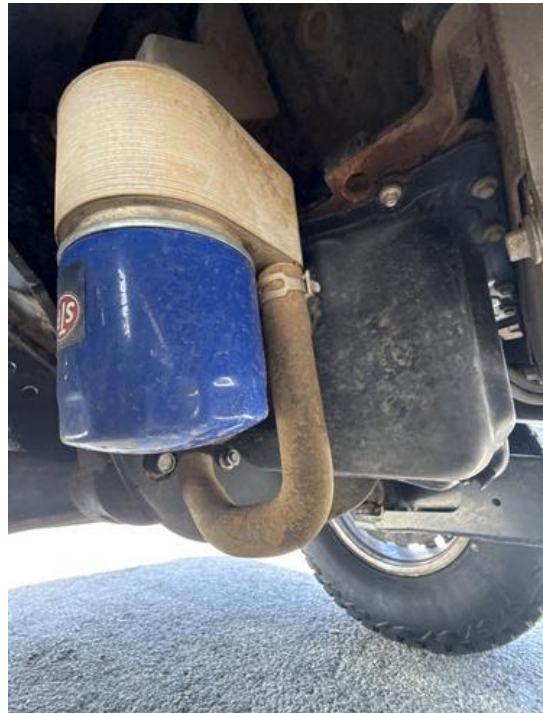
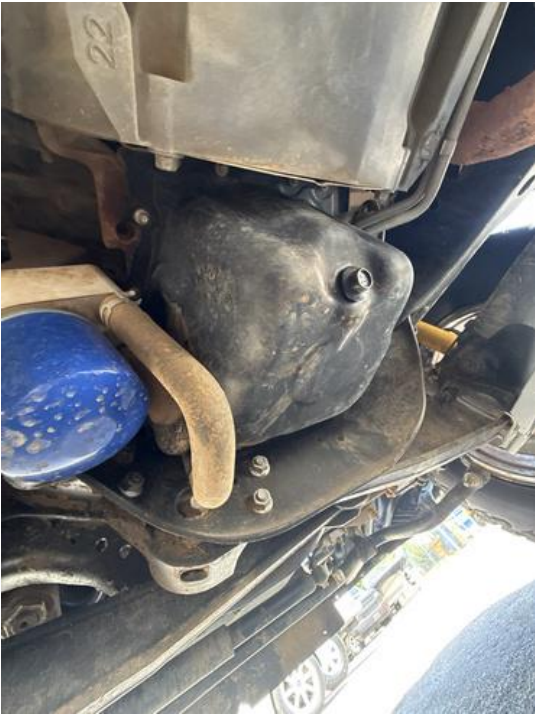
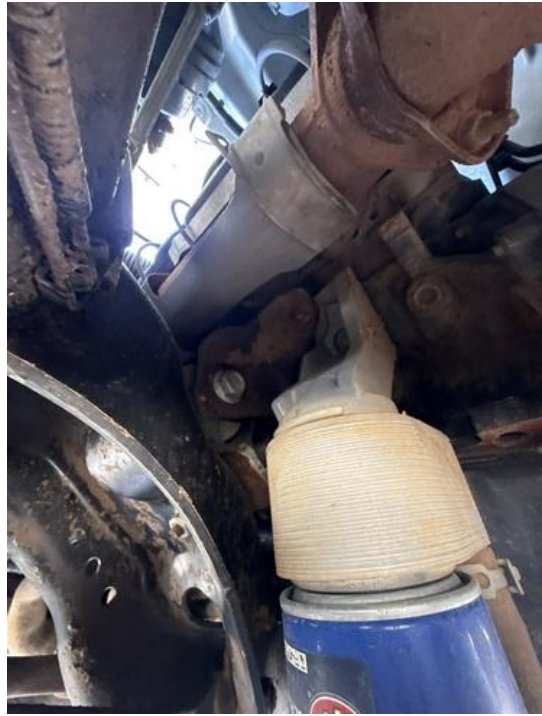
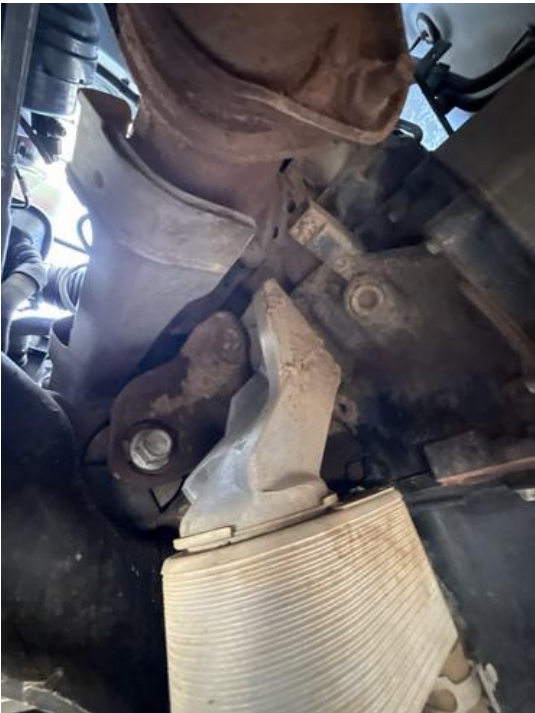
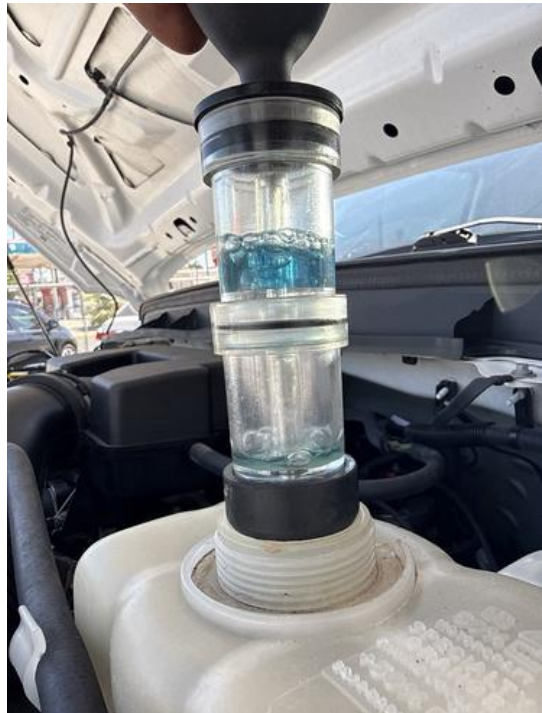
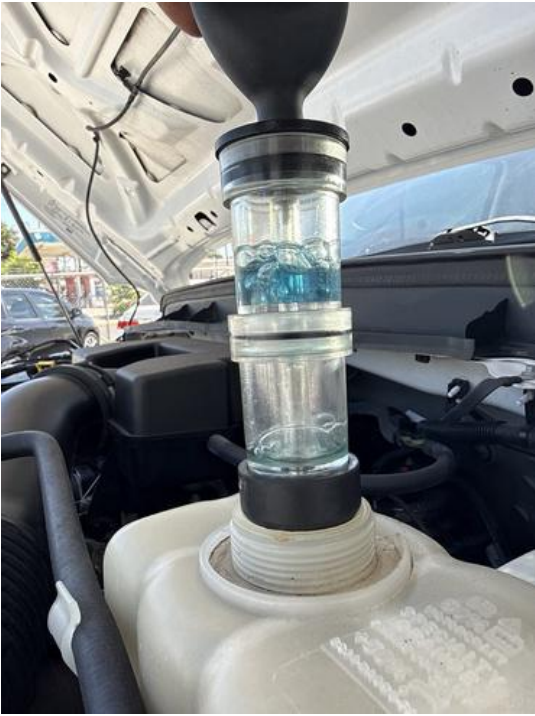
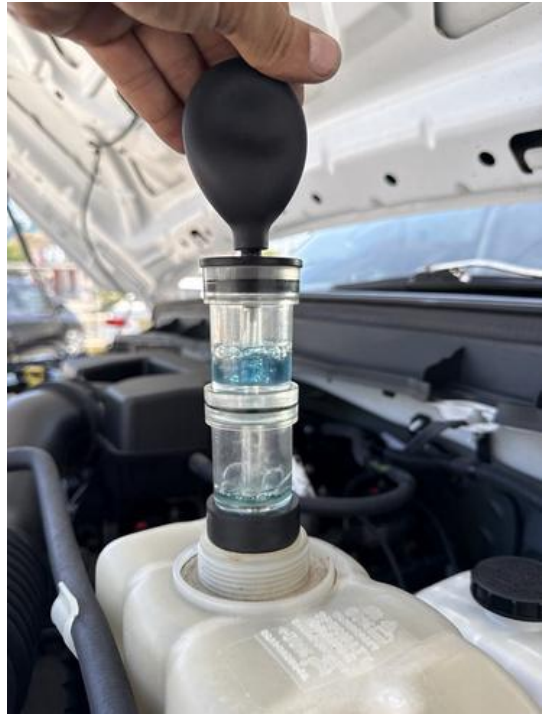
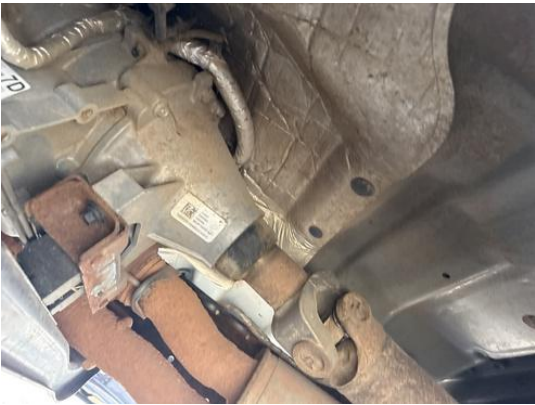
Engine clean internally, no gunk or sludge presents. Proper signs of maintenance present. Block test passed, no internal combustion leak out. Coolant mixture correct and cooling system functionality is healthy. All external engine accessories in good working. No leaks or seepage from anywhere on the engine. External drive belts in decent condition. Currently no concern in mechanical issues present in relation to the engine or related accessories.

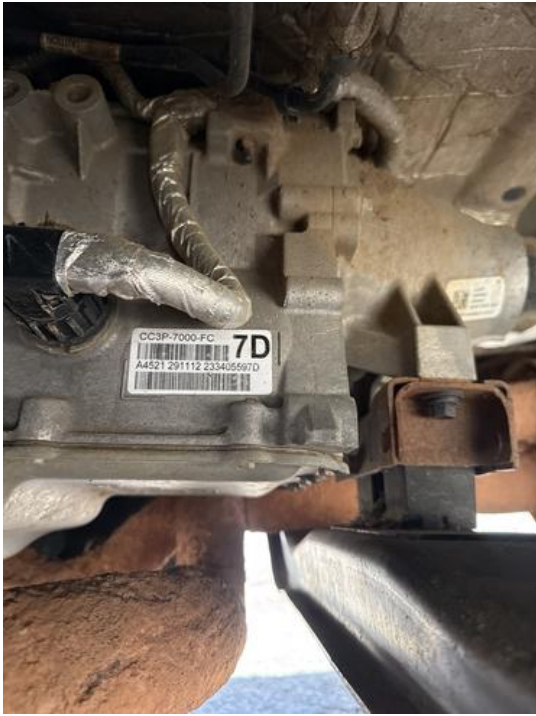
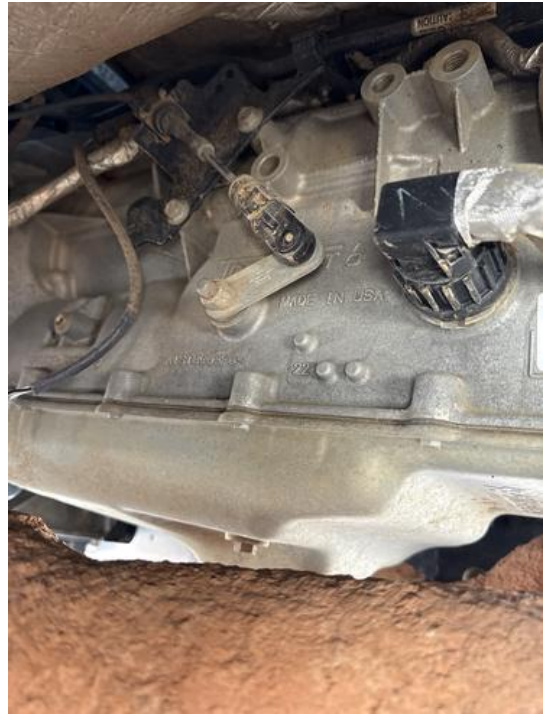
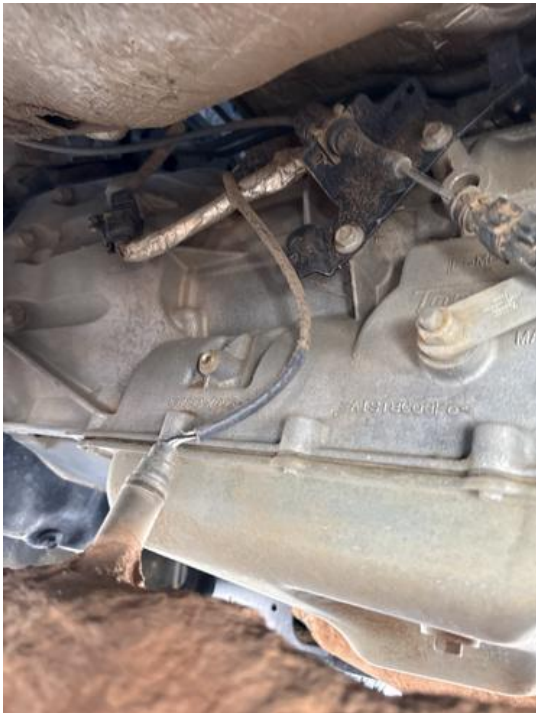
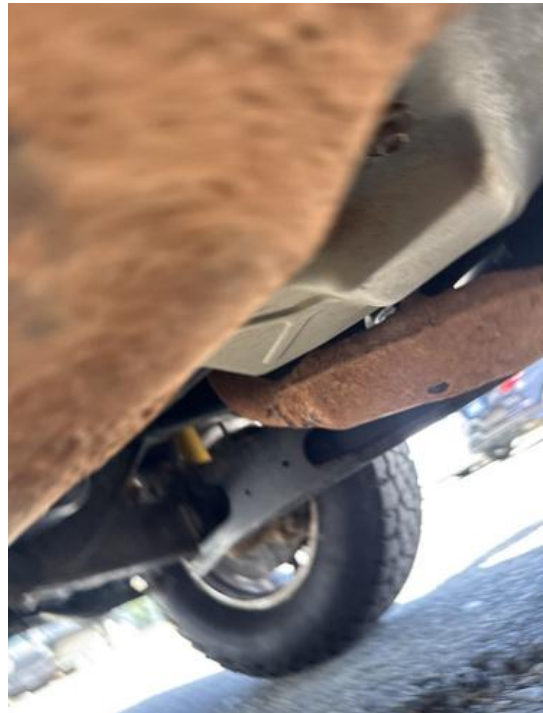
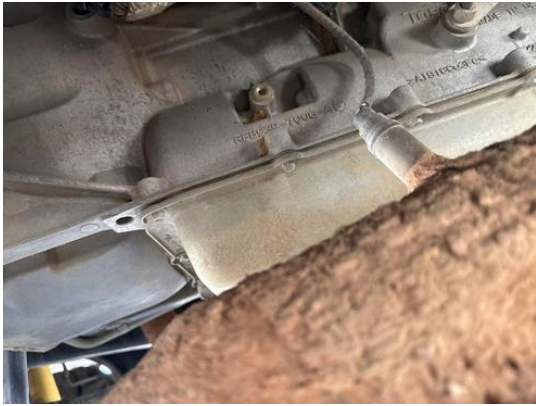
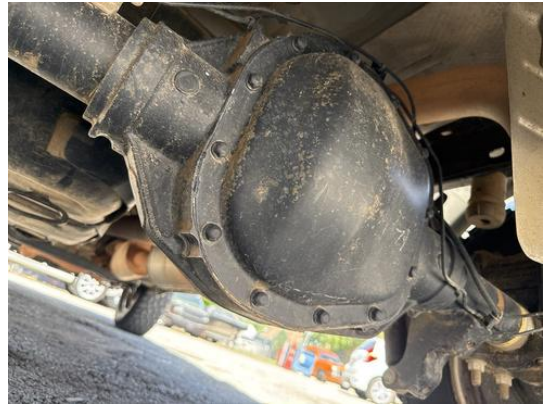
No transmission fluid leaks from the transmission casing or the transmission pan area. The tail shaft seal is free of any fluid leaks. The driveshaft is in healthy condition. Shift transitions out on the road are correct across the board. No fluid leak out from the rear differential.

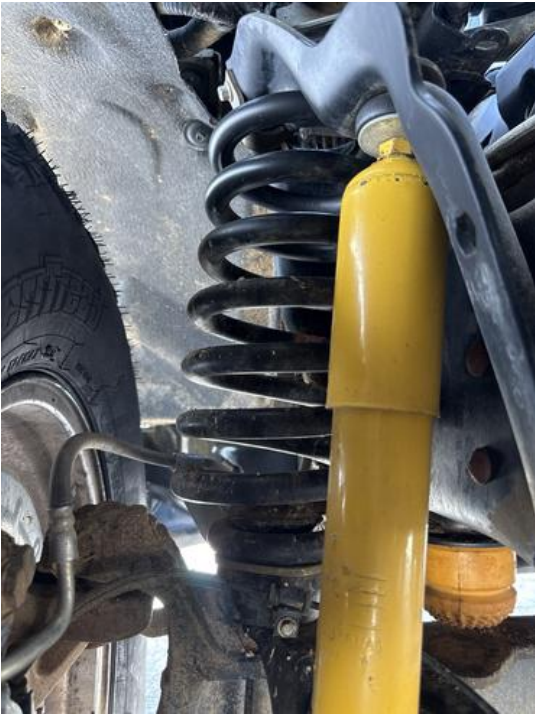
Photo 122

**Rear differential condition**

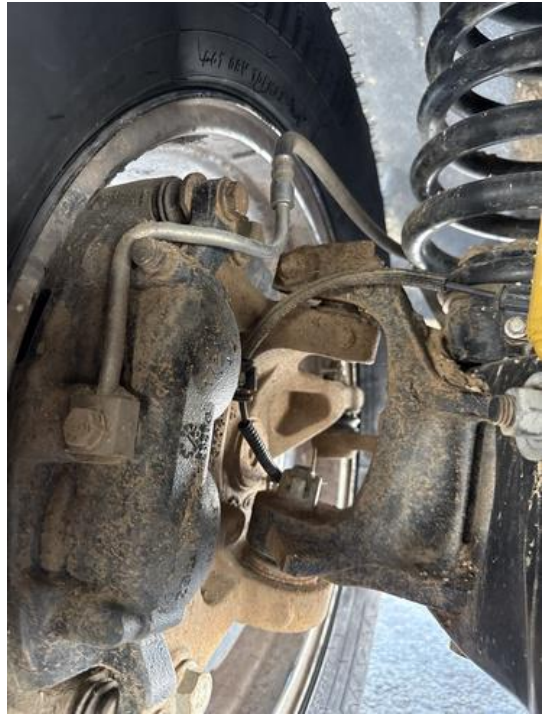
Photo 123

Normal fatigue notice to the suspension components. All of the suspension components seem to be original. None of the suspension components are blown out and due form the replacement. The No excessive surface rust on the exposed metal. No abnormal noise or feedback from the suspension while out on the road. All of the rubber in relation to the mounts, joints and bushings has decent texture.

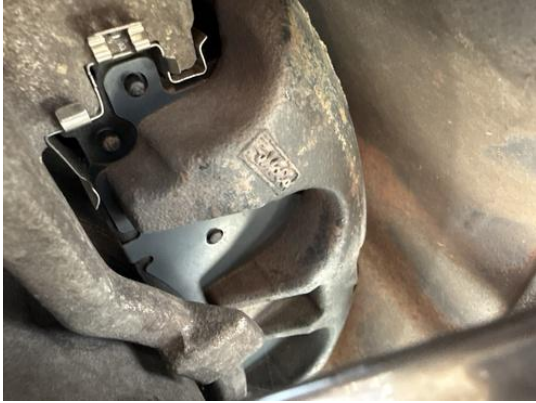
Photo 138

| Braking system condition | |
|---|---|
| Brake fluid condition | Healthy |
| Brake fluid leaks | None |
| Moisture content in brake fluid | None |
