Peace of Mind Automotive Inspection Report.

Site conducted	Unanswered
Customer name	Luis Imj auto motor sales
Date / Time	Dec 26th
Payment method	Invoice
Inspection cost	Fleet
Vehicle Year / Make / Model / Color	2013 ford f250 with fenced truck bed
VIN	36317 last 5
	Photo 1
license plate	Dealer
Mileage	95427
Color	White

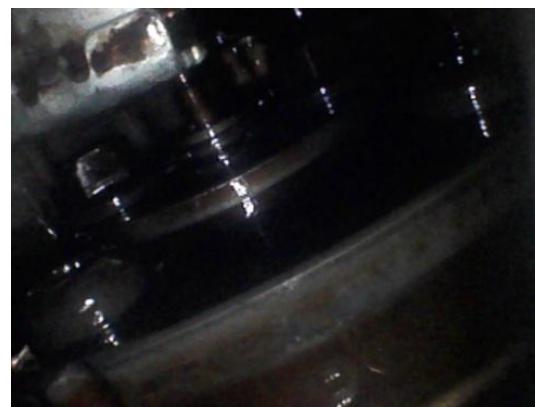
Photo 131

There was a little bit of oil residue noticed at the bottom side of the valve cover gasket area, no attention is required at this point, however a future repair to expect/future maintenance to expect will be replacement of the valve cover gaskets

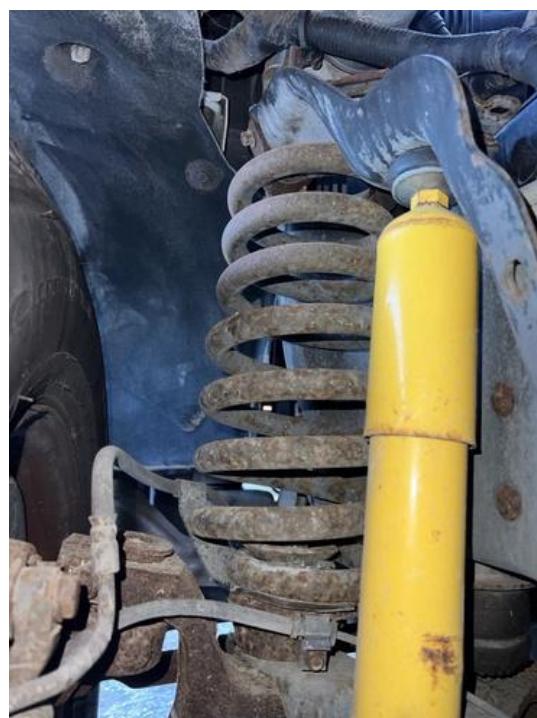
Photo 165

Normal fatigue notice to the suspension components. All of the suspension components seem to be original. None of the suspension components are blown out and due form the replacement. The No excessive surface rust on the exposed metal. No abnormal noise or feedback from the suspension while out on the road. All of the rubber in relation to the mounts, joints and bushings has decent texture.

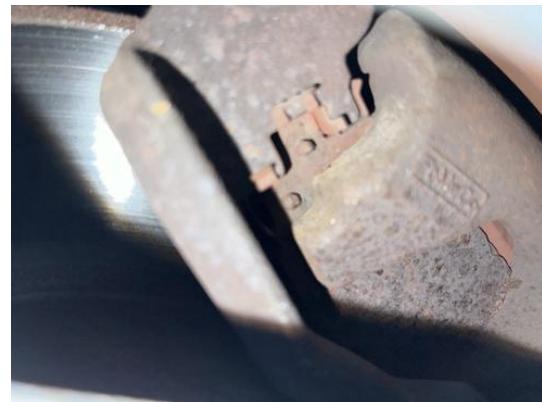
Photo 179

Brake fluid condition	Healthy
Brake fluid level	Healthy
Brake fluid leaks	None
Moisture content in brake fluid	None
Brake lines	Healthy
Brake calipers front	Healthy
Brake calipers rear	Healthy
Brake drums rear	N/A
Brake rotors front	Healthy
Brake rotors rear	Healthy
Front brake pad life remaining	25-50% remaining
