## Peace of Mind Automotive Inspection Report.

**Complete**

| Score | 4 / 4 (100%) | Flagged items | 0 | Actions | 0 |
|---|---|---|---|---|---|
| Vehicle Year / Make / Model / Color | | 2013 Honda fit | | | |

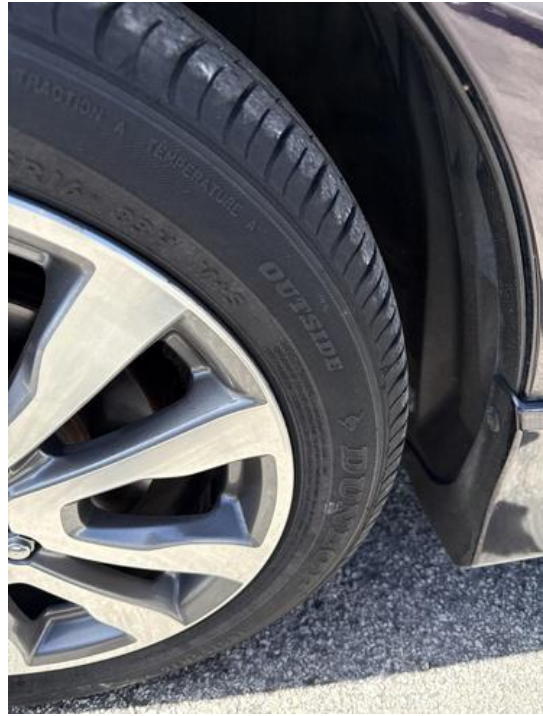
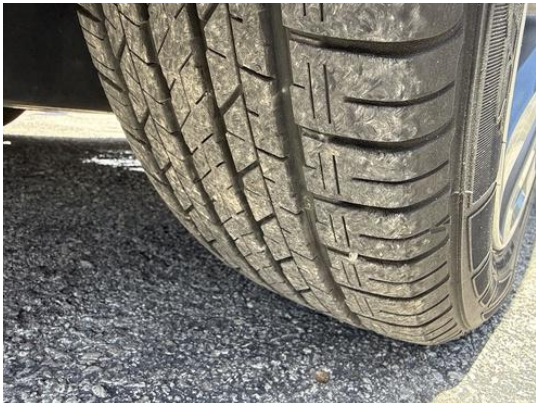
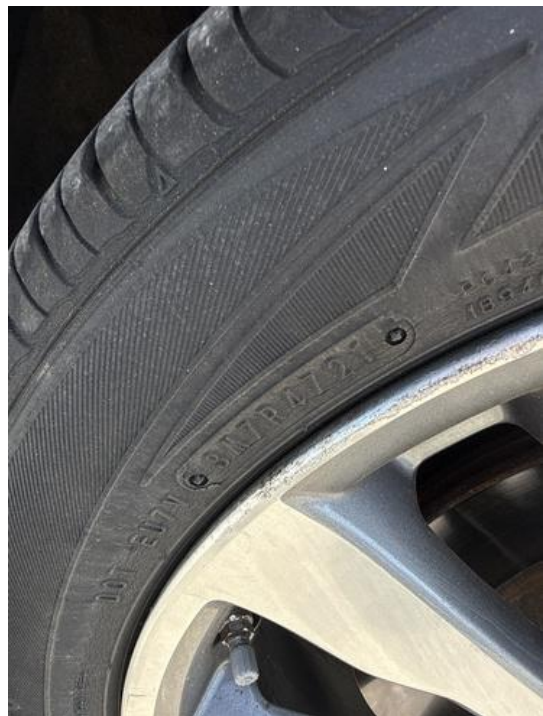
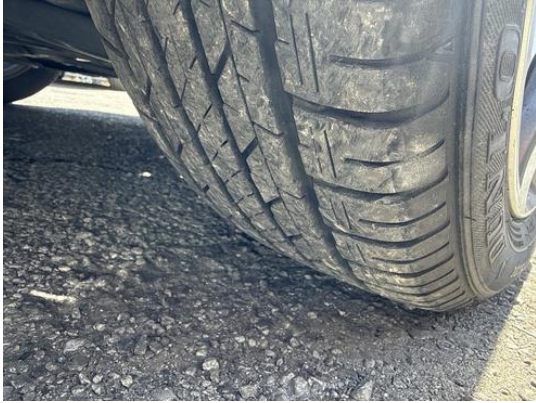
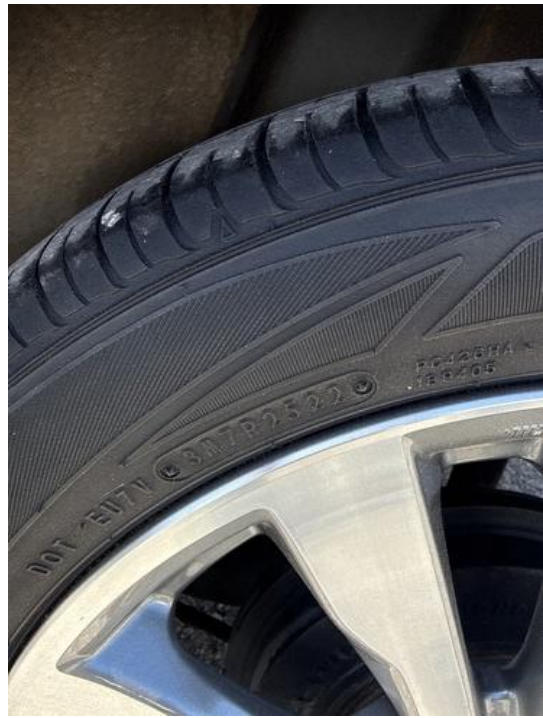
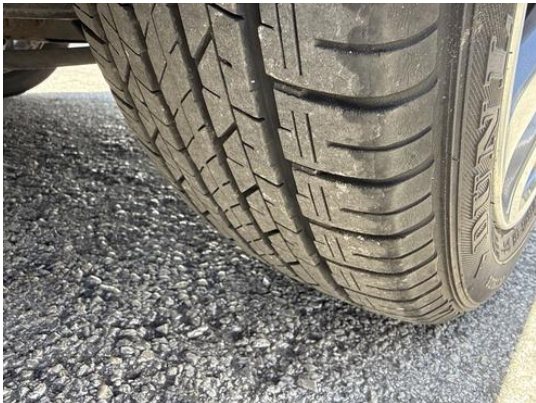
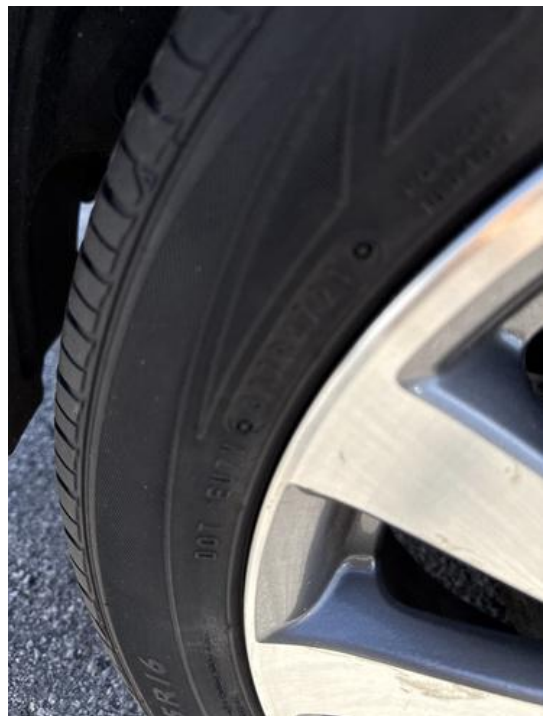
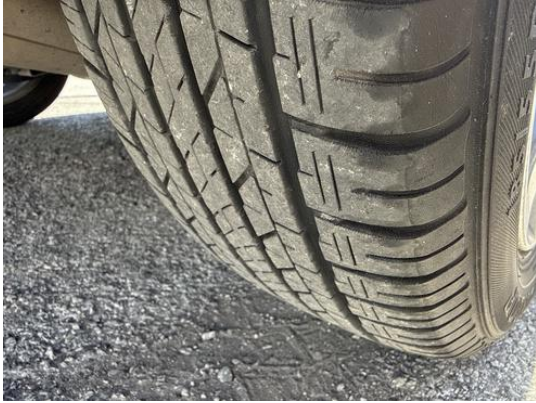
All four tires are matching. Tires are dated from 2021. Tires have right around 75% tread light remaining all around and are evenly worn.

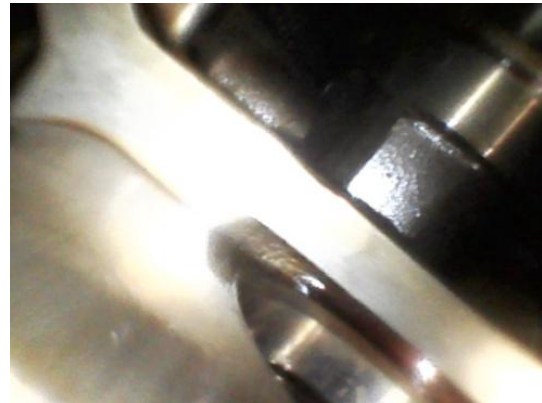
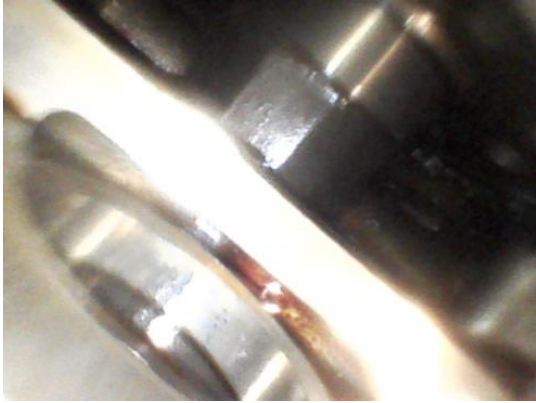
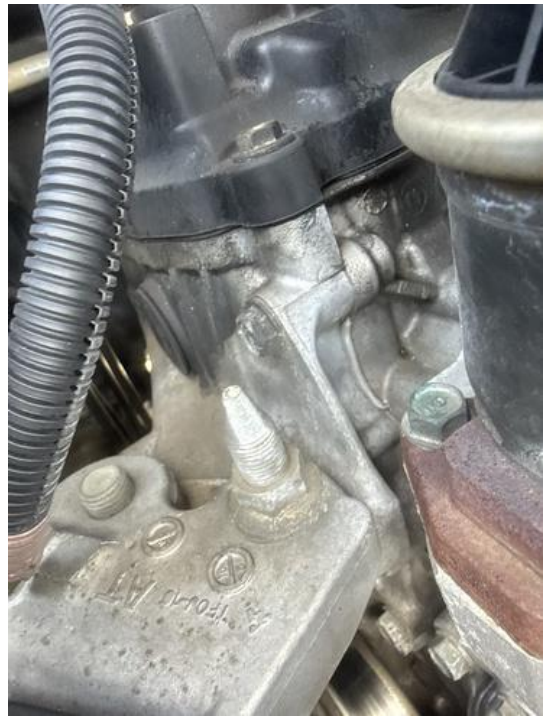
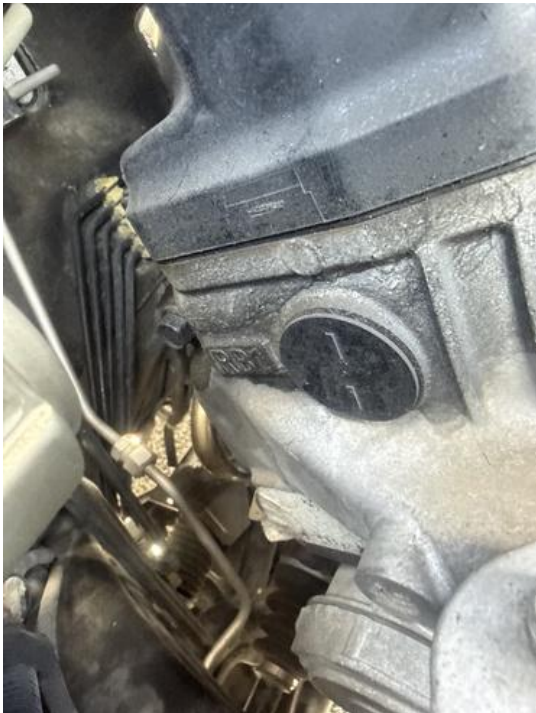
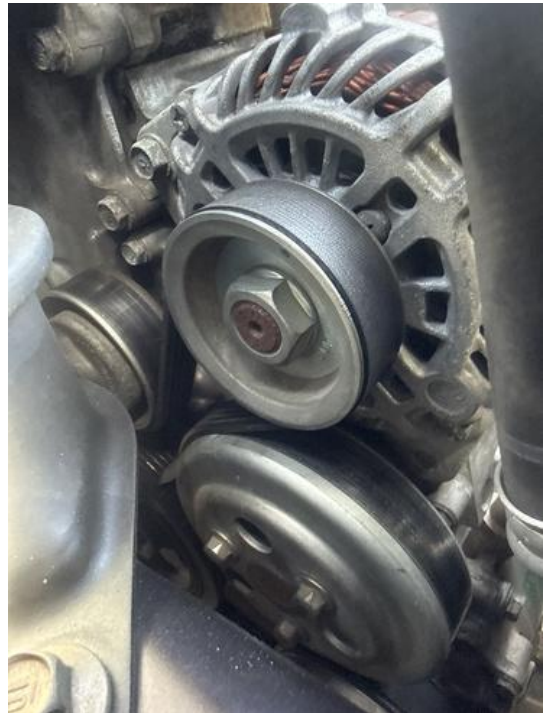
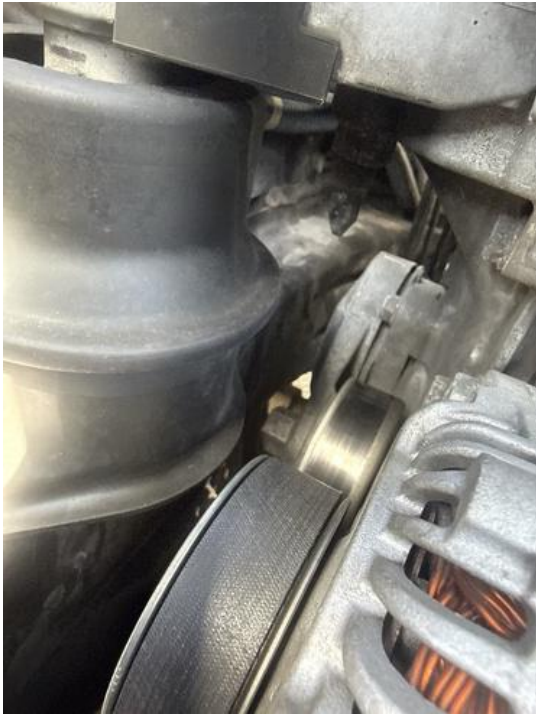
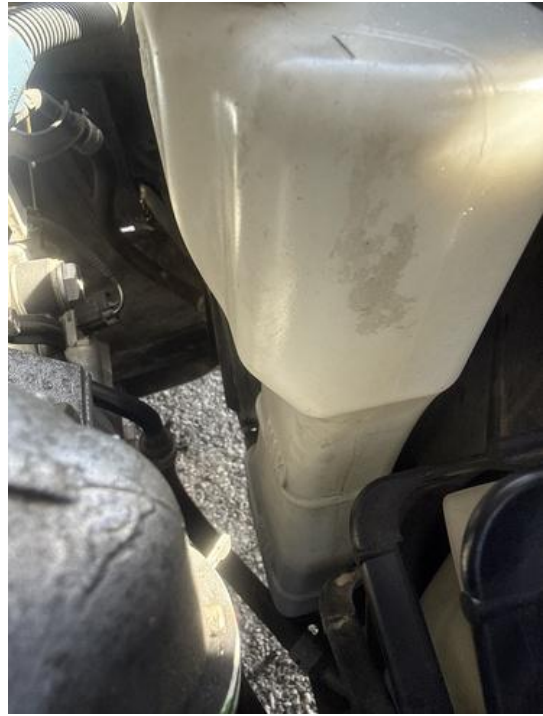
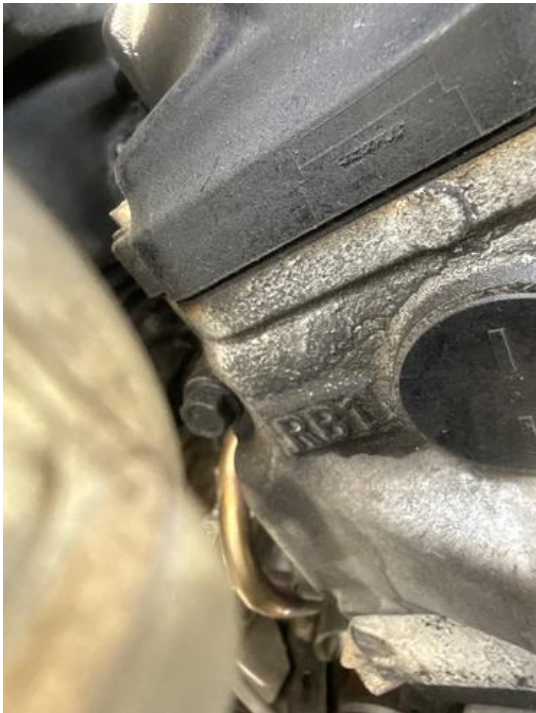
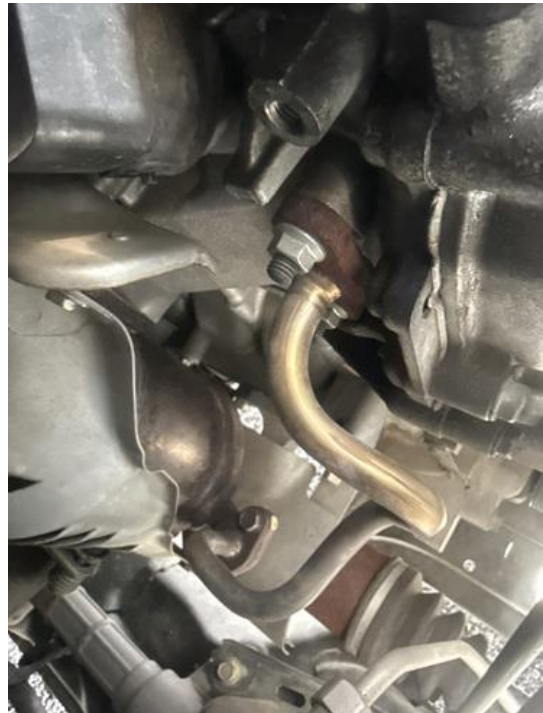
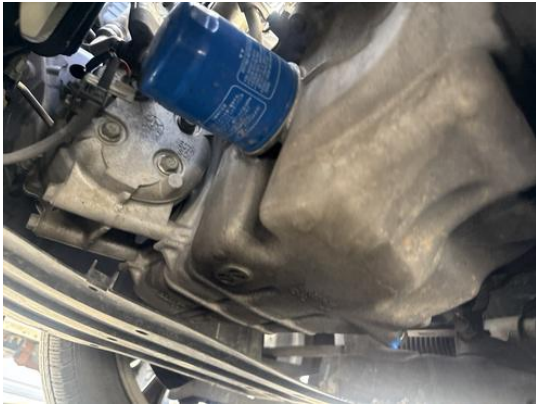
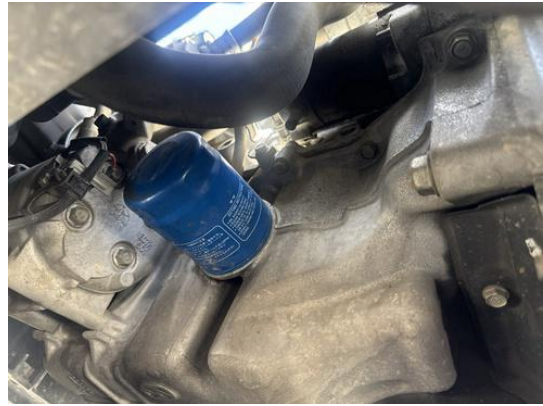
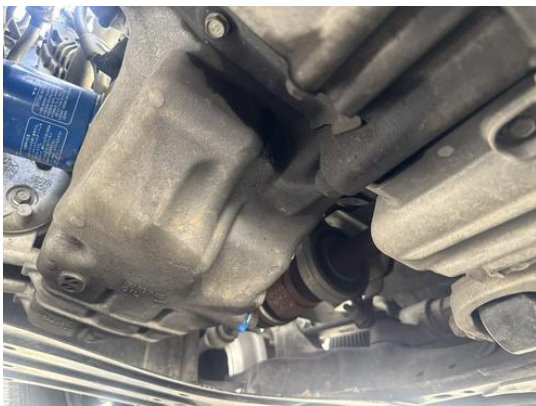
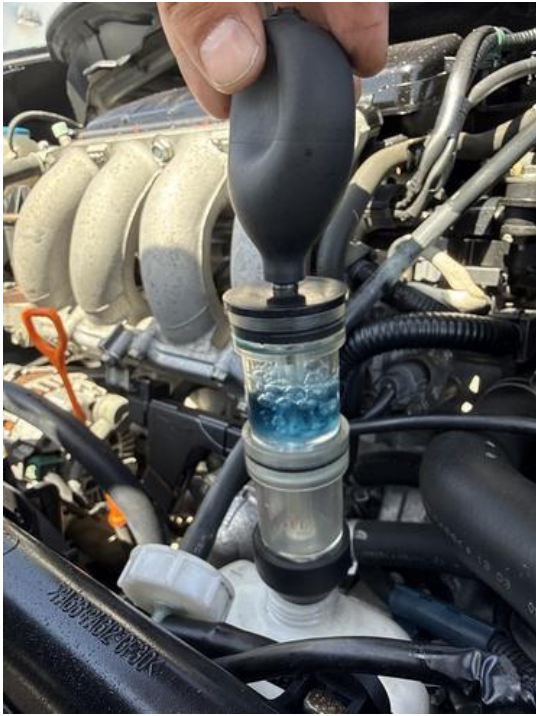
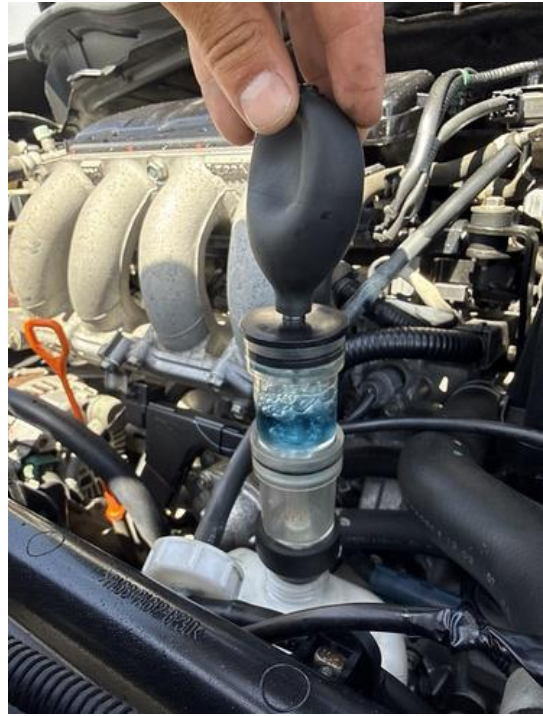
Engine clean internally, no gunk or sludge presents. Proper signs of maintenance present. Block test passed, no internal combustion leak out. Coolant mixture correct and cooling system functionality is healthy. All external engine accessories in good working. No leaks or seepage from anywhere on the engine. External drive belts in decent condition. Currently no concern in mechanical issues present in relation to the engine or related accessories.

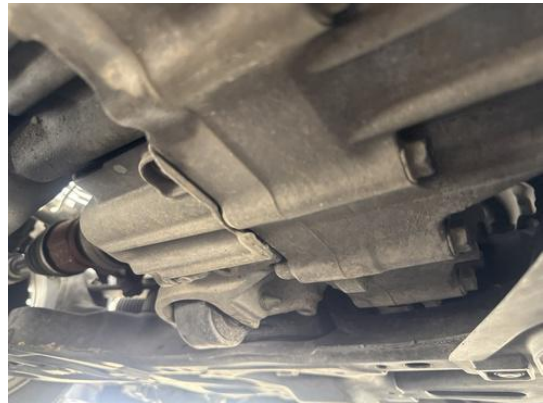
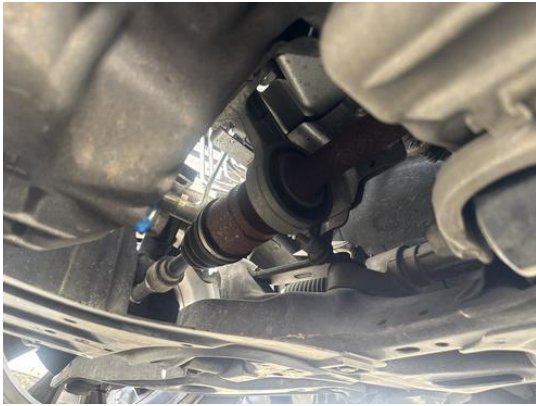
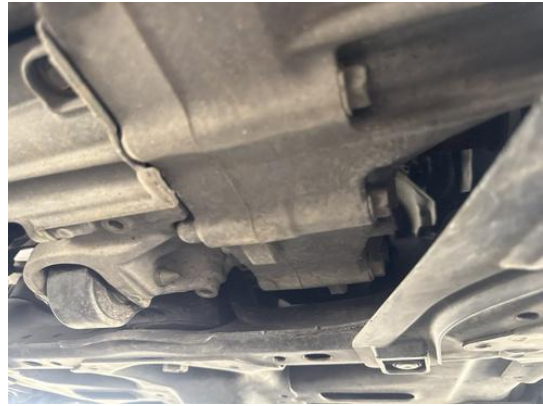
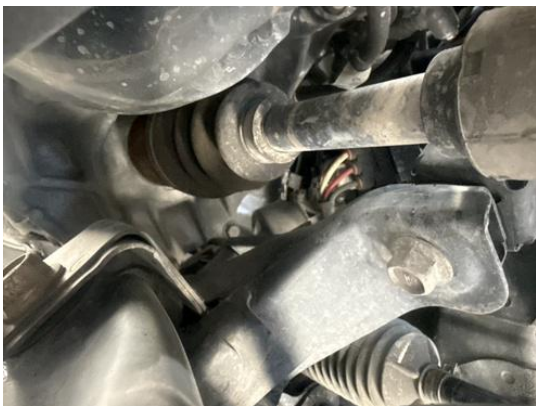
No transmission fluid leaks from the transmission casing. Both the left and right side axle seals are free of any fluid leaks. Both the left and right side CV axle are in healthy condition. Shift transition out on the road are correct.

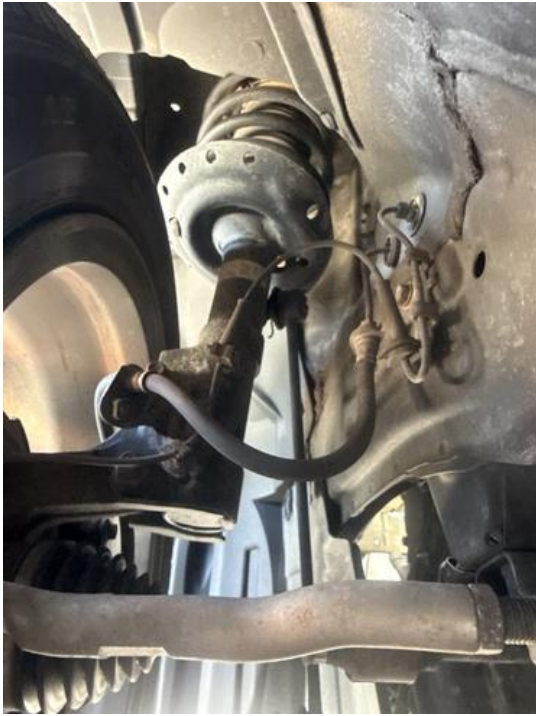
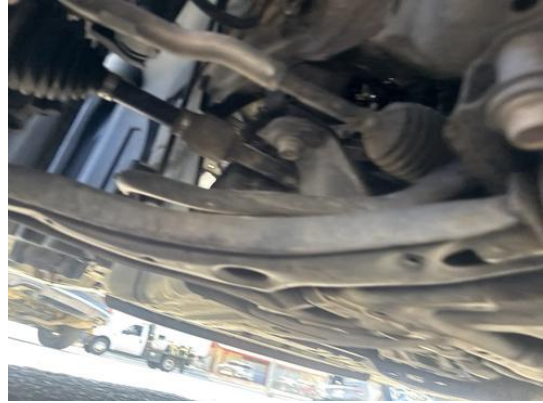
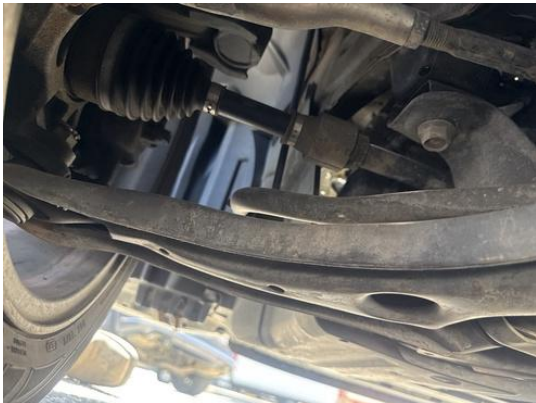
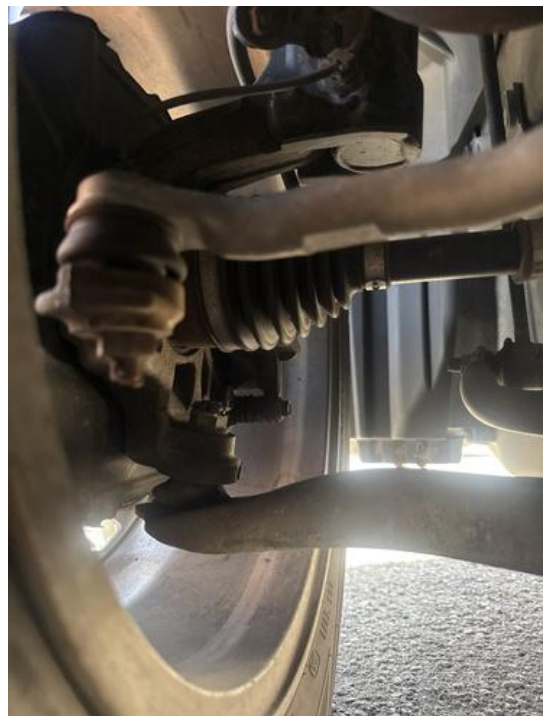
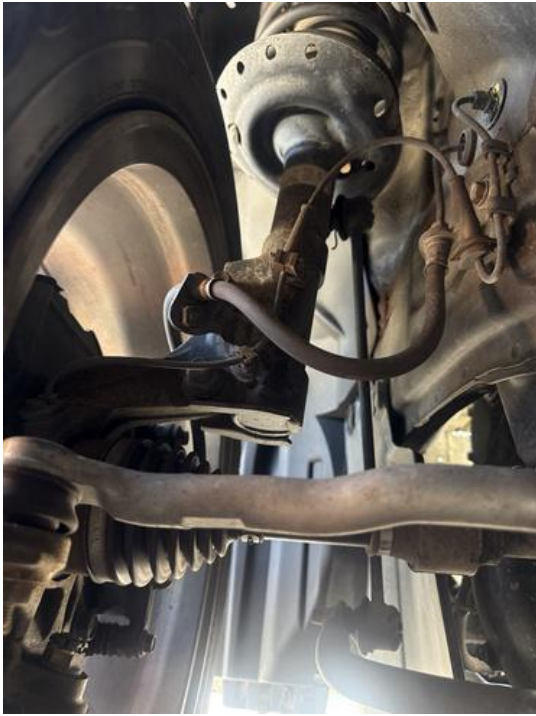
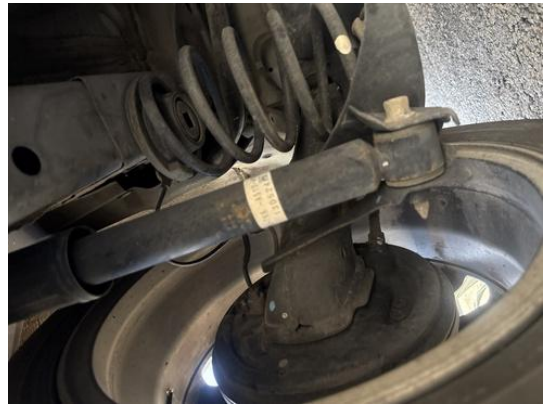
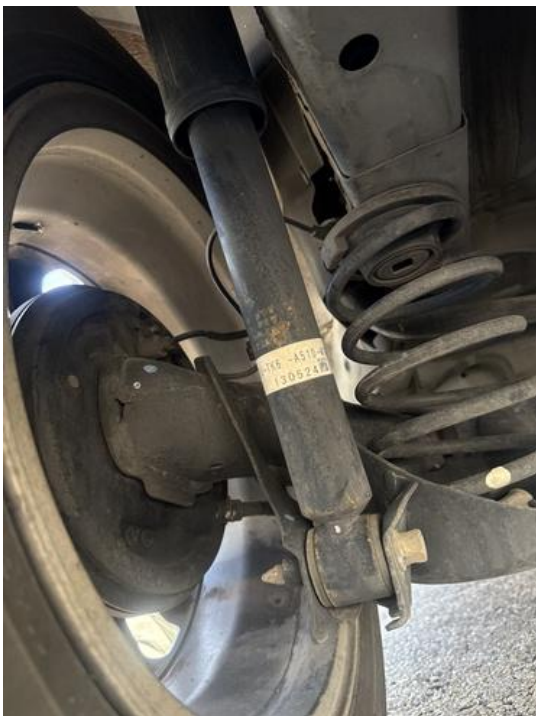
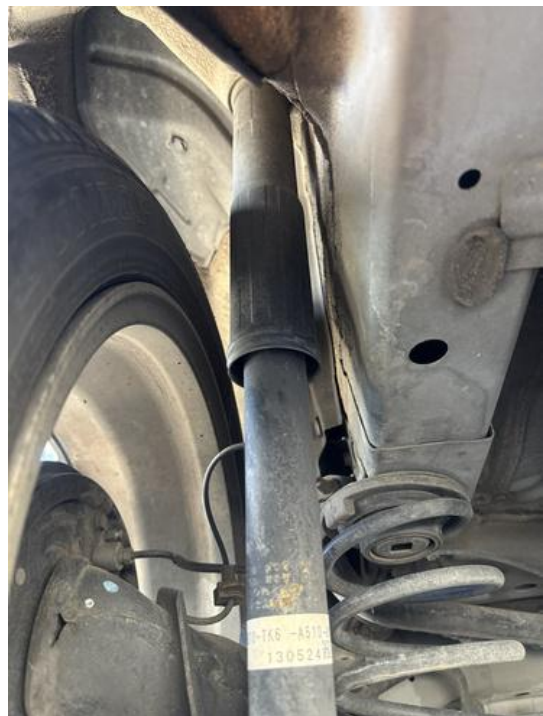
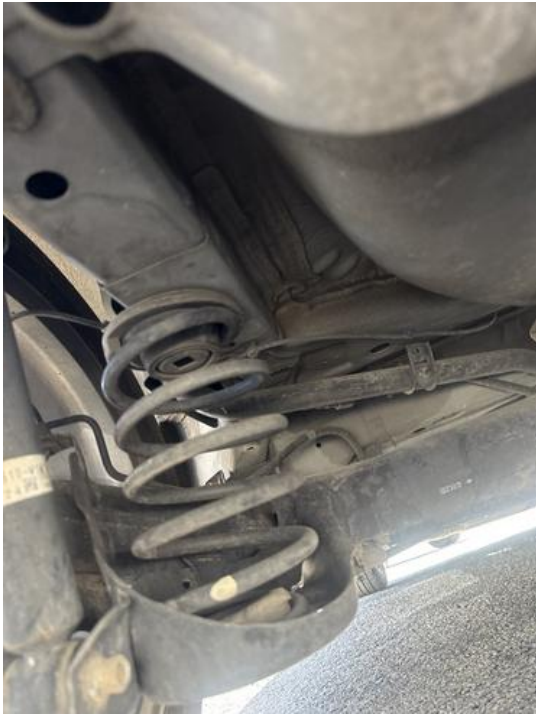
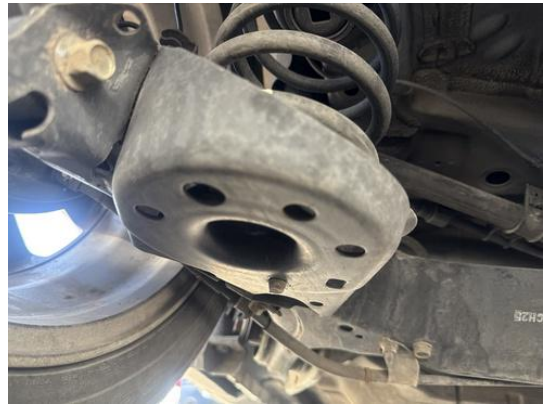
Normal fatigue notice to the suspension components. All of the suspension components seem to be original. None of the suspension components are blown out and due form the replacement. The No excessive surface rust on the exposed metal. No abnormal noise or feedback from the suspension while out on the road. All of the rubber in relation to the mounts, joints and bushings has decent texture.
