Peace of Mind Automotive Inspection Report.

Score	4 / 4 (100%)	Flagged items	0	Actions	0
Site conducted					Unanswered
Customer name					Luis Imj auto motor sales
Date / Time					June 2nd
Payment method					Invoice
Inspection cost					Fleet
Vehicle Year / Make / Model / Color					2013 Honda civic
VIN					74608 last 5

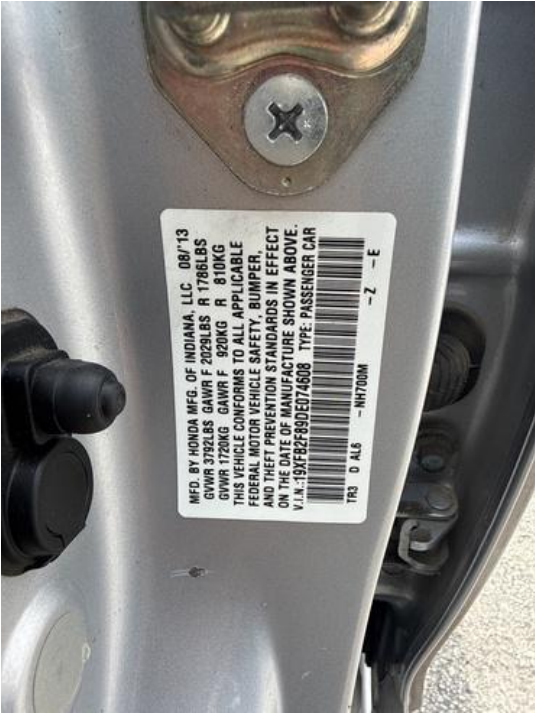
Photo 1				
license plate					Dealer
Mileage					157588
Color					Silver

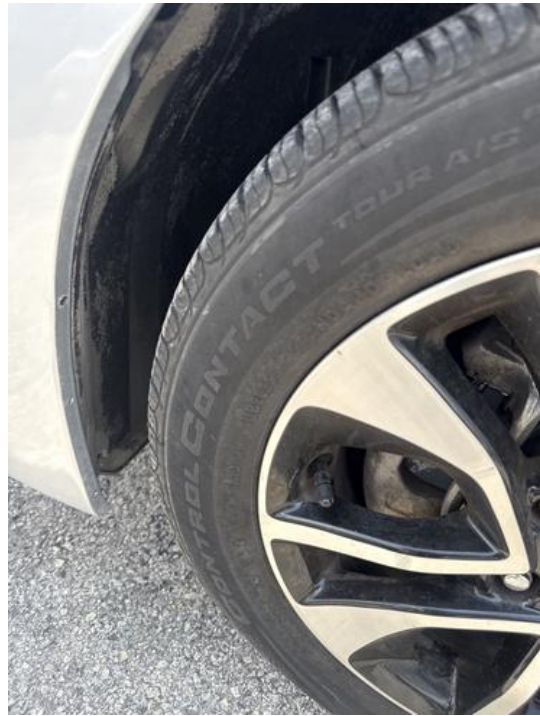
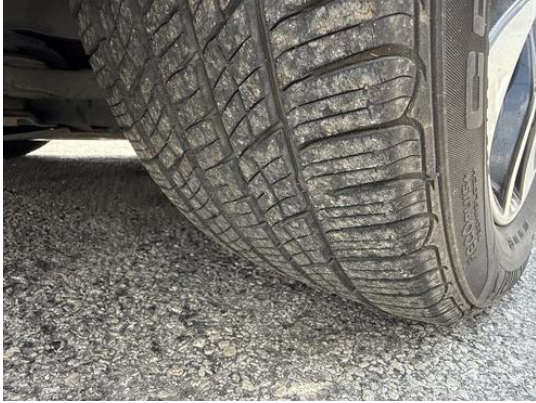
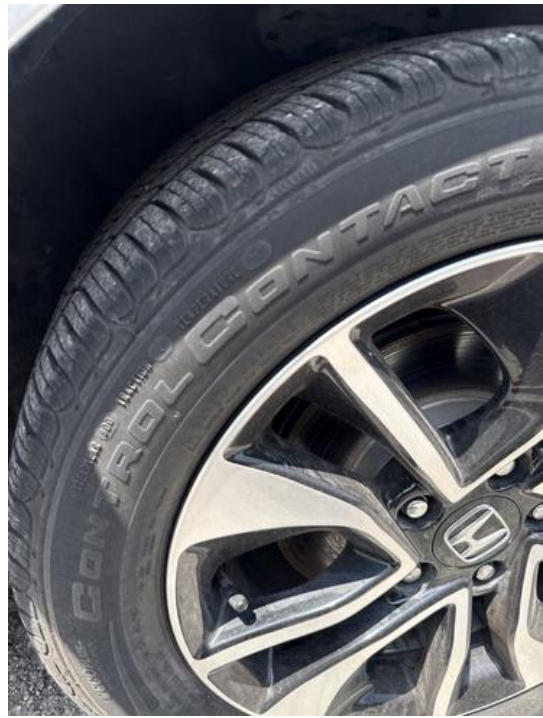
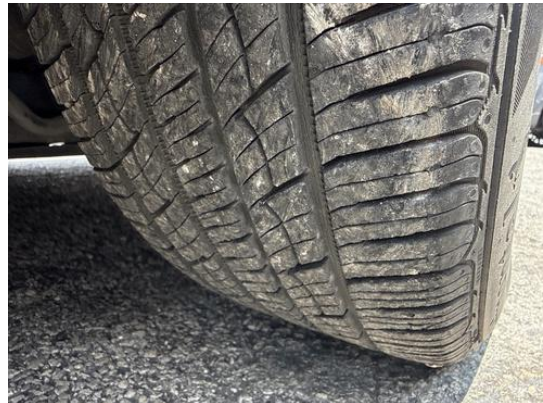
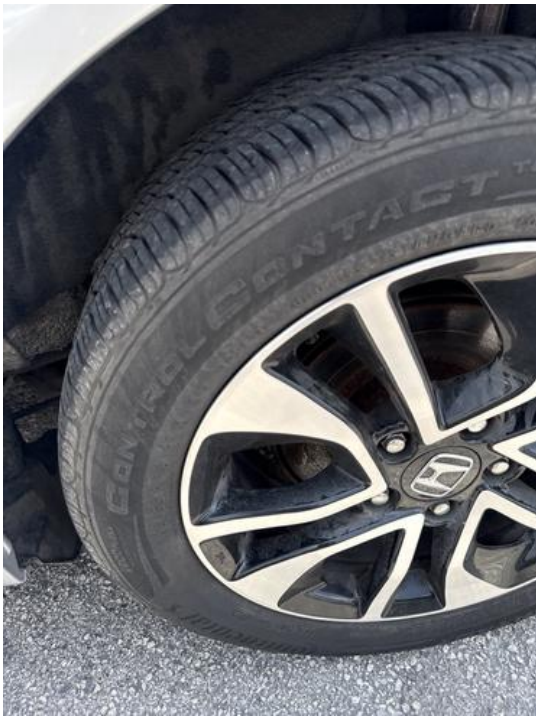
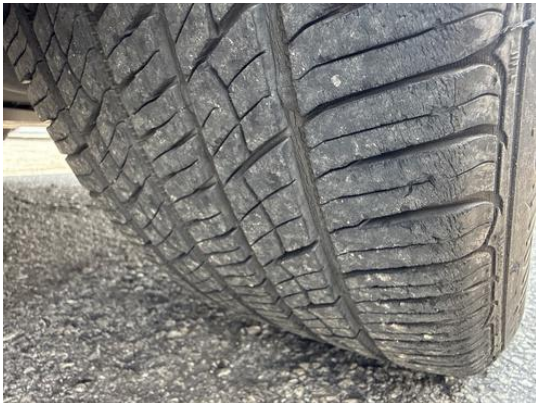
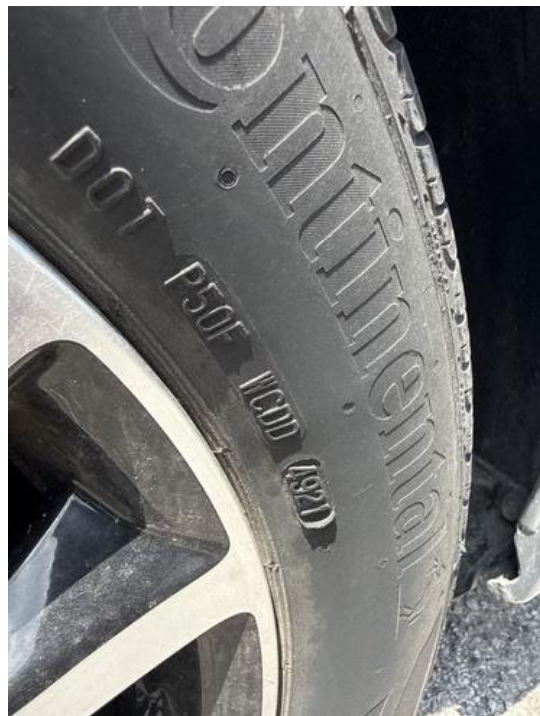
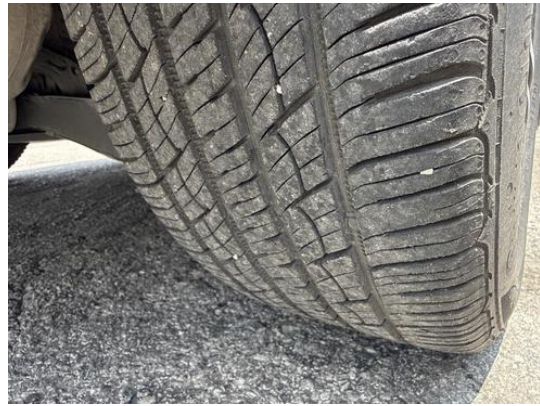
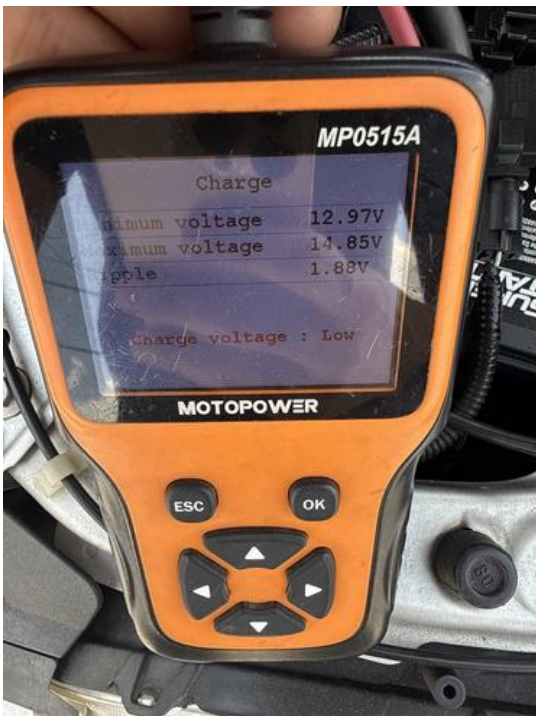
All four tires are matching and in healthy condition. Tires are dated from late 2022. All four tires are evenly worn and have right around 75% tread life remaining.

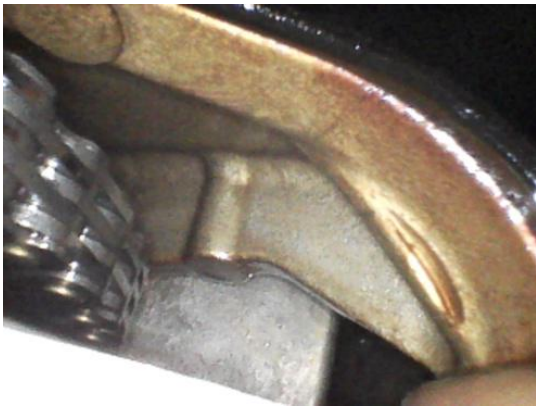
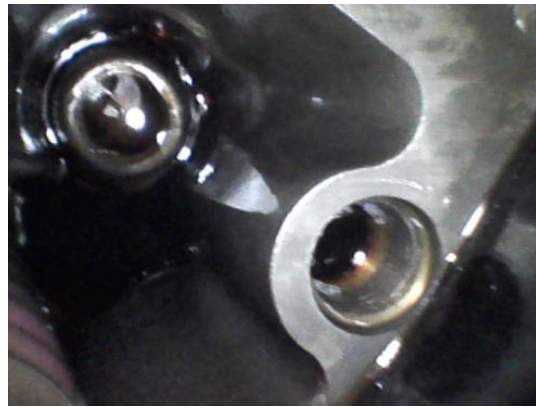
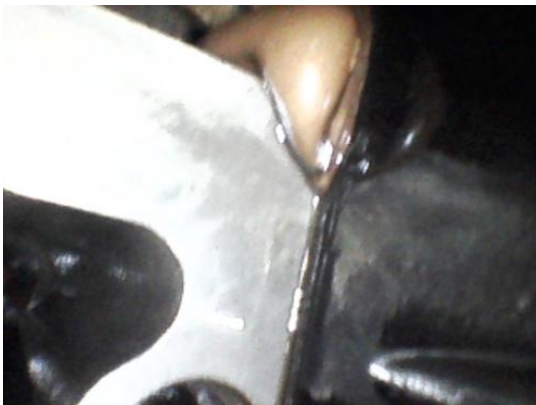
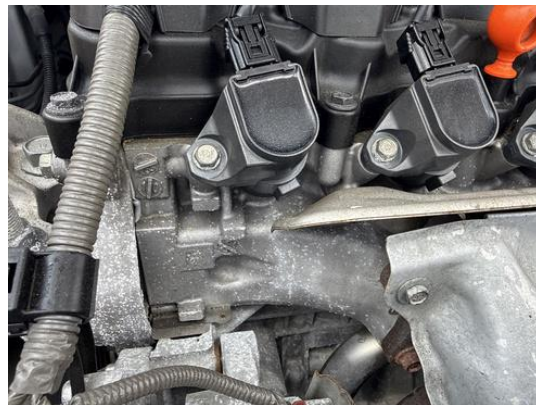
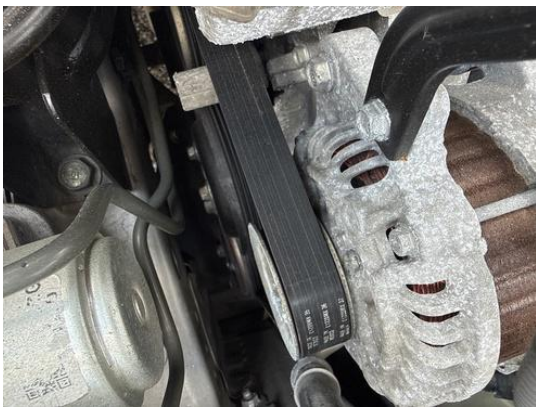
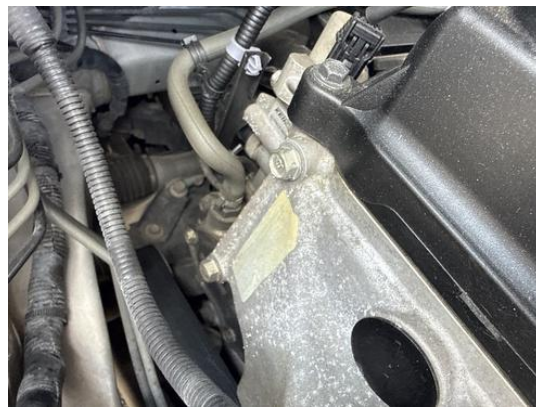
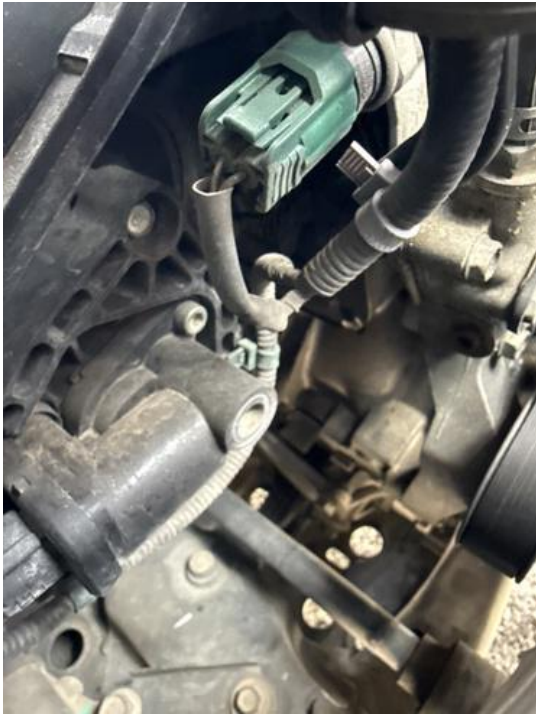
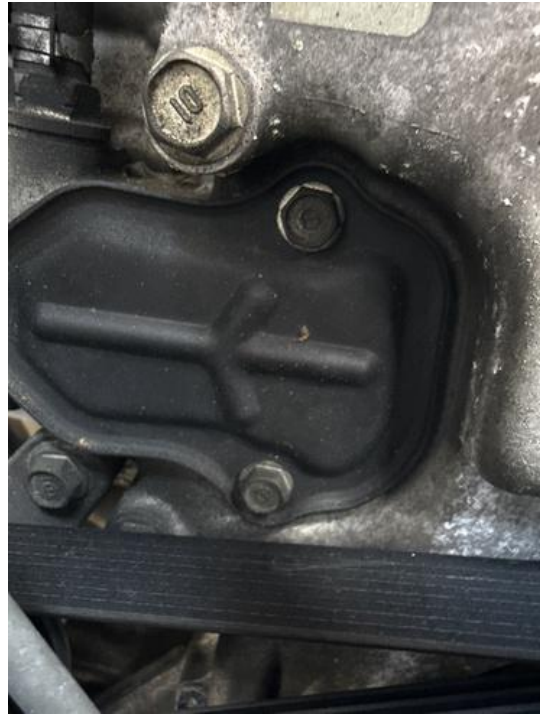
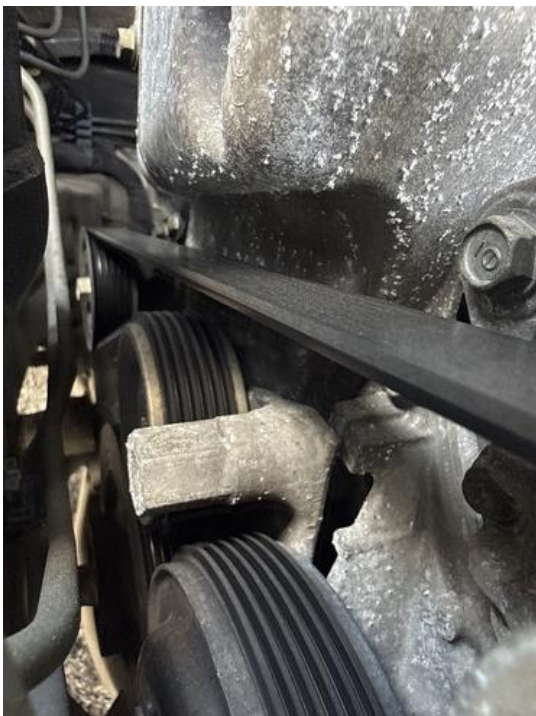
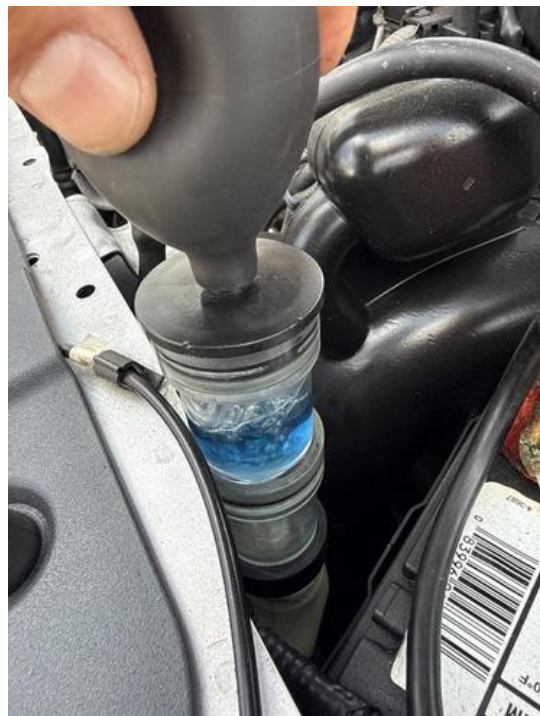
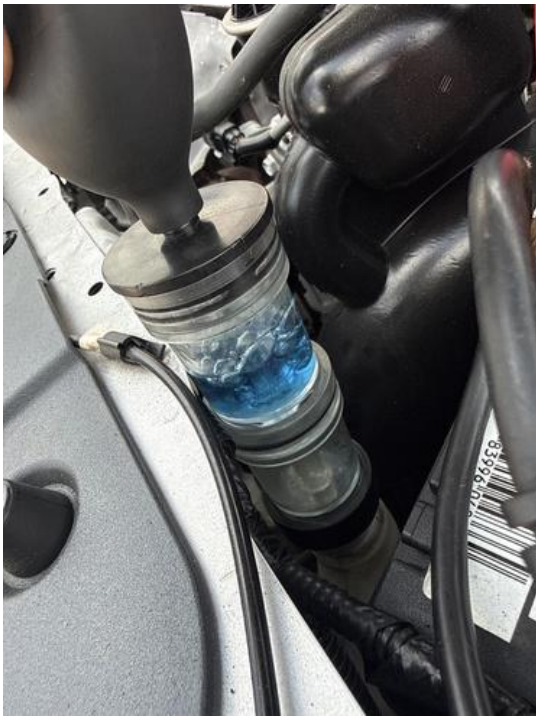
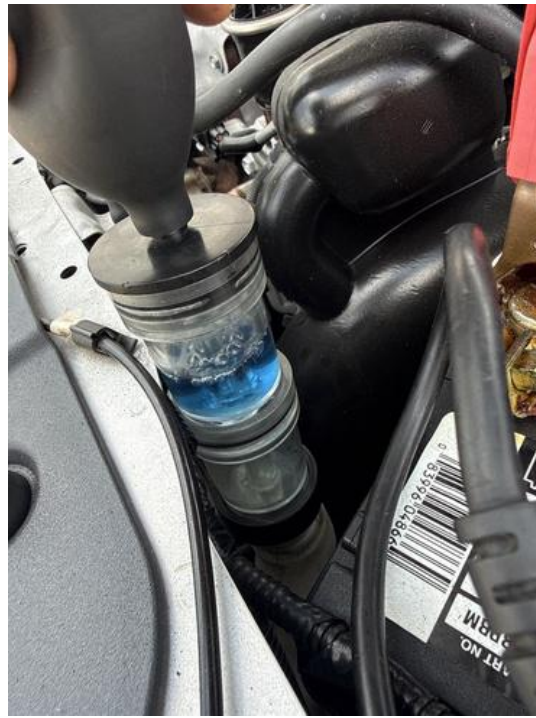
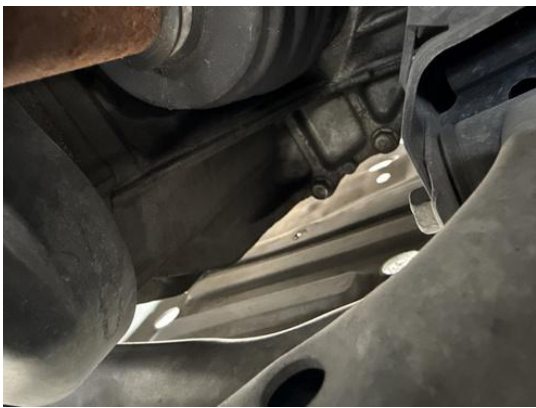
Engine clean internally, no gunk or sludge presents. Proper signs of maintenance present. Block test passed, no internal combustion leak out. Coolant mixture correct and cooling system functionality is healthy. All external engine accessories in good working. No leaks or seepage from anywhere on the engine. External drive belts in decent condition. Currently no concern in mechanical issues present in relation to the engine or related accessories.

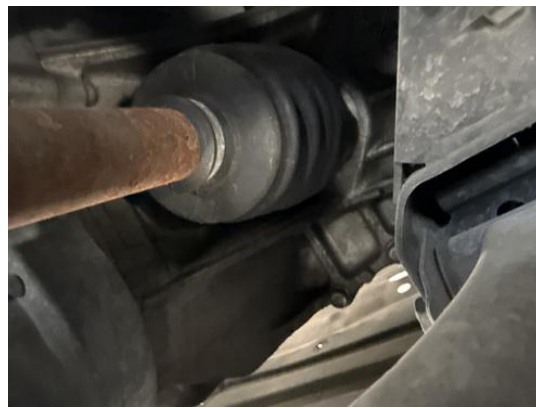
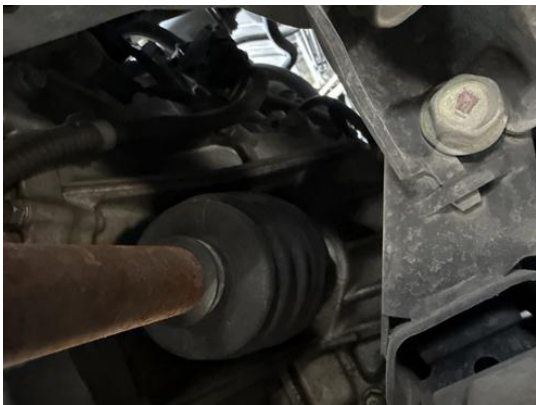
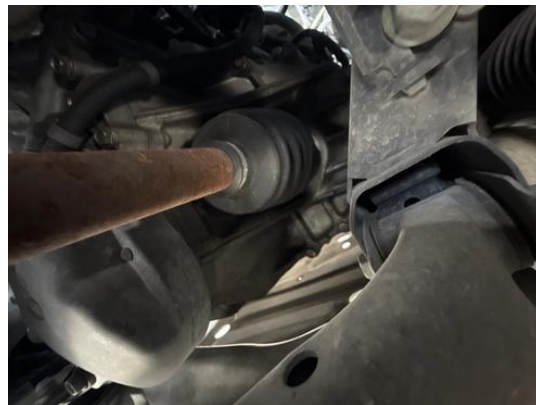
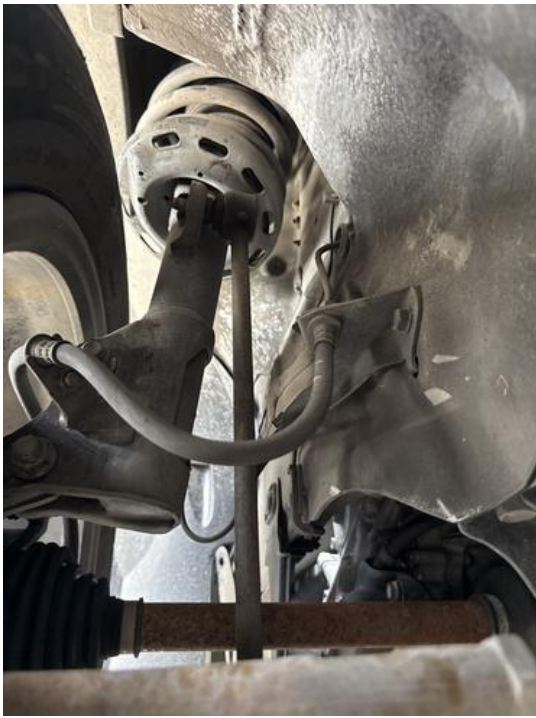
No transmission fluid leaks from the transmission casing or the transmission pan area. Both left and right side axle seals are free of any fluid leaks. Both left and right side CV axle are in healthy condition. Shift transitions out on the road are correct across the board.

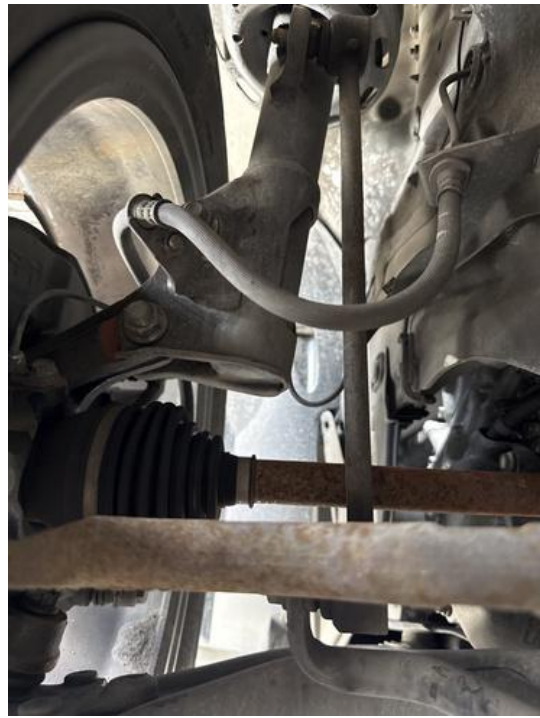
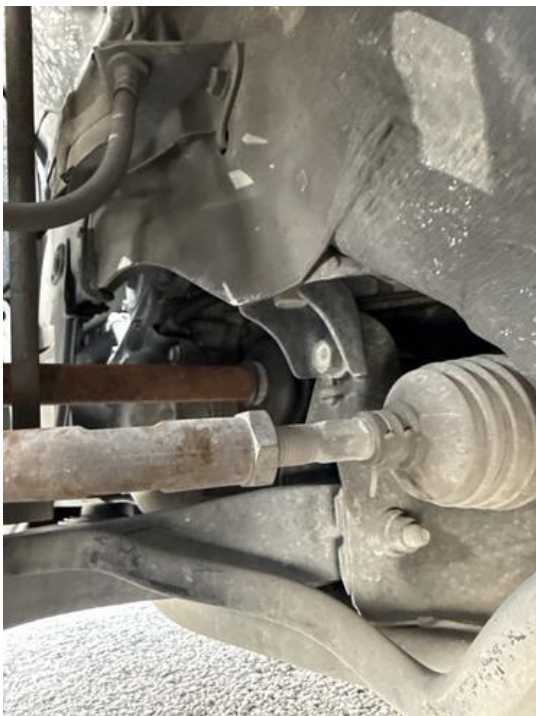
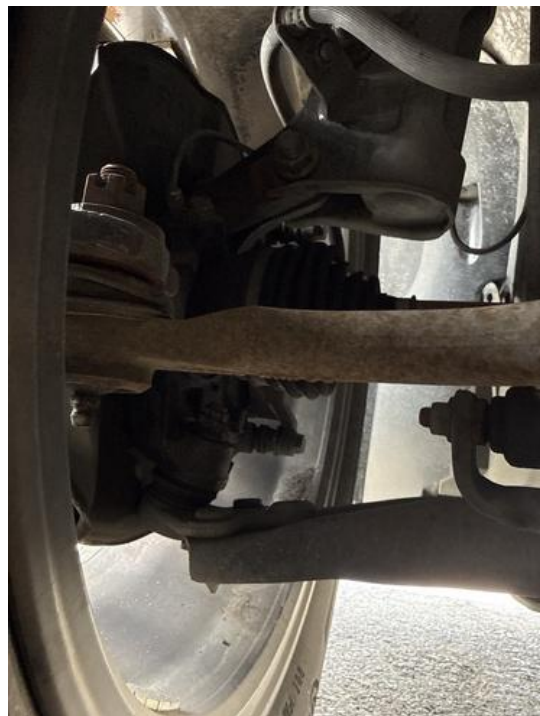
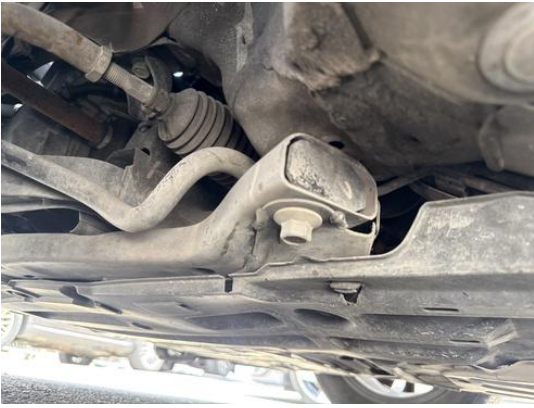
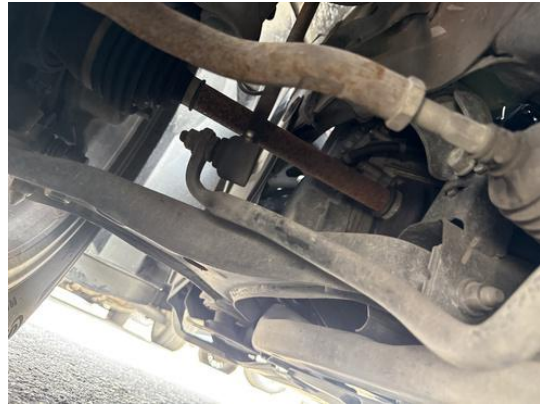
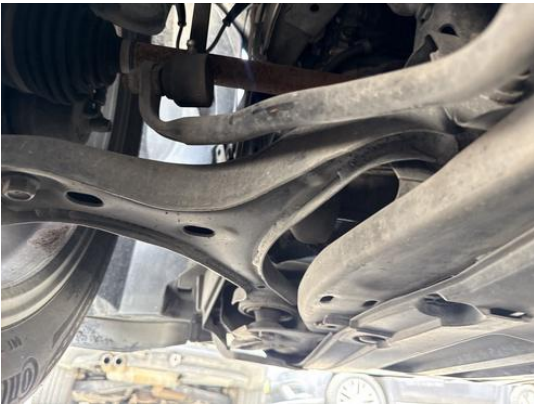
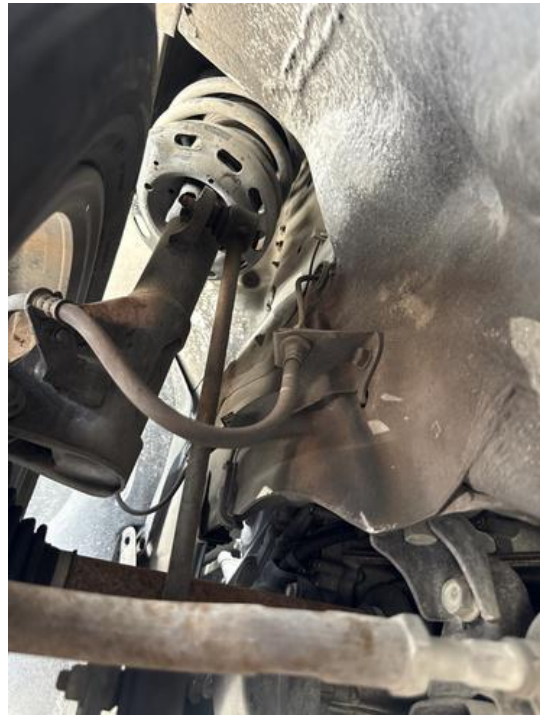
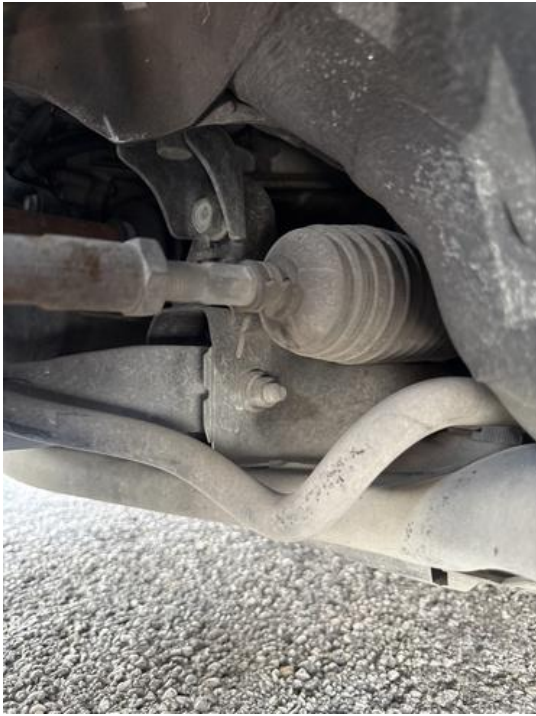
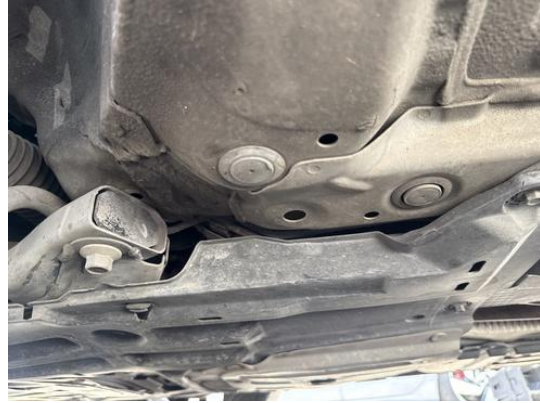
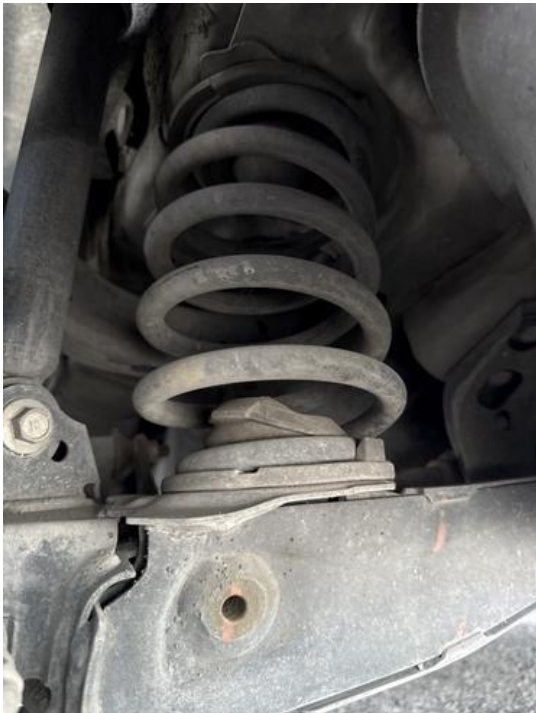
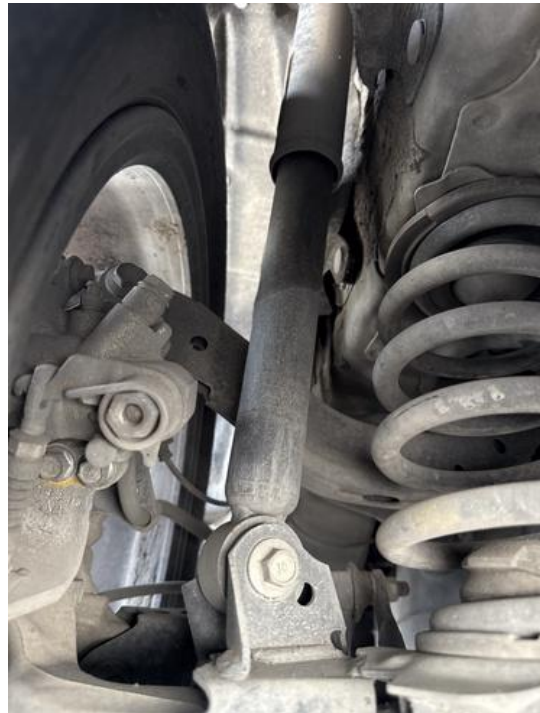
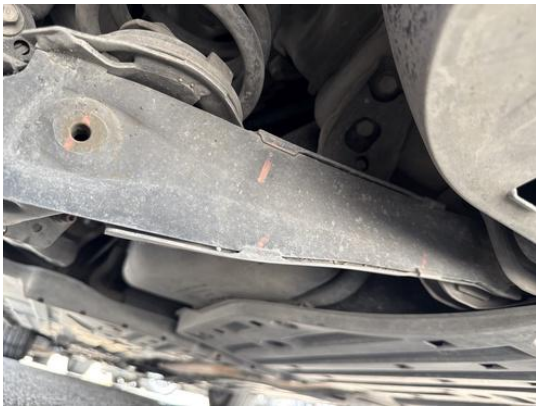
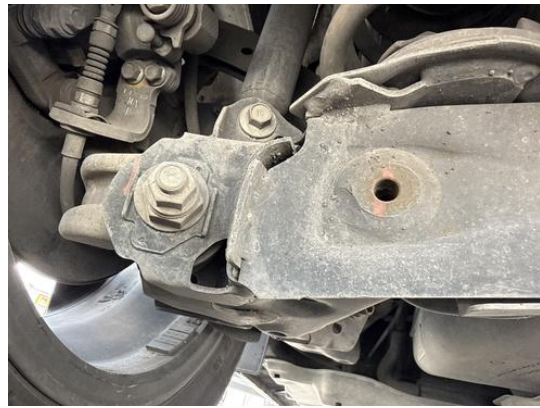
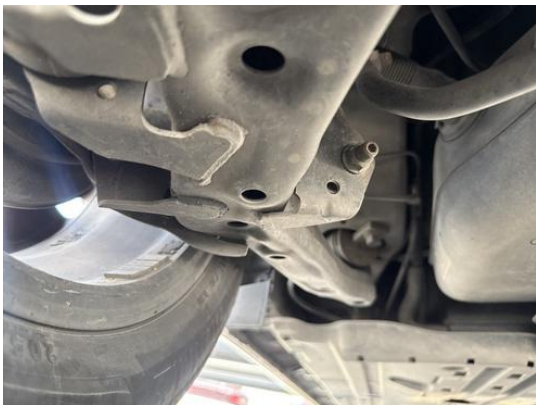
Normal fatigue notice to the suspension components. All of the suspension components seem to be original. None of the suspension components are blown out and due form the replacement. The No excessive surface rust on the exposed metal. No abnormal noise or feedback from the suspension while out on the road. All of the rubber in relation to the mounts, joints and bushings has decent texture.

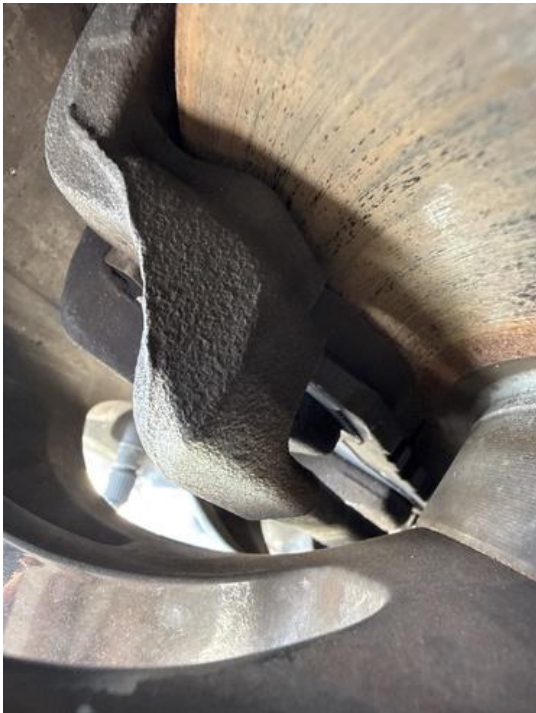
Photo 130

<p>Photo 130 Photo 131</p>	
Rear brake pad life remaining	75-100% remaining
