## Peace of Mind Automotive Inspection Report.

**Joe Trejo Jr.**  
**210-557-0686**

| Vehicle Year / Make / Model / Color | | | | 2014 ford f150 | |

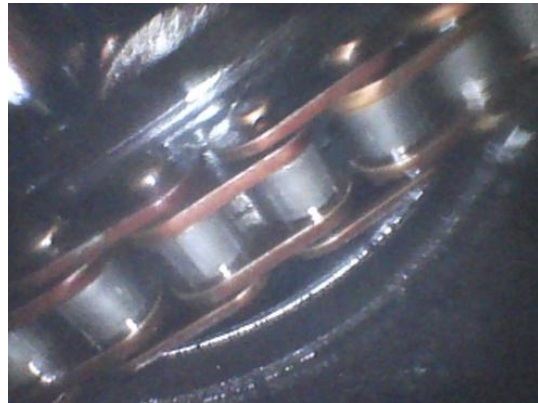
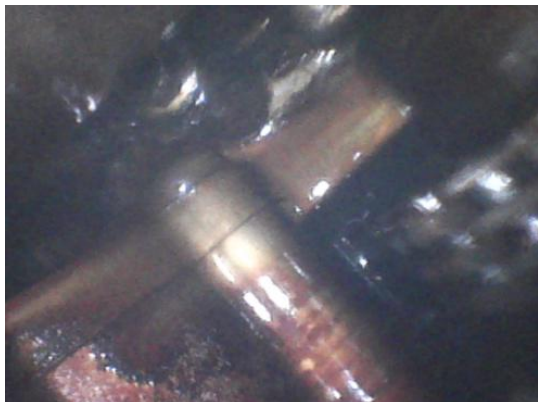
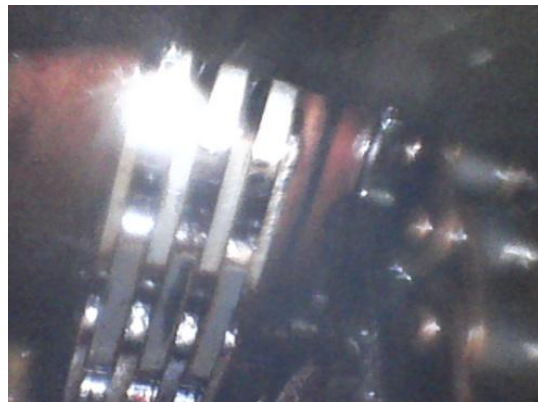
Photo 137

Engine clean internally, no gunk or sludge presents. Proper signs of maintenance present. Block test passed, no internal combustion leak out. Coolant mixture correct and cooling system functionality is healthy. All external engine accessories in good working. No leaks or seepage from anywhere on the engine. External drive belts in decent condition. Currently no concern in mechanical issues present in relation to the engine or related accessories.

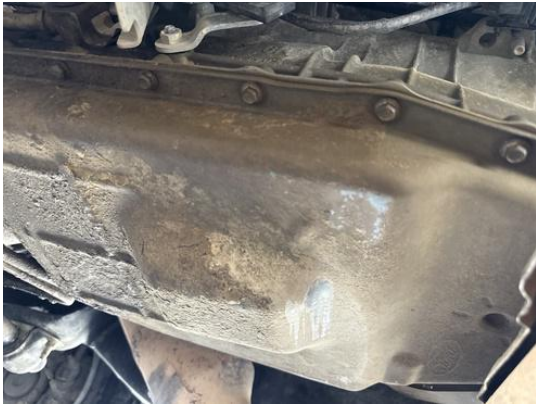
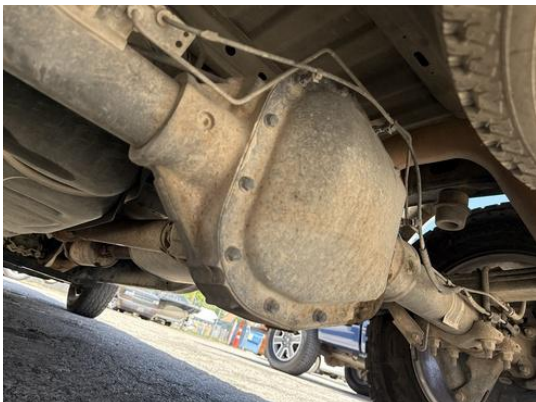
Photo 156

| Transmission / Differentials | |
|---|---|
| <p>No transmission fluid leaks from the transmission casing or the transmission pan area. The tail shaft seal is free of any fluid leaks. The driveshaft is in healthy condition. Shift transitions out on the road are correct across the board. No fluid leak out from the rear differential.</p> | |

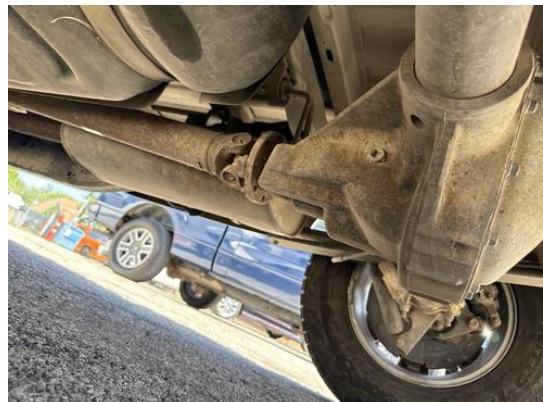
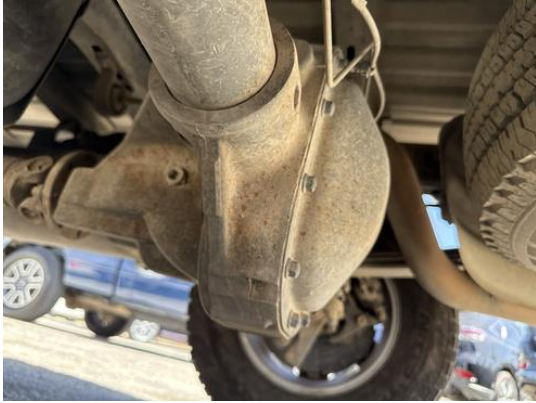
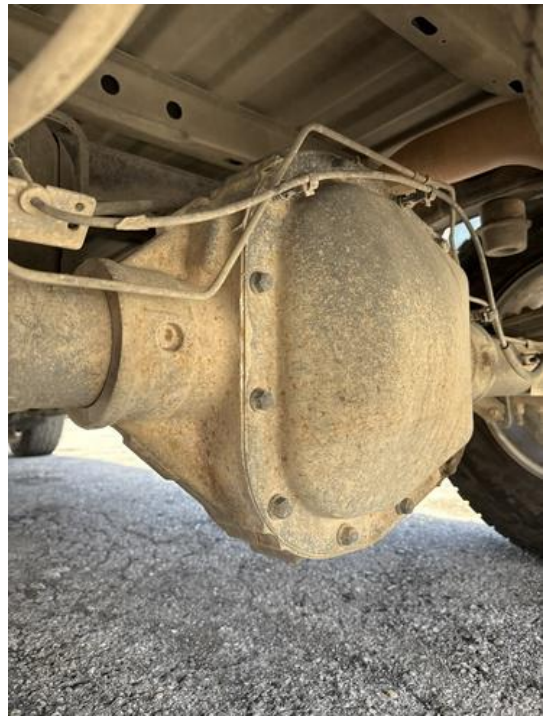
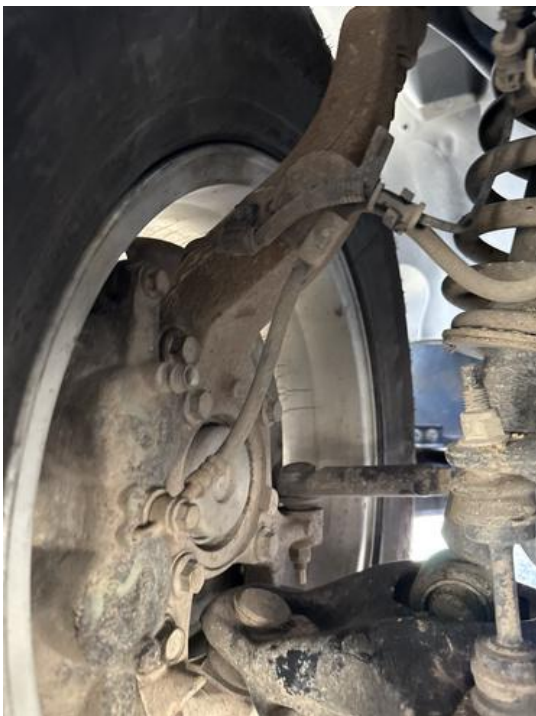
Photo 161

| Transmission / Differentials | |
|---|---|
| Rear differential condition | Healthy |
| Differential leaks | None |

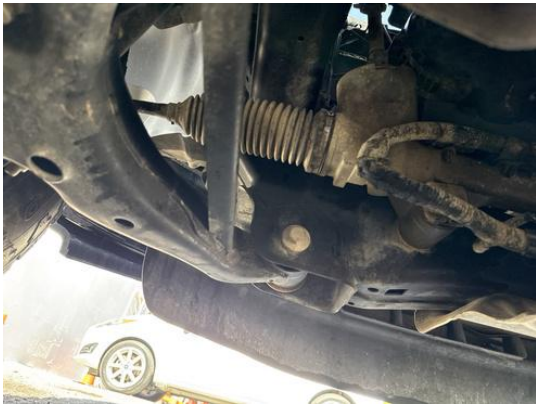
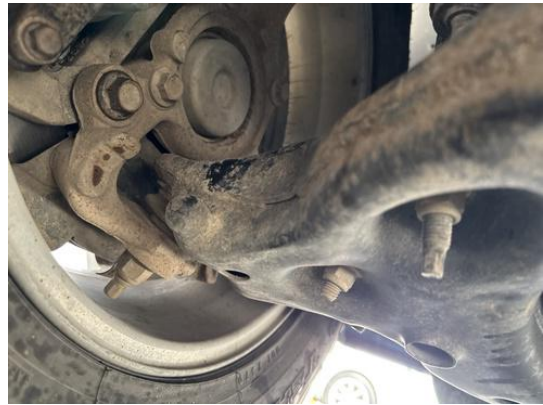
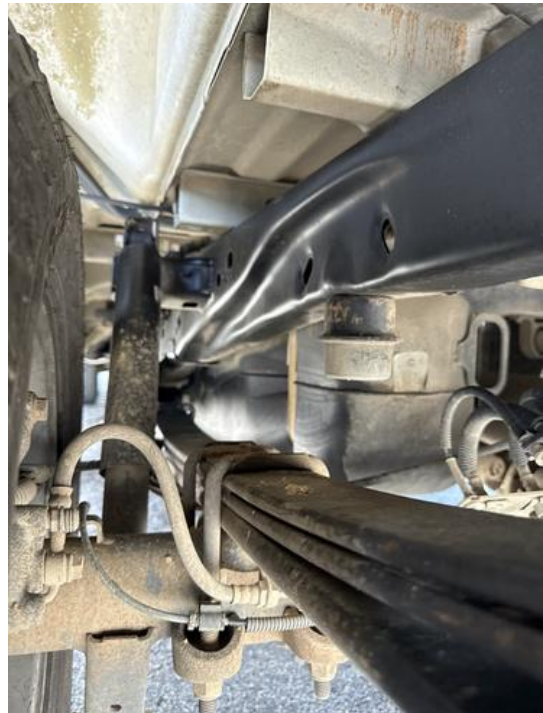
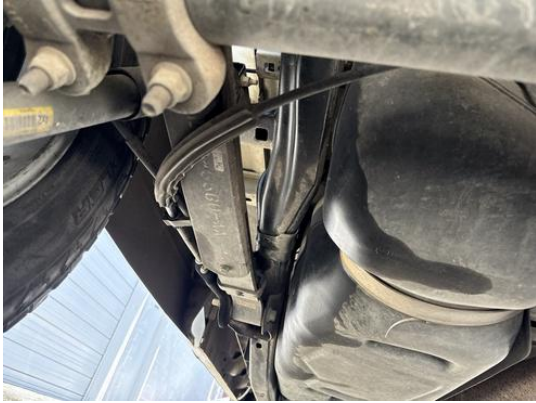
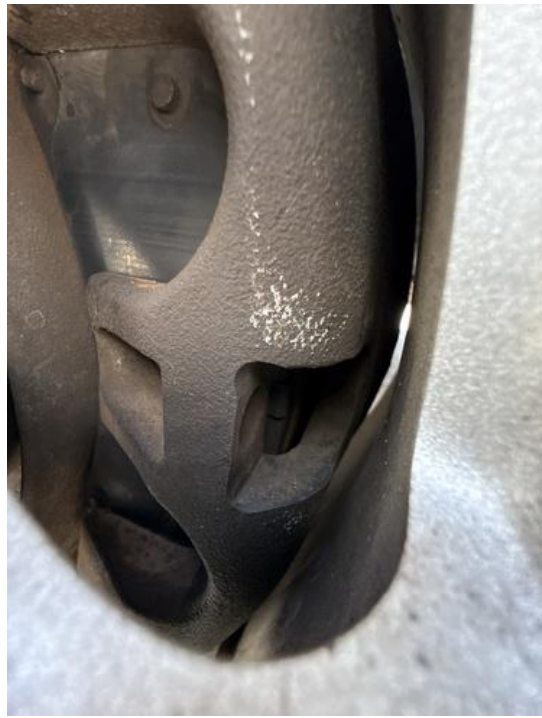
Photo 168

Normal fatigue notice to the suspension components. All of the suspension components seem to be original. None of the suspension components are blown out and due form the replacement. The No excessive surface rust on the exposed metal. No abnormal noise or feedback from the suspension while out on the road. All of the rubber in relation to the mounts, joints and bushings has decent texture.

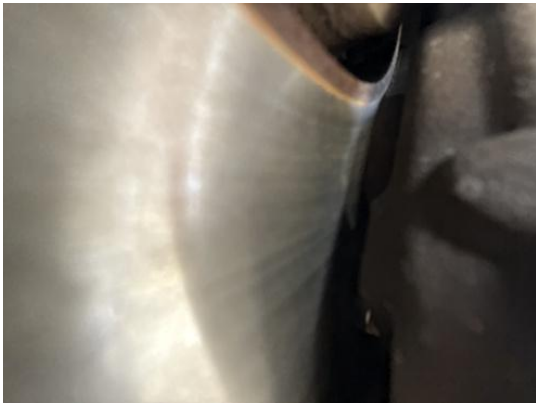
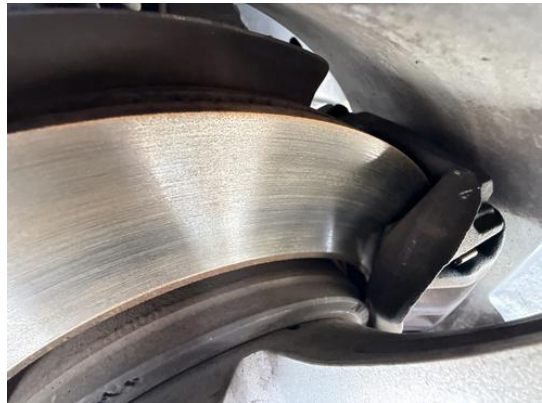
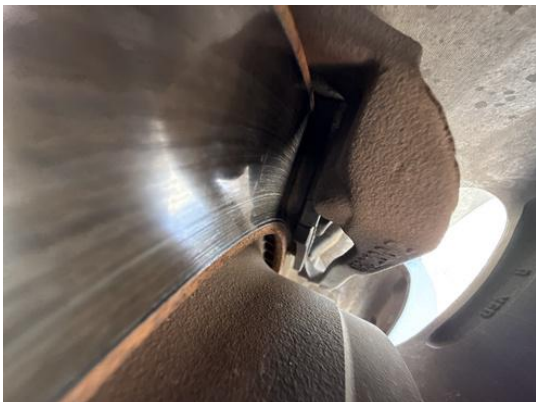
Photo 180

| Braking system condition | |
|---|---|
| Brake fluid condition | Healthy |
| Brake fluid leaks | None |
| Moisture content in brake fluid | None |
