Peace of Mind Automotive Inspection Report.

Site conducted	Unanswered
Customer name	Luis LMJ auto motor sales
Date / Time	Jan 21st
Payment method	Invoice
Inspection cost	199
Vehicle Year / Make / Model / Color	2013/14 ford f150

VIN	24733 last 5
------------	--------------

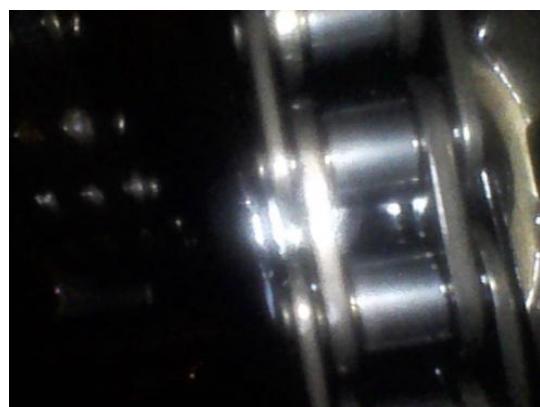
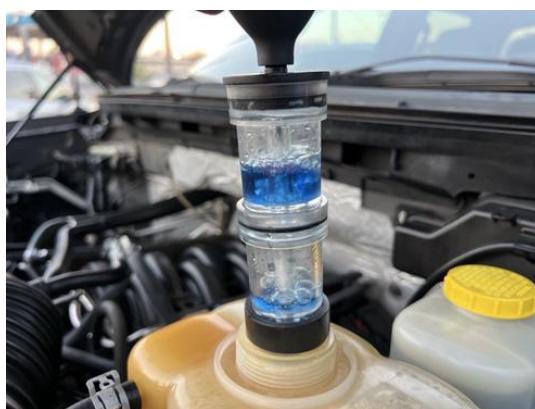
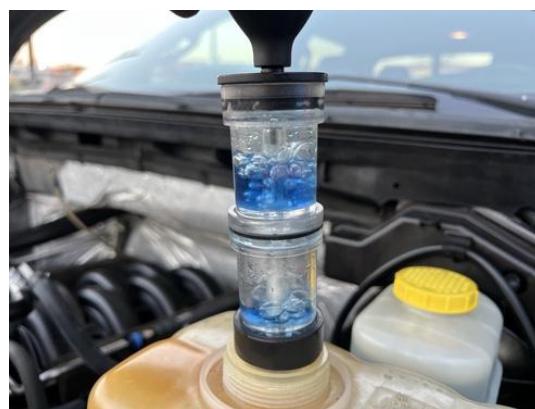
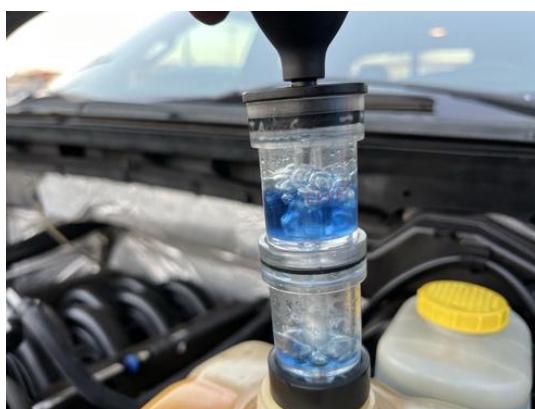
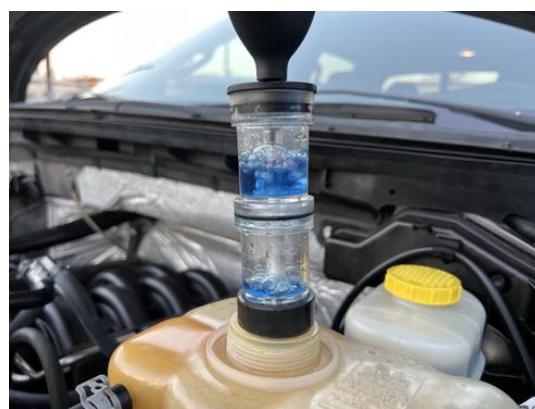
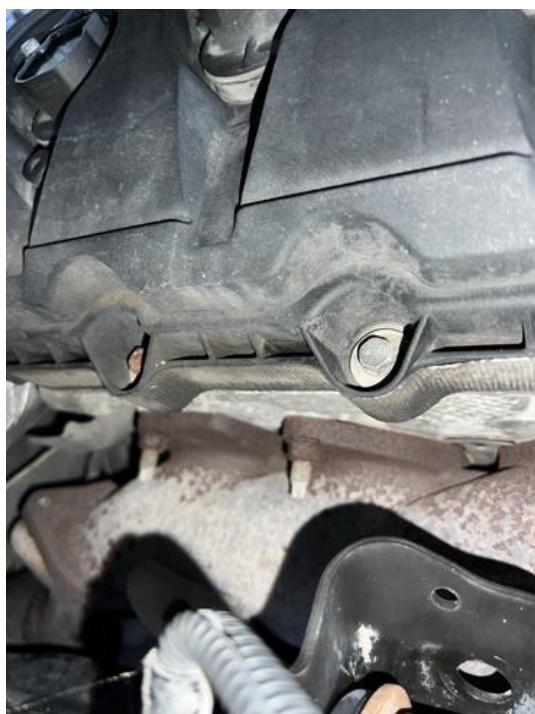
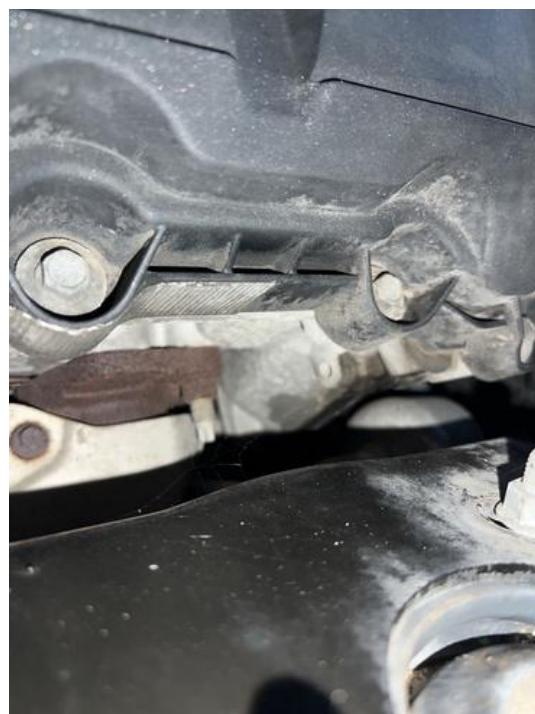
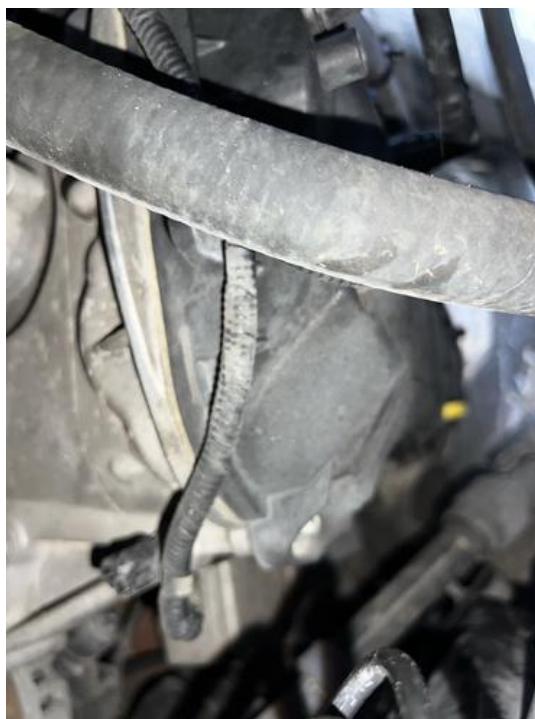
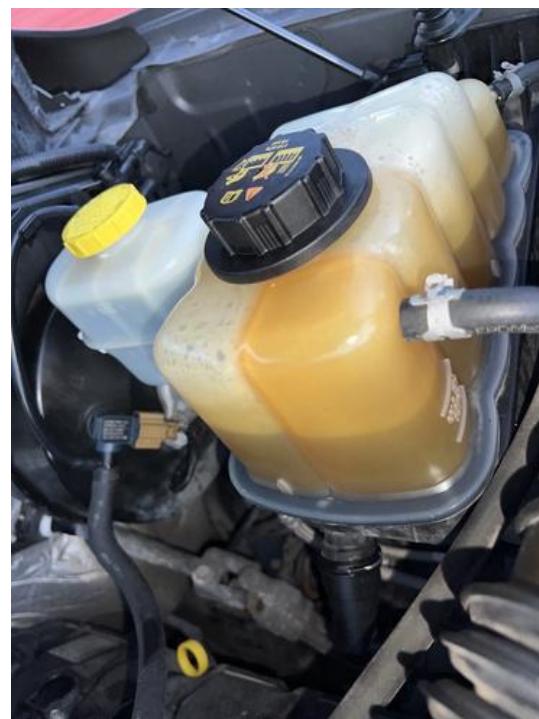
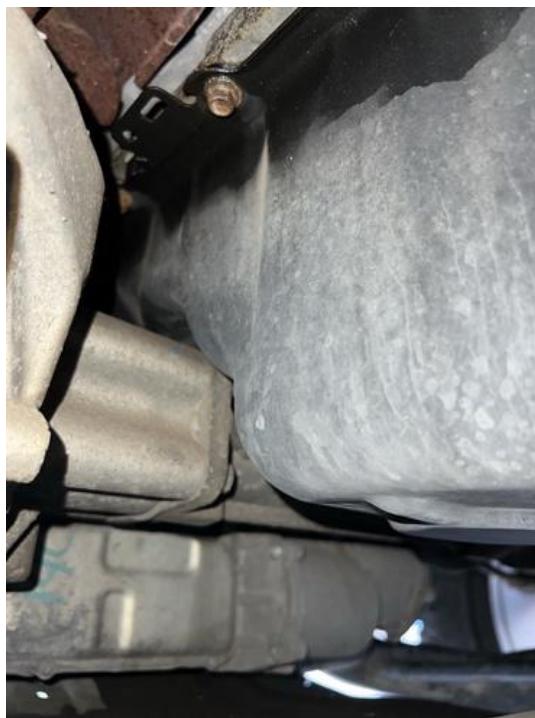
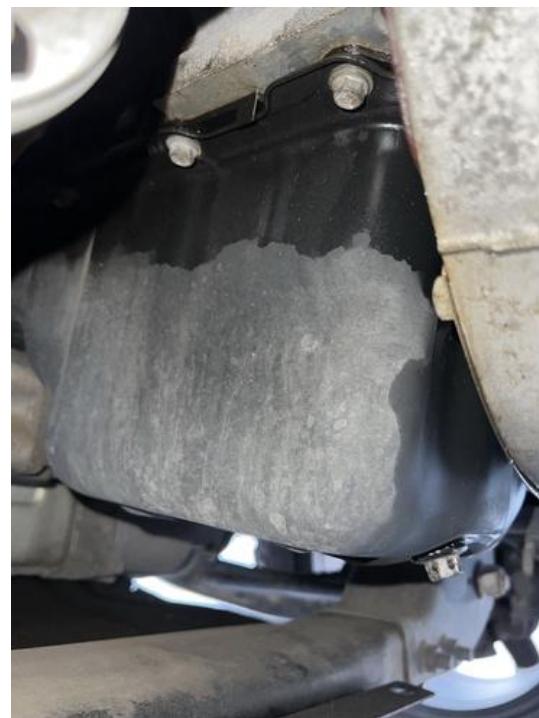
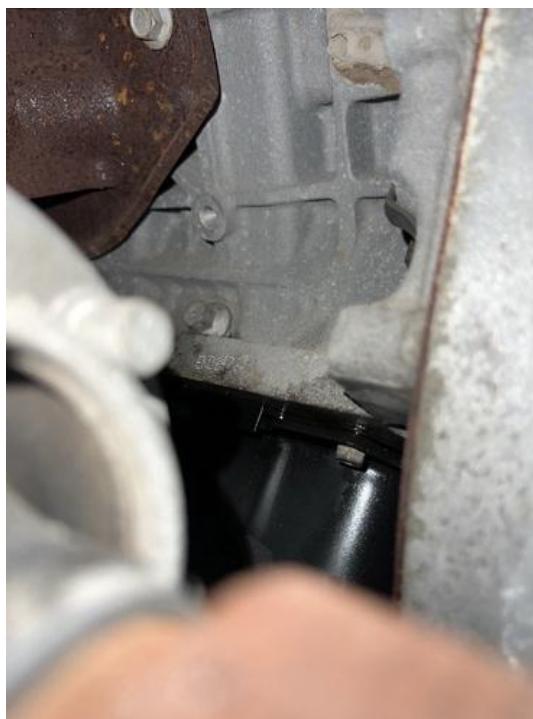
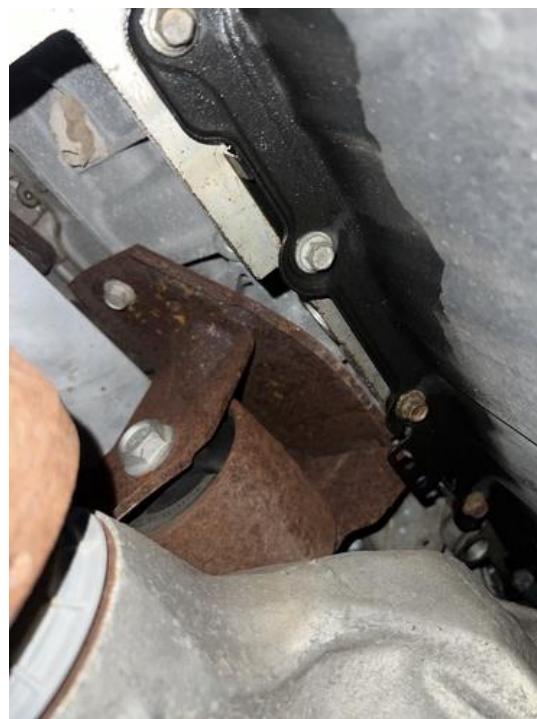
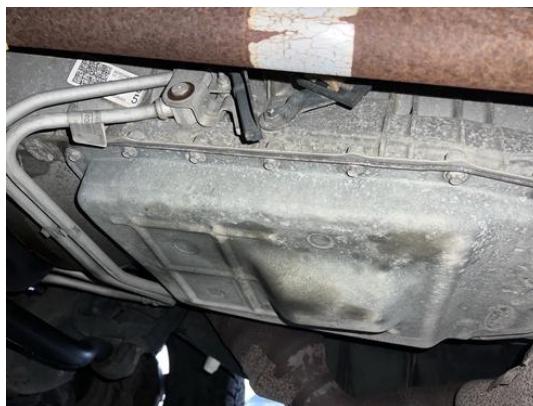
There was a small amount of oil residue noticed around the oil pan gasket area, as well as at the engine and transmission meeting points. This was only oil residue, no fresh fluid leak out at the time of the inspection. A future repair to expect down the road will likely be resealing of the oil pan gasket and potentially replacement of the rear main seal.

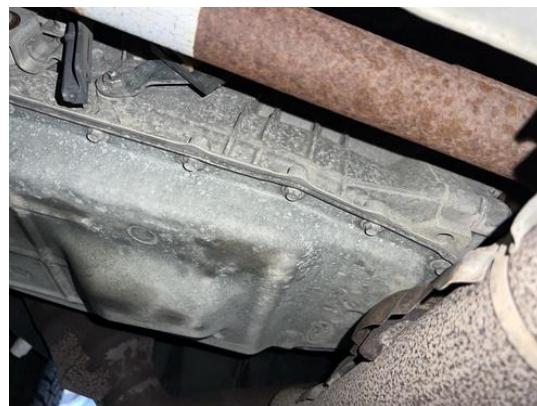
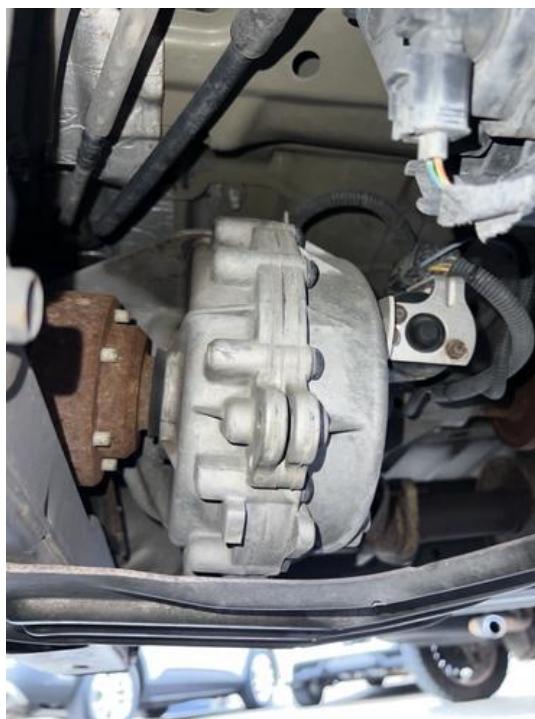
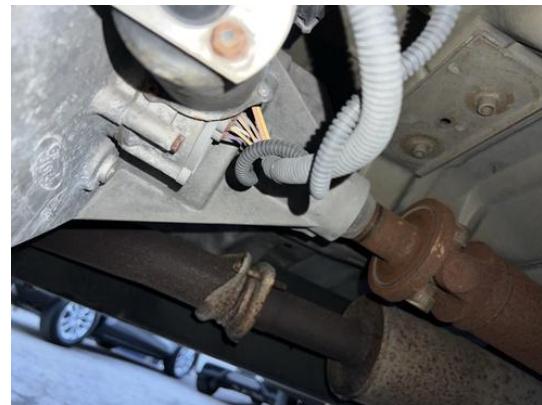
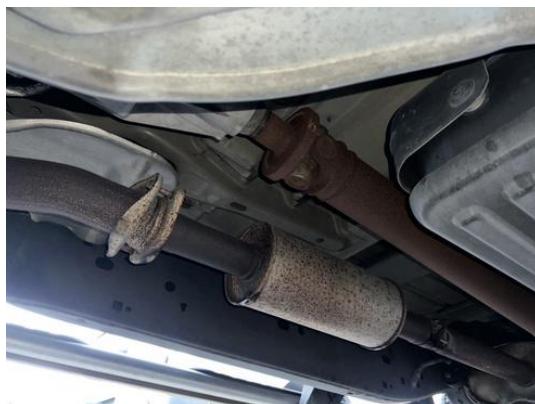
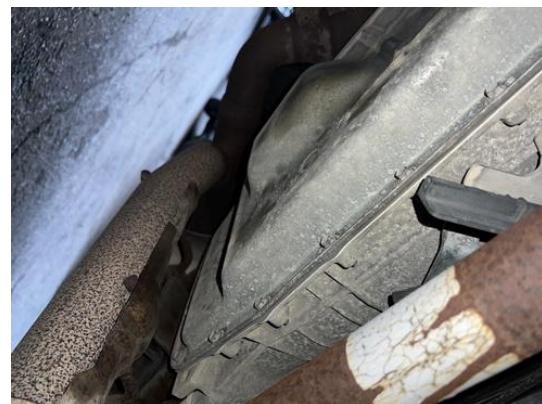
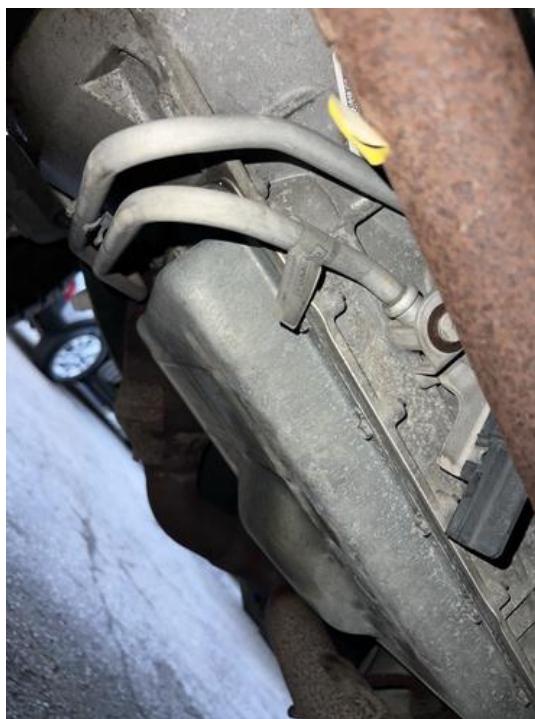
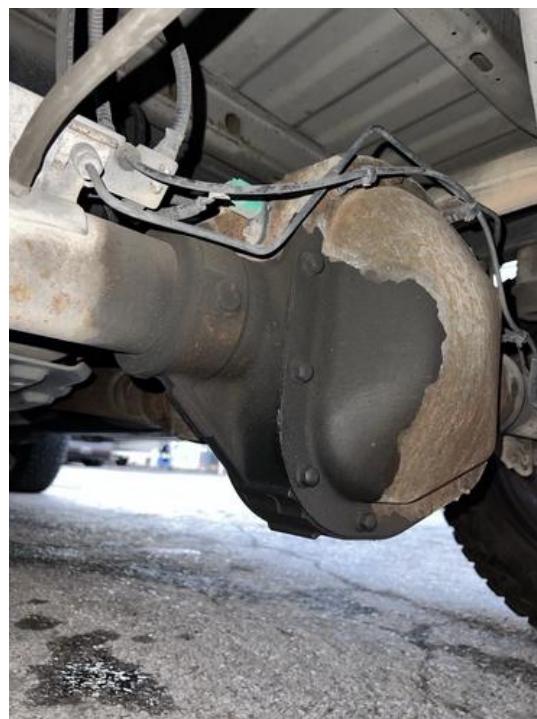
No transmission fluid leak out from the transmission casing or the transmission pan area. Drive shaft and seal is free of any fluid leaks. The rear differential is free of any fluid leak out. Shift transitions out on the road are correct across the board. 4 x 4 system functionality is correct.

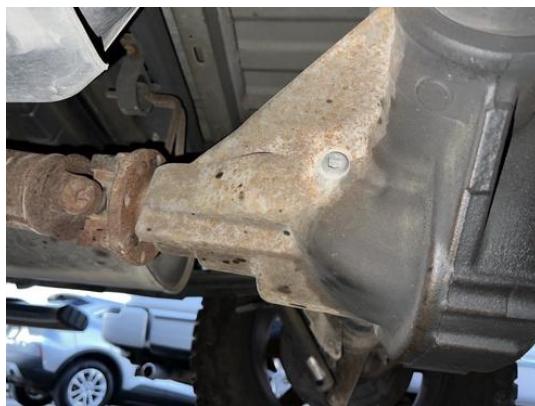
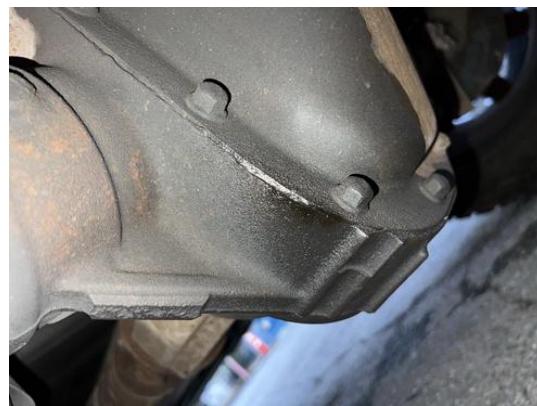
Small amount of fluid residue noticed around the rear differential area, no attention is needed as of now, but a future repair to expect will be resealing of the rear differential

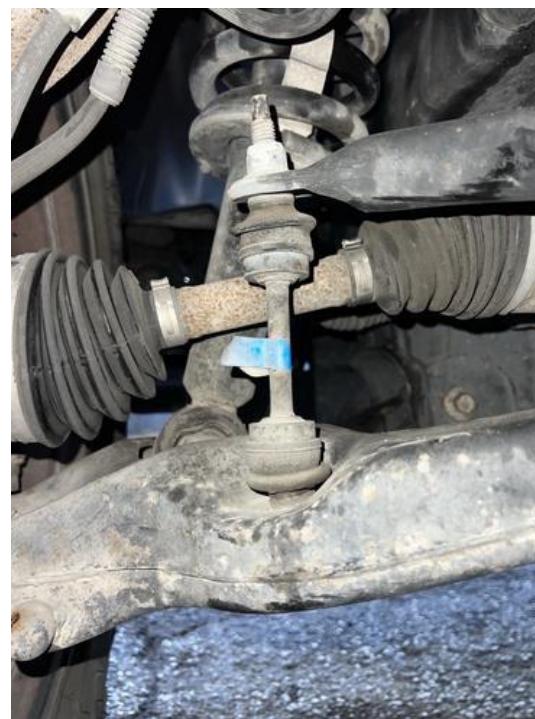
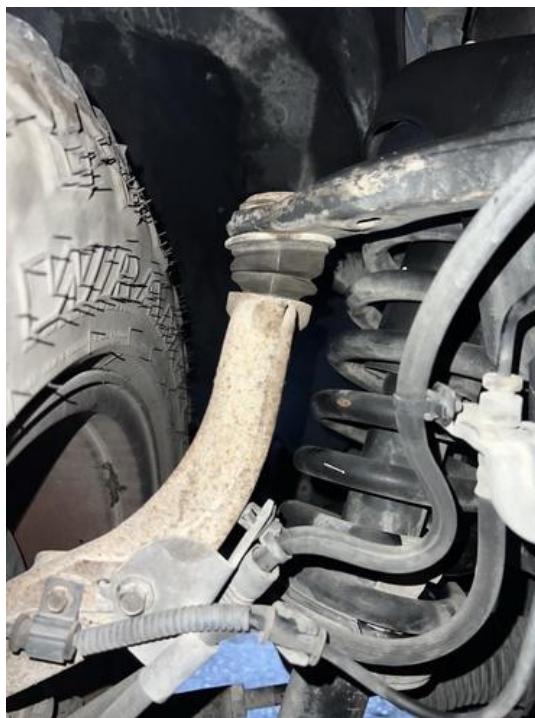
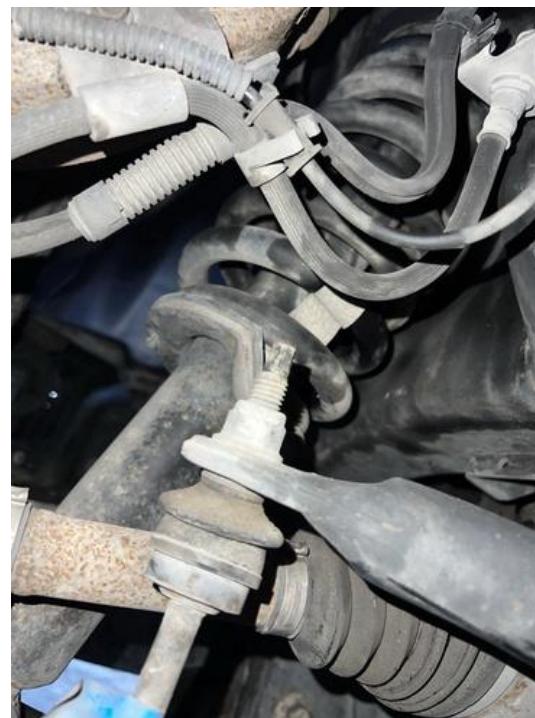
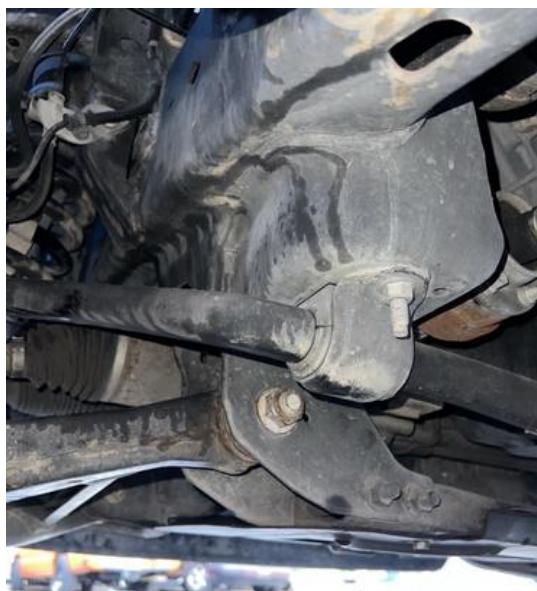
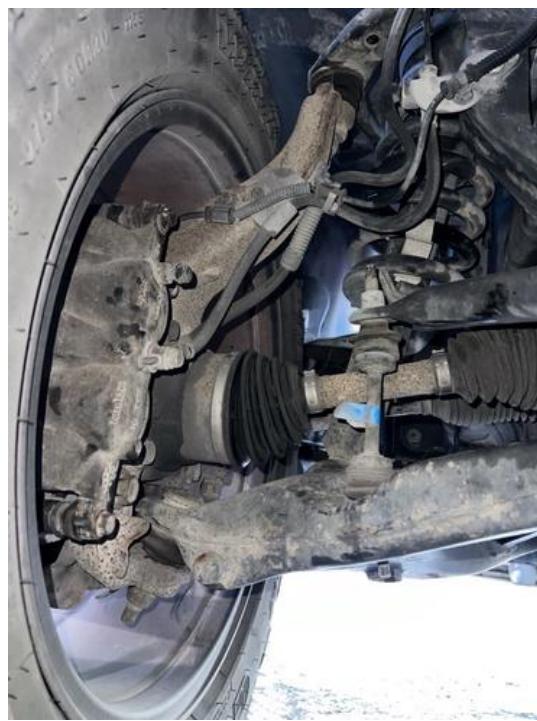
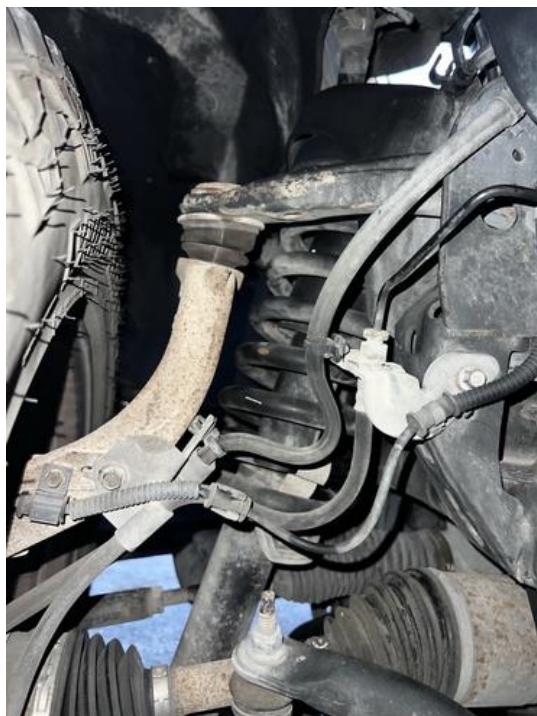
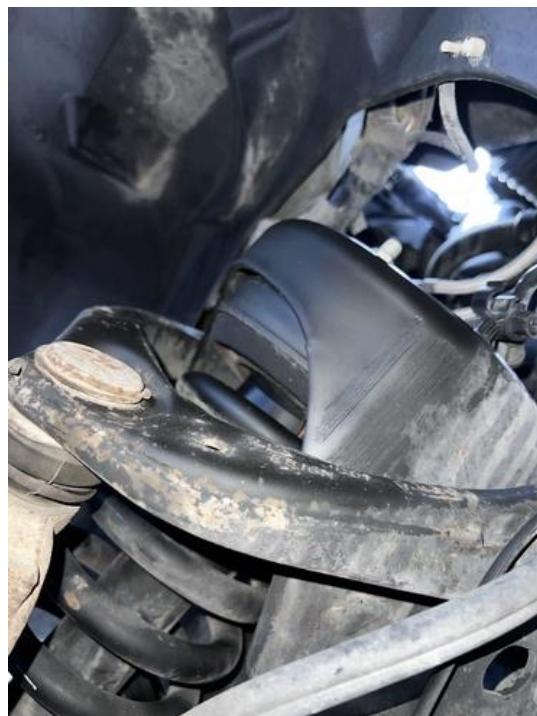
Normal fatigue notice to the suspension components. All of the suspension components seem to be original. None of the suspension components are blown out and due form the replacement. The No excessive surface rust on the exposed metal. No abnormal noise or feedback from the suspension while out on the road. All of the rubber in relation to the mounts, joints and bushings has decent texture.
